Site Visit Report

Licensee	
Name of Installation	Boliden Tara Mines Limited
Licensee	Boliden Tara Mines Designated Activity Company
Licence Register No.	P0516-04
CRO Number	33148
Site Address	Knockumber, Navan, Meath, C15 NH63
Site Visit Reference No.	SV33332

On 12/11/2025, Boliden Tara Mines Designated Company (the licensee) Industrial Emissions (IE) Licence Reg. No. P0516-04, notified the Agency of a failure of the tailings pipeline on the Knockumber mine site (Incident Ref. No. INCI031562). Following the notification of the incident, the Agency conducted a site visit to investigate the release of tailings from the pipeline failure to the surrounding ground.

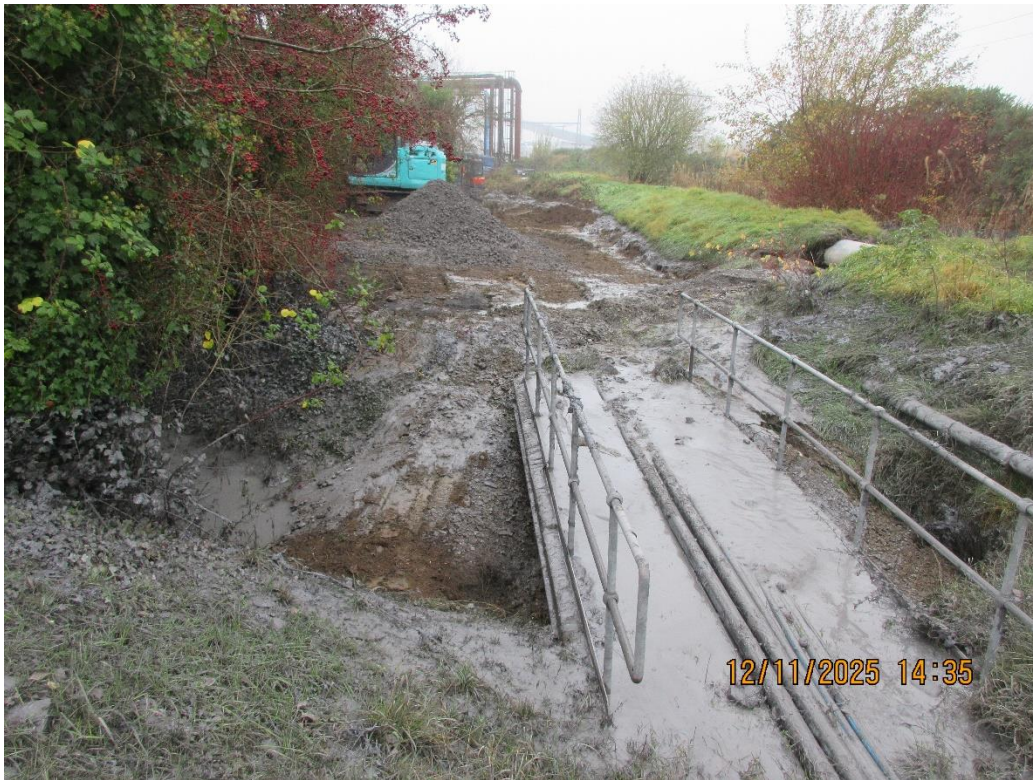
The licensee explained that the differential pressure alarms had been activated at 05:30 on 12/11/2025, and the AG mill went into shutdown at 05:36. The pipeline was then flushed out with water to prevent blockages. The licensee then conducted a walkover of the pipeline, during which they discovered the location of the failure. At the time of the failure, the licensee was backfilling and the content of the pipeline consisted of fine tailings and water being pumped at a rate of approximately 2,000m³/hr. The licensee estimated that the fine tailings accounted for approximately 5% of the contents of the tailing pipeline with the rest being water. It was later estimated that between 250 to 300 tonnes of tailings solids were released to the surrounding area due to the failure of the pipeline.

Photograph 1: Tailings in the area around the pipeline failure.

- Replaced the failed pipeline section and resumed site operations;
- Tankered all pooled carrying water away from the site of the incident;
- Sent the failed pipeline section for integrity testing; and,
- Began works to remove and replace the affected soil at the site of the incident.

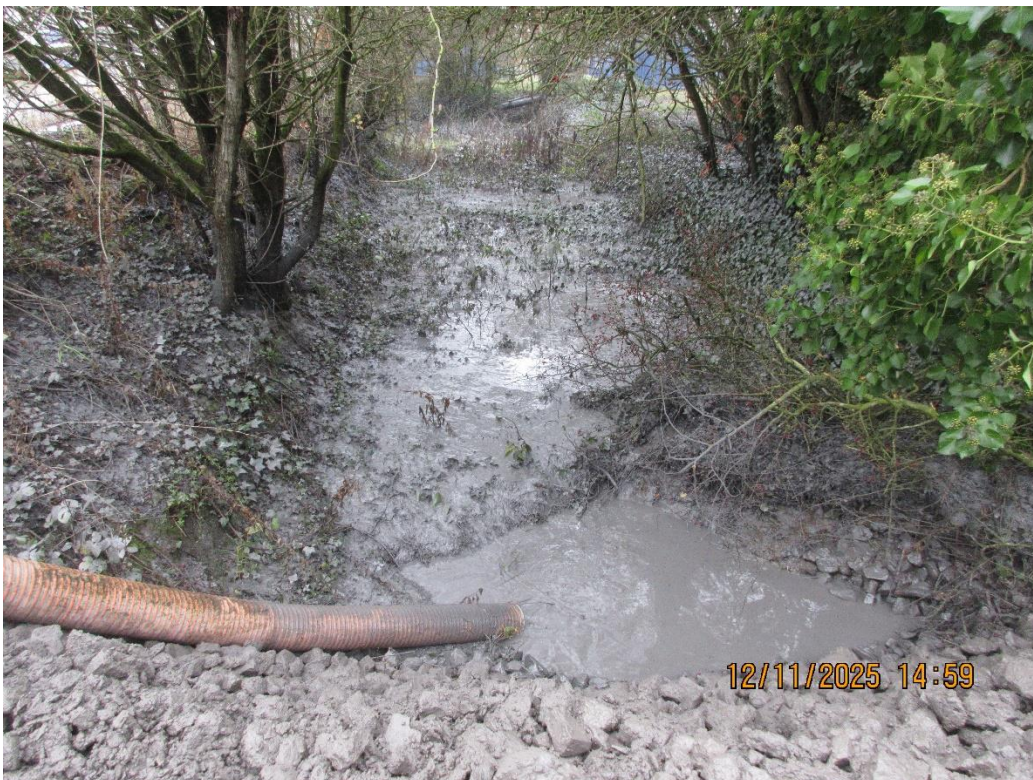
Photograph 2: Drainage ditch on near side of access road

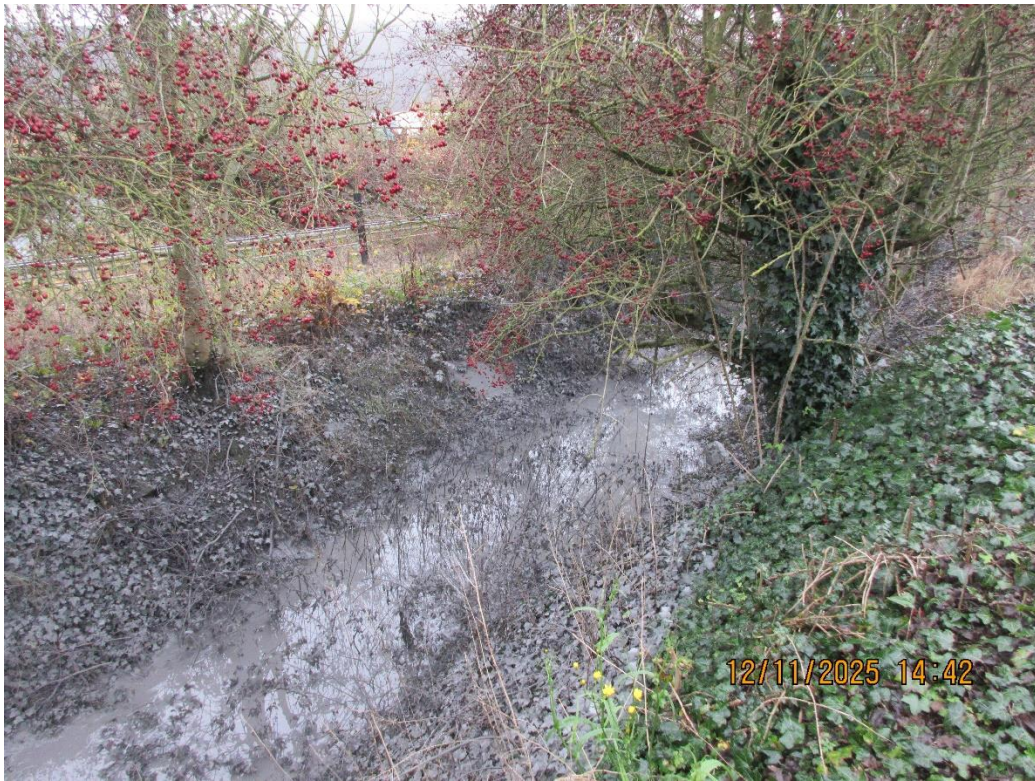
Photograph 3: Drainage ditch on far side of access road

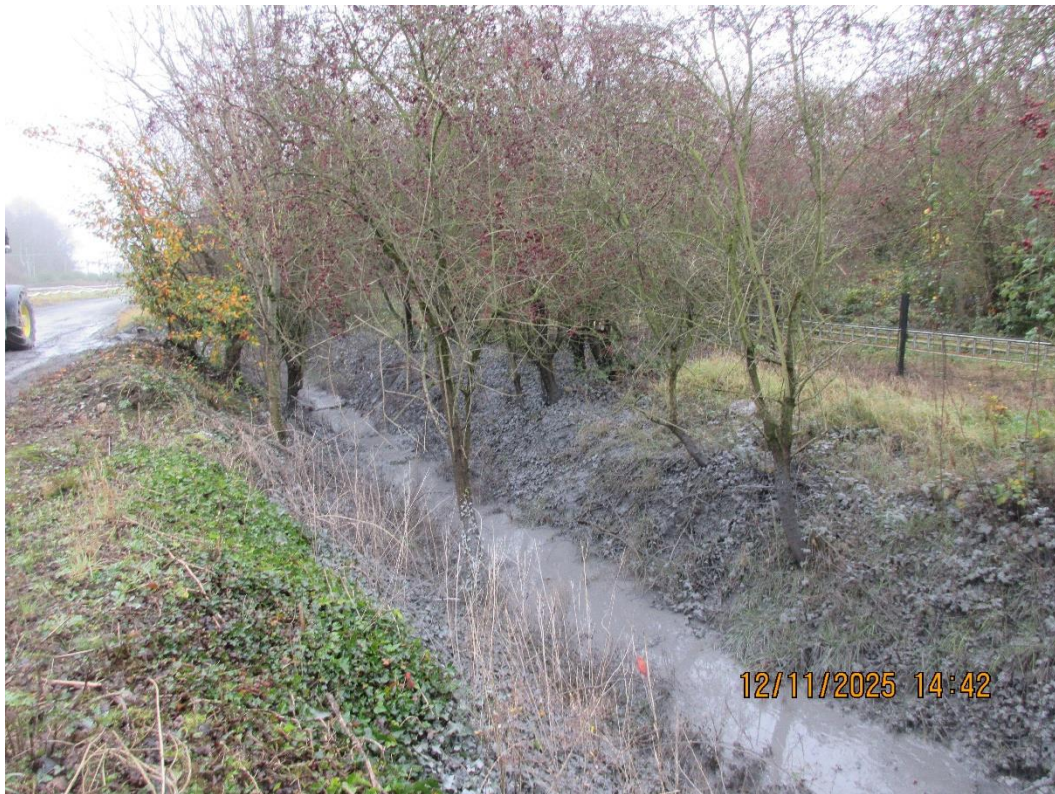
Photograph 4: Drainage ditch on far side of access road

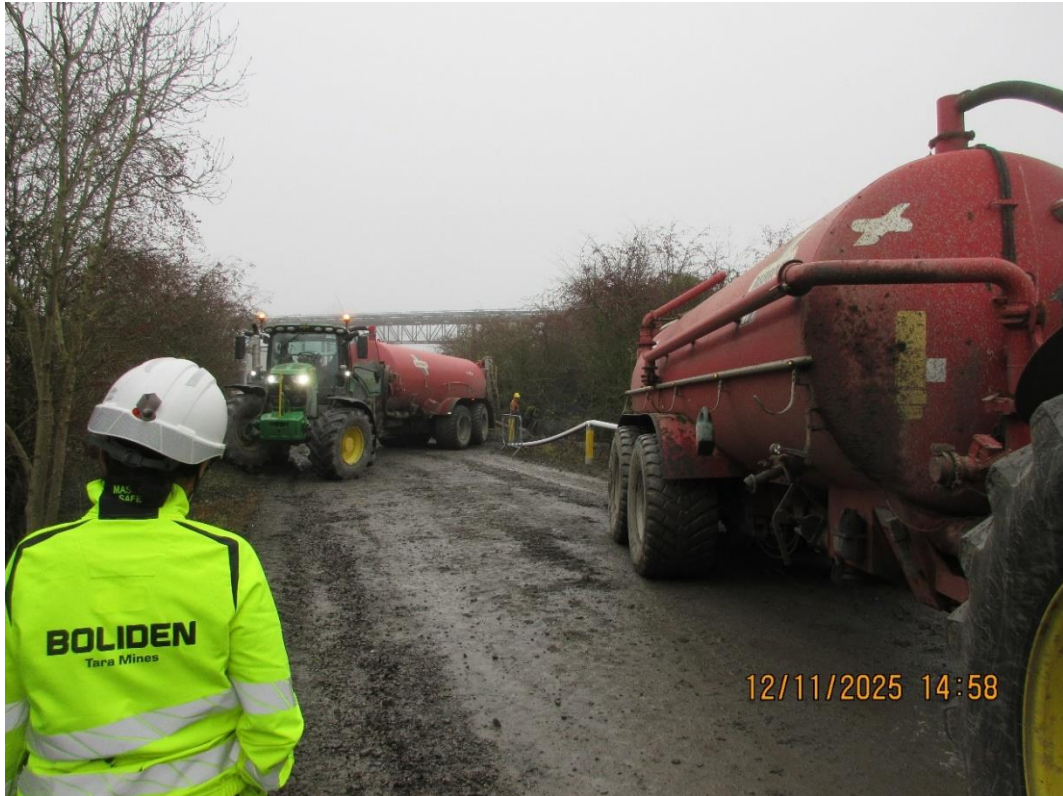
On 12/11/2025, the licensee notified the Agency of an incident (Ref No. INCI031562) regarding an uncontrolled release of tailings on the licenced site due to a failure of the tailings pipeline. Following the notification, the Agency conducted a site visit at the Knockumber mine site. The Agency inspected the location of the incident and the area where the pipeline failure had occurred. Tailings was observed coating the drainage ditches on either side of the nearby access road (Photographs 1, 2, 3 and 4 refer). Tankers were present at the site of the incident pumping water from the drainage ditches for disposal in the Tailings Management Facility (TMF) (Photograph 5 refer).

Photograph 5: Tankers extracting tailings-carrying water

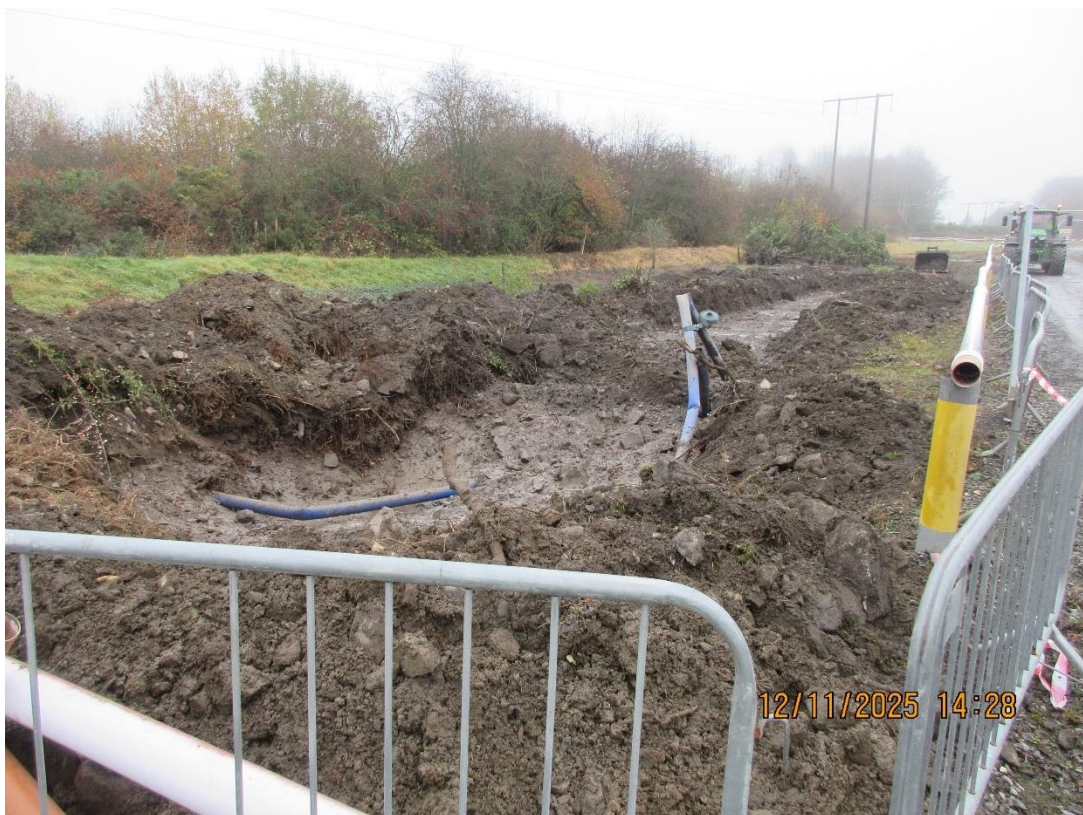
The licensee also informed the Agency that the drainage ditch beside the pipe was connected to a culvert that drained to the site surface water pond. To prevent further mobilization of the tailings and water, the licensee constructed two berms, one within the drainage ditch in front of the culvert and the other beside the road (Photographs 6 and 7 refer). The Agency inspected the site surface water pond and observed that the water was grey in colour and some of the vegetation was stained with a grey material (Photographs 8 and 9 refer). The licensee took a sample at a manhole upstream of the site surface water pond, which was observed to be clear in appearance (Photograph 10 refers). Prior to the Agency arriving onsite, the licensee took a number of samples from the surface water ponds onsite to determine if there was any evidence of contamination as a result of the incident. Subsequent results from these samples received by the Agency under Incident Report INCI031562 indicated that there was no evidence of contamination in the surface water ponds and the results were within the licence limits for emission to water at emission point ref. no. SW1. The licensee explained that after passing through the site surface water ponds, the water would drain to the reclaim water ponds in the mine water pond system.

Photograph 6: Containment berm beside access road

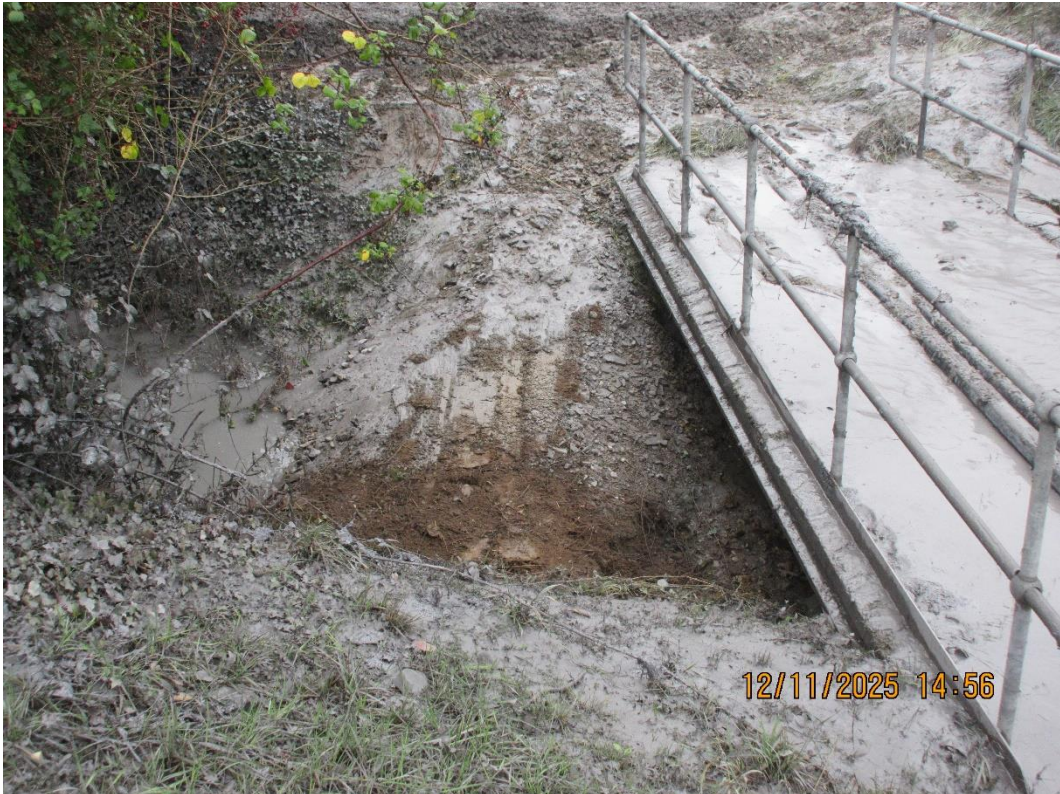
Photograph 7: Containment berm in drainage ditch

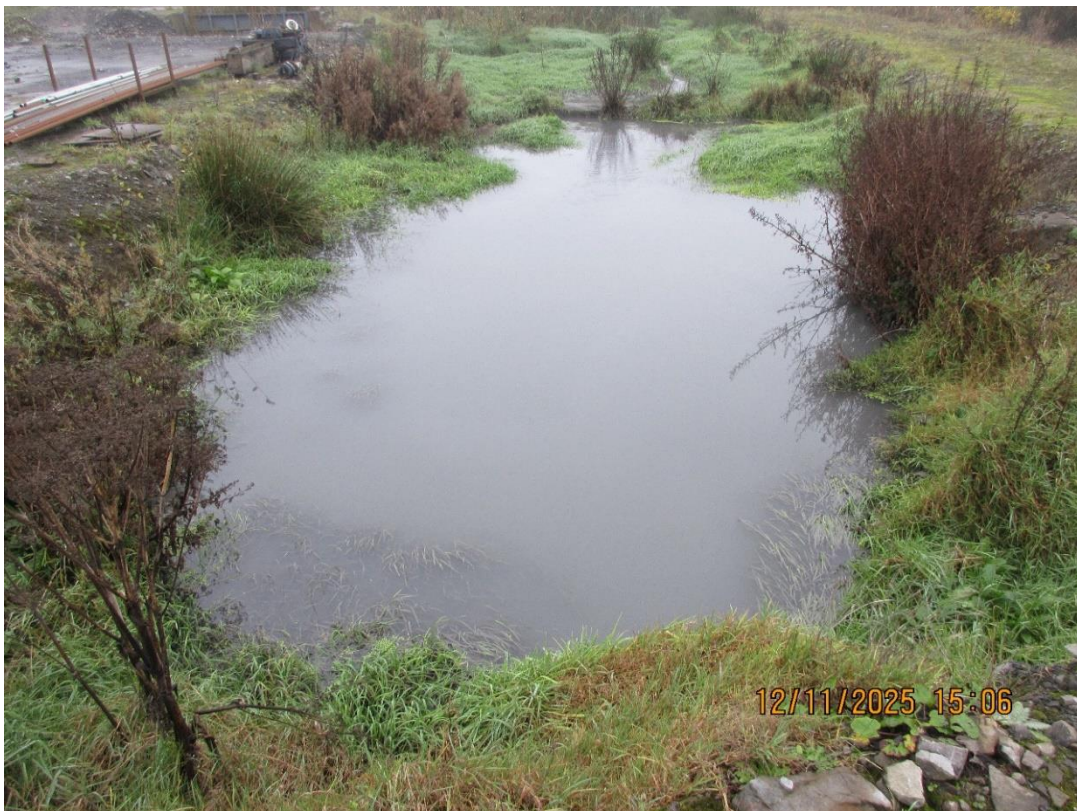
Photograph 9: Site surface water pond

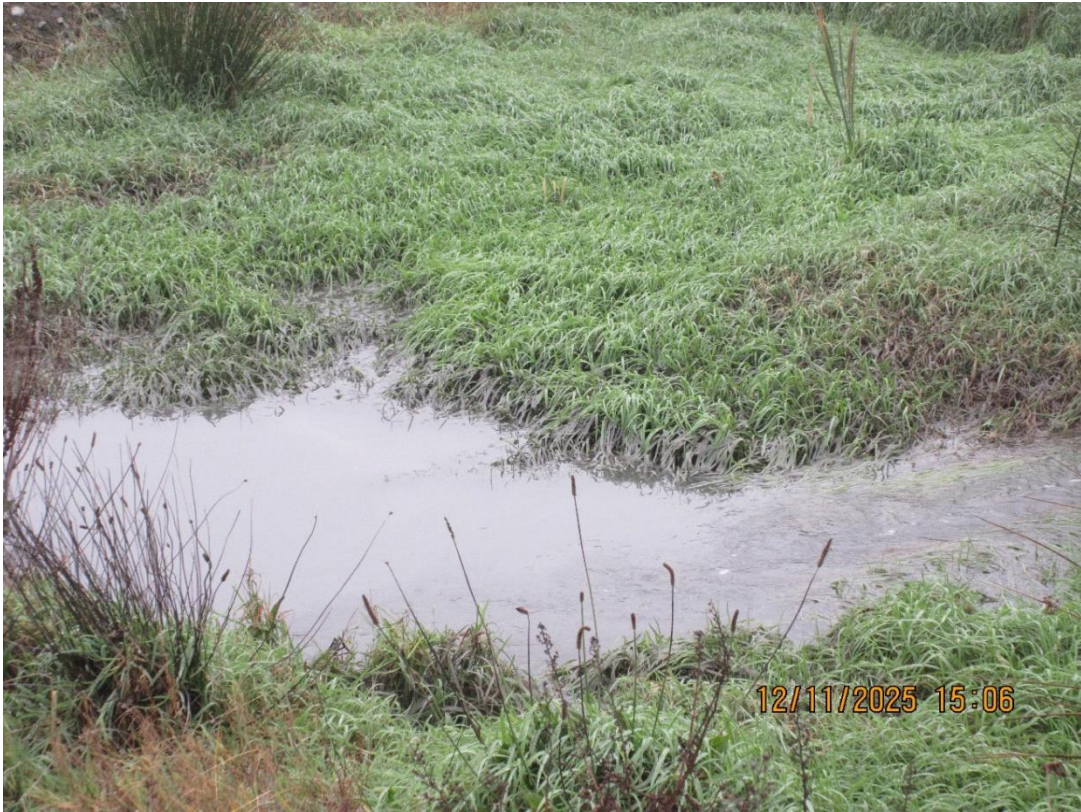
Photograph 10: Grey staining on vegetation in site surface water pond

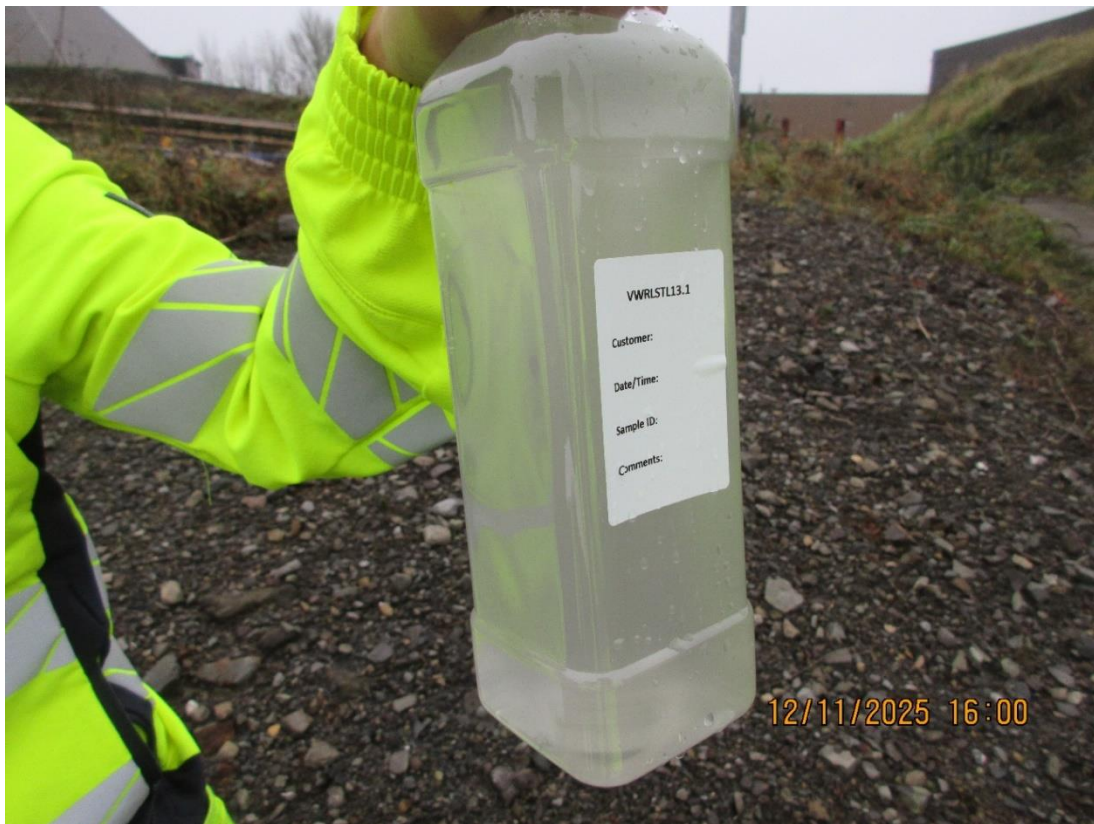
Photograph 11: Water sample from upstream of site surface water pond

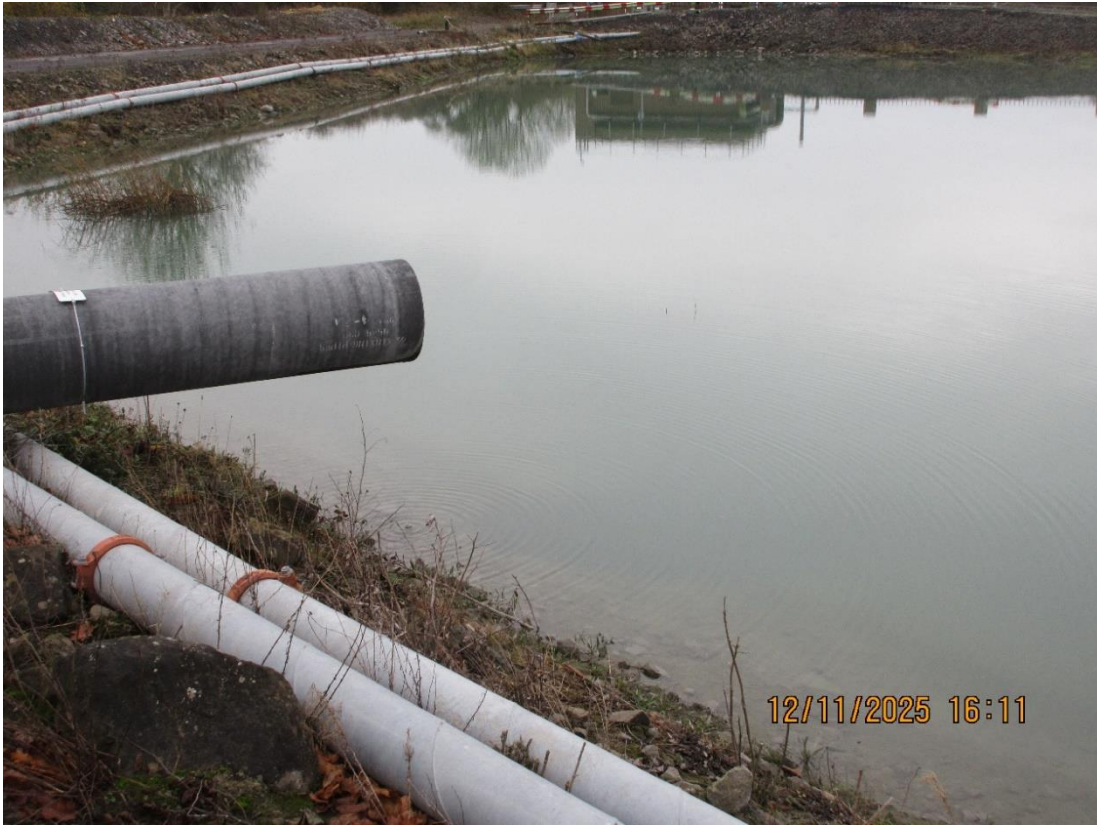
The Agency inspected the reclaim water ponds but could not identify any evidence to suggest that tailings had entered the system (Photograph 11 refers). The licensee also informed the Agency that the water in the reclaim pond was normally reused in the mining process or treated in the wastewater treatment plant before being discharged via surface water emission point SW1.

Photograph 11: Reclaim pond number 1
