Site Visit Report

Licensee	
Name of Installation	Electricity Supply Board
Licensee	Electricity Supply Board
Licence Register No.	P1138-1
CRO Number	N/A
Site Address	Land to north of existing ESB National Supply Store, Townlands of Goddamendy and Cruiserath, Corduff Road, Dublin 15, Dublin
Site Visit Reference No.	SV29484

Site Visit Detail			
Date Of Inspection	26/11/2024		
Time In	10:15	Time Out	12:20
EPA Inspector(s)	Aimee Carroll Deborah Foy		
Additional Visitors			
Licensee Personnel and Role	Filippo Capello, Renewable Operations Manager for Distributed Generation. Lorna Byrne, Safety & Environmental Specialist for Distributed Generation. Trevor Flynn, Technical Support.

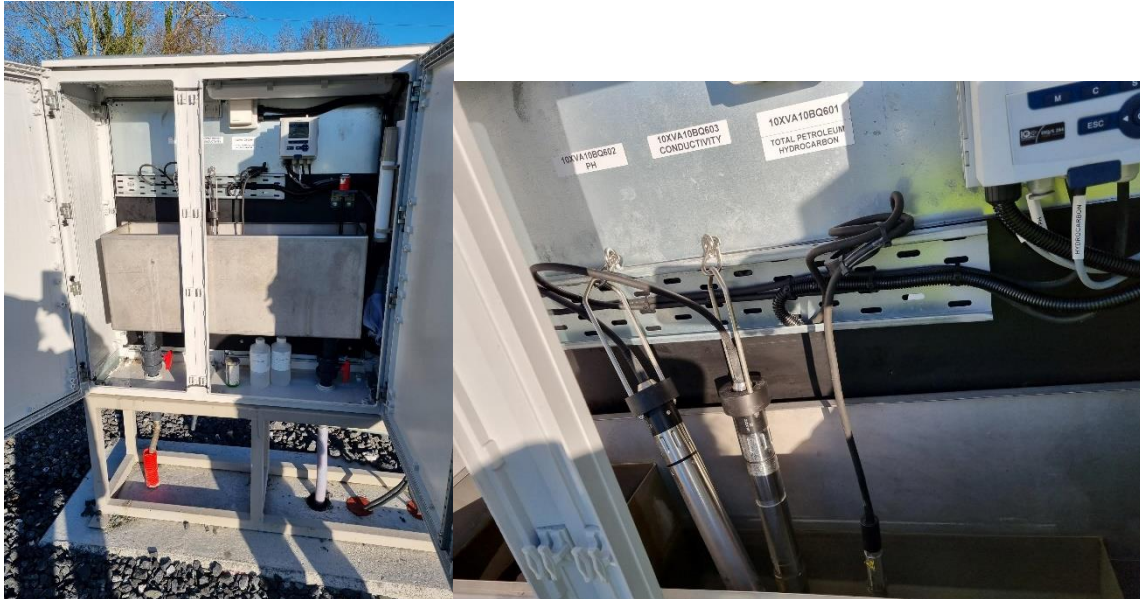
Picture 1 & 2: Stormwater Monitoring point SW1

Answer	Condition Number	Non Compliance	Observation
4.1	No	6.11		Yes
Comment / Action Required				
At the time of the site visit the site drainage map did not clearly identify storm water monitoring point SW1 and sewer water monitoring point SE1.				
Action Required:				
The licensee shall update the current drainage map to clearly identify storm water monitoring point SW1 and to confirm the coordinates of and clearly identify sewer water monitoring point SE1.

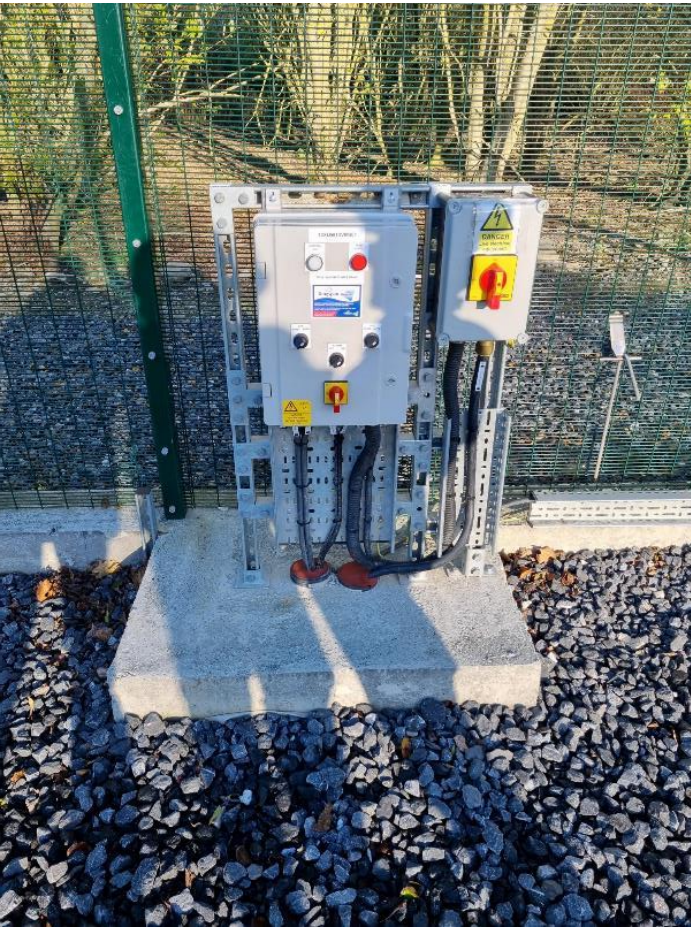
Picture 6: SE1

Answer	Condition Number	Non Compliance	Observation
4.3	Checked	3.8	Yes	
Comment / Action Required				
At the time of the site visit there was no label present to identify sewer monitoring point SE1.				
This is a non-compliance with Condition 3.8.				
Action required:				
The licensee shall ensure that all monitoring locations are clearly labelled in accordance with condition 3.8 of the licence.
