The Lisheen Mine - Closure, Restoration & Aftercare Management Plan

As Built Document

Golder Associates Ireland Limited

November 2020

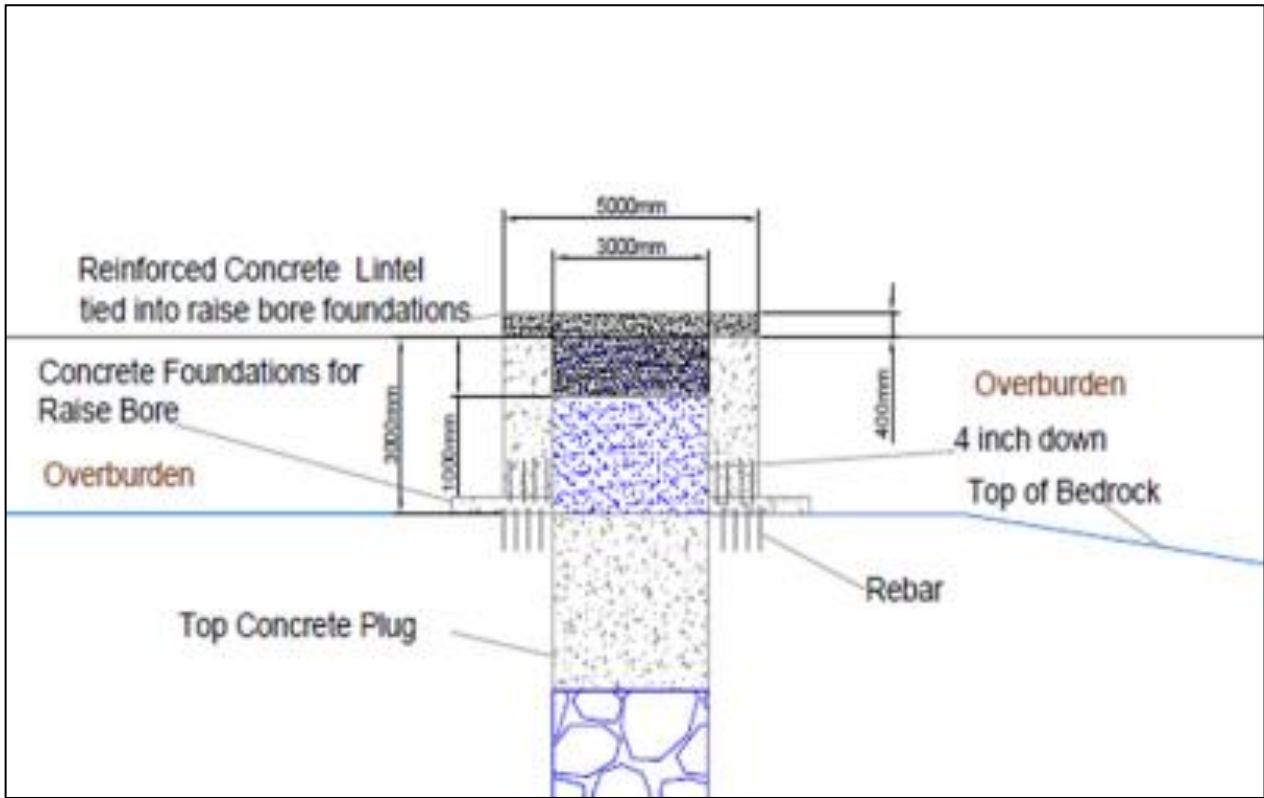
Figure 3-4: Re-design of shaft filling featuring concrete lintel

Following a site visit and discussion with the Department of Communication, Climate Action and Environment, (DCCAE), to review the ventilation shaft filling process, the DCCAE made a recommendation for an alteration to the design of the top section.

Initially they were designed to be topped with glacial till and a final layer of topsoil, peat or hardcore to blend in with its surrounding features. Subsequently the design of the top sections was revisited and replaced with concrete lintels and approved by DCCAE prior to completion.

Measuring bars were anchored into the major fill underneath the lintel and run through the lintel in a sleeve which can be used for measuring potential settlement. The purpose of the recommendation was to further protect against any future consolidation in the shaft from expressing itself on surface.

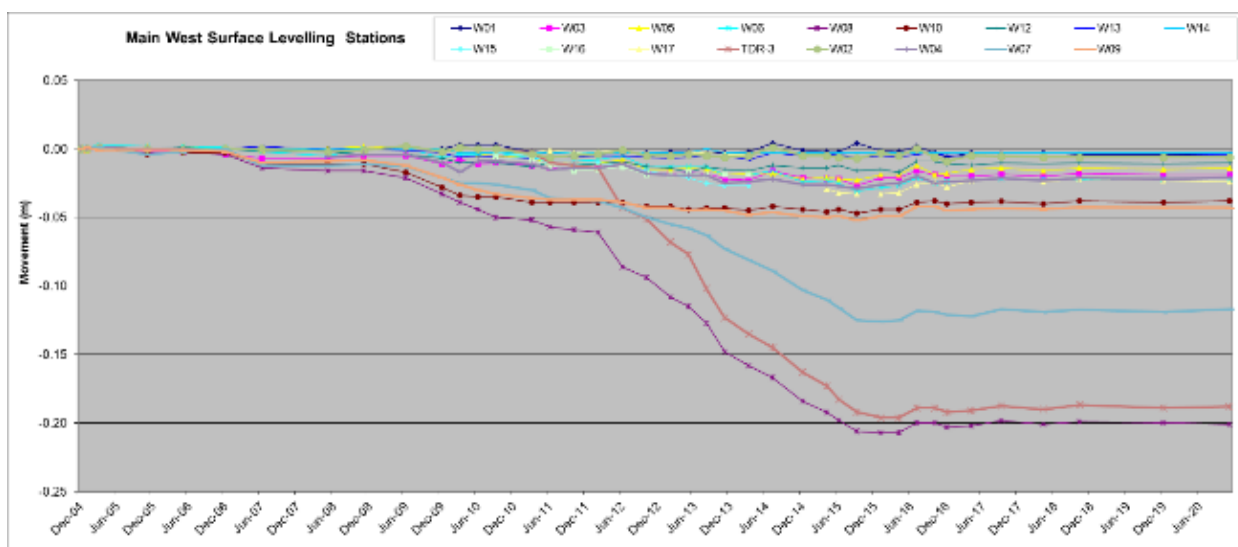
Figure 3-7: Graph of Main West surface level monitoring

Subsidence monitoring clearly shows the three stages of mining: primary which are single stopes with no requirement for backfill, secondary which are stopes backfilled to allow removal of secondary pillars, and tertiary with the final pillars removed. The amount of surface subsidence increased for each of the stages of mining, as was expected, and this is what was measured at Lisheen. Importantly once mining ceased all subsidence ceased, and in fact, once the Mine was allowed to flood there was actually a slight uplift in ground elevation (by approx. 10 mm). This too has since now stabilised, and all monitoring demonstrates that the ground is stable. Figure 3-7 below gives an example of how the ground settled during the mining period and how this settlement has ceased at all locations since mining ceased. The settlement data has essentially flatlined from 2017 onwards, demonstrating that movement has ceased.

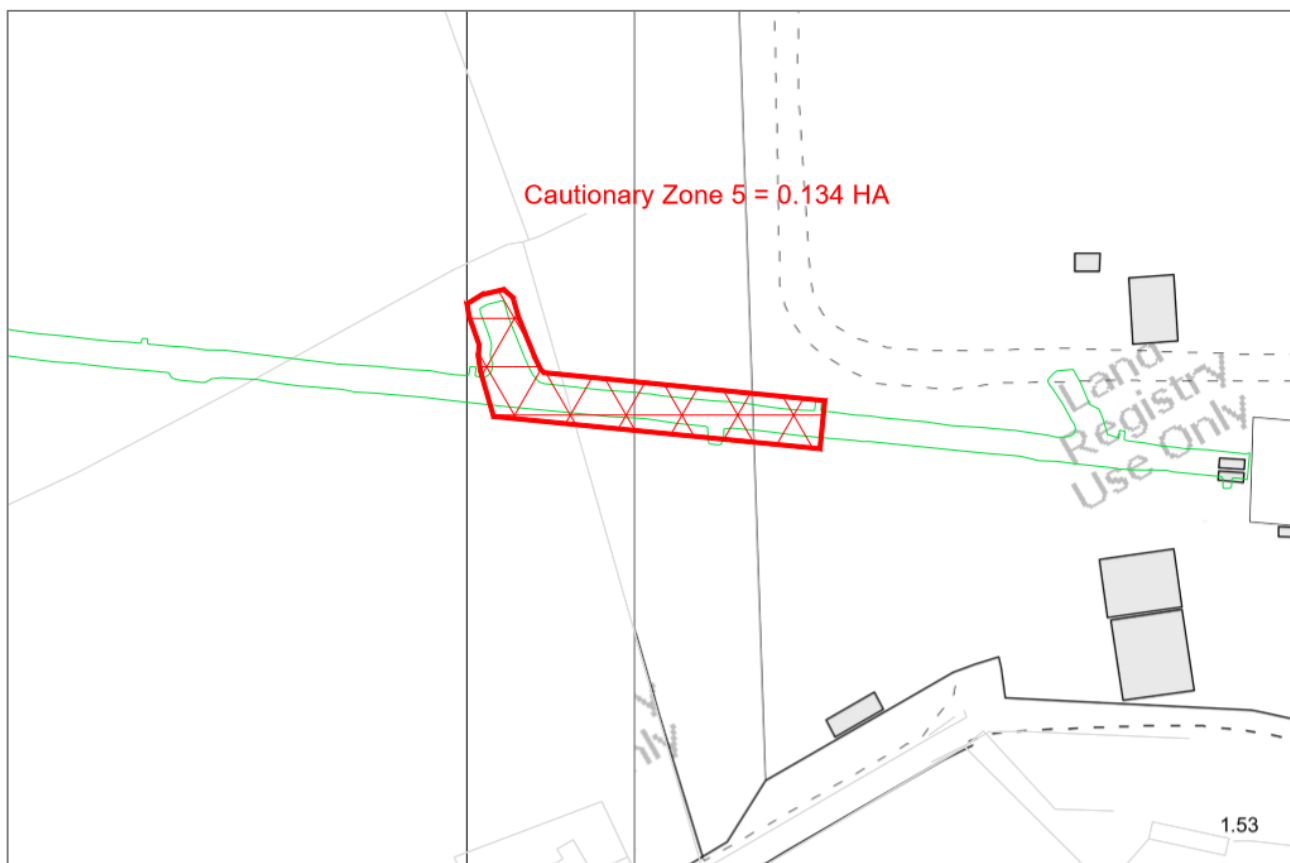
Figure 3-9: Cautionary zone 5

The DCCAE had some concerns in relation to the area around Remuck 2 on the Decline (a remuck is an excavated area to the side of a long straight excavation - in this instance the excavation height was higher than the Decline height). This area was not backfilled as it was outside the area that was required to be backfilled based on calculations completed for Lisheen. Although Lisheen and its consultants remain satisfied that all risks have been adequately addressed, Lisheen took the Department's concerns on board and it was agreed that a specific area on surface around Remuck 2 would be referred to as a Cautionary Zone on the land risk map as agreed with the DCCAE. It has been demarcated off and future land use in this section is restricted.

- (1) *Not to do or permit or allow any building or buildings to be constructed on the Cautionary Zone at any time.*
- (2) *Not to do or permit or allow any development of the Cautionary Zone at any time.*

- (3) *Not use or permit or suffer the Cautionary Zone to be used at any time for any purpose other than as agricultural land.*
- (4) *Erect and maintain stock proof fencing around the entire perimeter of the Cautionary Zone.*

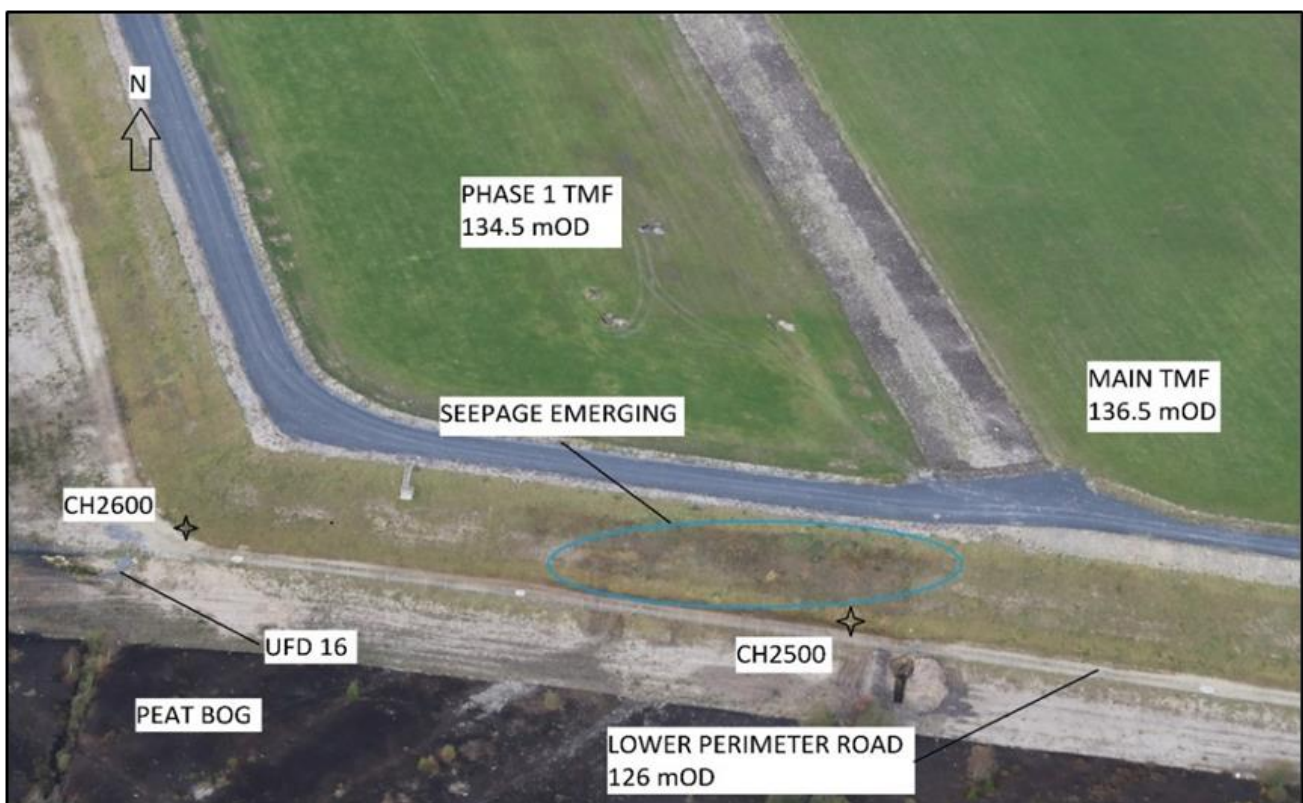
Figure 4-9: Lisheen TMF Aerial Photo (October 2018)

The degree of seepage was monitored regularly during the subsequent months and samples were taken and tested for water quality. The samples returned results showing sulphate contents of approximately 800 mg/l, which is indicative of tailings cap water. The scale of the seepage volume increased during August / September 2018 and an investigation was initiated in October 2018.

Investigations carried out between November 2018 – April 2019, through non-intrusive and intrusive methods led to the uncovering of seepage eroded ‘wash-out areas’ within the Phase 1 TMF dam wall, primarily at chainage CH2500 where the bulk of the seepage was exiting the dam wall. Seepage erosion ‘pipes’ were uncovered on the downstream side of the installed lining system and subsequent excavations tracked the flows

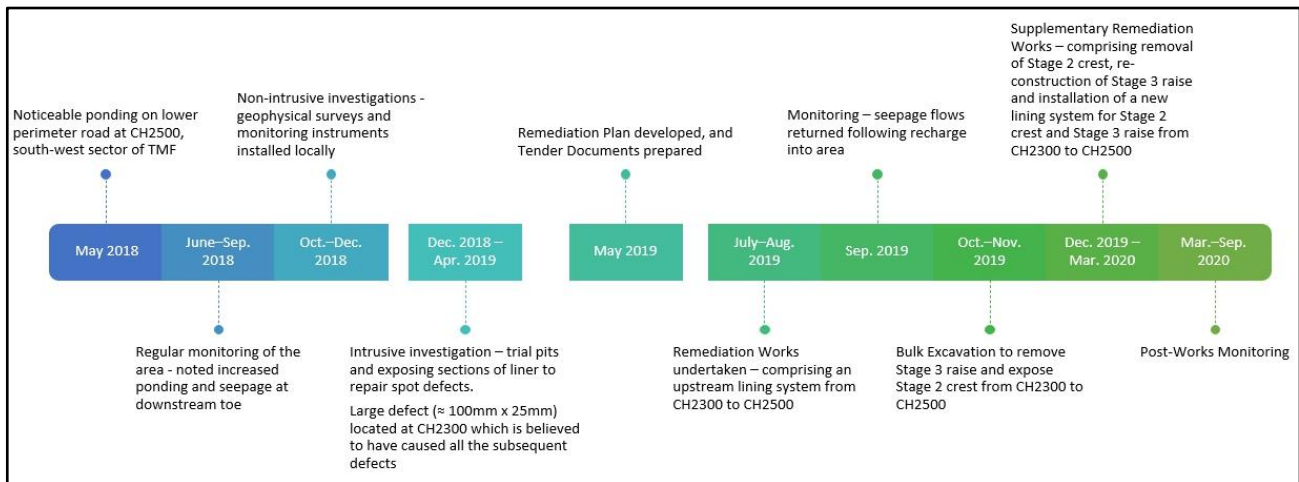
Figure 4-10: Lisheen TMF Seepage Remediation Timeline

Figure 4-11 provides the timeline for the remediation of the Lisheen TMF.

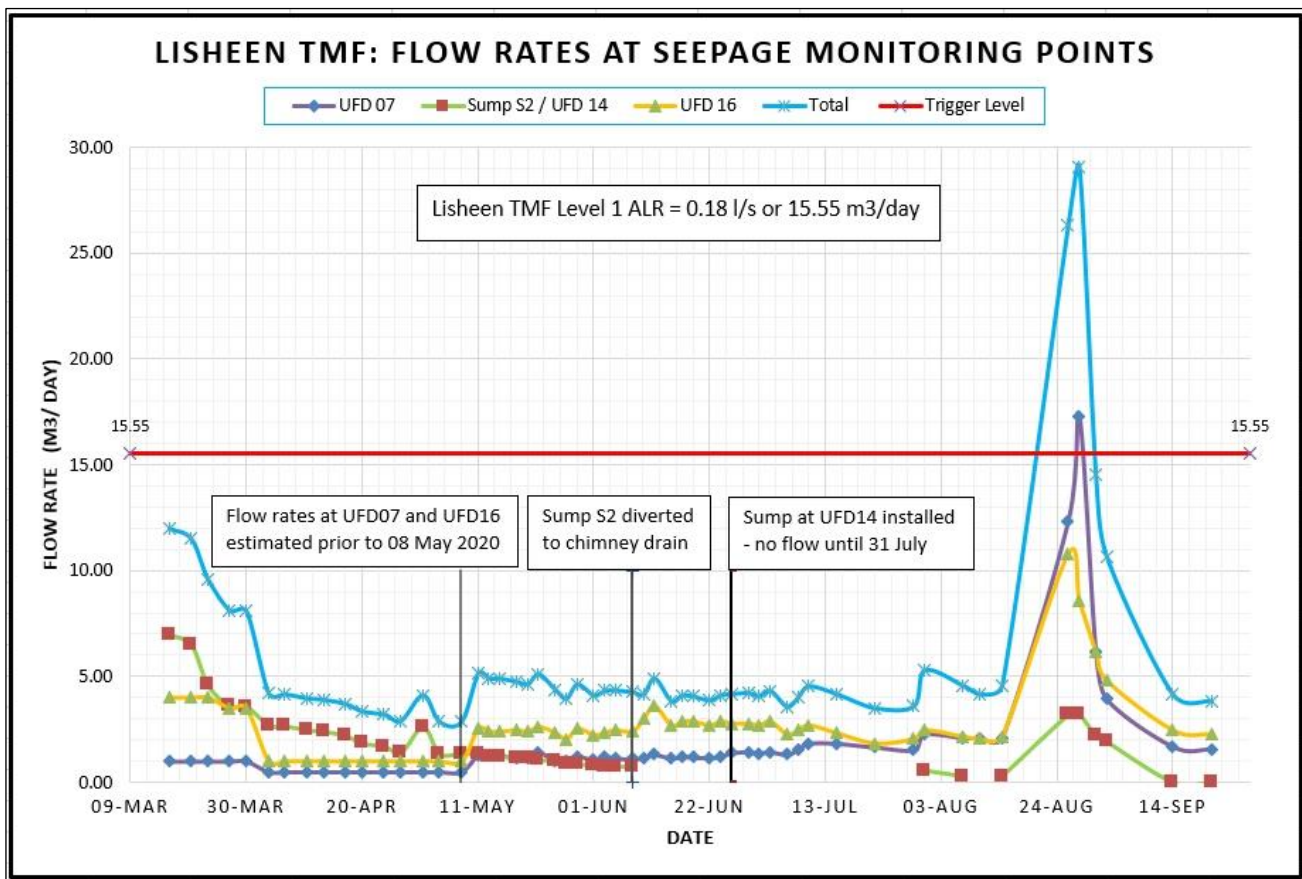
Figure 4-11: Lisheen TMF Seepage Flow Rates at Monitoring Points (March to September 2020)

Figure 4-11 below shows the flow rate monitoring data from March to September 2020 at the three UFD locations and Figure 4-12 below shows the Action Leakage Rates (ALRs) and Response Plans agreed in April 2020.
