# Site Visit Report

Licensee	
<b>Name of Installation</b>	Anglo Beef Processors Ireland t/a ABP Nenagh
<b>Licensee</b>	Anglo Beef Processors Ireland Unlimited Company
<b>Licence Register No.</b>	P0184-01
<b>CRO Number</b>	217122
<b>Site Address</b>	Grange, Nenagh, Tipperary
<b>Site Visit Reference No.</b>	SV18109

Report Detail	
<b>Issue Date</b>	19/07/2019
<b>Prepared By</b>	Anthea Southey

Site Visit Detail					
<b>Date Of Inspection</b>	03/07/2019	<b>Announced</b>	No		
<b>Time In</b>	13:00	<b>Time Out</b>	16:25		
<b>Agency Personnel On Site</b>	Anthea Southey Brendan Kissane				
<b>Licensee Personnel and Role</b>	Fergal Maguire, Environmental Officer Don O'Brien, Plant Manager				
<b>Photo Taken</b>	Yes	<b>Samples Taken</b>	Yes	<b>Video Taken</b>	No
<b>Odour Assessment</b>	No

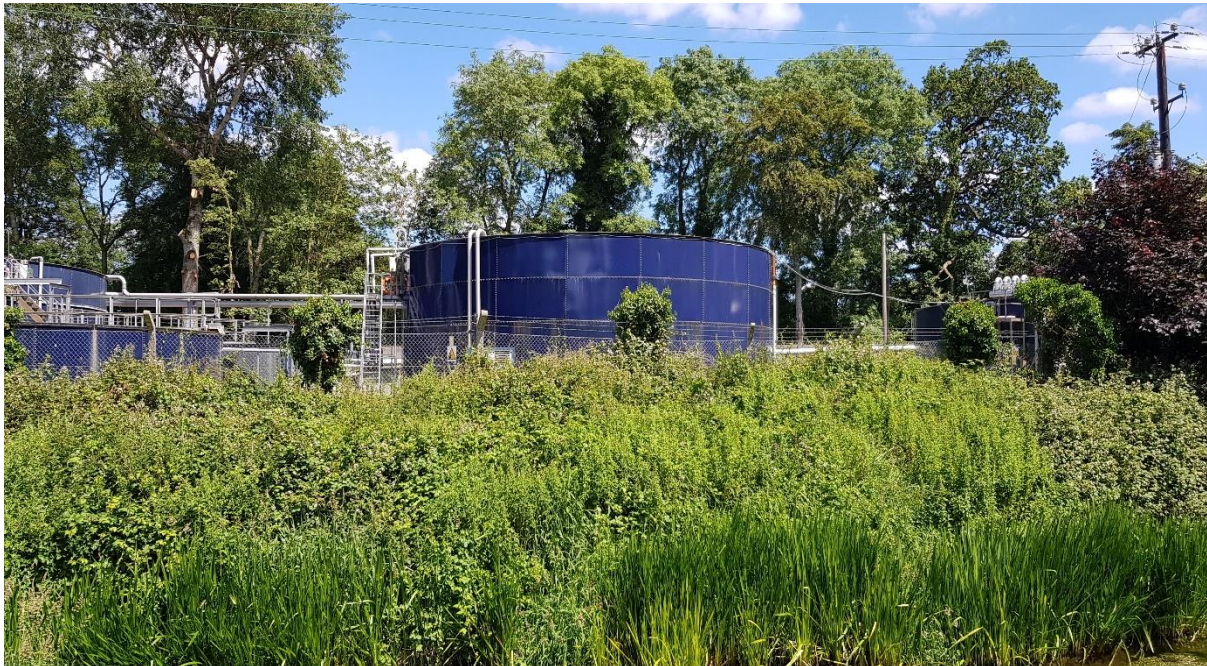
**Photo 1:** Waste water treatment plant (WWTP) at ABP Nenagh (taken from across the river).

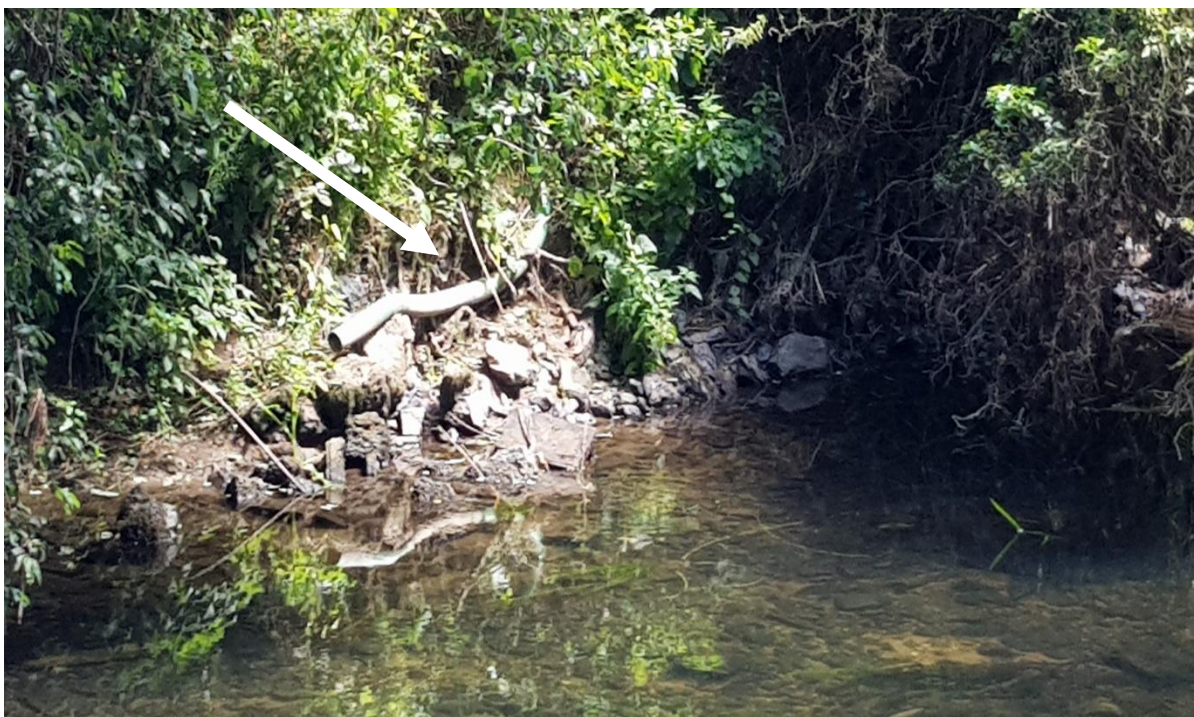
**Photo 2:** One of the unidentified pipelines located along the riverbank by ABP Nenagh.

Compliance investigation on site drainage network and removal of unauthorised pipelines along the river bank	Checked	4.1, 4.2 9.3.5	Yes	
<b>Comment / Corrective Action</b>				
<p>The EPA is issuing a non-compliance under Condition 9.3.5 of the licence due to the poor integrity/condition of the site drainage pipelines and manholes as identified in the pipeline integrity test reports completed in February 2019.</p> <p>The EPA is opening a compliance investigation (Ref: CI001783) with the licensee as a result of the unauthorised discharge to the River Nenagh and the observations made by the EPA inspectors during the site visit.</p> <p>The licensee will be required to undertake the following corrective actions within the timeframes specified in the compliance investigation:</p> <ol style="list-style-type: none"> <li>1. CI Action A023226 - Undertake water quality monitoring in the River Nenagh commencing in July 2019 including physico-chemical monitoring (weekly basis) and a biological survey (u/s and d/s of the primary discharge point). A water quality investigation report shall be submitted to the EPA via EDEN by 31/10/2019.</li> <li>2. CI Action A023224 - Undertake a full assessment of the structural integrity and location of all drainage pipelines and manholes (process, foul and sewer) at ABP Nenagh by 31/07/2019. Implement a pipeline repair programme without delay and submit a summary report detailing the repairs and an updated site drainage drawing to the EPA via EDEN by 30/09/2019.</li> <li>3. CI Action A023225 - Undertake a survey of all pipelines located along the river bank and adjacent to ABP Nenagh. A report on the findings of the survey and corrective actions taken to remove the pipelines shall be submitted to the EPA via EDEN by 30/09/2019.</li> </ol>

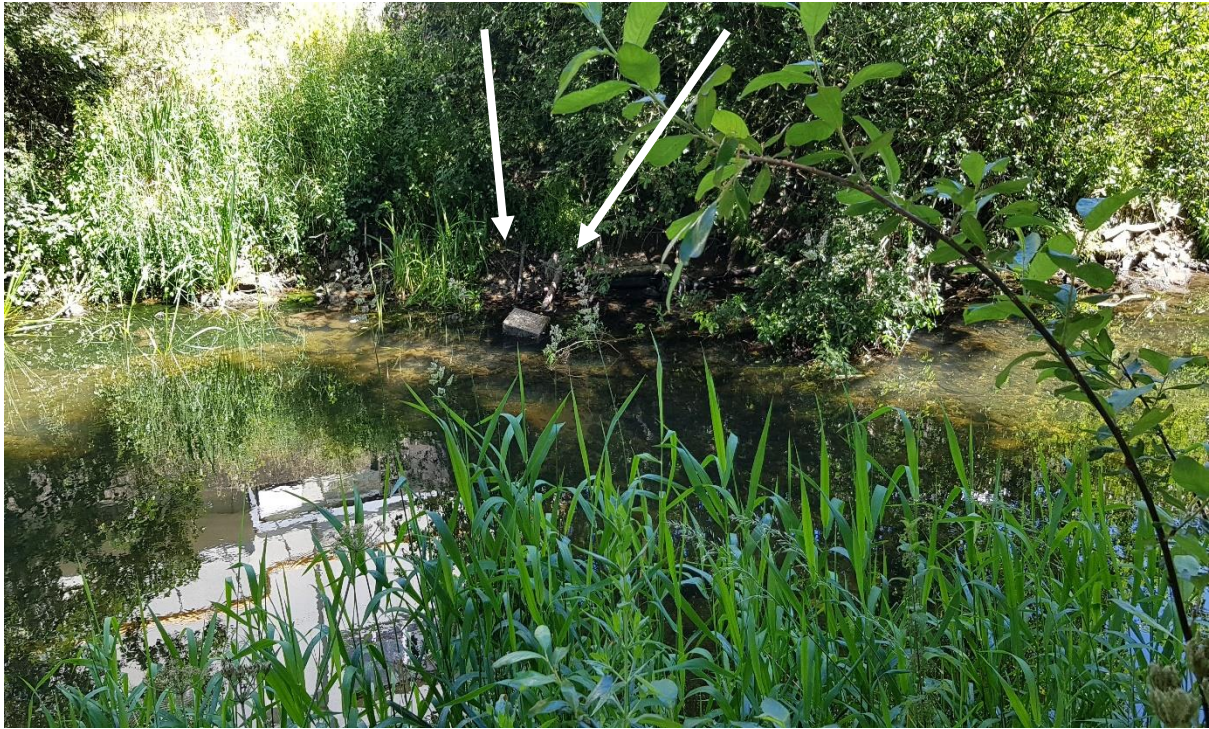
**Photo 3:** Additional unidentified pipelines along the river bank by ABP Nenagh.

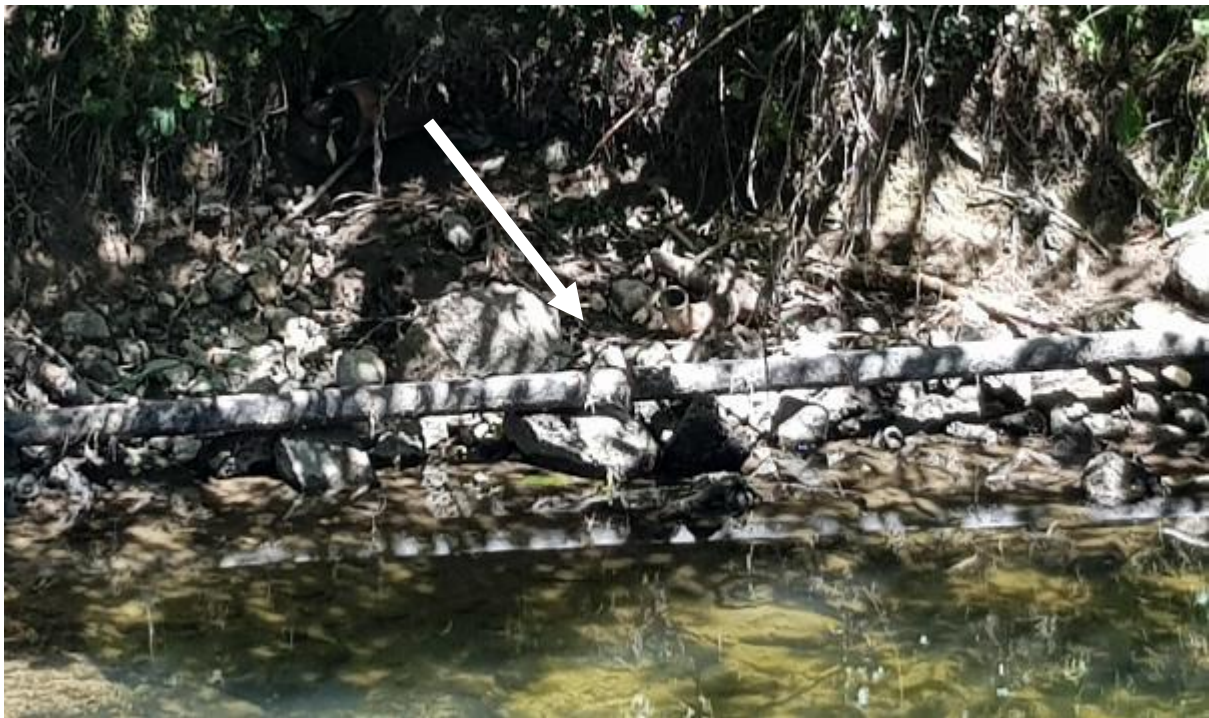
The EPA is issuing a non-compliance under Condition 6.1 of the licence following the unauthorised discharge to the River Nenagh which was notified to the EPA on 02/07/2019. It was also noted by the inspectors that there was a slight cloudiness in the River Nenagh downstream of the primary discharge point which shall be investigated by the licensee.

**Photo 4:** Unidentified pipeline along the riverbank by ABP Nenagh. It was noted that the River Nenagh was slightly cloudy d/s of the primary discharge point (WEP1).

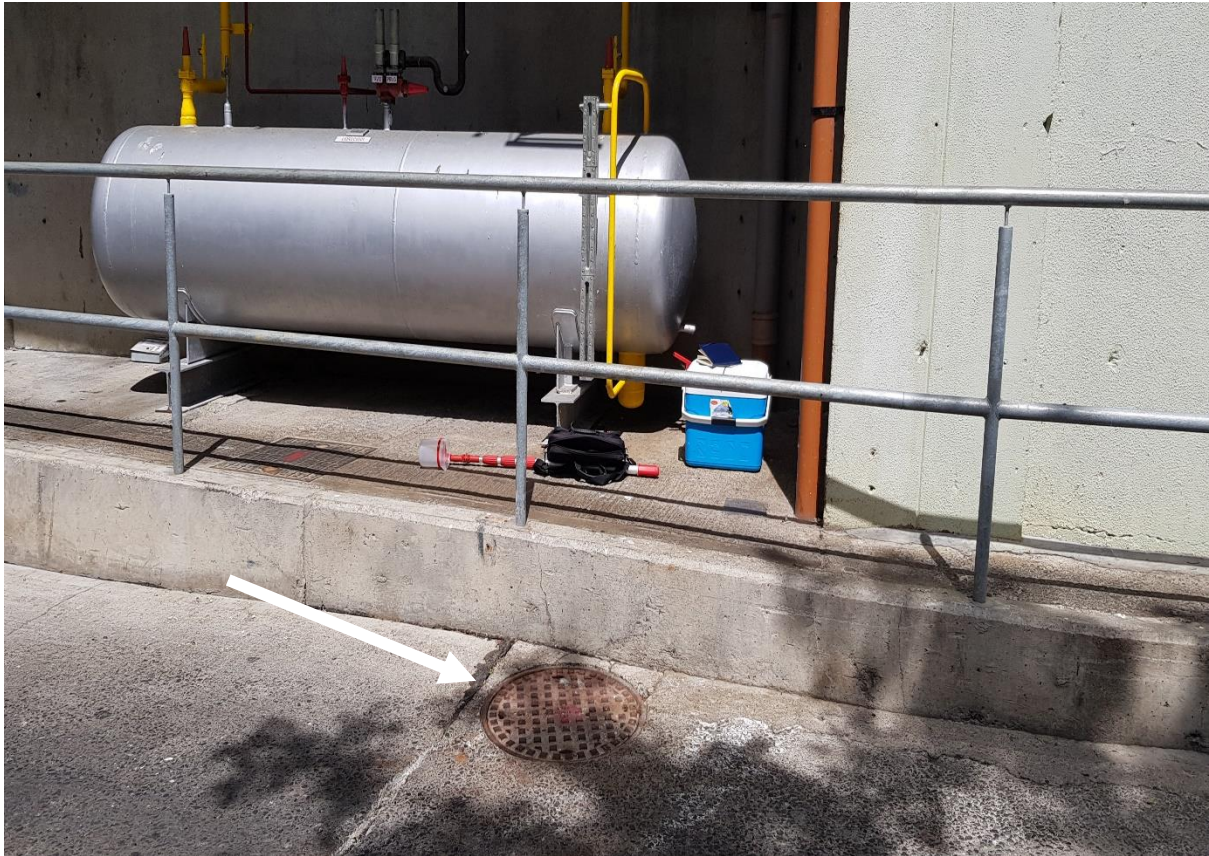
**Photo 5:** Manhole (Ref: F18) is located outside of the chilling rooms and boning halls (indicated by the white arrow). The unauthorised discharge pipeline at the riverbank was traced back to this manhole by the licensee. This manhole is on the foul line which carries effluent and washings from this area to the WWTP.

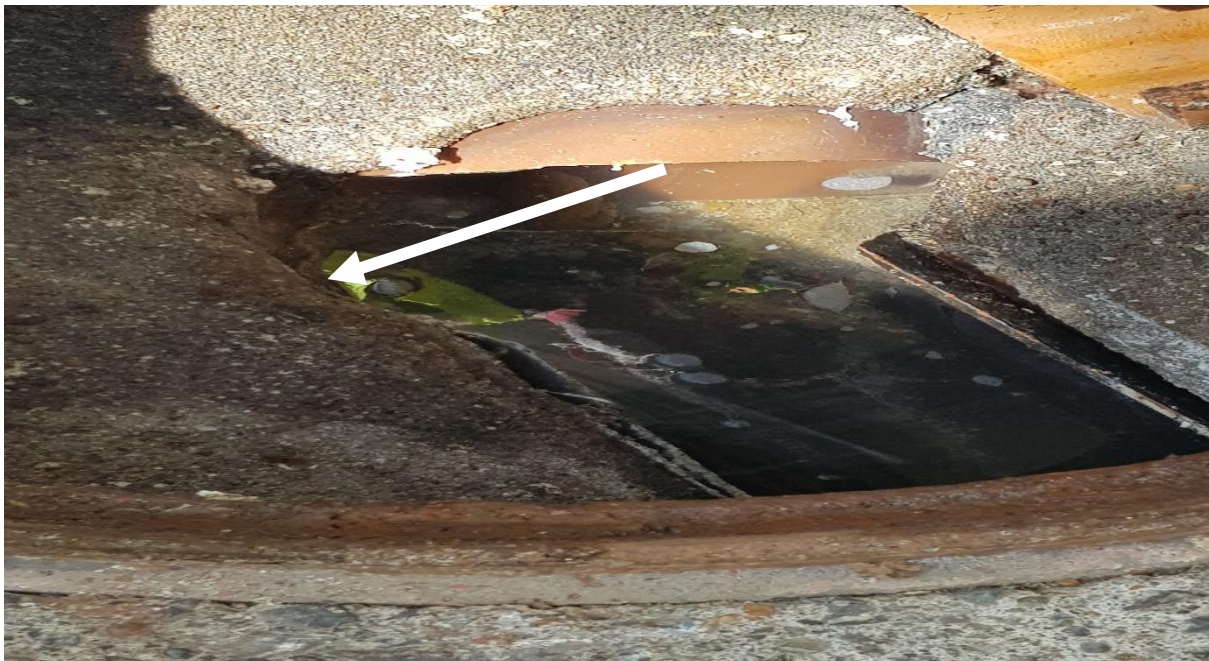
**Photo 6:** Photo taken inside the manhole (Ref: 18). The licensee considers that corrosion to the concrete within the manhole (indicated by the white arrow) permitted an unauthorised discharge of effluent and washings to the River Nenagh on 02/07/2019.

The EPA is issuing a non-compliance under Condition 6.1 of the licence following an unauthorised discharge to the River Nenagh which was notified to the EPA on 02/07/2019 by Inland Fisheries Ireland and the Nenagh Anglers Association. The discharge took place on 02/07/2019 between 9:30 pm and 12:30pm.

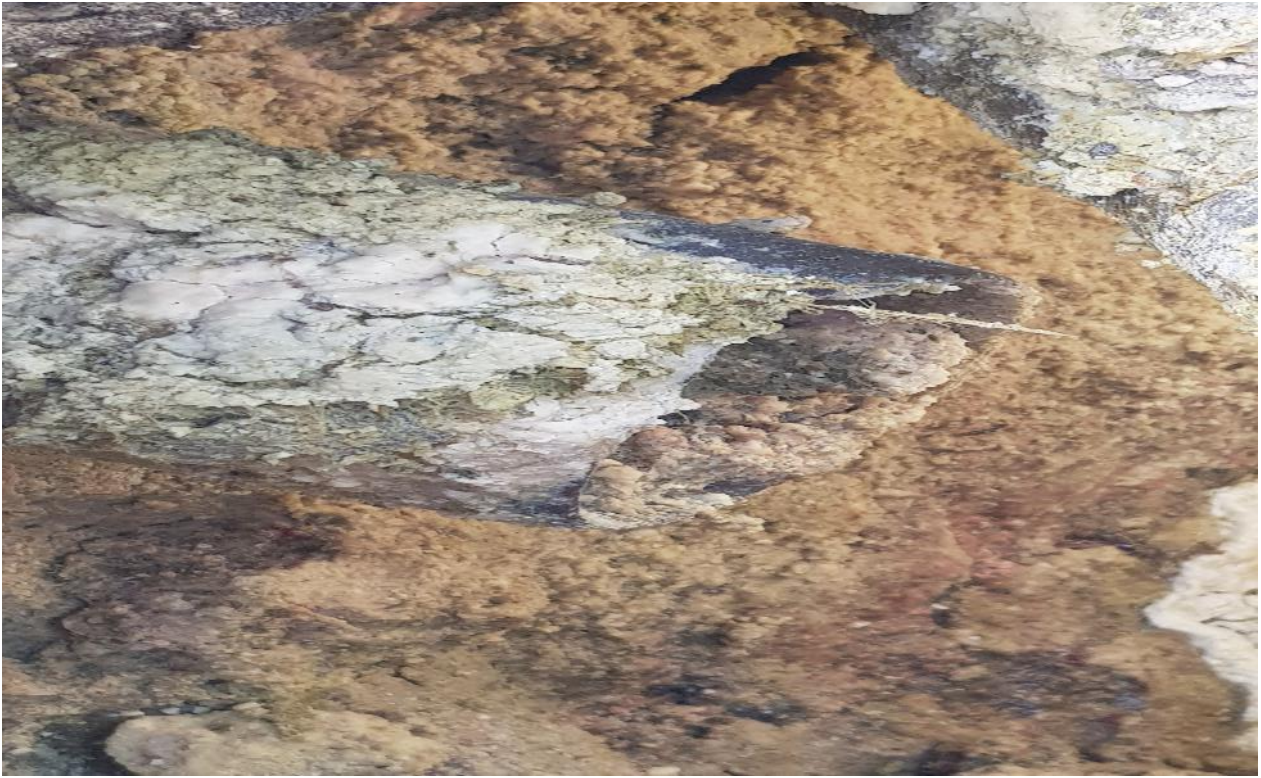
**Photo 7:** Photo taken in manhole (FM19) which is in very poor condition with an accumulation of congealed fat and solids in the foul pipelines leading to the WWTP.

The EPA is issuing a non-compliance under Condition 9.3.5 of the licence due to the poor integrity/condition of the site drainage pipelines and manholes as identified in the pipeline integrity test report completed in February 2019.
