Assessment of NOx Fugitive Emission Incidents at Chemifloc Shannon

Prepared by Liam Tolton BE C.Eng. M.Sc. (Eng.). DGSA

Date: 14th December 2020

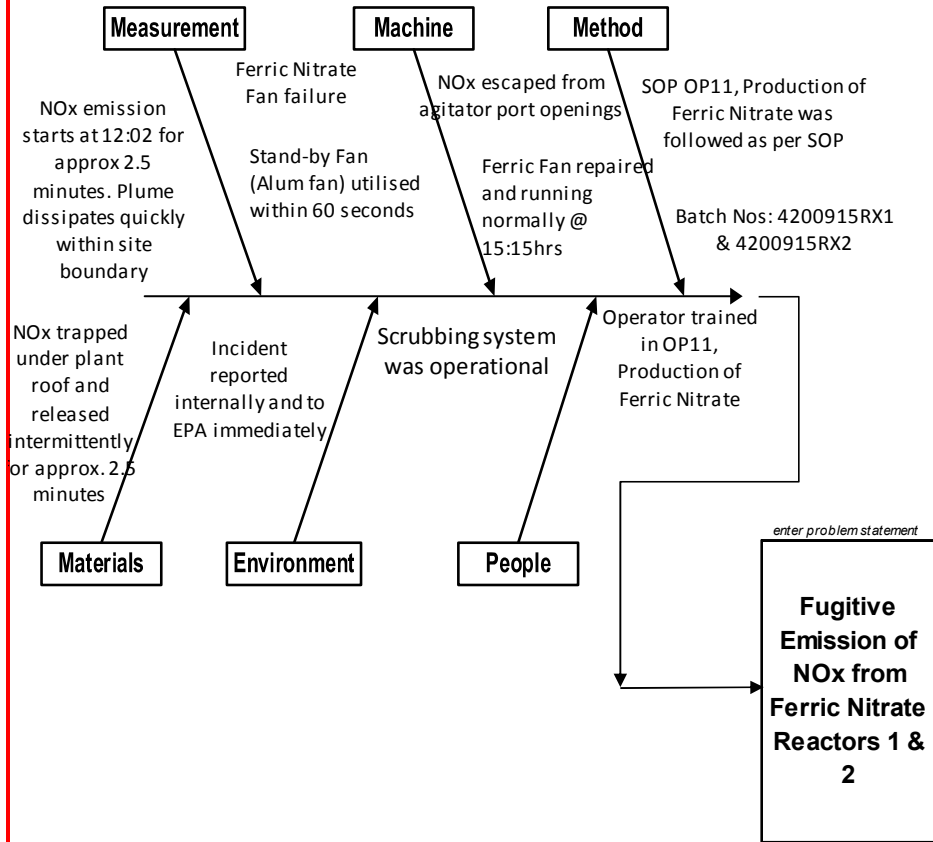
Analyse Causes (Cause and Effect)

The Root Cause Analysis revealed that the Ferric Fan motor tripped due to ingress of moisture at the terminal box. The fan gradually slowed down resulting in a minor loss of containment at the agitator openings as the suction draw from the fan reduced. The emission was relatively minor from an environmental perspective as was demonstrated in the Chemifloc incident report. The Alum Fan which forms part of the integrated abatement system is designed to act as a standby fan in the event of a failure of the Ferric Fan. This required the operator to operate the slide valves to allow the Alum Fan to perform the standby function. The operator was trained to make the changeover and carried out the actions within a couple of minutes thereby quickly restoring normal system operation.
