Galmoy Mines Ltd

Galmoy Mines TMF Independent Audit 2023

Project no. 41000013

Date: March 2024

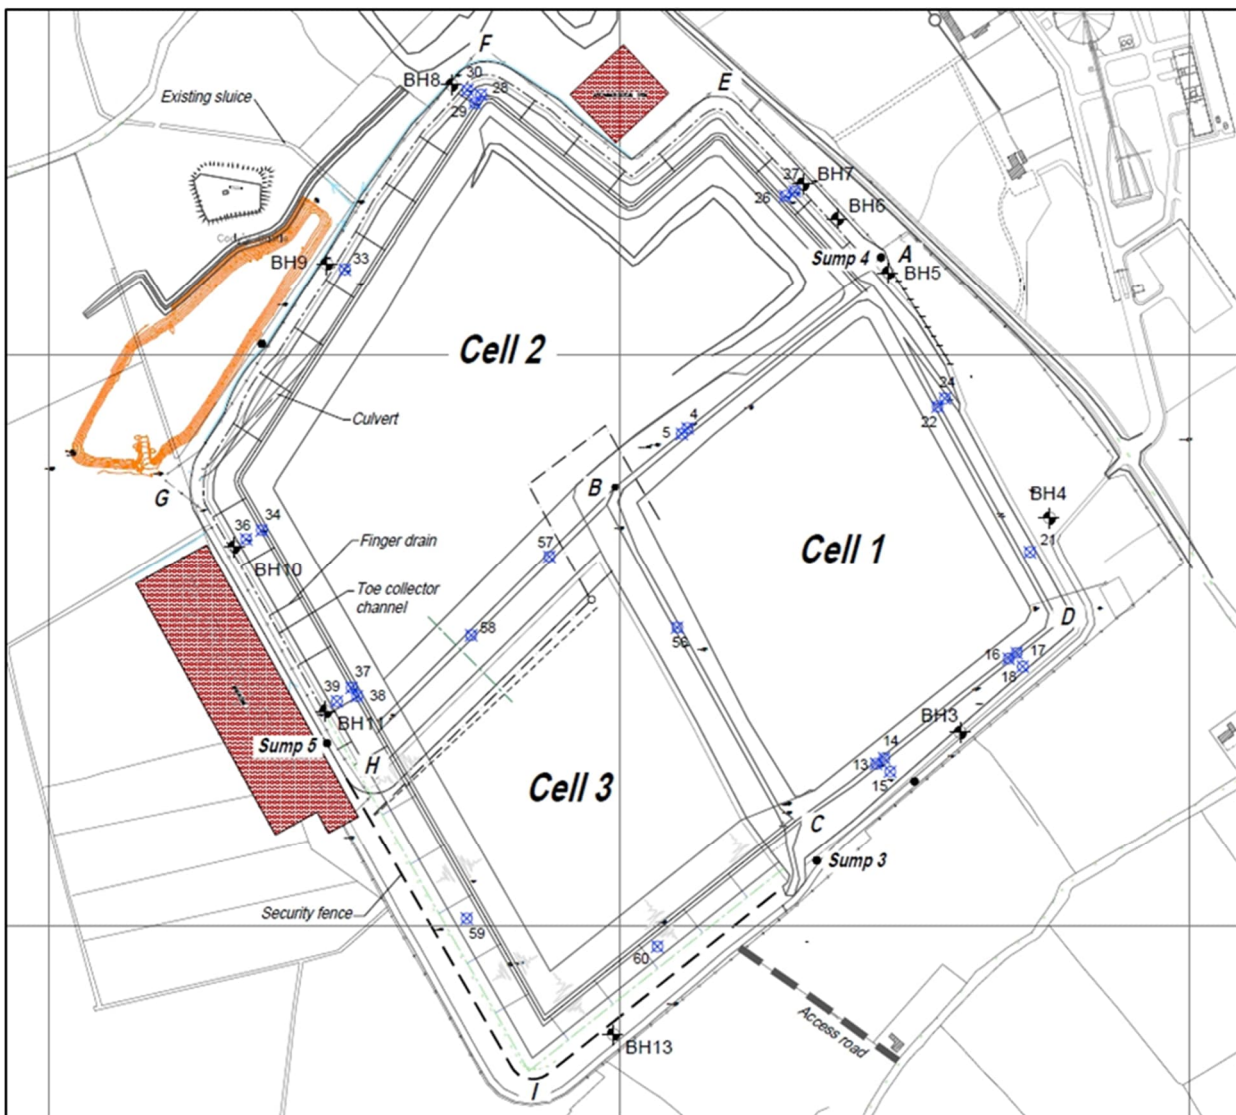
Figure 2-1 – Instrumentation and Monitoring Points Layout

To facilitate the evaluation of the TMF, the dam area has been divided into Sectors A to I and the original monitoring points installed are tabulated in Table 2-1 below. A number of these original monitoring points are no longer active resulting from the modifications to Cell 3, the closure works, decommissioning, damage, and/or loss.

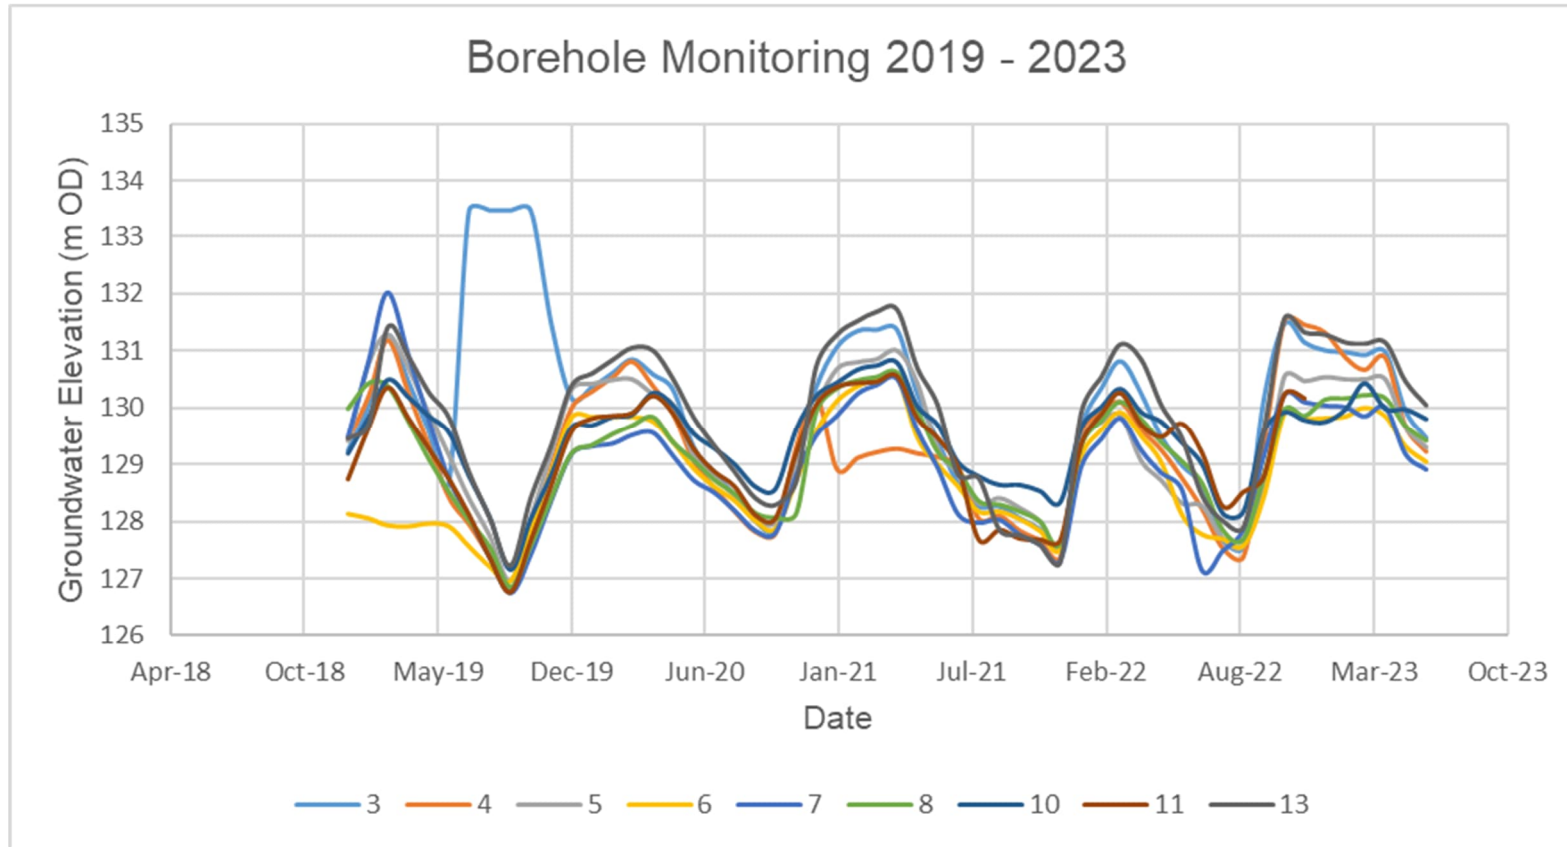
Figure 2-2 - Borehole Groundwater Monitoring 2019 - 2023

- BH09 recorded the lowest depths to groundwater at an average of 2.5 m BGL between 2020 and 2023.
- BH07 recorded the greatest depths to groundwater at an average of 8.96 m BGL between 2019 and 2023.
- Groundwater elevations are generally within 1 m of each other.
- The elevation of BH9 is unknown, although the measured levels indicate that the groundwater level is at a comparable level to the other monitoring wells.

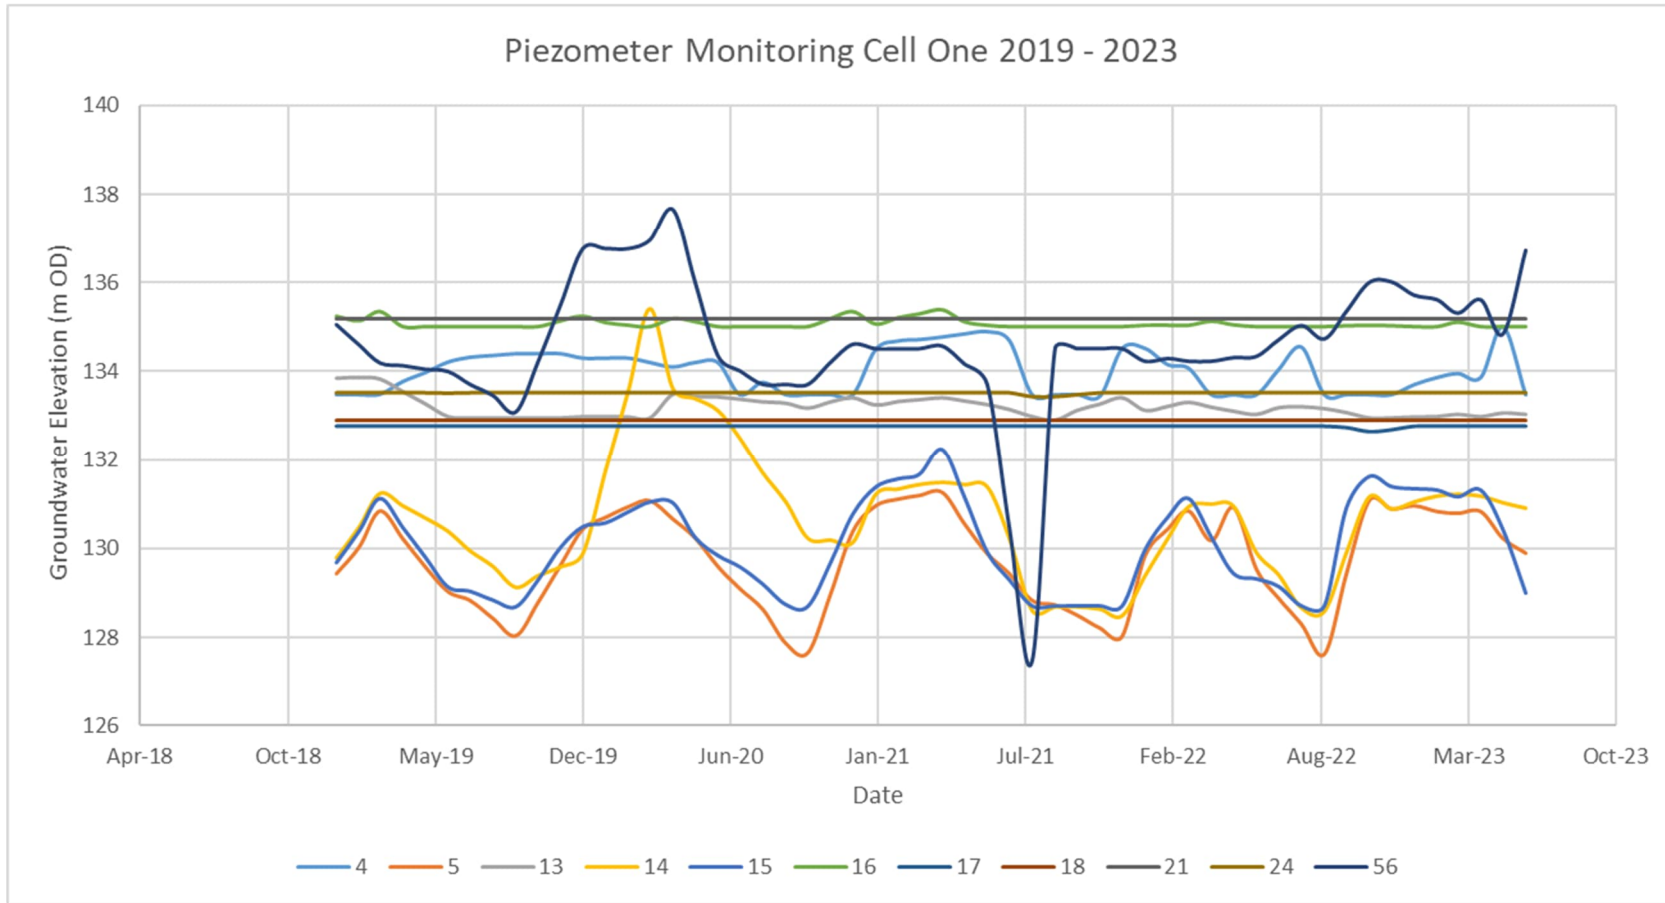
Figure 2-6 - Piezometer Groundwater Monitoring Cell One 2019 - 2023

- Cells one, two and three generally followed consistent trends in each of the piezometers measured inclusive of seasonal variations.
- In Cell one, Pz56 reported the largest variation in groundwater elevations, between 127.66 m OD (April 2020) and 127.49 m OD (August 2021).
- In Cell two, Pz28 Pz56 reported the largest variation in groundwater elevations, between 123.53 m OD (November 2021) and 133.34 (August 2022).
- The largest variation in groundwater elevation was recorded as 13.26 m (140.13 m AOD and 126.86 m AOD) between Pz26 and Pz28 from 2019 to 2023 (Cell Two).
- Pz19 and Pz25 are both blocked between 2019 and 2023.
- The elevation of Pz20 is unknown, although the measured levels indicate that the groundwater level is at a comparable level to the other monitoring wells.

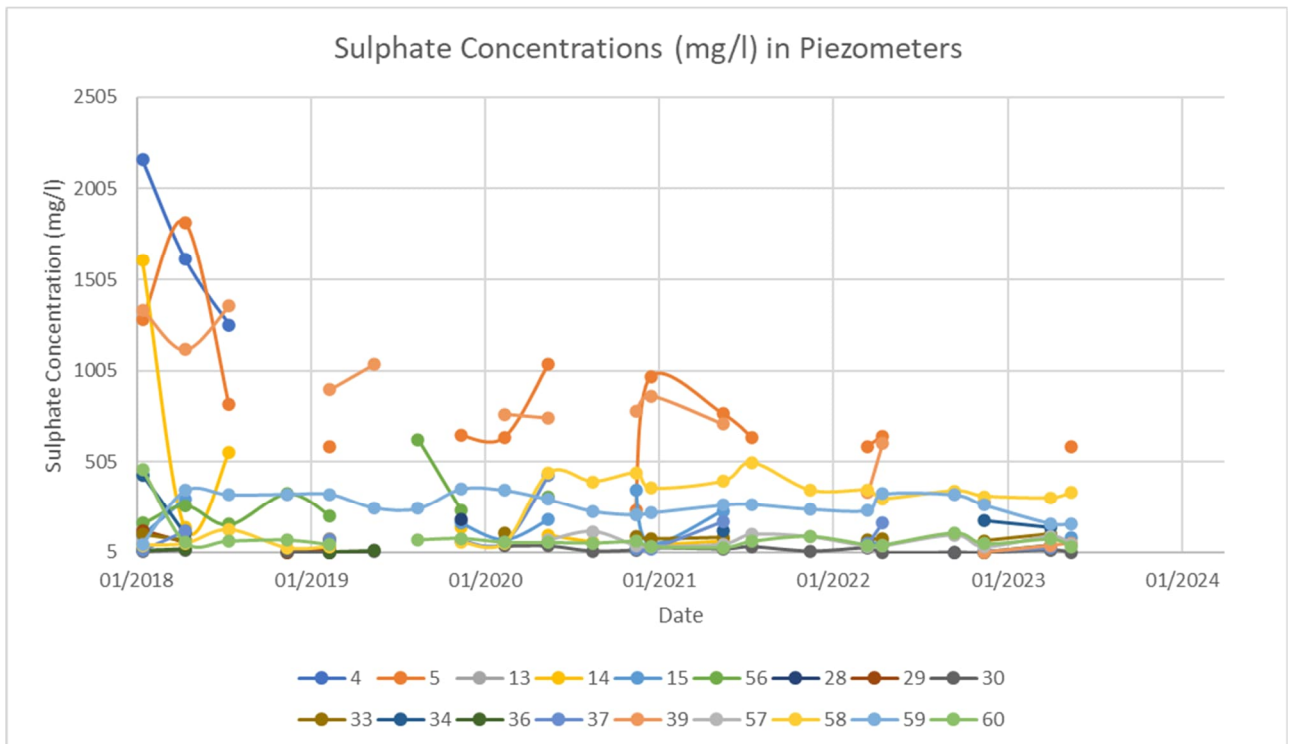
Figure 2-9 – Sulphate Concentrations in Piezometers 2018 - 2023

- The overall data from 2018 to 2023 shows a steady trend.
- Pz4 and Pz5 located in Sector A – B are installed in the dam crest between Cell 1 and Cell 2, into the dam wall foundations and the underlying bedrock respectively, and report a similar range of concentrations to those between 2016 and 2018. Sulphate

concentrations range from 237.6 mg/l to 1,820 mg/l. The high sulphate levels at this location reflect past issues relating to the integrity of the lining at this locality. Seepage will be controlled by the low permeability of the tailings and the level of defect in the lining and thus will be minimal

- Pz14 located in Sector C to D has historically reported sulphate concentration levels <200 mg/l and reported concentrations of 500 mg/l and 1,600 mg/l in 2018. However, levels have returned to <200 mg/l in 2019, 2020 and 2021. No sample has been collected since Q2 2021.
- Pz39 located in Sector G – H is installed in the dam wall foundations and reports the highest trending levels of sulphate with similar values reported prior to 2018. However, there is a decreasing trend from 2018 to 2023.
- Pz59 located in Sector H – I is installed into the bedrock and is reporting sulphate concentrations between 160 and 350 mg/l, which are slightly lower than those reported prior to 2018. These levels are greater than the background sulphate concentrations recorded by the perimeter boreholes and would suggest a seepage route from the Cell 3 lining at this location.

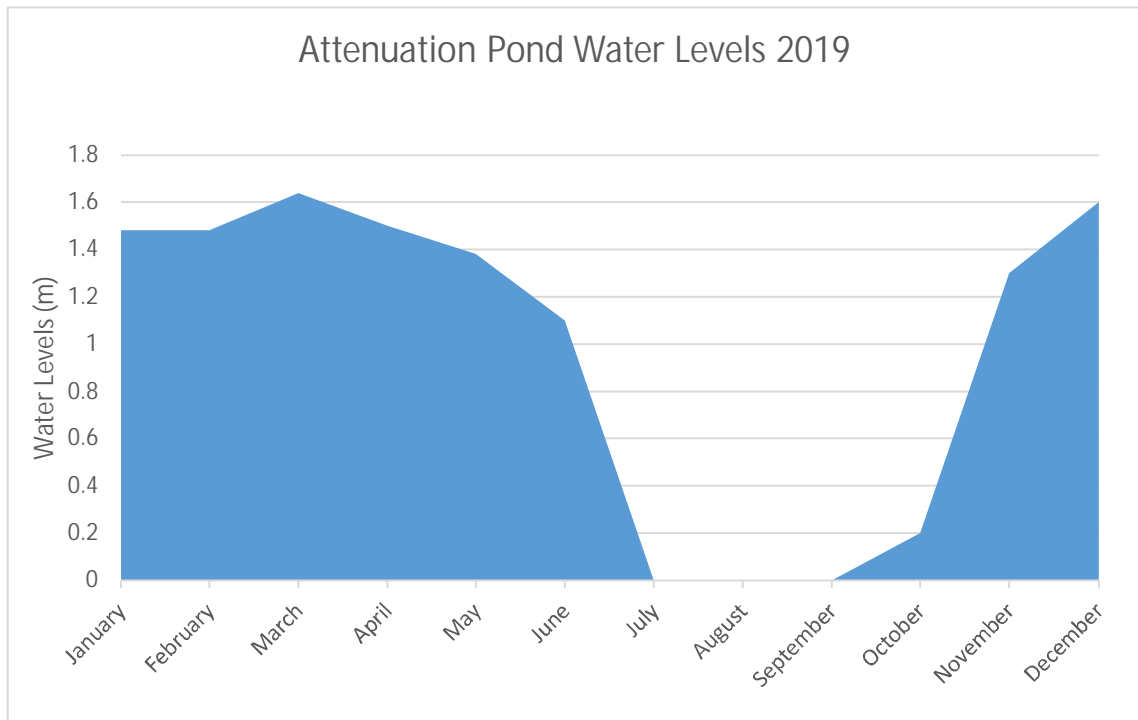
Figure 3-1 - Attenuation Pond Water Levels in 2019

The attenuation pond and outfall structure are operating accordingly and appear to be in good working order. Refer to Figure 3-1, Figure 3-2, Figure 3-3, Figure 3-4, and Figure 3-5 below for water levels recorded in the Attenuation Pond between 2019 and 2023.
