Health Beacon
Naas Road Business Park,
20 Muirfields Dr,
Inchicore,
Co Dublin

Bund Integrity Assessment
Inspection and Testing of Bund Structures

Document No: BH2015-JM

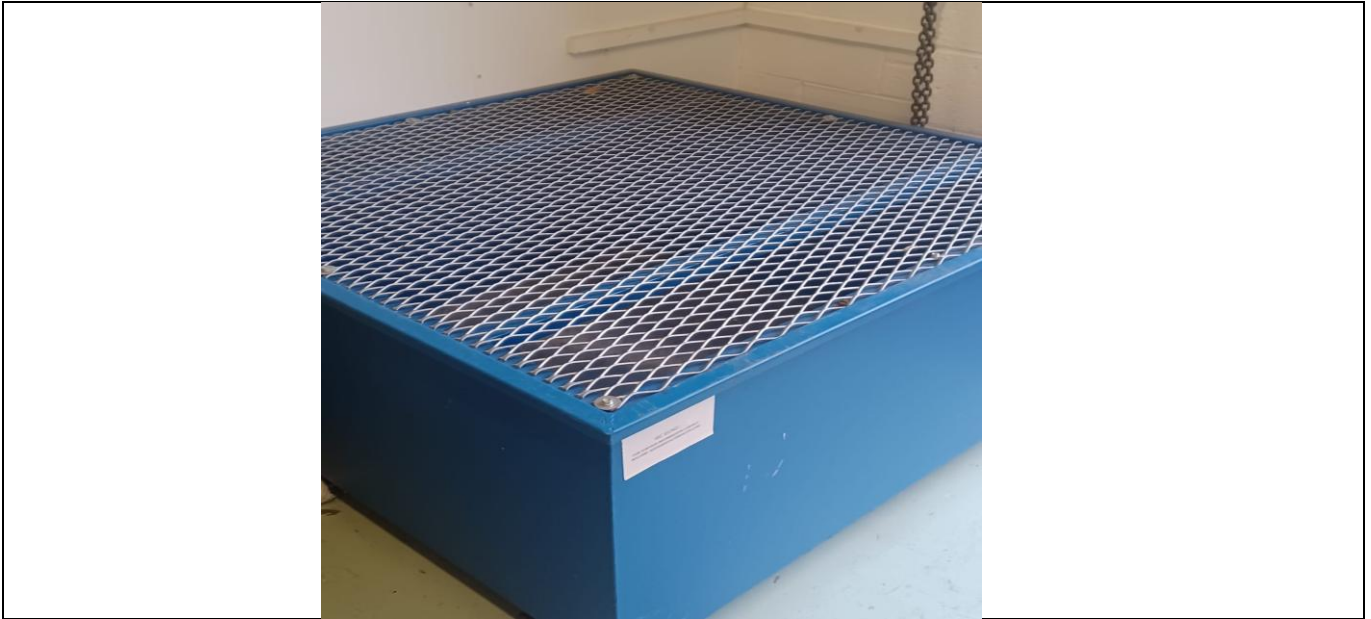
Health Beacon IBC Bund:

Visual Inspection: Visual Inspection around internal and external of bund walls reveals no signs of breaches or leaks.

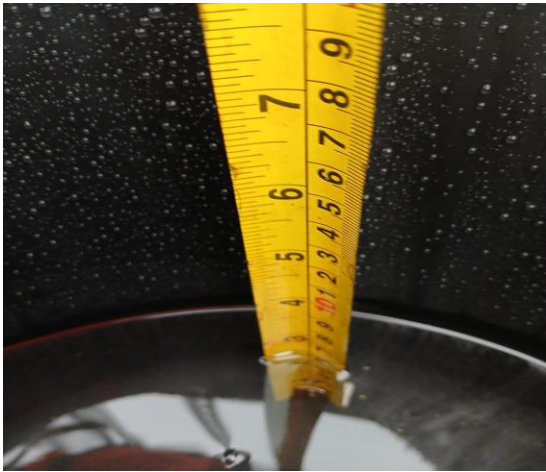
Day 1 (01/08/2024)

Reference Vessel Level: 60mm

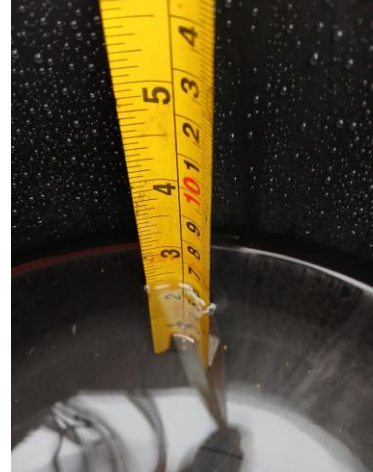
Day 2 (02/08/2024)

Reference Vessel Level: 60 mm

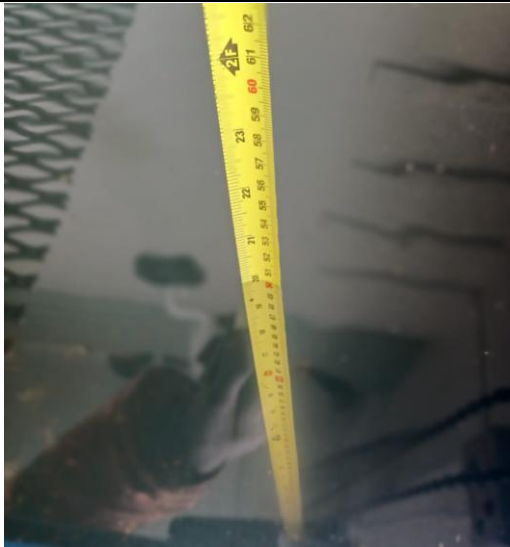
Bund Test Depth: 504 mm

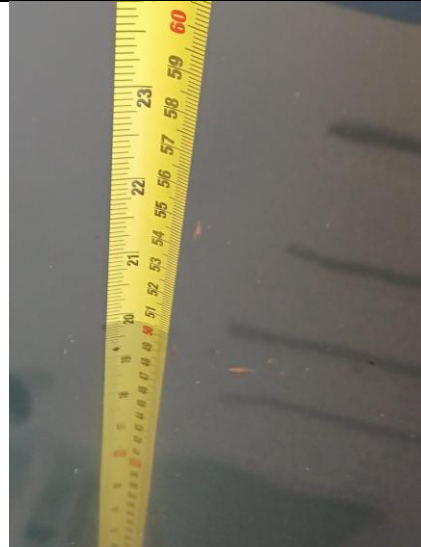
Description / Comments of Hydrostatic Test:
 Test completed successfully, depth of water in bund measured and photographed at the beginning of the test and 1 hour after. The stationary Bund was Housed indoors which prohibited external weather events having any impact on the test. Based on the survey and hydrostatic test carried out ENVA deem the IBC bund to be of sound integrity and therefore Passed.

Bund Test Depth: 504 mm

Visual Inspection around internal and external of bund walls reveals no signs of breaches or leaks.		
Result (Pass/Fail)	PASS	
Recommendation(s): Retest April 2028 as per the conditions outlined in license.		
Signed:
