Side Slope Stability Assessment 2023

Arthurstown Landfill (W004-04)

Project Number: GCU0303001

6 October 2023

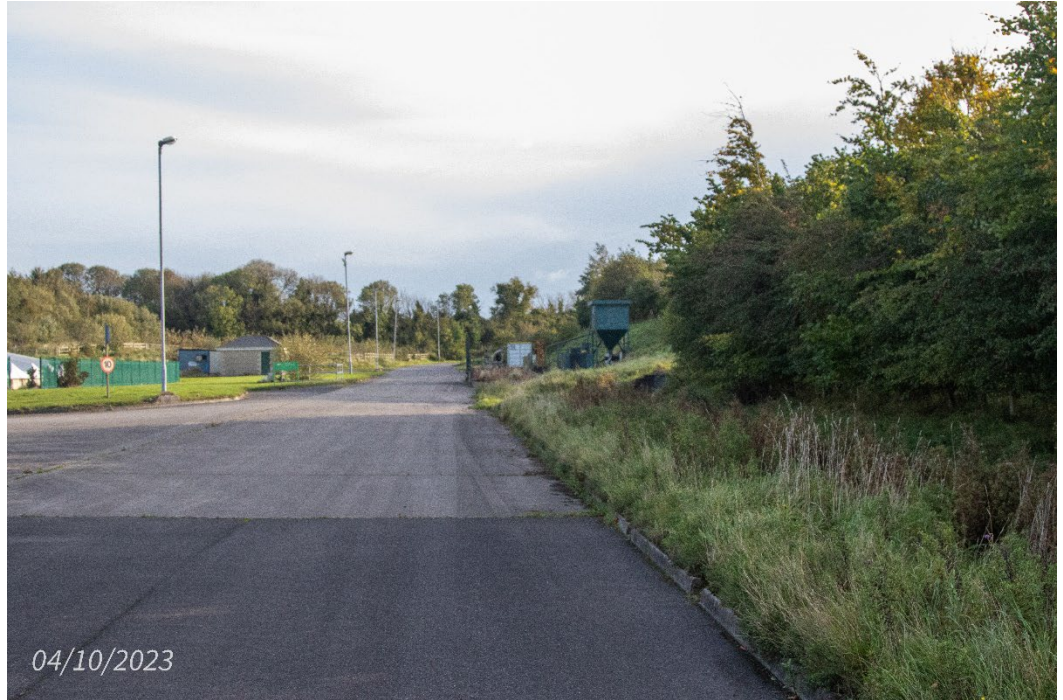
Photograph 1

Comments: Northwest slopes of Stages 1 and Stages 3 & 4.

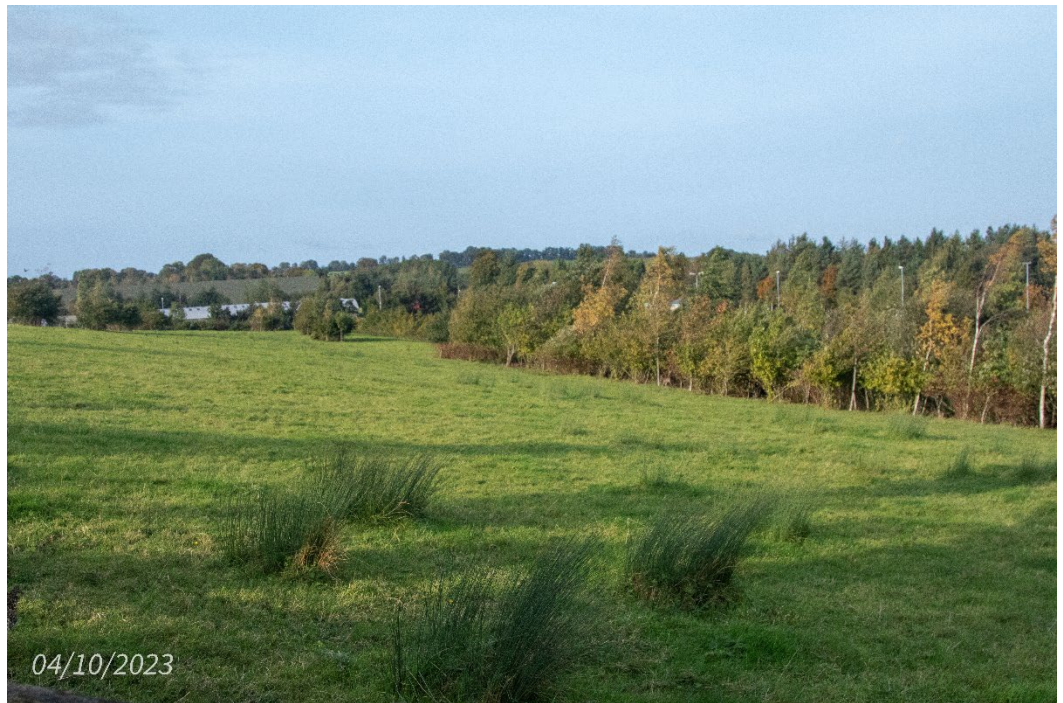
Photograph 2

Comments: Northwest slope of Stage 1.

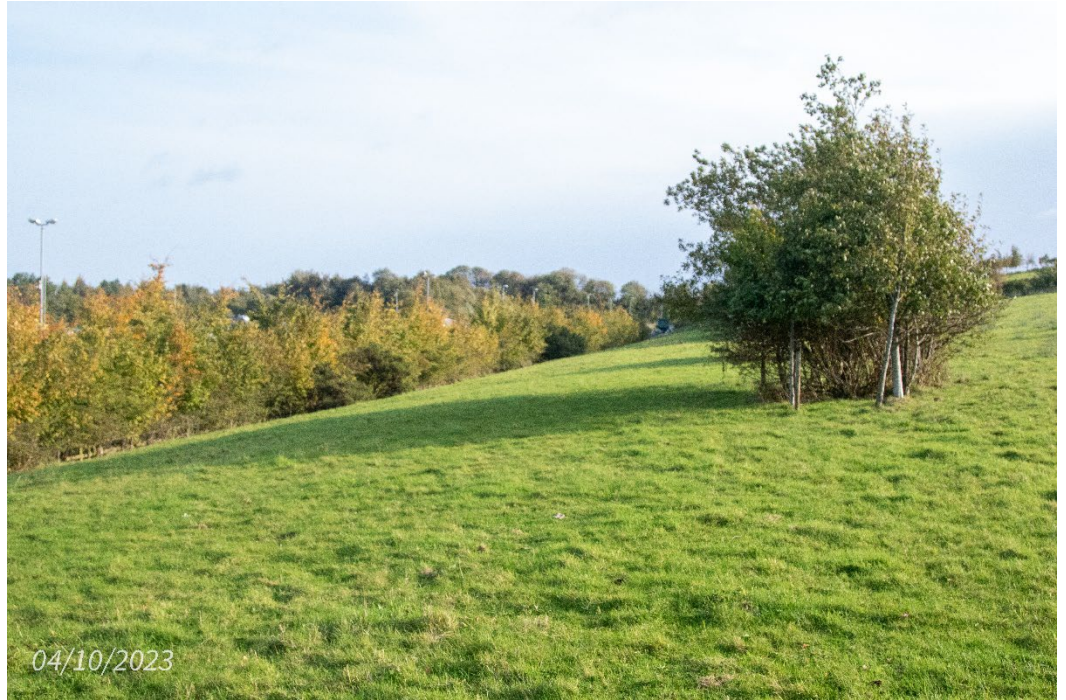
Photograph 3

Comments: Stage 1 slopes.

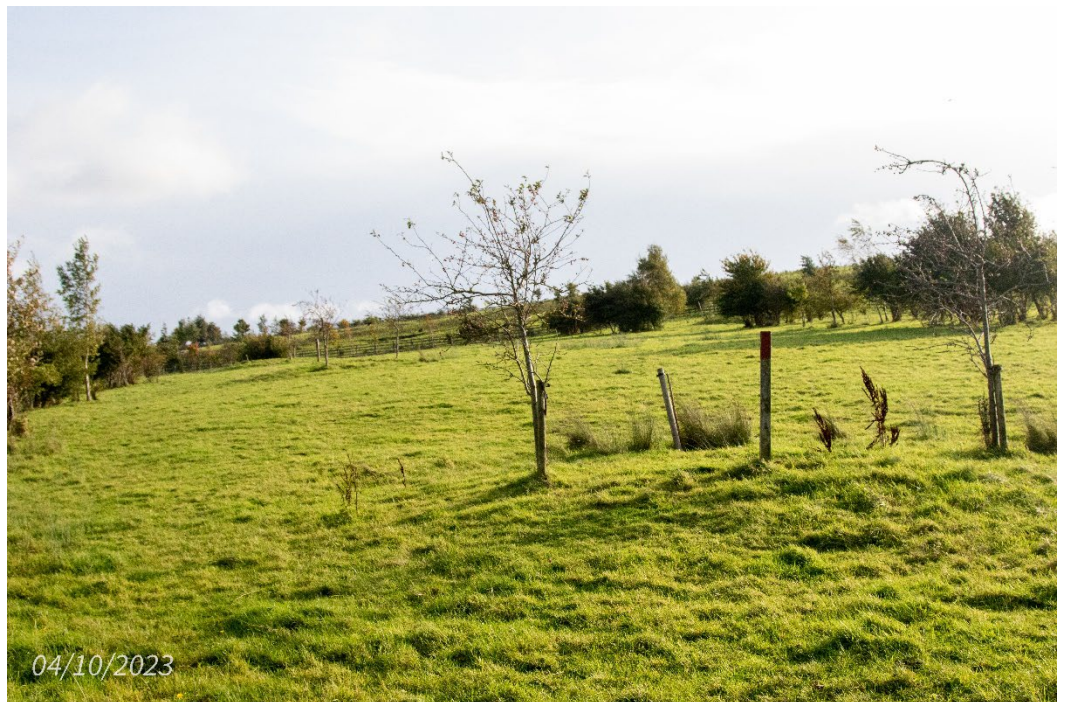
Photograph 4

Comments: Stage 1 slopes.

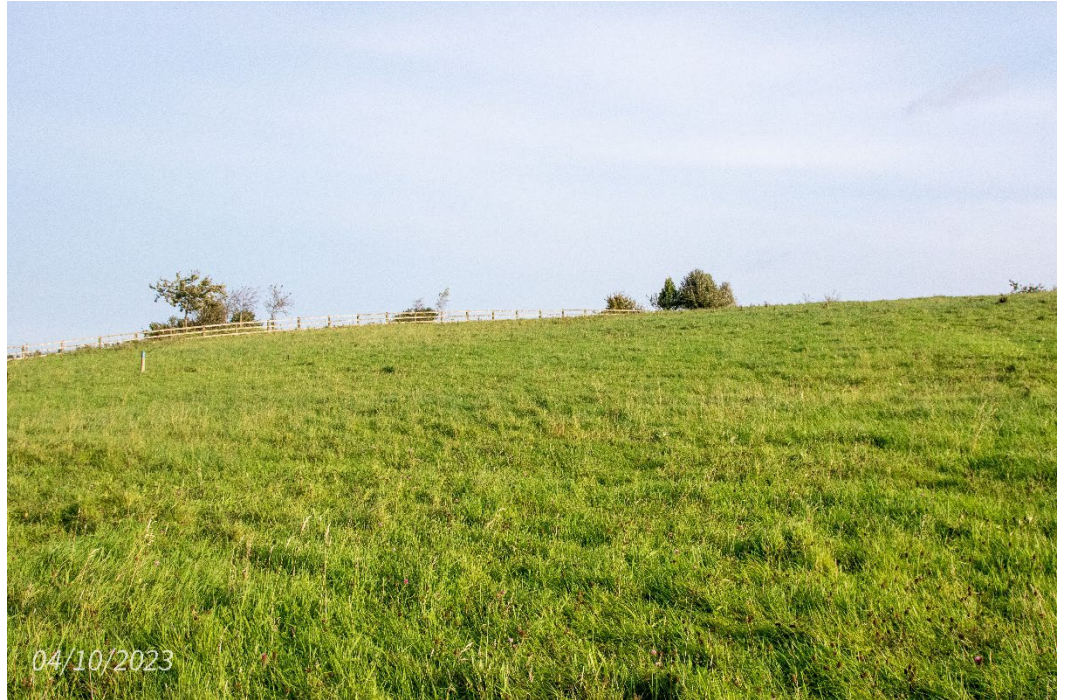
Photograph 5

Comments: Stage 1 slopes.

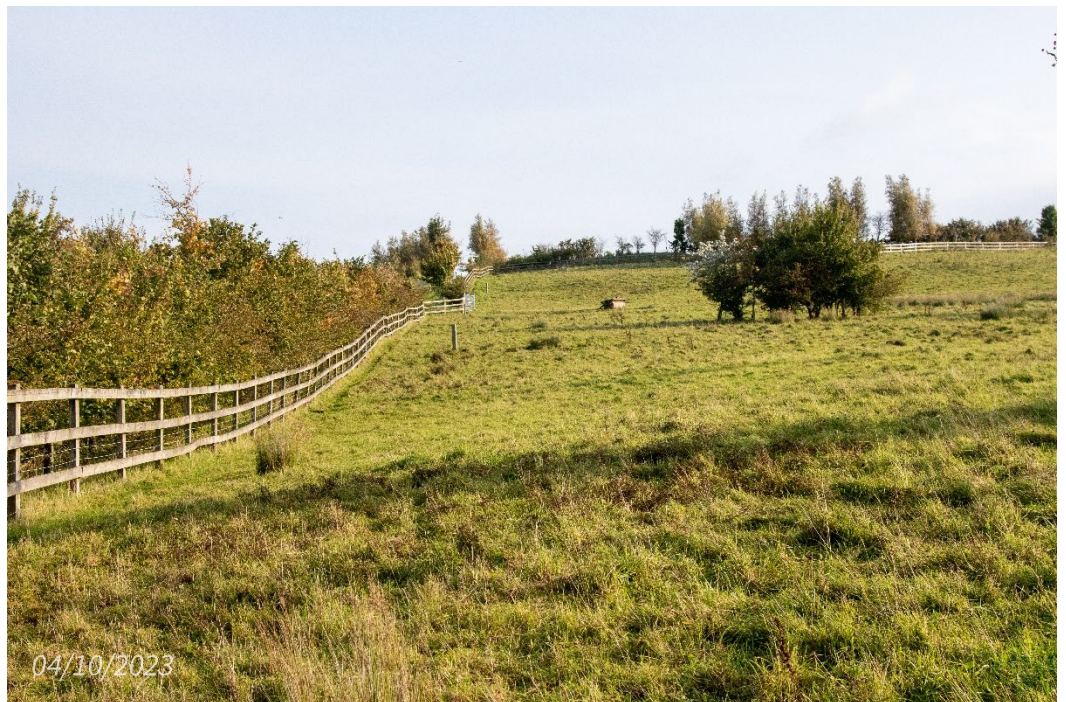
Photograph 6

Comments: Stage 2 slopes.

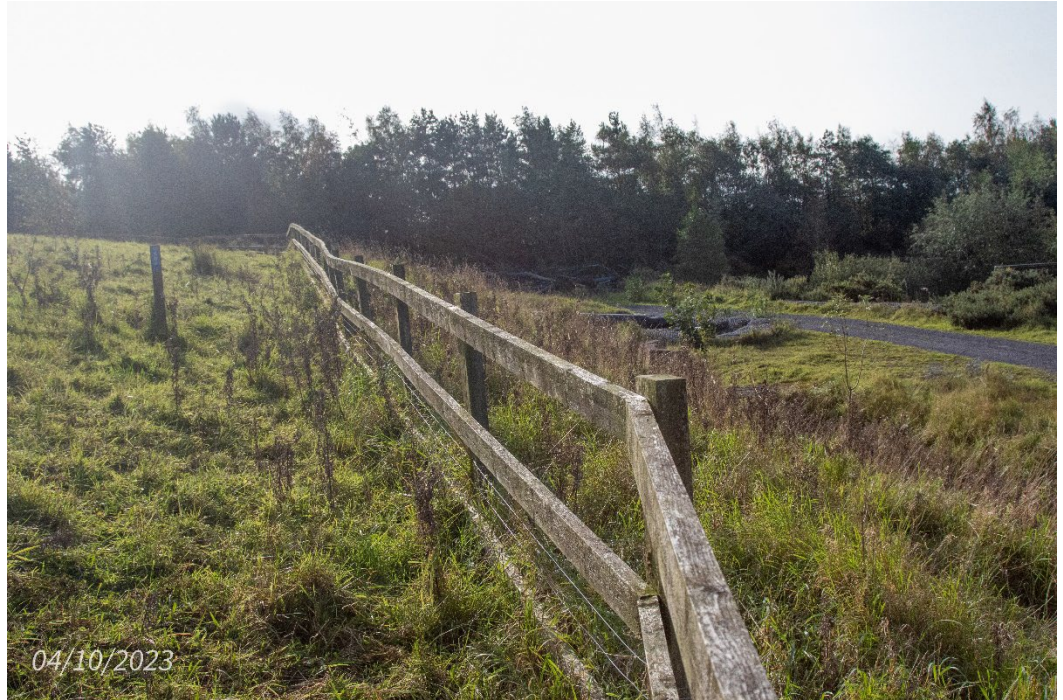
Photograph 7

Comments: Southern boundary of Stage 2.

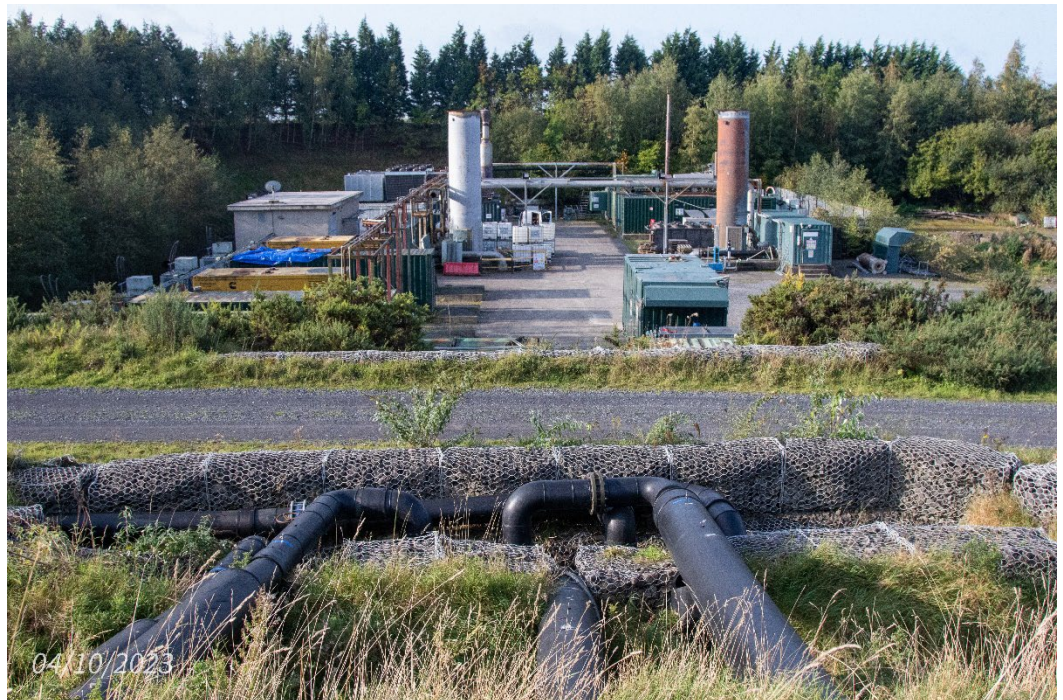
Photograph 8

Comments: Gas Utilisation Compound (GUP).

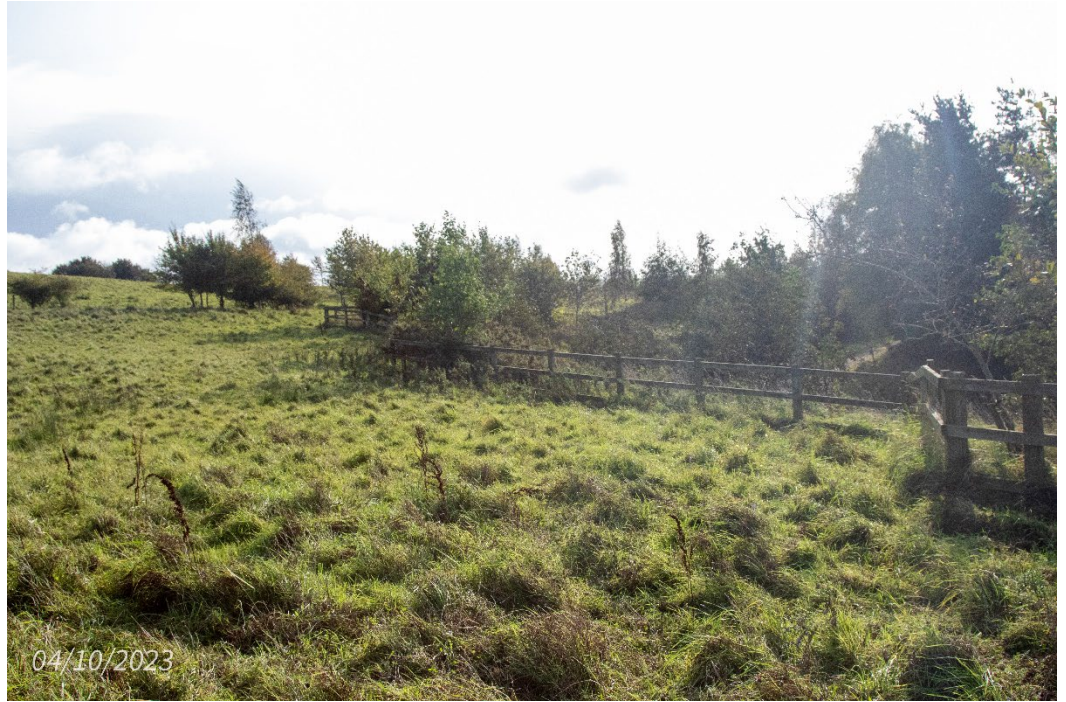
Photograph 9

Comments: Stage 2 slopes.

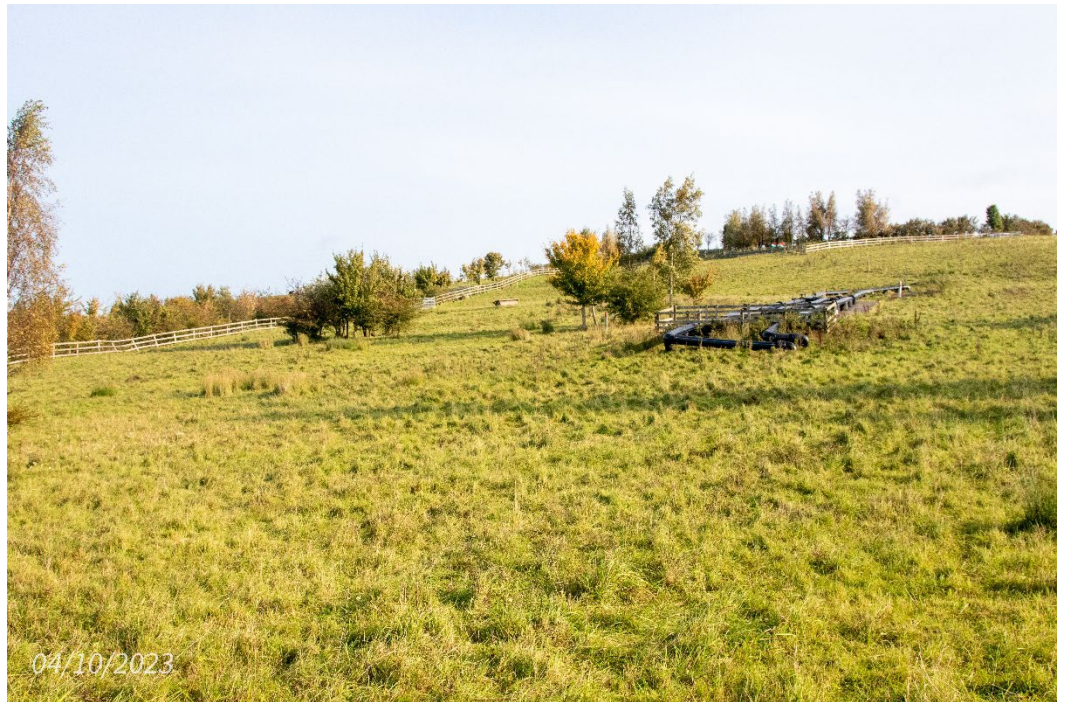
Photograph 10

Comments: LFG manifold within Stage 2.

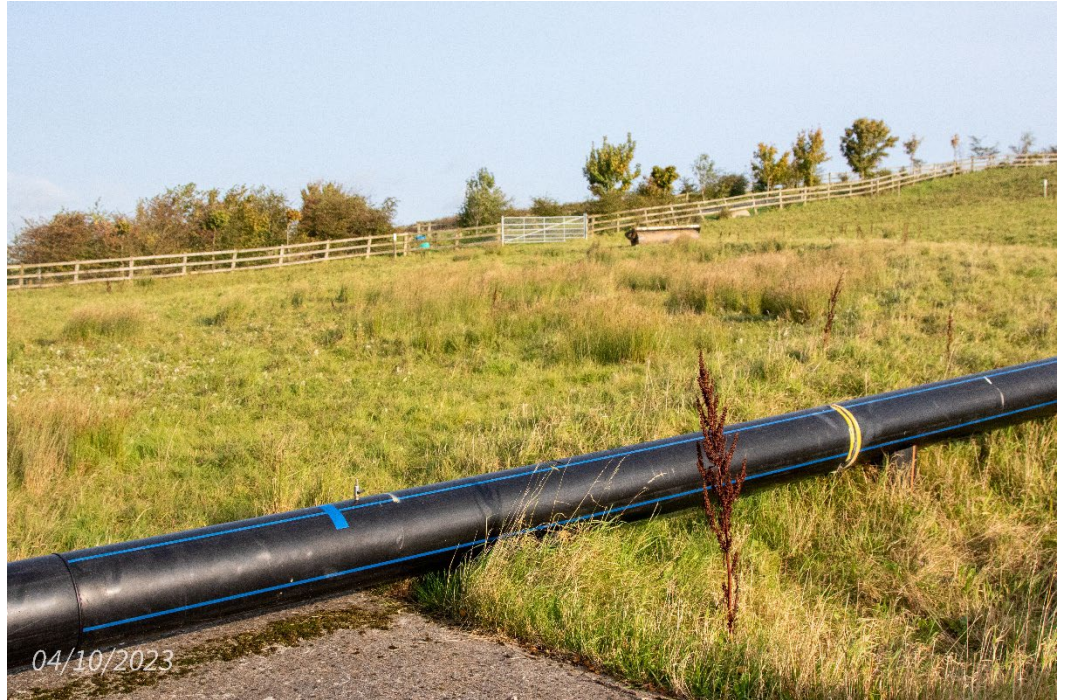
Photograph 11

Comments: LFG
Collection pipework –
visible settlement within
Stage 2.

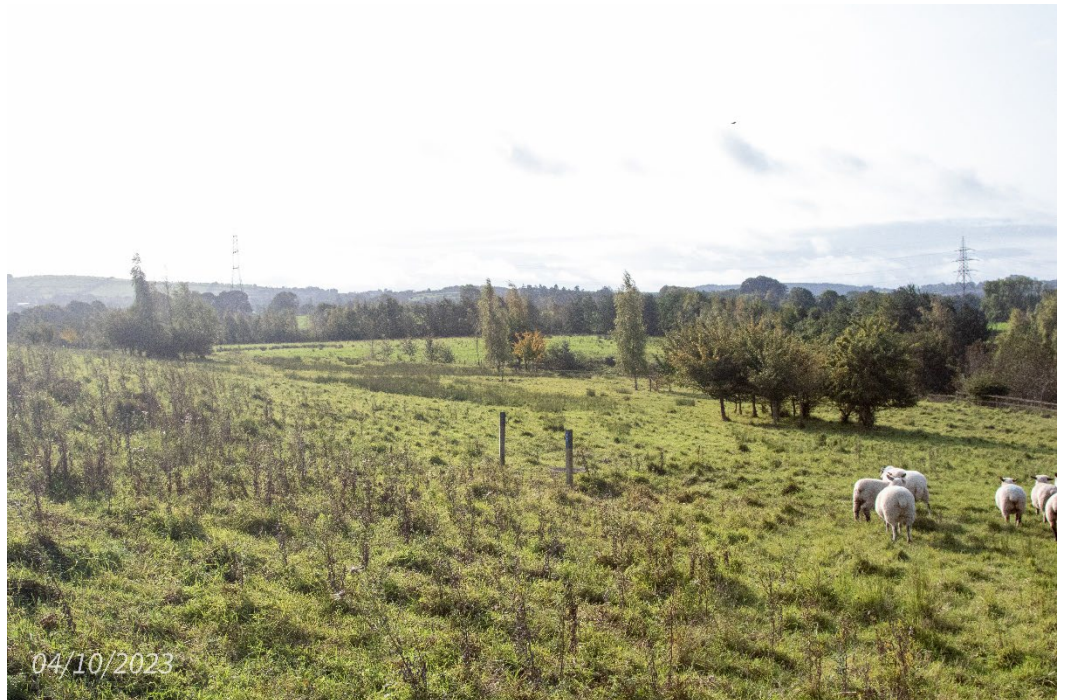
Photograph 12

Comments: Stage 2
slopes

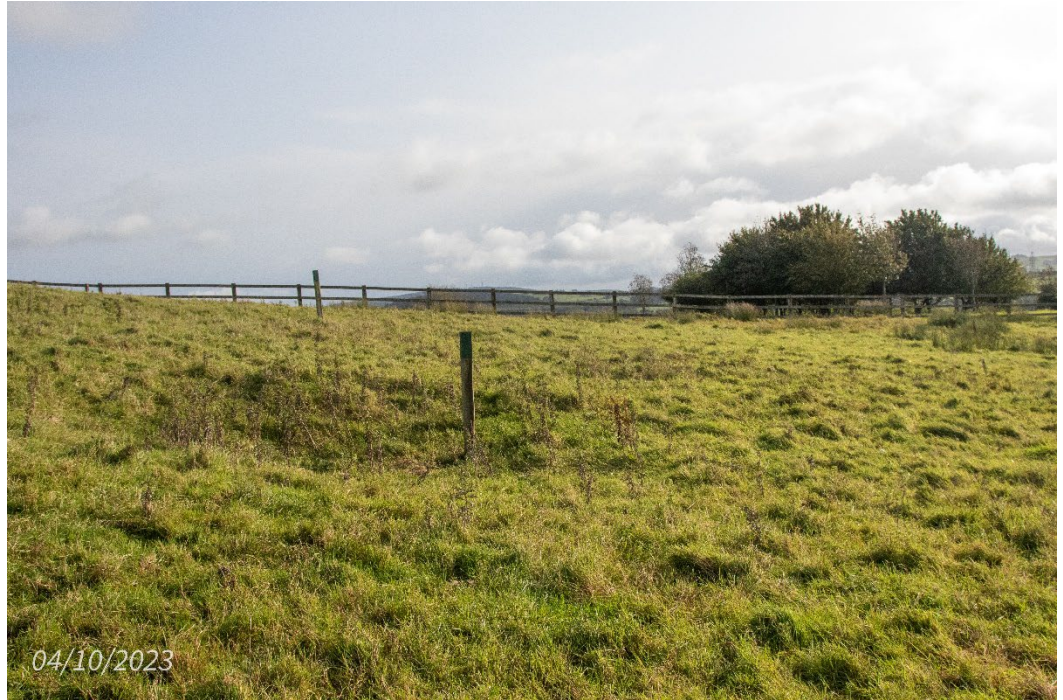
Photograph 13

- **Stage 2** – visible signs of settlement could be observed within Stage 2, i.e. at infrastructure that form a part the landfill gas collection infrastructure, such as manholes and concrete slabs (refer to Photo Views 13, 26 and 27 for an example). It is considered likely that the observed settlement occurred in the years immediately after the cessation of landfilling activities at the Site. The degree of settlement was observed to be similar when compared to the previous visual assessments. It is recommended that these locations will be inspected to assess if any damage to the underground installations have occurred and remediated if required.

Comments: Localised settlement within Stage 2.

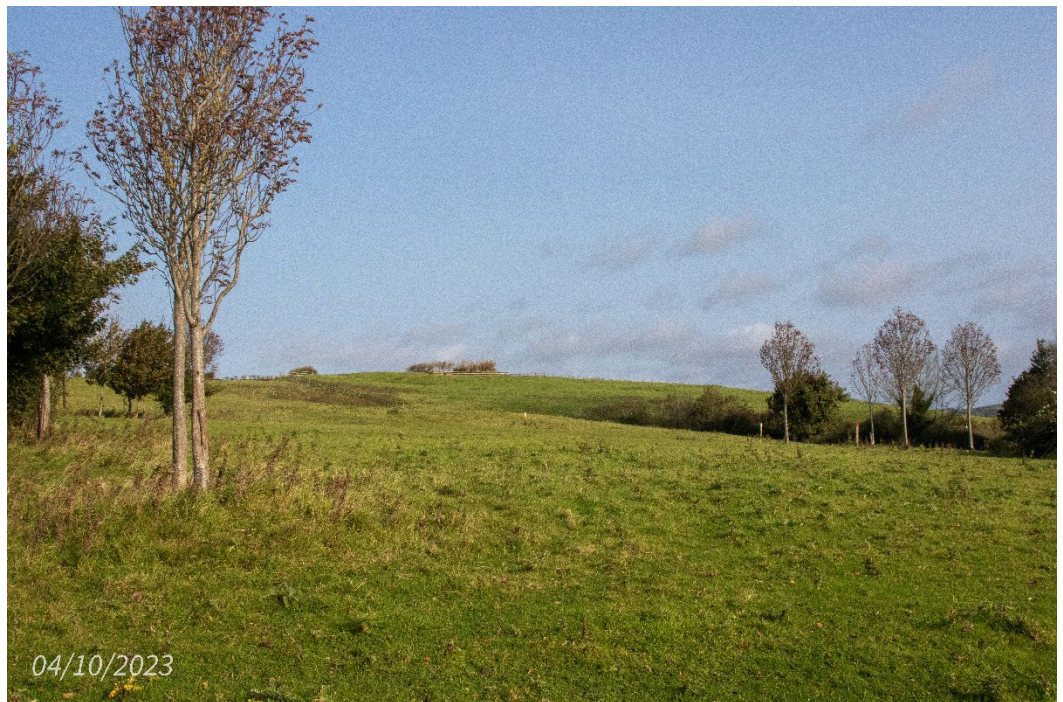
Photograph 14

Comments: Stage 2 – view towards Stage 3&4.

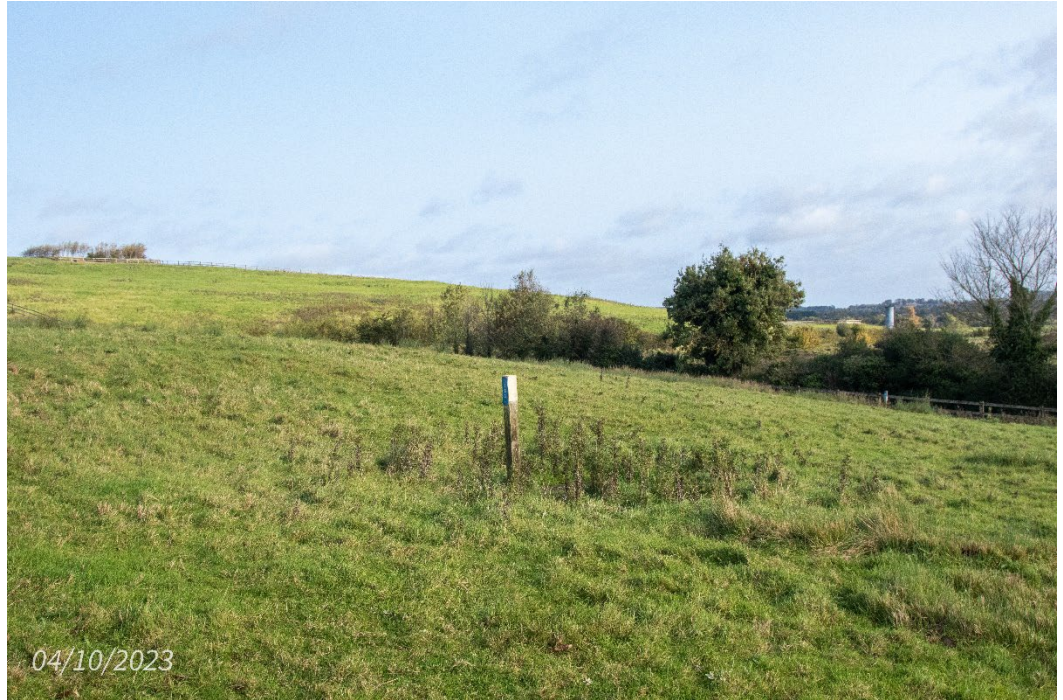
Photograph 15

Comments: Eastern boundary slopes of Stage 2 and 3&4.

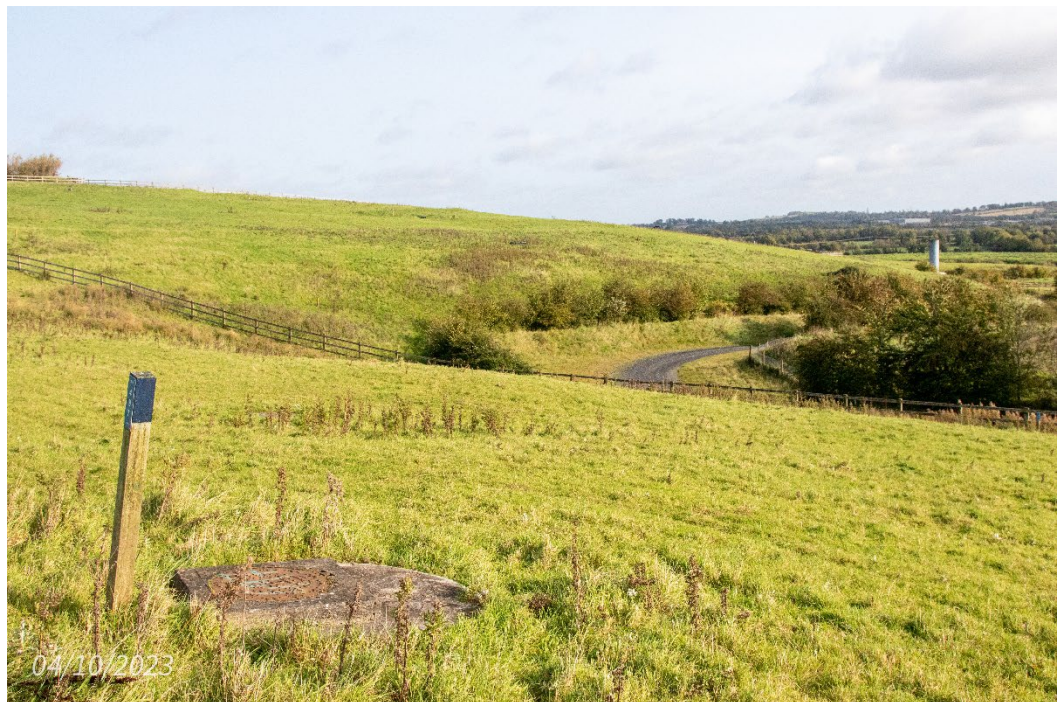
Photograph 16

Comments: Eastern boundary slopes of Stage 2 and 3&4.

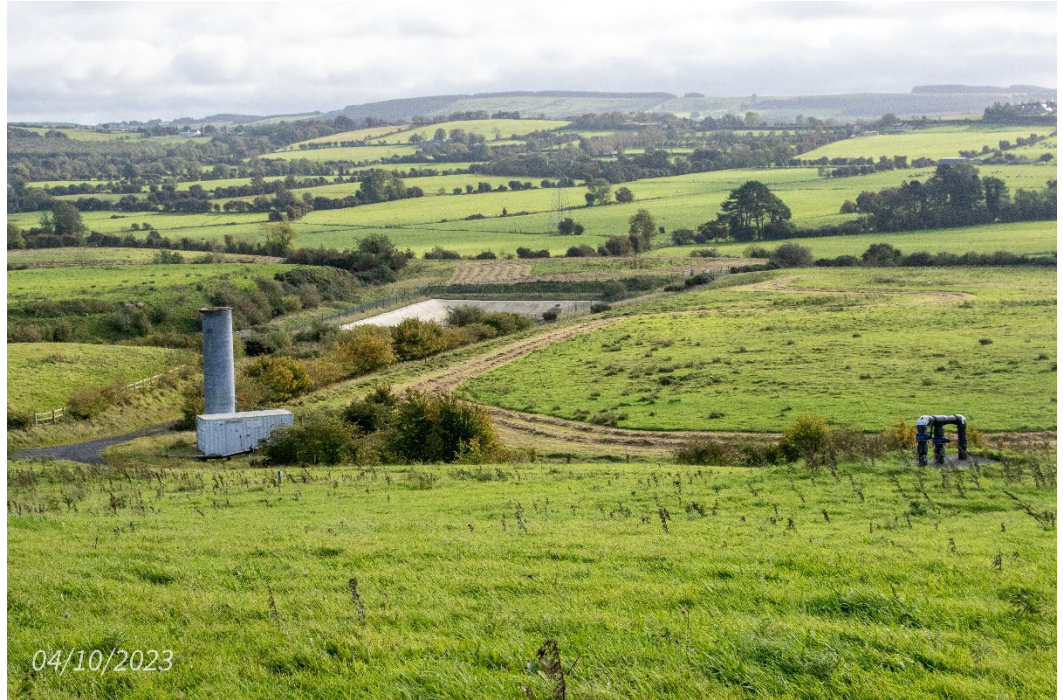
Photograph 17

Comments: Stage 3&4 – temporary flare and Surface Water holding lagoon.

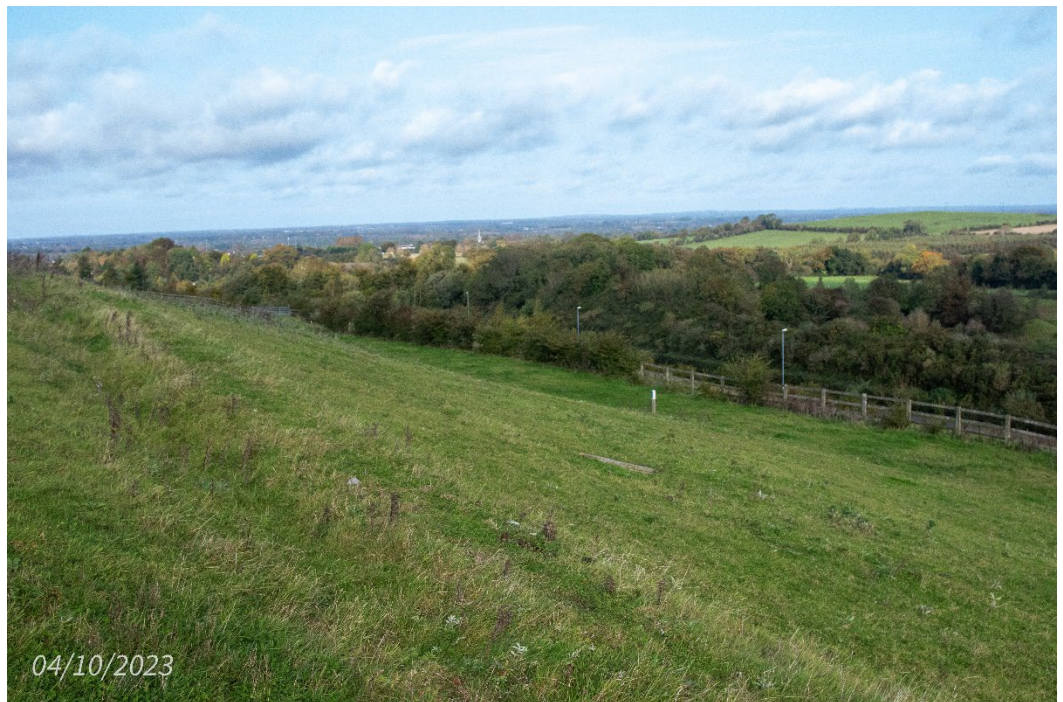
Photograph 18

Comments: Stages 3&4 – northern slopes.

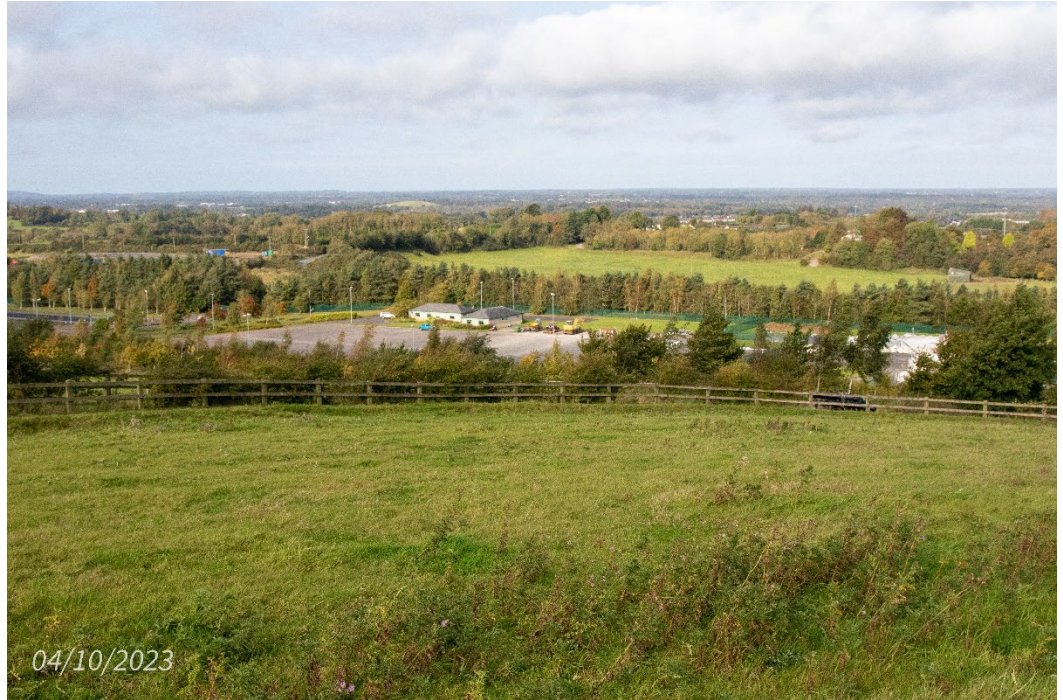
Photograph 19

Comments: Stage 3&4 – view towards site office and leachate compound.

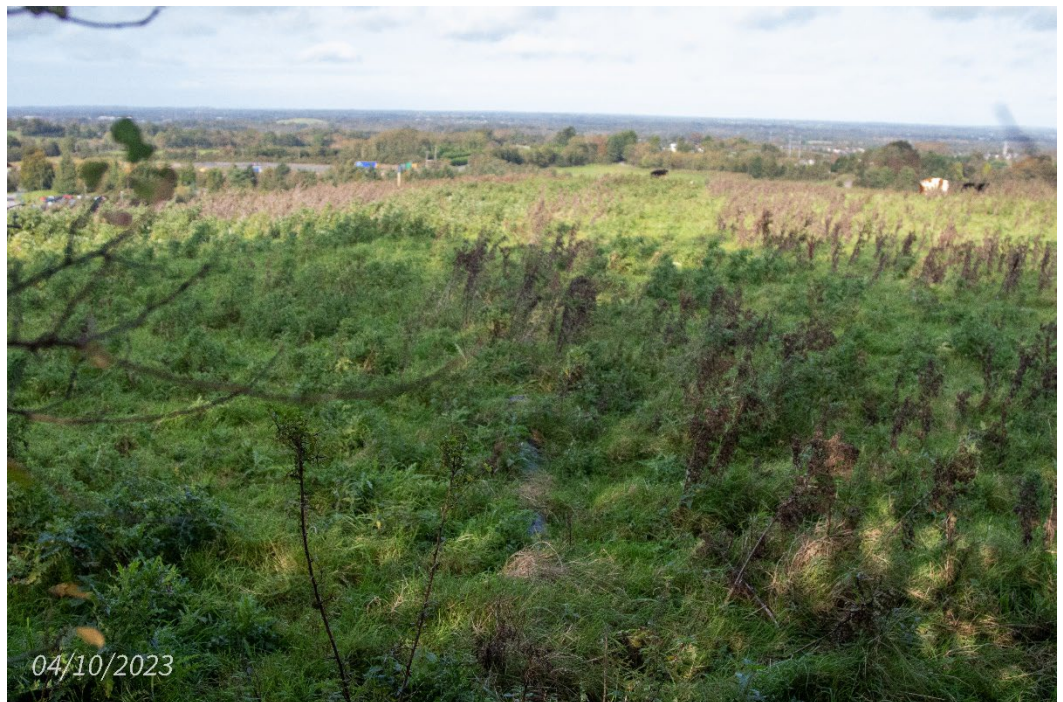
Photograph 20

Comments: Minor settlement visible during previous site assessments. Covered by heavy vegetation.

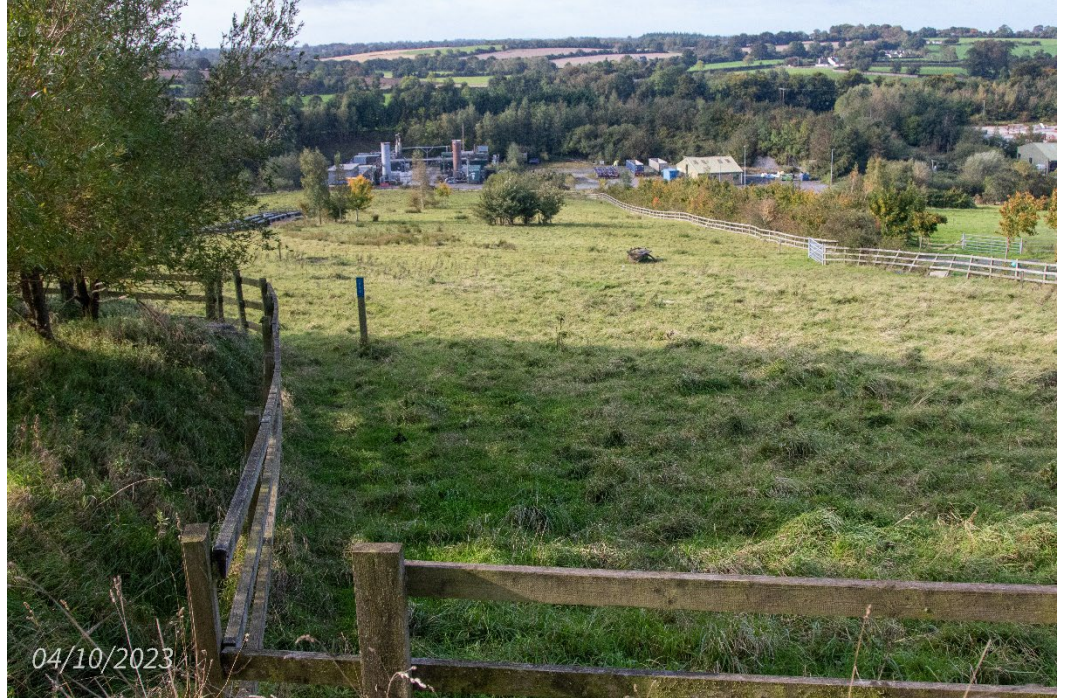
Photograph 21

Comments: Stage 2 slopes.

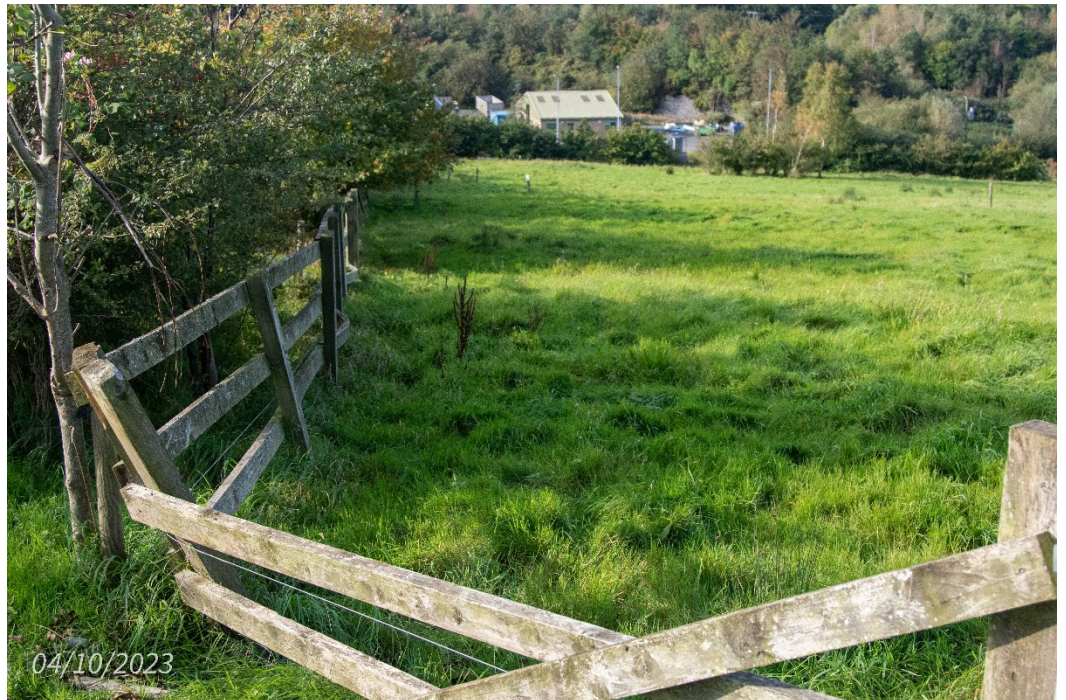
Photograph 22

infrastructure and wooden fencing running along field boundaries (see Photo Views 22 and 29) for the buckled fences within the Site). The fence between Stage 2 and Stages 4 was repaired in 2022.

Comments: Stage 1 slopes.

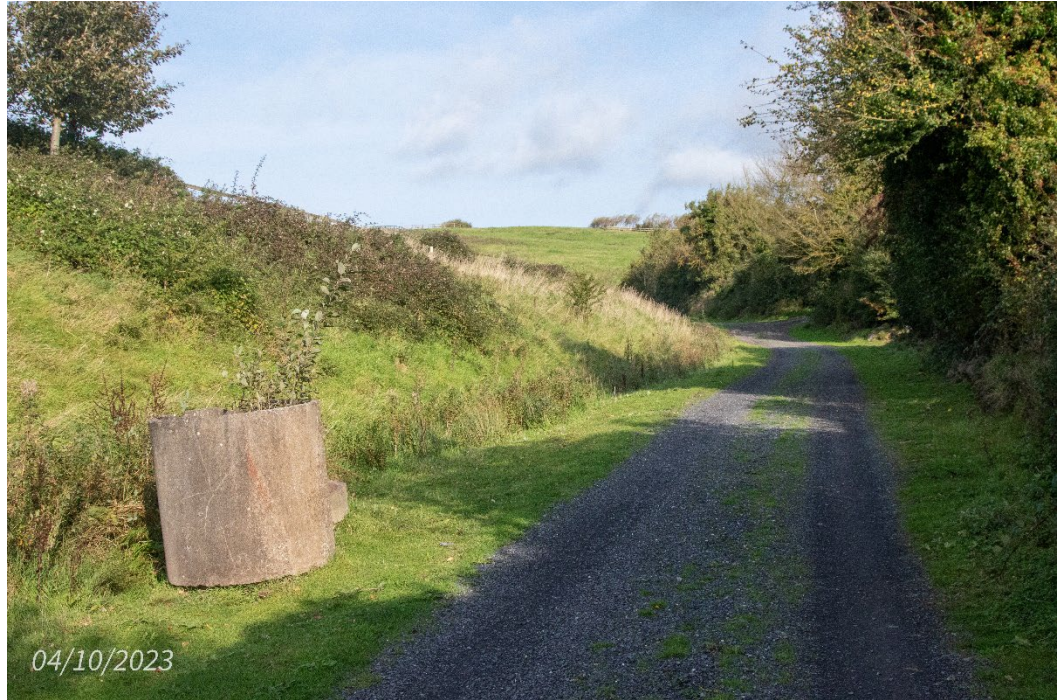
Photograph 23

Comments: Eastern slope of Stage 2 – minor slope instability within boundary embankment.

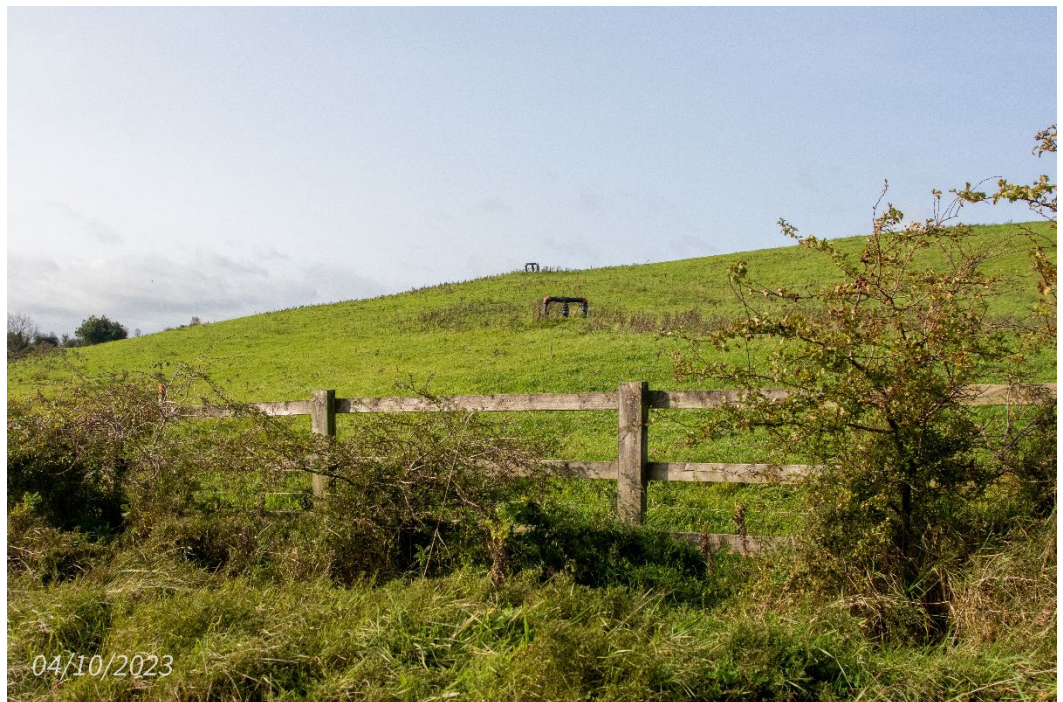
Photograph 24

Comments: Stage 3 and 4 slopes.

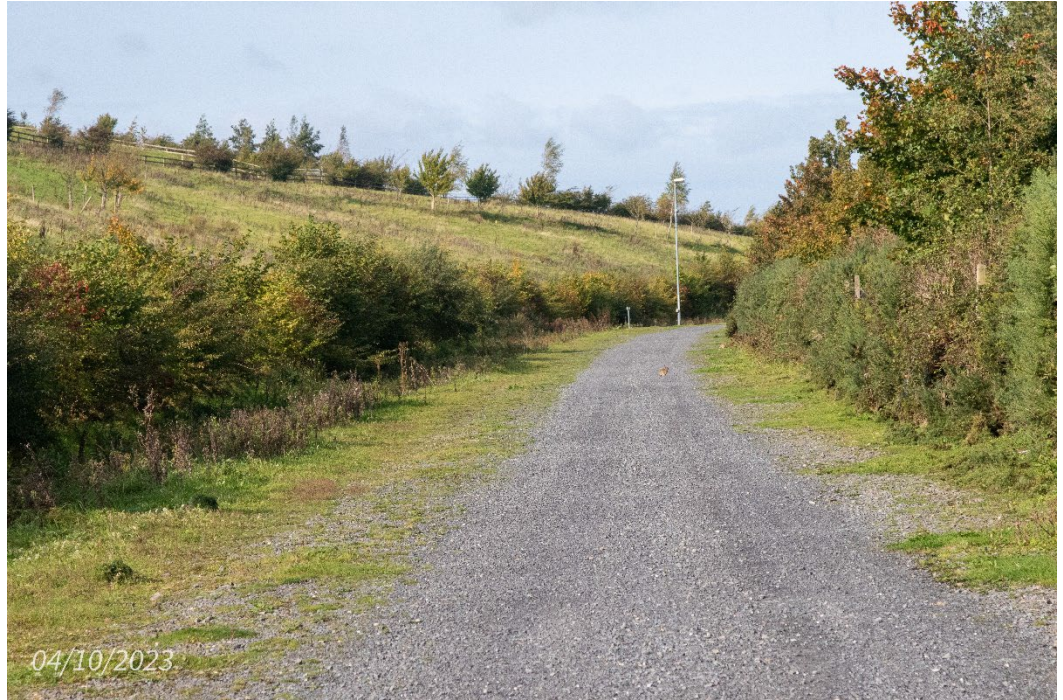
Photograph 25

Comments: Northern boundary slope of Stage 3&4.

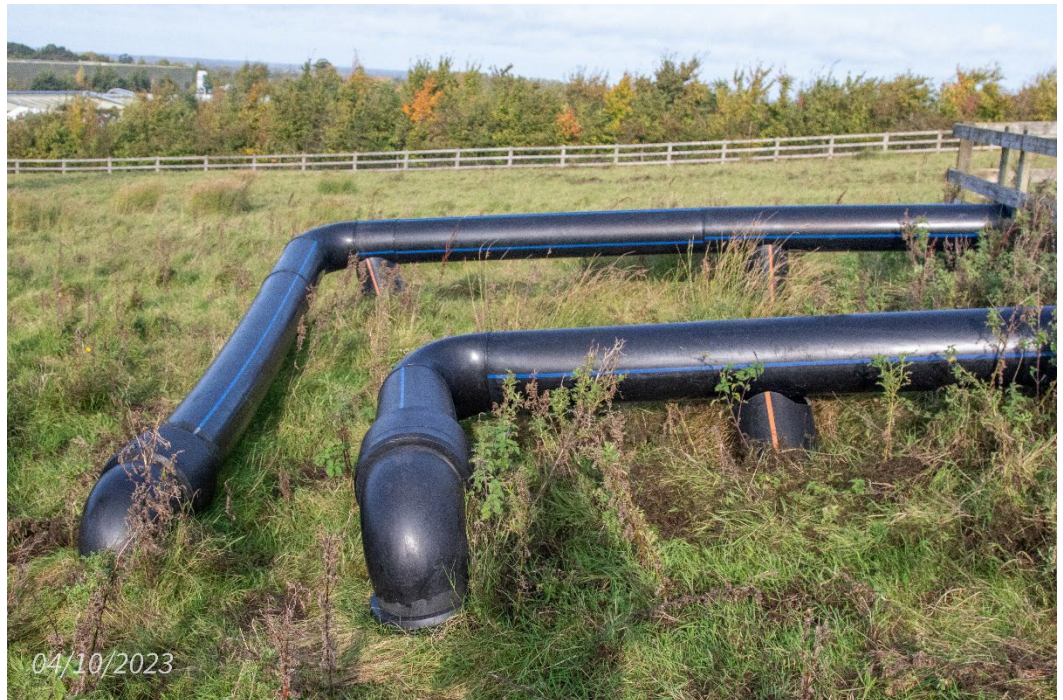
Photograph 26

Comments: Close view of Landfill gas collection pipework within Stage 2.

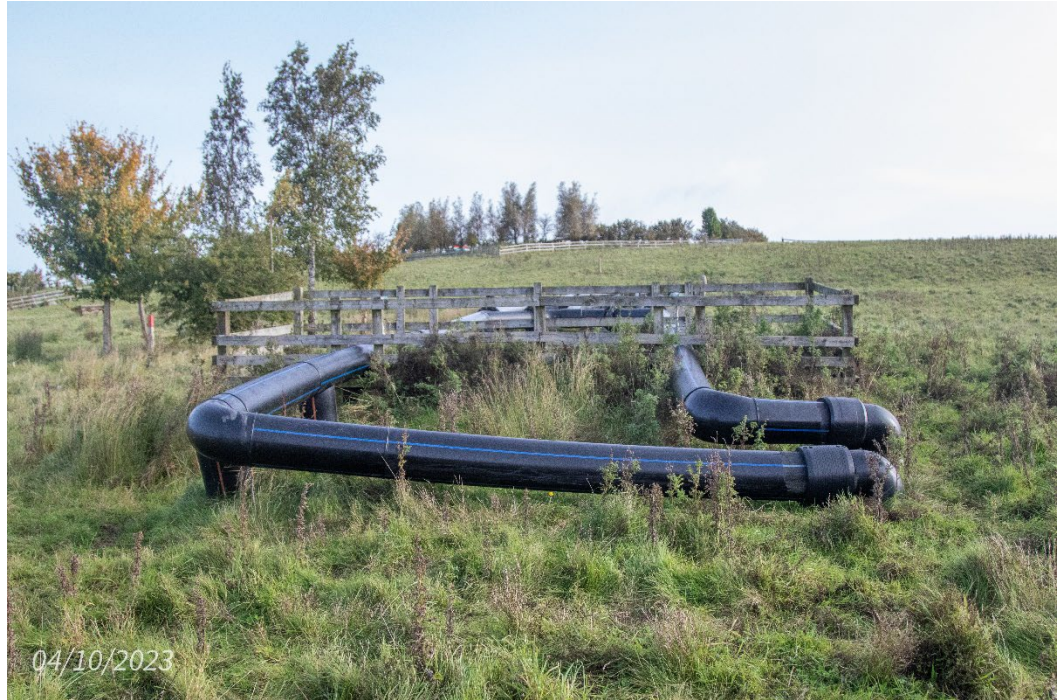
Photograph 27

Comments: Landfill gas collection pipework within Stage 2.

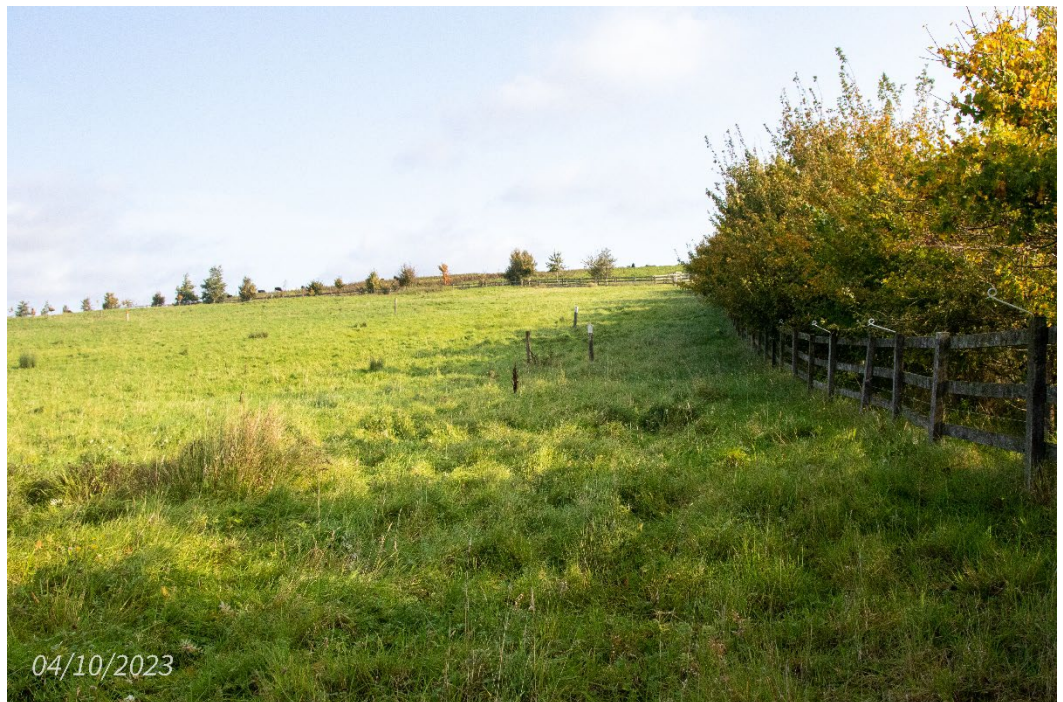
Photograph 28

Comments: Slightly buckled fence at Stage 1 and 2 boundary.

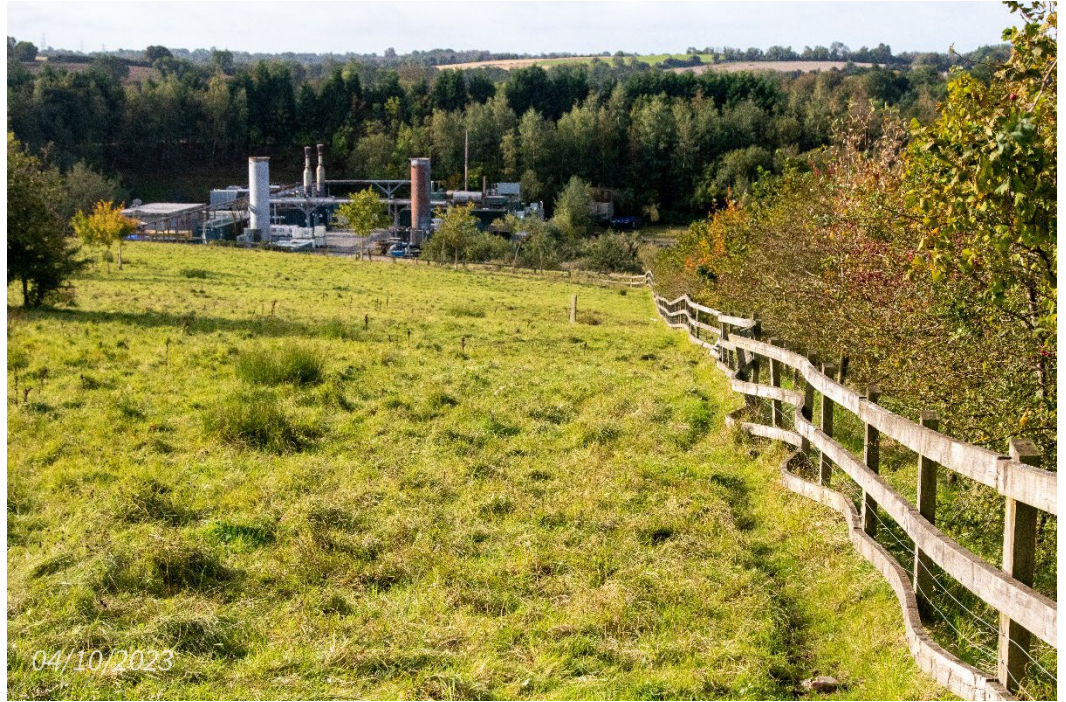
Photograph 29

Comments: Buckled fence at Stage 1 and 2 boundary.

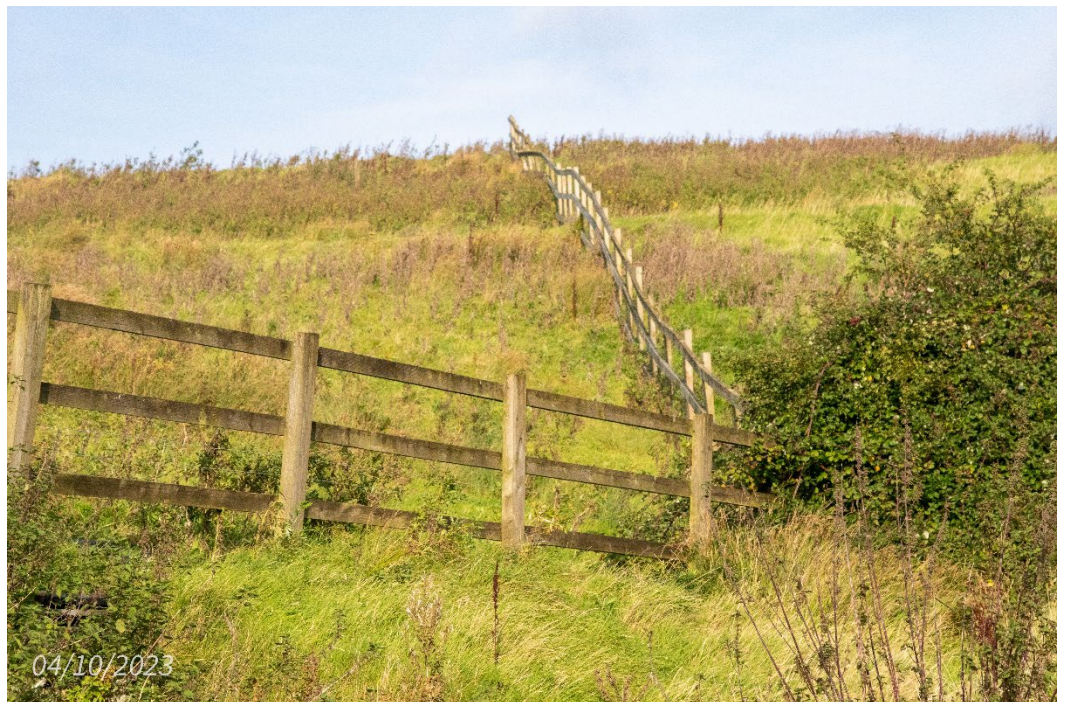
Photograph 30

Comments: Repaired fence between Stage 2 and Stages 3&4.
