# **Bund Integrity Assessment**

**MC Building Chemicals**

**Q.E.D. Engineering Ltd.**

**December 2022**

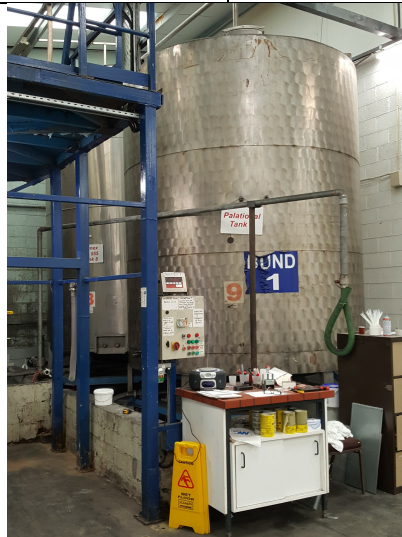
### Record Sheet for Bund Testing – Bund 1

<b>HYDROSTATIC TEST DETAILS:</b> N/A	
<b>VISUAL TEST DETAILS: INSPECTION DESCRIPTION &amp; RESULTS:</b> Visual Inspection carried out on the 19 <sup>th</sup> December 2022. Floors and walls of bund in good condition and bund was recently repaired and sealed.	
<b>Result (Pass/Fail)</b>	Pass
<b>RECOMMENDATIONS:</b> Bund passed visual inspection, therefore deemed to have passed. Retest again in 3 years (December 2025).	
<b>SIGNED:</b> <i>Patricia Murtagh</i>	<b>TITLE/POSITION:</b> Environmental Consultant
<b>DATE:</b> 19/12/22

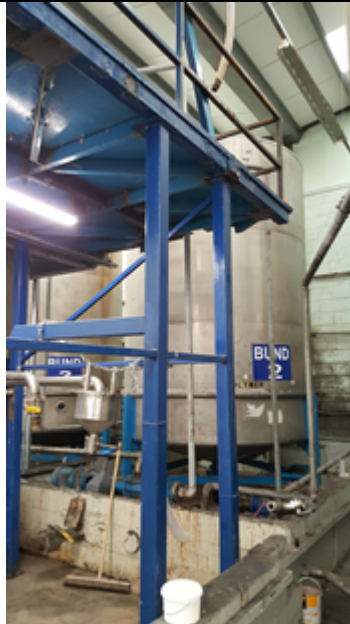
## Record Sheet for Bund Testing – Bund 2

<b>Deemed practical/safe to conduct hydrostatic test? Yes/No:</b> No		
<b>If no, give reasons:</b> Low lying electrical equipment and pumps located in bund so not possible to put water in this area.		
<b>HYDROSTATIC TEST DETAILS:</b> N/A		
<b>VISUAL TEST DETAILS: INSPECTION DESCRIPTION &amp; RESULTS:</b> Visual Inspection carried out on the 19 <sup>th</sup> December 2022. Floors and walls of bund in good condition and bund was recently repaired and sealed.		
<b>Result (Pass/Fail)</b>	Pass	
<b>RECOMMENDATIONS:</b> Bund passed visual inspection, therefore deemed to have passed. Retest again in 3 years (December 2025).		
<b>SIGNED:</b> <i>Patricia Murtagh</i>	<b>TITLE/POSITION:</b> Environmental Consultant	<b>DATE:</b> 19/12/2022

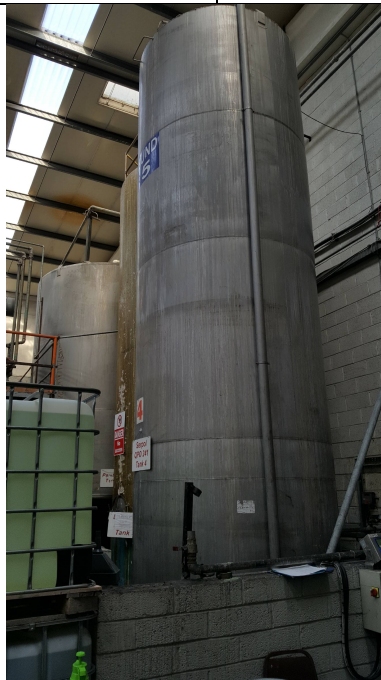
## Record Sheet for Bund Testing – Bund 5

<b>If no, give reasons:</b> Low lying electrical equipment and pumps located in bund so not possible to put water in this area.		
<b>HYDROSTATIC TEST DETAILS:</b> N/A		
<b>VISUAL TEST DETAILS: INSPECTION DESCRIPTION &amp; RESULTS:</b> Visual Inspection carried out on the 19 <sup>th</sup> December 2022. Floors and walls of bund in good condition and bund was recently repaired and sealed.		
<b>Result (Pass/Fail)</b>	Pass	
<b>RECOMMENDATIONS:</b> Bund passed visual inspection, therefore deemed to have passed. Retest again in 3 years (October 2022).		
<b>SIGNED:</b> <i>Patricia Murtagh</i>	<b>TITLE/POSITION:</b> Environmental Consultant	<b>DATE:</b> 19/12/22

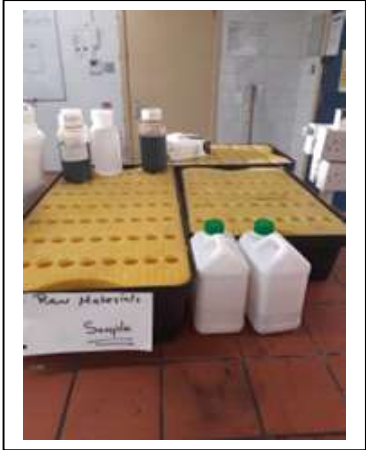
## Record Sheet for Bund Testing – No. 15678

<b>Description / Comments of Hydrostatic Test:</b>														
The water level dropped slightly in the bund which also corresponds to the drop in the reference vessel. This is attributed to evaporation. Bund is in good condition.														
<b>VISUAL TEST DETAILS: INSPECTION DESCRIPTION &amp; RESULTS:</b>														
Bund in good condition. No evidence of seepage of water.														
<b>Result (Pass/Fail)</b>	Pass													
<b>RECOMMENDATIONS:</b>														
Bund test passed, so retest again in 3 years (December 2025).														
<b>SIGNED:</b> <i>Patricia Murtagh</i>	<b>TITLE/POSITION:</b> Environmental Consultant	<b>DATE:</b> 04/01/23

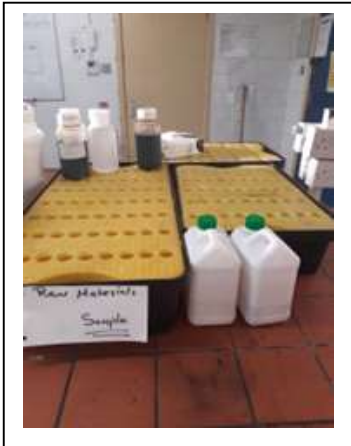
## Record Sheet for Bund Testing – No. 15679

<b>Description / Comments of Hydrostatic Test:</b>														
The water level dropped slightly in the bund which also corresponds to the drop in the reference vessel. This is attributed to evaporation. Bund is in good condition.														
<b>VISUAL TEST DETAILS: INSPECTION DESCRIPTION &amp; RESULTS:</b>														
Bund in good condition. No evidence of seepage of water.														
<b>Result (Pass/Fail)</b>	Pass													
<b>RECOMMENDATIONS:</b>														
Bund test passed, so retest again in 3 years (December 2023).														
<b>SIGNED:</b> <i>Patricia Murtagh</i>	<b>TITLE/POSITION:</b> Environmental Consultant	<b>DATE:</b> 04/01/22

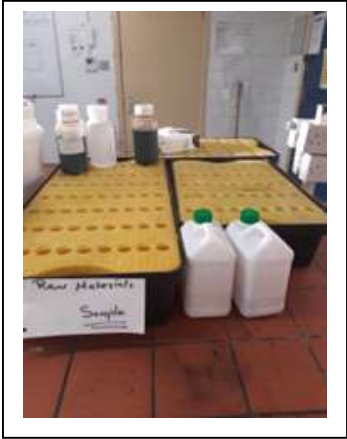
## Record Sheet for Bund Testing – No. 15680

**Description / Comments of Hydrostatic Test:**  
 The water level dropped slightly in the bund which also corresponds to the drop in the reference vessel. This is attributed to evaporation. Bund is in good condition.

**VISUAL TEST DETAILS: INSPECTION DESCRIPTION & RESULTS:**  
 Bund in good condition. No evidence of seepage of water.

**RECOMMENDATIONS:**  
 Bund test passed, so retest again in 3 years (December 2025).

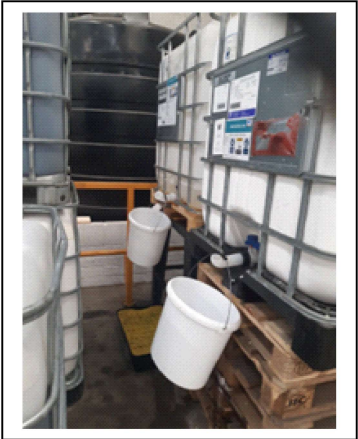
## Record Sheet for Bund Testing – No. 15681

<b>Description / Comments of Hydrostatic Test:</b>														
There was no change in water level in the bund or reference vessel over 24 hours.														
<b>VISUAL TEST DETAILS: INSPECTION DESCRIPTION &amp; RESULTS:</b>														
Bund in good condition. No evidence of seepage of water.														
<b>Result (Pass/Fail)</b>	Pass													
<b>RECOMMENDATIONS:</b>														
Bund test passed, so retest again in 3 years (December 2025).														
<b>SIGNED:</b> <i>Patricia Murtagh</i>	<b>TITLE/POSITION:</b> Environmental Consultant	<b>DATE:</b> 04/01/23

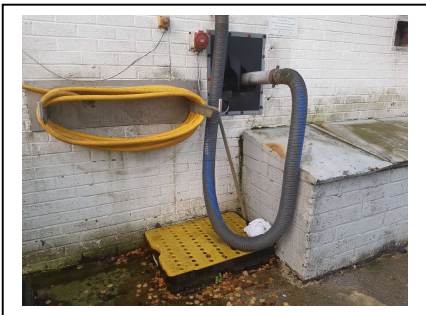
## Record Sheet for Bund Testing – No. Z001

<b>Description / Comments of Hydrostatic Test:</b>														
There was no change in water level in the bund or reference vessel over 24 hours.														
<b>VISUAL TEST DETAILS: INSPECTION DESCRIPTION &amp; RESULTS:</b>														
Bund in good condition. No evidence of seepage of water.														
<b>Result (Pass/Fail)</b>	Pass													
<b>RECOMMENDATIONS:</b>														
Bund test passed, so retest again in 3 years (December 2022).														
<b>SIGNED:</b> <i>Patricia Murtagh</i>	<b>TITLE/POSITION:</b> Environmental Consultant	<b>DATE:</b> 04/01/23

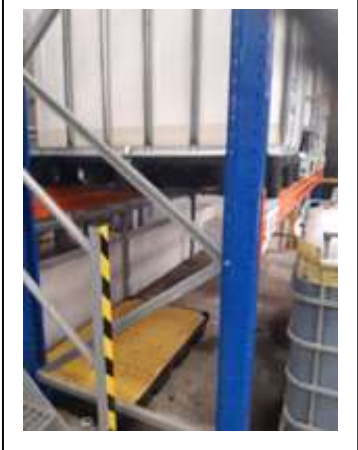
## Record Sheet for Bund Testing – No. Z003

<b>Description / Comments of Hydrostatic Test:</b>														
There was no change in water level in the bund or reference vessel over 24 hours.

<b>VISUAL TEST DETAILS: INSPECTION DESCRIPTION &amp; RESULTS:</b>														
Bund in good condition. No evidence of seepage of water.														
<b>Result (Pass/Fail)</b>	Pass													
<b>RECOMMENDATIONS:</b>														
Bund test passed, so retest again in 3 years (December 2025).														
<b>SIGNED:</b> <i>Patricia Murtagh</i>	<b>TITLE/POSITION:</b> Environmental Consultant	<b>DATE:</b> 04/01/23

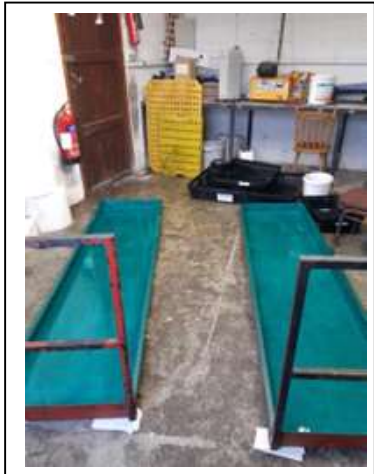
## Record Sheet for Bund Testing – SR520 Drip Tray

20/12/22	1.0cm	11.5cm												
<b>Description / Comments of Hydrostatic Test:</b>														
There was no change in water level in the bund or reference vessel over 24 hours.														
<b>VISUAL TEST DETAILS: INSPECTION DESCRIPTION &amp; RESULTS:</b>														
Bund in good condition. No evidence of seepage of water.														
<b>Result (Pass/Fail)</b>	Pass													
<b>RECOMMENDATIONS:</b>														
Bund test passed, so retest again in 3 years (December 2023).														
<b>SIGNED:</b> <i>Patricia Murtagh</i>	<b>TITLE/POSITION:</b> Environmental Consultant	<b>DATE:</b> 04/01/23

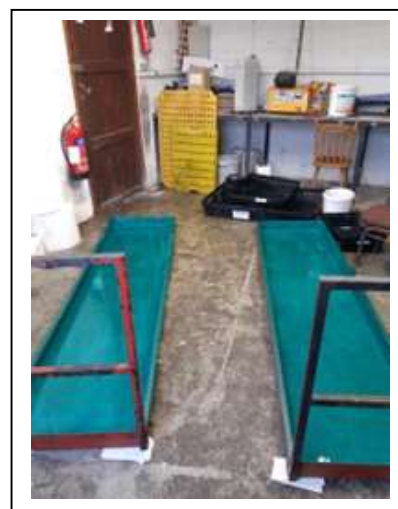
## Record Sheet for Bund Testing – Lignex Drip Tray

<b>Fill Rate</b>		<1.5m in 24hrs
<b>Stabilisation Period</b>		24hrs
<b>Duration of the Test</b>		24 hrs
<b>Acceptance Criteria (Total permissible drop in water level)</b>		10mm
<b>Water Level Change in Reference Vessel</b>		No
<b>Date and Time</b>	<b>Water Level in Bund</b>	<b>Water Level in Reference Vessel</b>
19/12/22	1.0cm	11.5cm
20/12/22	1.0cm	11.5cm
<b>Description / Comments of Hydrostatic Test:</b> There was no change in water level in the bund or reference vessel over 24 hours.		
<b>VISUAL TEST DETAILS: INSPECTION DESCRIPTION &amp; RESULTS:</b> Bund in good condition. No evidence of seepage of water.		
<b>Result (Pass/Fail)</b>	Pass	
<b>RECOMMENDATIONS:</b> Bund test passed, so retest again in 3 years (December 2023).		
<b>SIGNED:</b> <i>Patricia Murtagh</i>	<b>TITLE/POSITION:</b> Environmental Consultant	<b>DATE:</b> 04/01/23

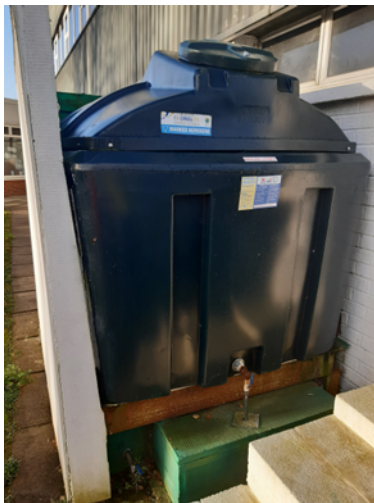
## Self-Bunded Tank

One double skin, self-bunding tanks is in place at the site. This tank was visually inspected on 19/12/22.

Tank Capacity: 2,000 litres  
Bund Capacity: Double Skin, therefore self bunding  
Tank Servicing: Offices  
Location of Tank: Located along footpath beside wall at front corner of site.  
Condition of Tank: Good condition, with protective wall and protection around pipework  
Conclusion: Tank double skin, so does not require external bunding. Located in secure area, protected from traffic impact and visually inspected by site management on a regular basis.
