# Site Visit Report

Licensee	
<b>Name of Installation</b>	Bord na Mona Biomass Limited
<b>Licensee</b>	Bord na Mona Biomass Limited
<b>Licence Register No.</b>	P0503-01
<b>CRO Number</b>	303311
<b>Site Address</b>	Allen Group, c/o Derrygreenagh Works, Rochfordbridge, Westmeath
<b>Site Visit Reference No.</b>	SV27811

Site Visit Detail			
<b>Date Of Inspection</b>	16/03/2023		
<b>Time In</b>	11:10	<b>Time Out</b>	11:40
<b>EPA Inspector(s)</b>	Billy Shanahan		
<b>Additional Visitors</b>			
<b>Licensee Personnel and Role</b>	N/A

The Agency carried out this site visit to Garrymore bog to review the activity onsite.

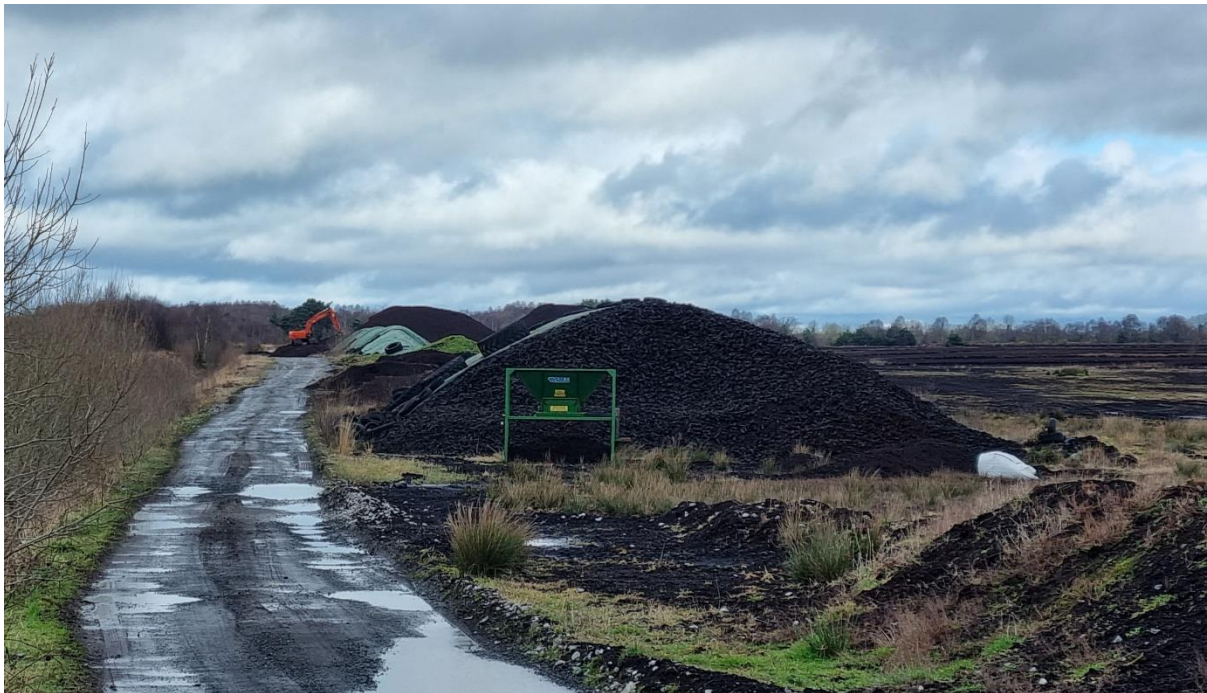
Answer	Condition Number	Non Compliance	Observation
1.1	Garrymore Bog	Checked		
<b>Comment / Action Required</b>				
The following was noted during this site visit to Garrymore bog: <ul style="list-style-type: none"><li>• Multiple stockpiles were noted on the western side of the site and a machine was noted to be working on one of the stockpiles (Photograph 1, 2 and 3).</li><li>• A temporary portacabin was noted in the yard area of the bog (Photograph 4)</li><li>• A machinery yard was noted in the southern area of the bog (Photograph 5)</li><li>• A pile of black plastic was noted onsite adjacent to the yard area (Photograph 6)</li><li>• A red O'Harte Transport lorry was noted to be leaving the site when the Inspector was arriving onsite.</li></ul>

Photograph 1: Stockpiles of Peat and a Machine Working

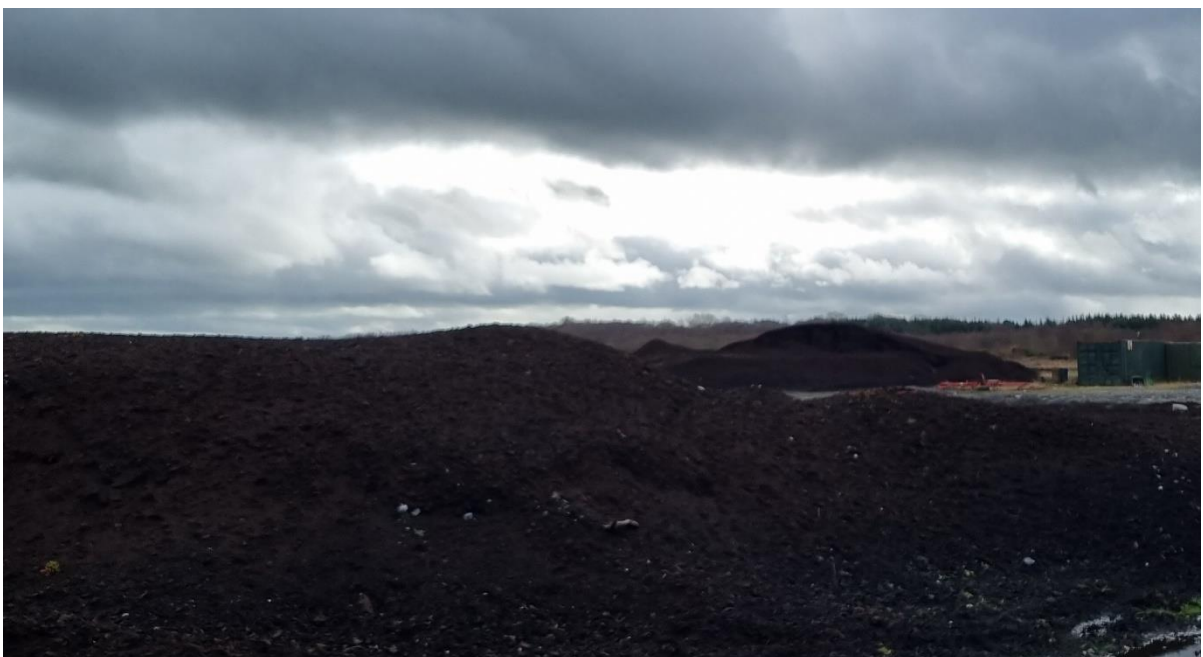
Photograph 2: Stockpiles of Peat

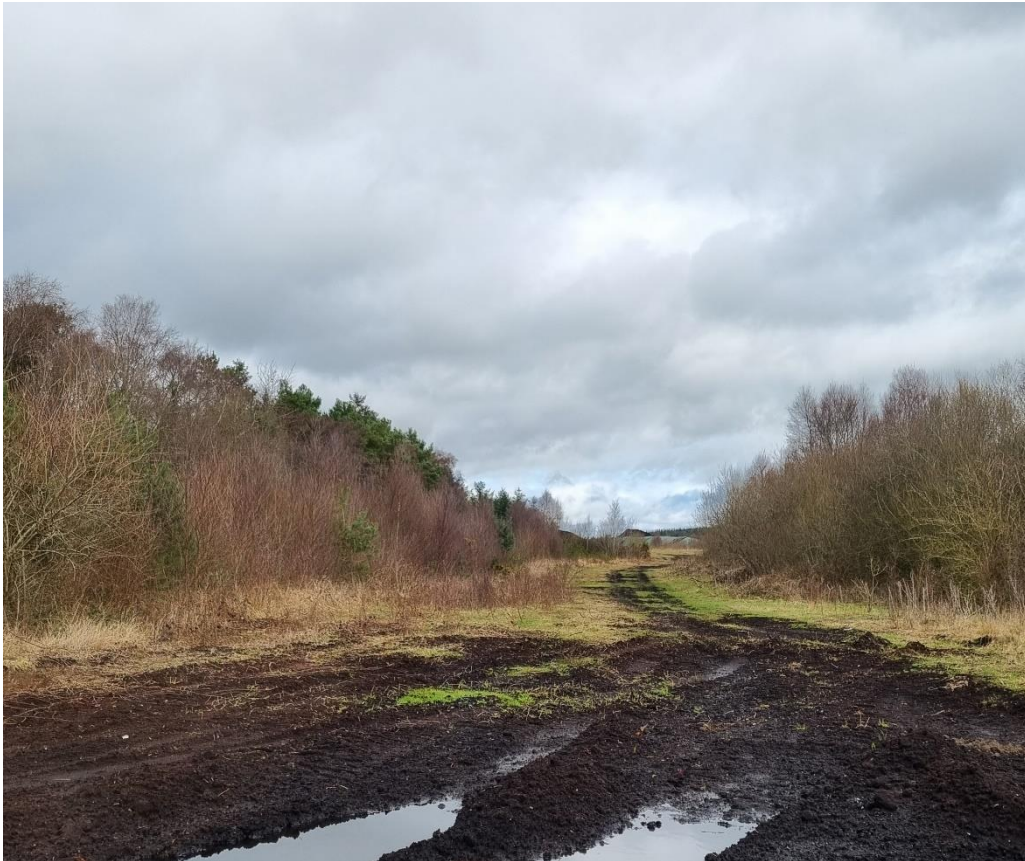
Photograph 3: Stockpiles of Peat

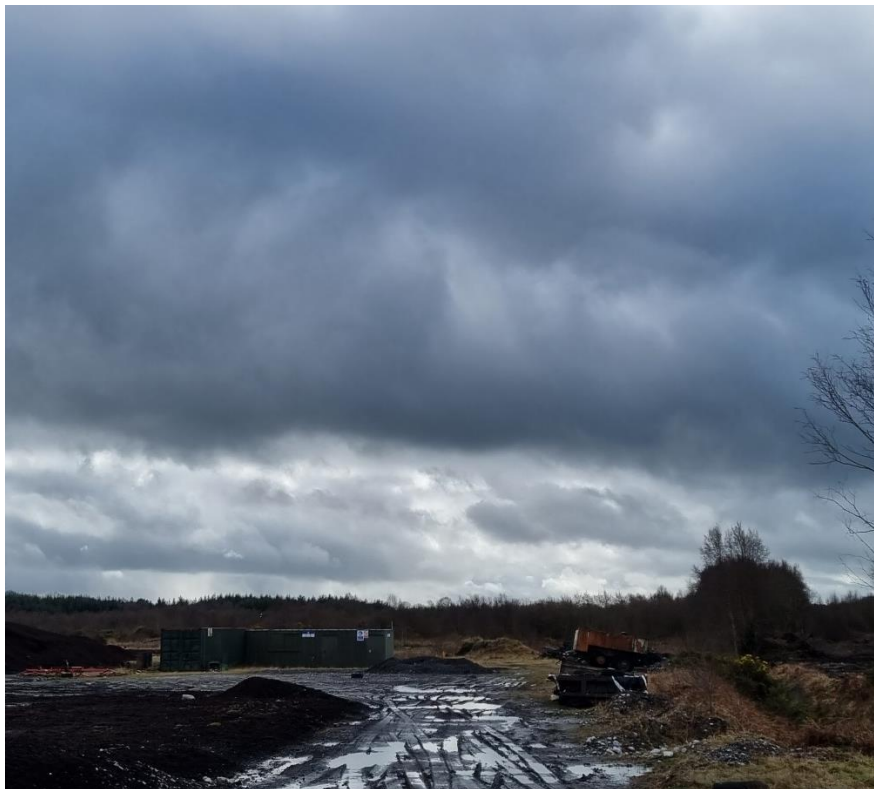
Photograph 4: Portacabin Onsite

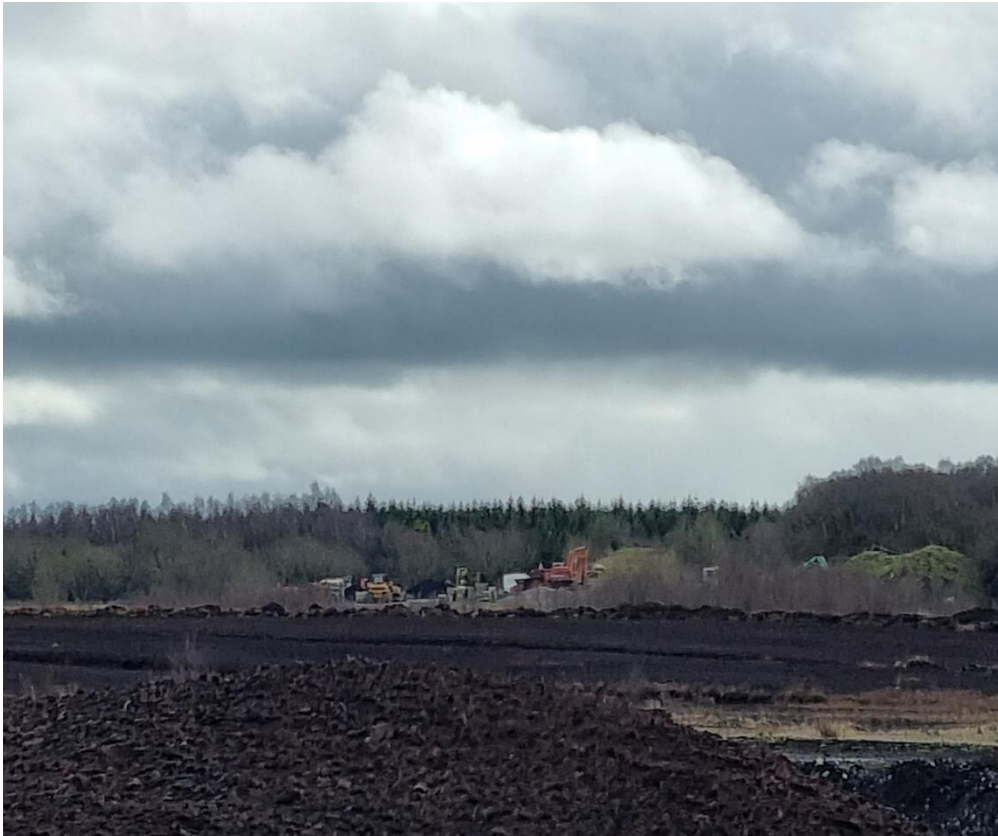
Photograph 5: Machine Yard to the Southern Area of Bog

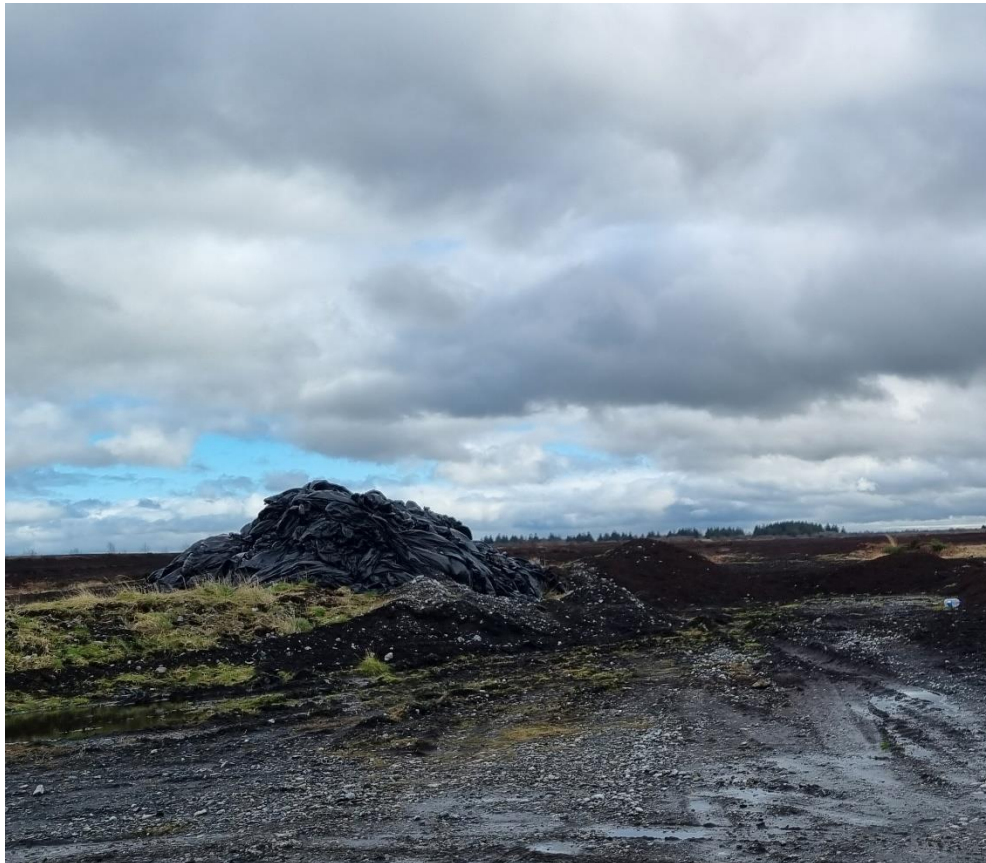
Photograph 6: Stockpiles of Black Plastic Onsite
