LISHEEN TMF ANNUAL REVIEW 2024

PROJECT NO. 4100013

DATE: MARCH 2025

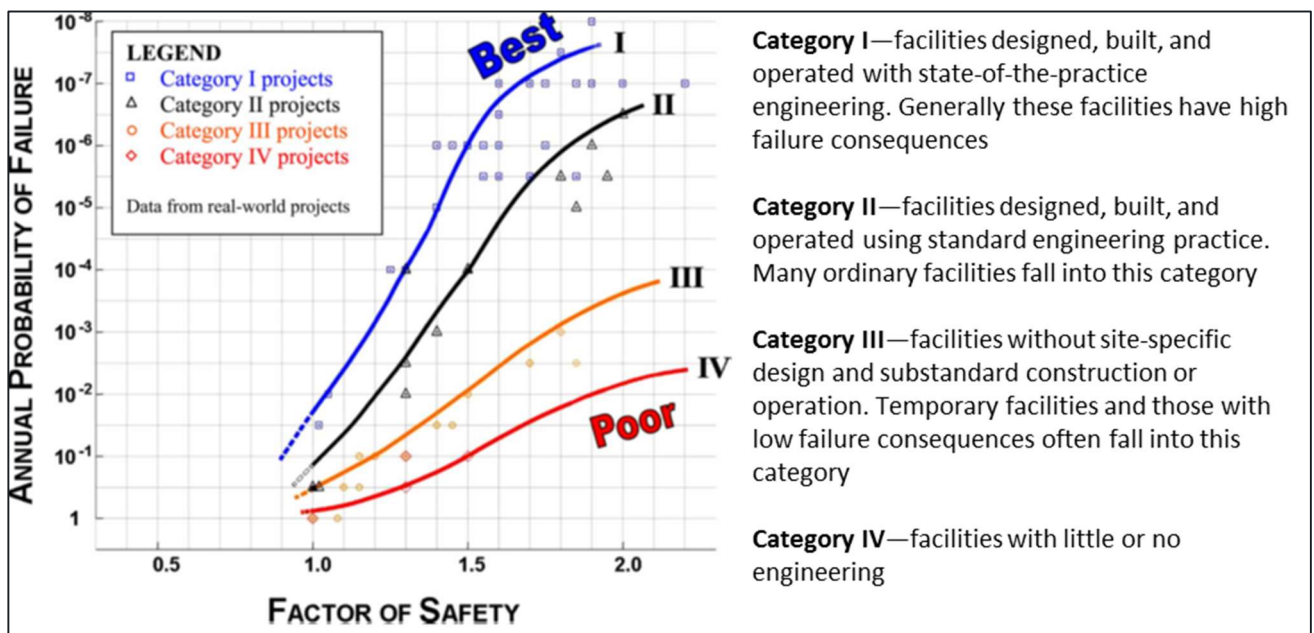
Figure 5: Factor of Safety versus Annual Probability of Failure (Silva et al. 2008)

The Lisheen TMF and ancillary infrastructure are considered to be at least a Category II facility, with components of a Category I facility.

The Lisheen TMF can be considered to have an annual probability of failure in the 1.00 E-4 to 1.00 E-5 range, which corresponds to Very Unlikely to Highly Improbable risk.
