Site Visit Report

Licensee	
Name of Installation	Inagh
Licensee	Clare County Council
Licence Register No.	W0109-02
CRO Number	
Site Address	Ballyduff Beg, Inagh, Clare
Site Visit Reference No.	SV27177

Report Detail	
Issue Date	05/12/2023
Prepared By	Aisling Carroll

Site Visit Detail			
Date Of Inspection	17/10/2023		
Time In	14:34	Time Out	16:30
EPA Inspector(s)	Aisling Carroll		
Additional Visitors			
Licensee Personnel and Role	Maire Rutledge - Assistant Scientist Brendan Flynn - Senior Executive Engineer Pat Baker - Facility Manager Eamon Reynolds - Site Supervisor

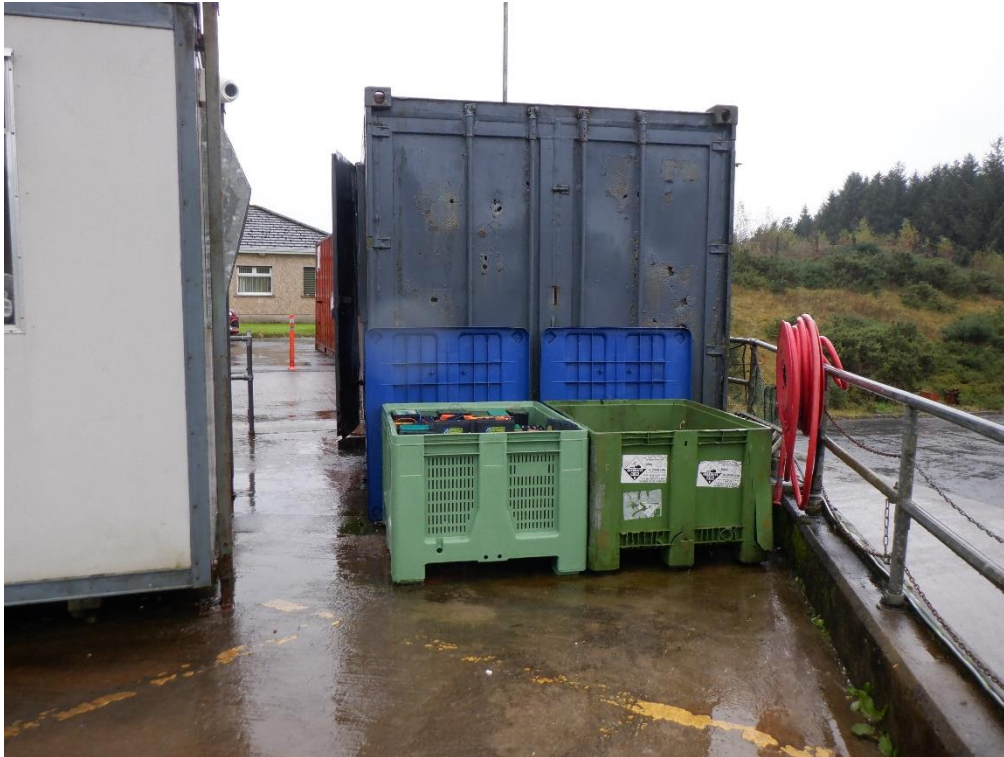
Comment / Action Required				
<p>The Civic Amenity Site at the facility collects and temporarily stores Waste Electrical and Electronic Equipment (WEEE) from residential customers (Photographs 1 & 2 refer). Certain WEEE, and fractions thereof, can cause emissions that are hazardous to the environment.</p> <p>Fluorescent tubes, which are classed as hazardous, were not being stored under a weather-proof covering at the facility.</p> <p>Licence Condition 4.22.2 requires the Licensee to provide and maintain appropriate receptacles at the facility for the collection of recoverable and recyclable material.</p> <p>Action Required:</p> <p>Provide and maintain appropriate receptacles for collection and storage of hazardous WEEE at the facility to ensure compliance with Licence Condition 4.22.2 and the Agency's <i>Guidance for the Management of Household Hazardous Waste at Civic Amenity Sites</i>.</p>

Photograph 1: WEEE collection area for household batteries.

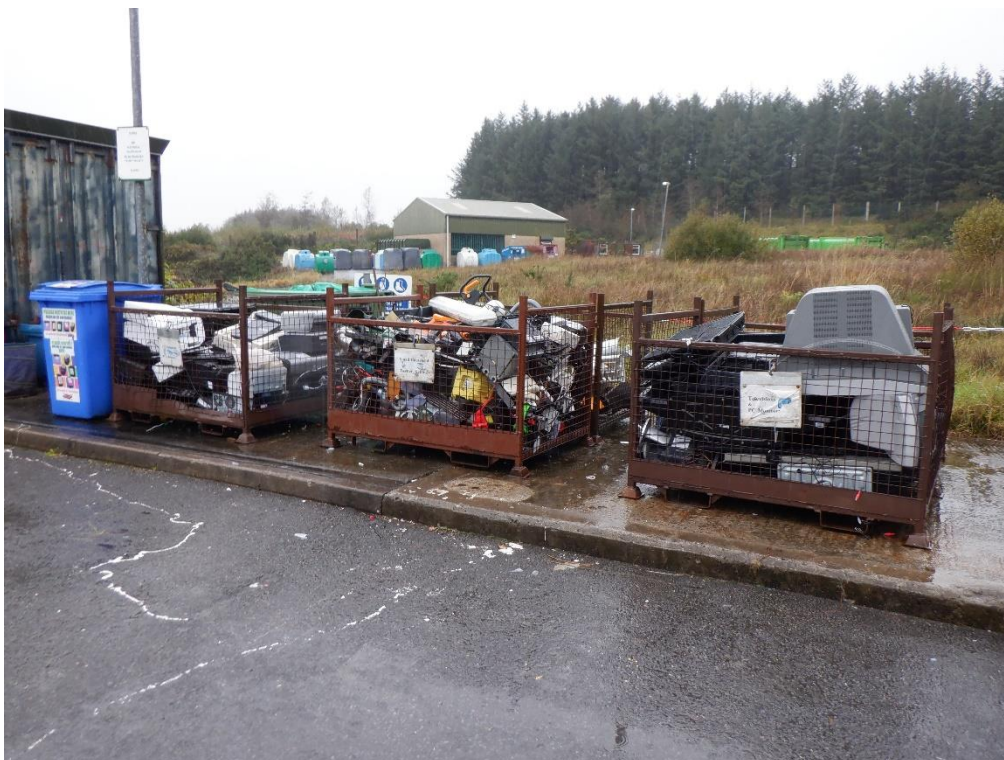
Photograph 2: WEEE collection area for household appliances.
