# Site Visit Report

Licensee	
<b>Name of Installation</b>	Kanturk
<b>Licensee</b>	Uisce Éireann
<b>Licence Register No.</b>	D0203-01
<b>CRO Number</b>	530363
<b>Site Address</b>	Cork
<b>Site Visit Reference No.</b>	SV31937

Report Detail	
<b>Issue Date</b>	14/02/2025
<b>Prepared By</b>	Brian Flynn

Site Visit Detail			
<b>Date Of Inspection</b>	29/01/2025		
<b>Time In</b>	10:30	<b>Time Out</b>	11:50
<b>EPA Inspector(s)</b>	Brian Flynn Aidan Jarvis		
<b>Additional Visitors</b>			
<b>Licensee Personnel and Role</b>	Representing Uisce Éireann: Richard Ellard. Representing Cork County Council (working in partnership with Uisce Éireann): Chris Ashe, Carol O'Sullivan, and Eugene O'Sullivan.

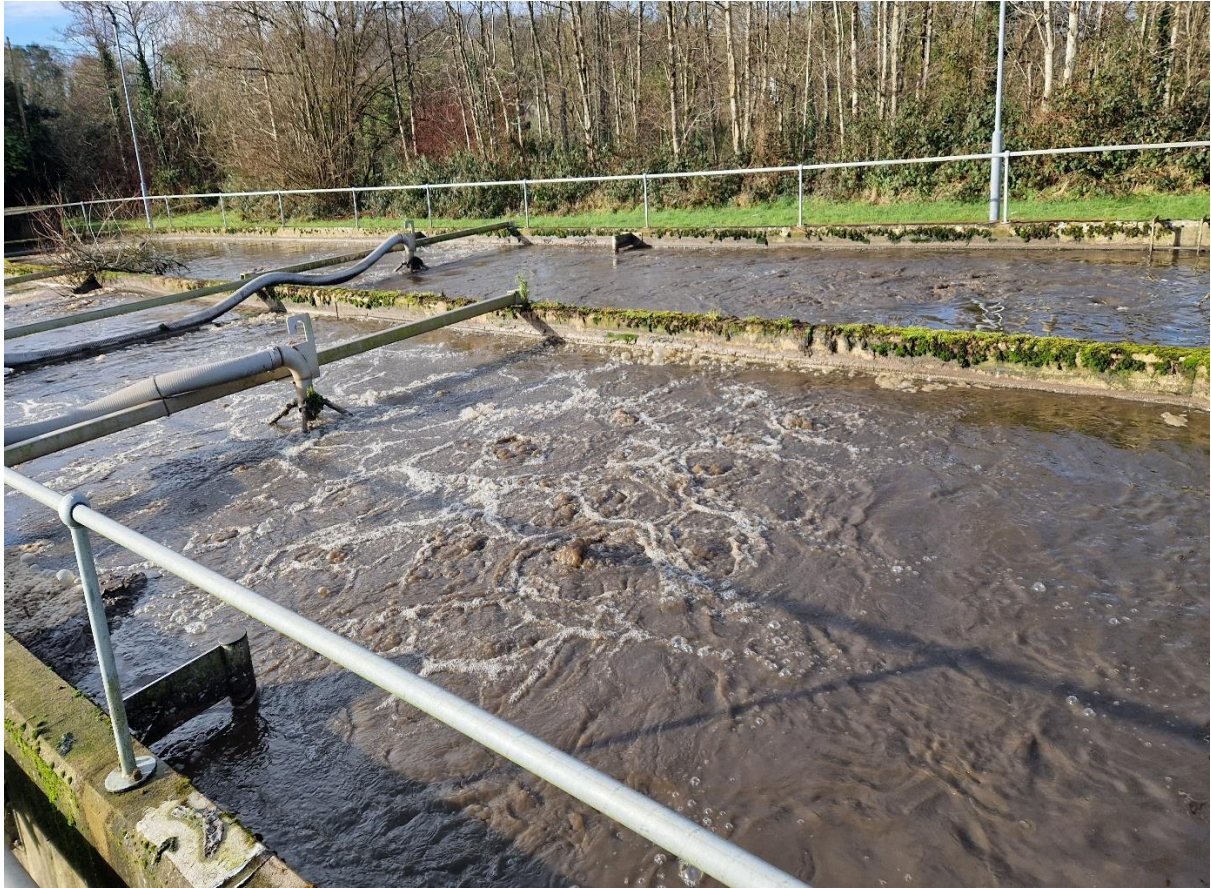
Answer	Condition Number	Non Compliance	Observation
3.1	Is there good evidence of mixing in the aeration basin?	Checked		
<b>Comment / Action Required</b>				
<p>Several diffusers were observed to be broken in both oxidation ditches during this site visit (See photograph No.1). There was no timeline available for their repair. This does not allow uniform oxygen delivery across the basin. Excessive ragging was also observed in both basins (See photograph No. 2) and this was stated to be adversely impacting the diffusers resulting in uneven air distribution across the basin.</p> <p><b>Uisce Éireann are required to:</b></p> <ul style="list-style-type: none"> <li>• Repair the broken diffusers without delay.</li> <li>• Remove ragging from both oxidation ditches to ensure optimum treatment is provided.</li> </ul>

**Photograph No. 1:** Uneven distribution of air from the diffused aeration system due to multiple broken diffusers attributed to excessive ragging and build up of solids in both oxidation ditches.

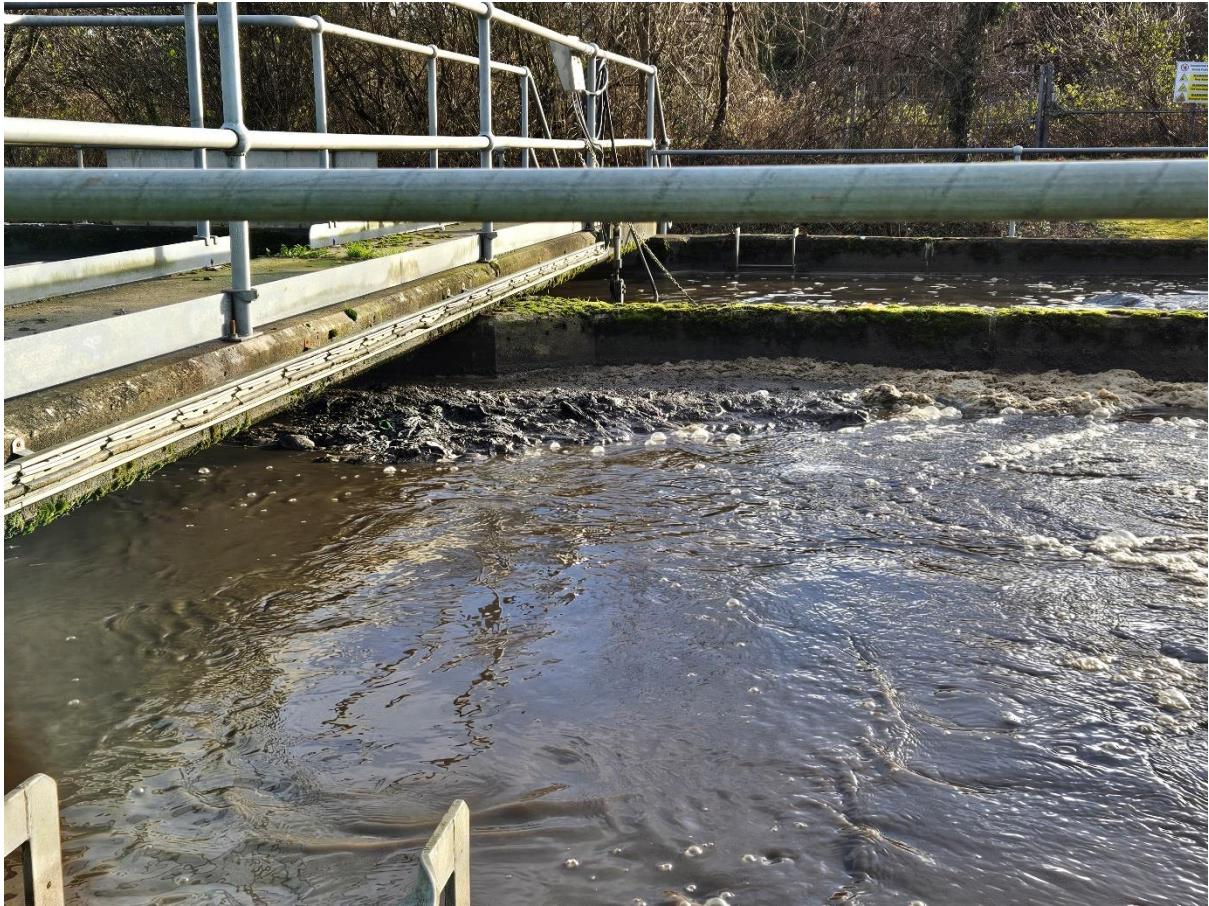
**Photograph No. 2:** Excessive build up of solids observed in both oxidation ditches affecting the effectiveness of treatment provided.
