Environmental Impact Assessment Report

Appendix 16.1

Appendix 16-1

Catalogue of Cultural Heritage Assets

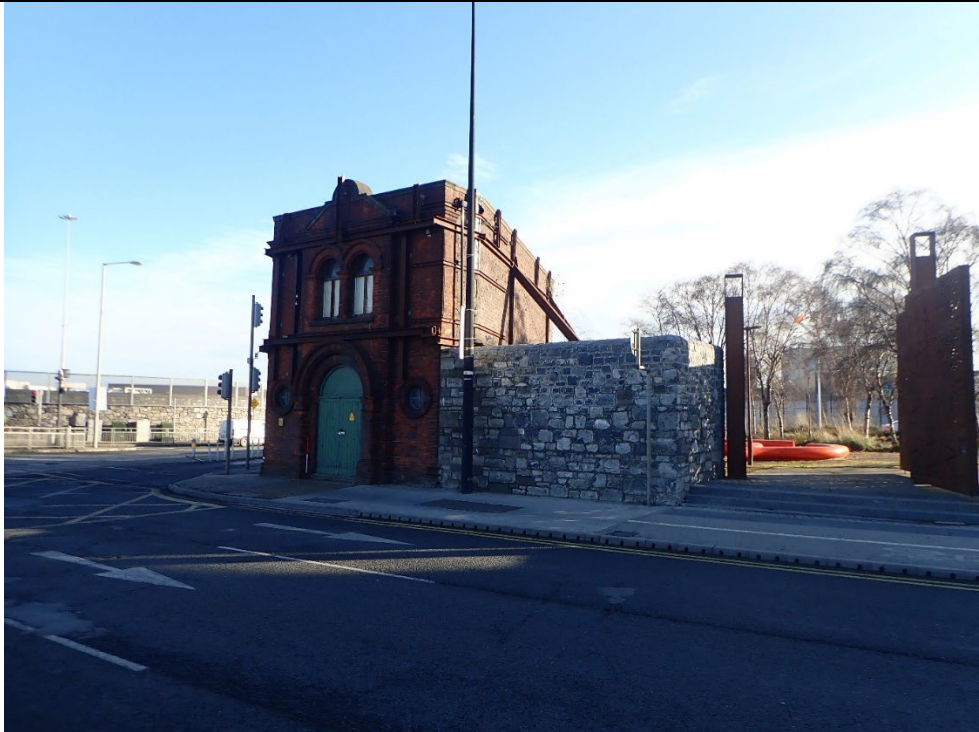
<p>View looking east from East Wall Road towards the Substation</p>

Reference	Site Name	Site Type	ITM Easting	ITM Northing
NIAH 50011170	Substation	Substation	718133	734901
Description	<p>The redbrick building that stands at the junction of East Wall Road and Alexandra Road in Dublin Port is a former electricity substation that was built in 1922, the year of Irish Independence. It has been rehabilitated in 2023 by Dublin Port Company as a small event space known as the Substation. The rehabilitation works were monitored archaeologically by ADCO under licence 21E0737 and in fulfillment of Dublin City Council's grant of planning, reference 2681/20.</p> <p>The Substation was built over the eighteenth-century sea wall that gives its name to East Wall Road and served as a dyke within which the city's growth was able to develop the North Lotts and what became the East Wall. The sea wall is a significant structure whose full width probably extends across much of East Wall Road. The element that has been discovered under the redbrick building is the eastern edge of the sea wall.</p>

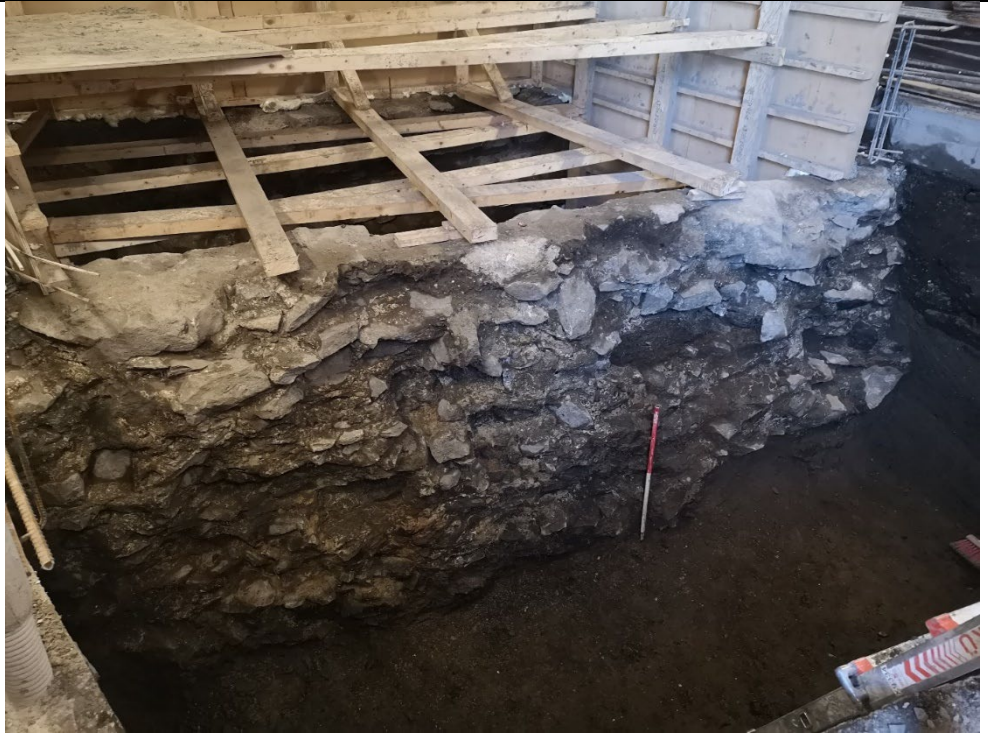
Excavated length of the former sea wall that lies under the Substation

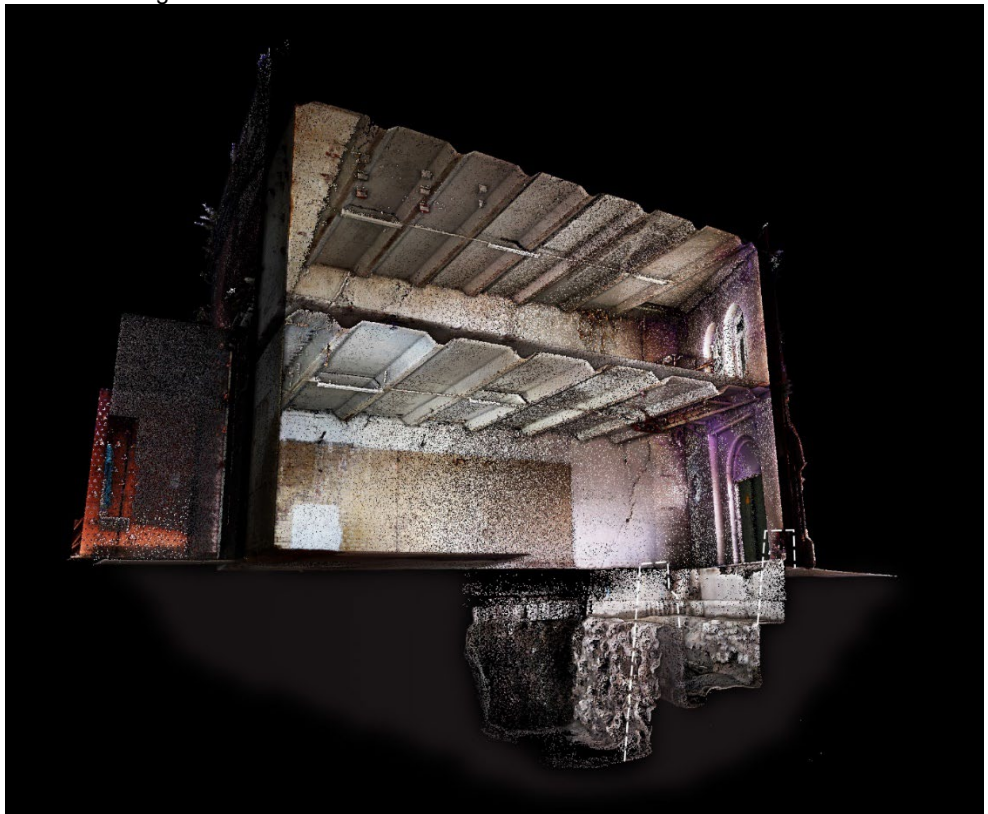
ADCO laser-scan survey showing the exposed extent of the sea wall underneath the Substation

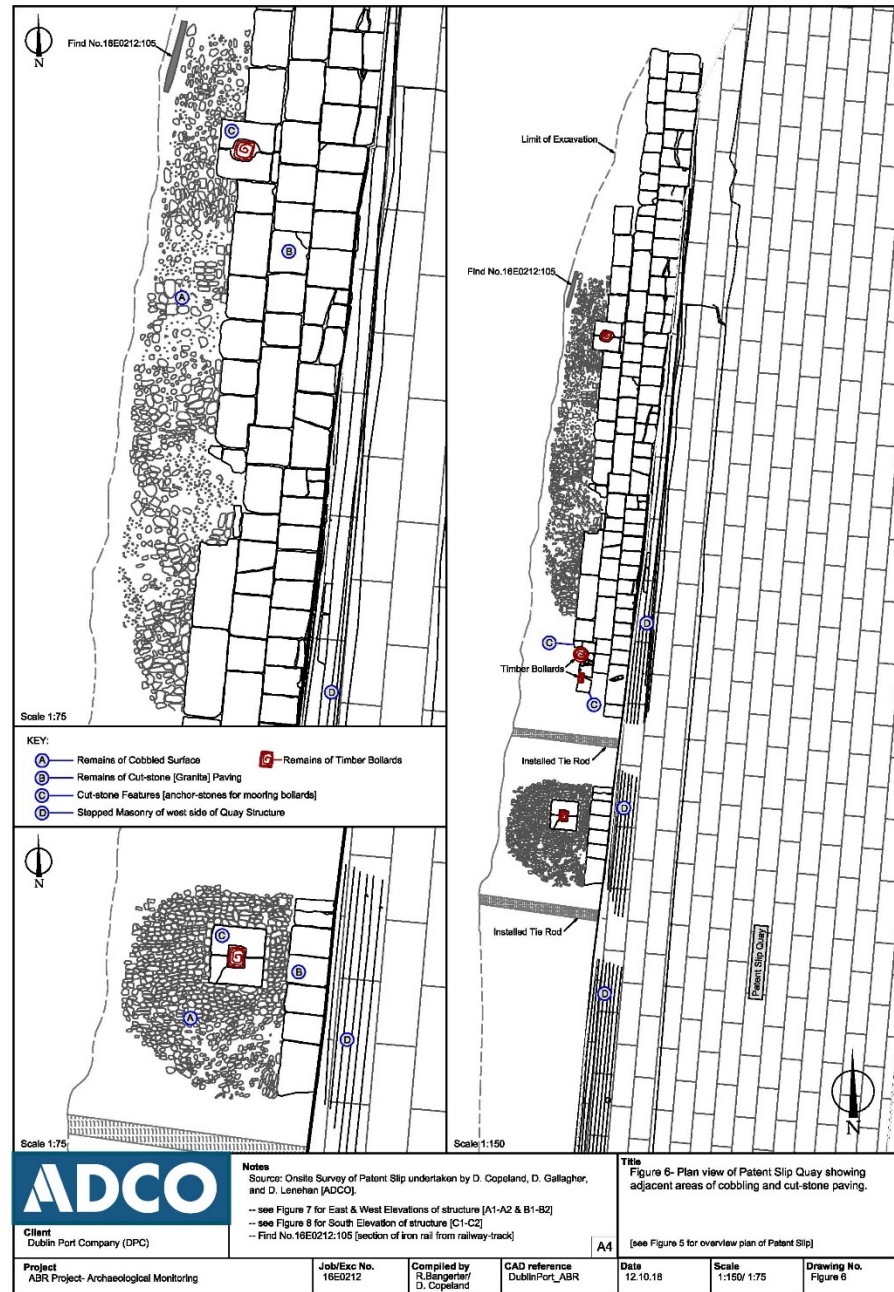
Reference	Site Name	Site Type	ITM Easting	ITM Northing
DCIHR 18-12-089_01	Patent Slip No 2	Slip	718225	734627
Description	Patent Slip No 2 was recorded on historic OS maps and was exposed and archaeologically recorded by ADCO under the permitted Alexandra Basin Redevelopment Project, archaeological licence 16E0212.

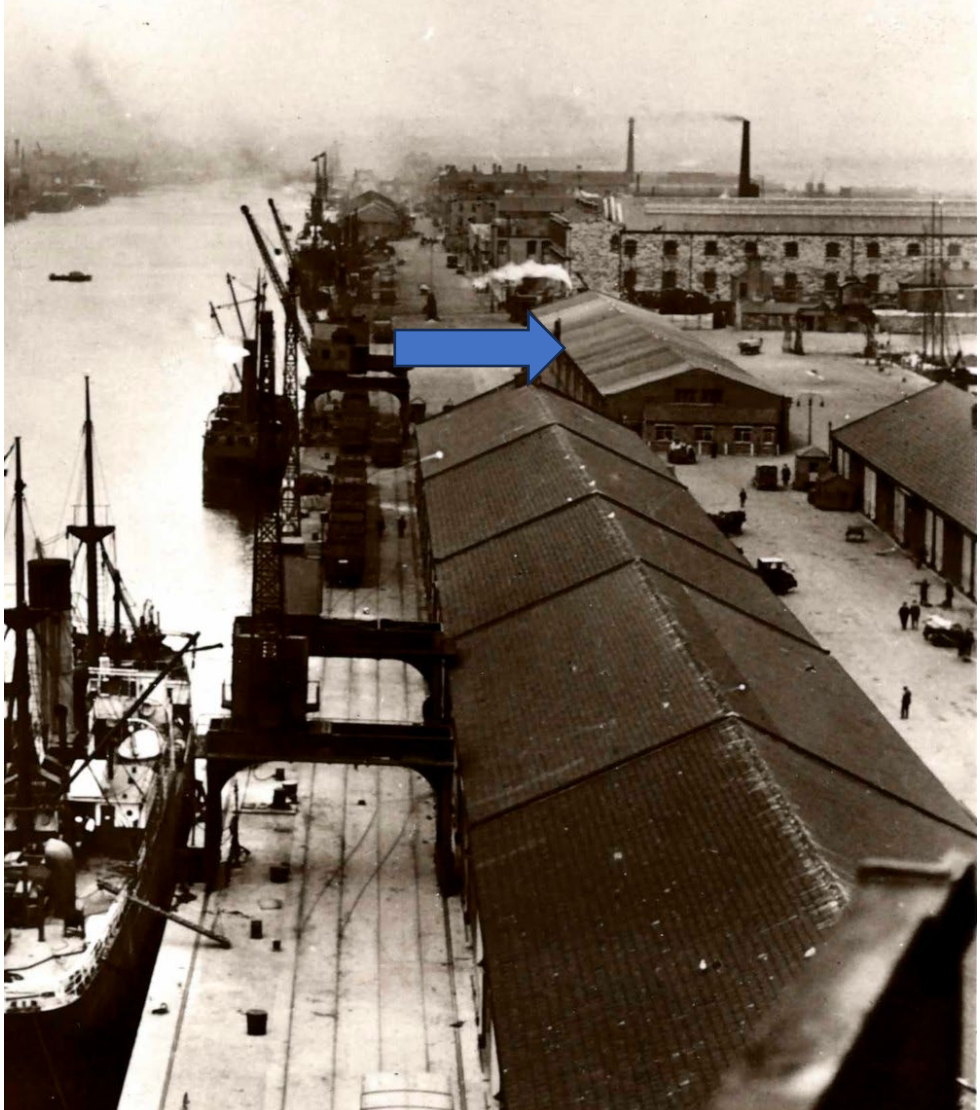
Reference	Site Name	Site Type	ITM Easting	ITM Northing
DCIHR 18-12-083-01	Goods Shed	Goods Shed	718181	734407
Description	One of the sheds of the North Wall Quay Extension (in foreground of picture). Sheds were built on North Wall Quay Extension shortly after its construction and were demolished in c. 1990s.

Proximity to development	Within development area
Likely Impacts	SPAR will cross over site. See Figure 5.5 in Chapter 5 of EIAR.
Recommended Mitigation	Archaeological monitoring and resolution

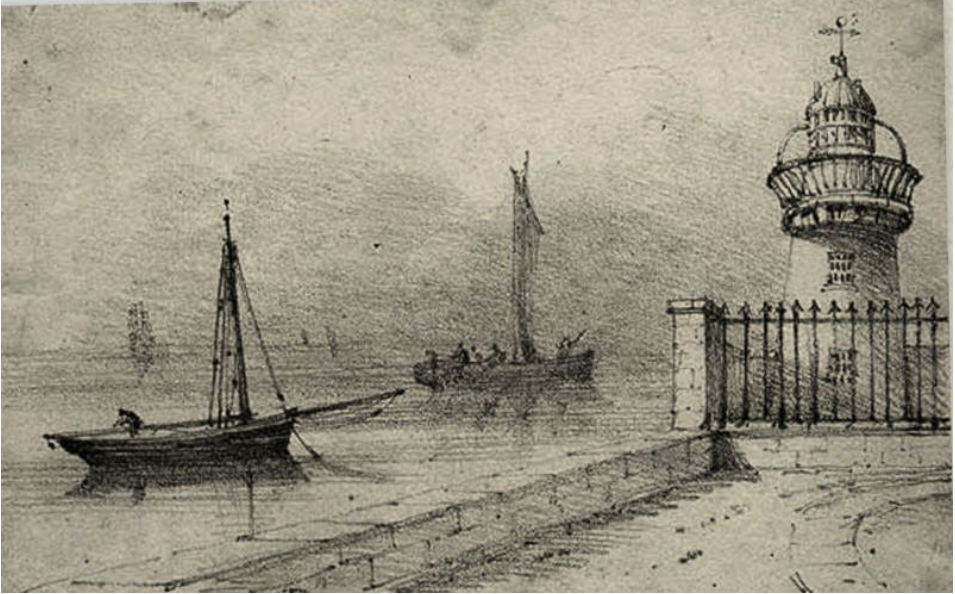
<p>Historic image showing the Light house and Dublin Bay Gabbards. Image courtesy of Cormac Lowth</p>

Reference	Site Name	Site Type	ITM Easting	ITM Northing
DCIHR 18-12-093	North Wall Quay Light	Lighthouse	718042	734390
Description	<p>Lighthouse at the entrance to the Liffey at the junction of the North Wall Quay and East Wall Road. Built c. 1820. Showed a steady light at a height of 33 feet and could be seen from a distance of 8 miles. Lighthouse contained a 5th order fixed lenticular light.</p> <p>Lighthouse was still present in 1864 during the launch of Knights Commander and was probably dismantled during the construction of North Wall Quay Extension. First addition Ordnance Survey 6-inch shows lighthouse. Not visible of Taylor's map 1816. Entrance gates to NWQE are now at this location.</p>			
Image/s

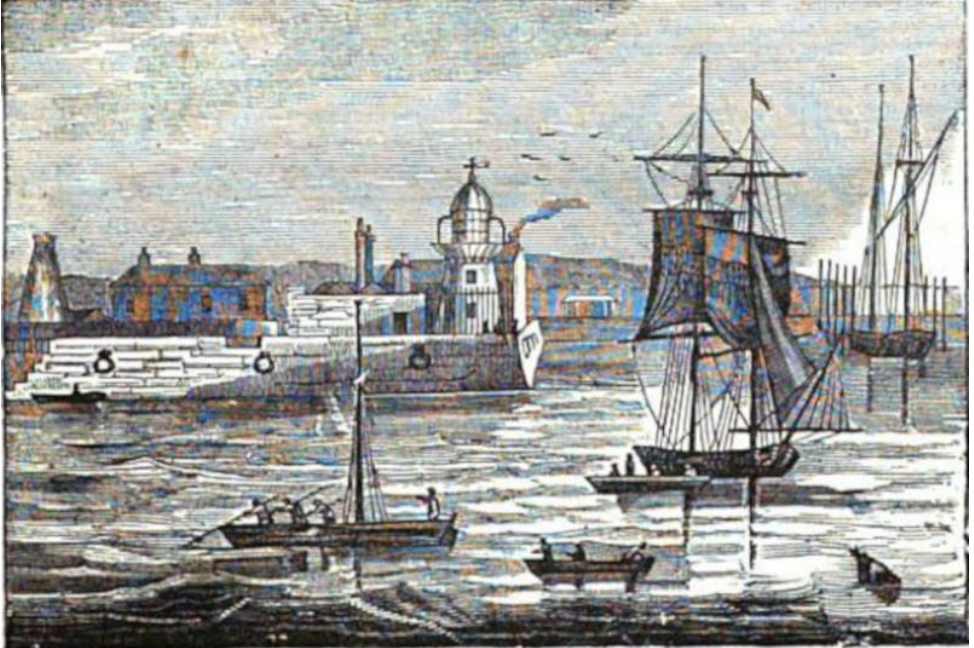
<p>A view of the North Wall, City of Dublin. <i>Dublin Penny Journal</i> 1834</p>
<p>Proximity to development</p>	<p>Outside development area</p>
<p>Likely Impacts</p>	<p>None</p>
<p>Recommended Mitigation</p>	<p>None</p>

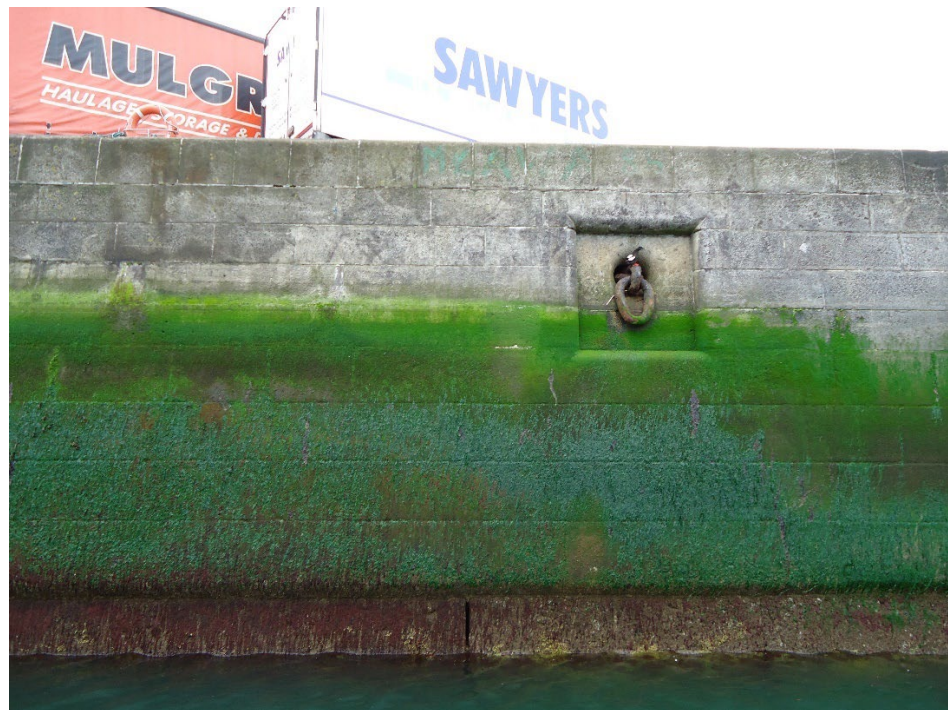
Photograph shows the top of two mass concrete foundation blocks and the join between both at the base of the image, with the granite ashlar coursing constructed above and a recessed mooring ring

<ul style="list-style-type: none"> • Capstones and upper courses of granite ashlar to be removed across bridge footprint • Excavation of NWQE surface to working depth of xxm across bridge footprint • Impact with one recessed mooring ring and associated stonework anticipated
Recommended Mitigation	<ul style="list-style-type: none"> • SPAR Bridge designed to minimise impact on NWQE • Supplemental detailed archaeological topographic survey prior to construction • Avoid impact with recessed mooring ring and associated stonework • Archaeological monitoring and resolution • Retention of ashlar granite for sympathetic re-use • Rebuild recessed mooring ring and associated stonework if impacts are unavoidable

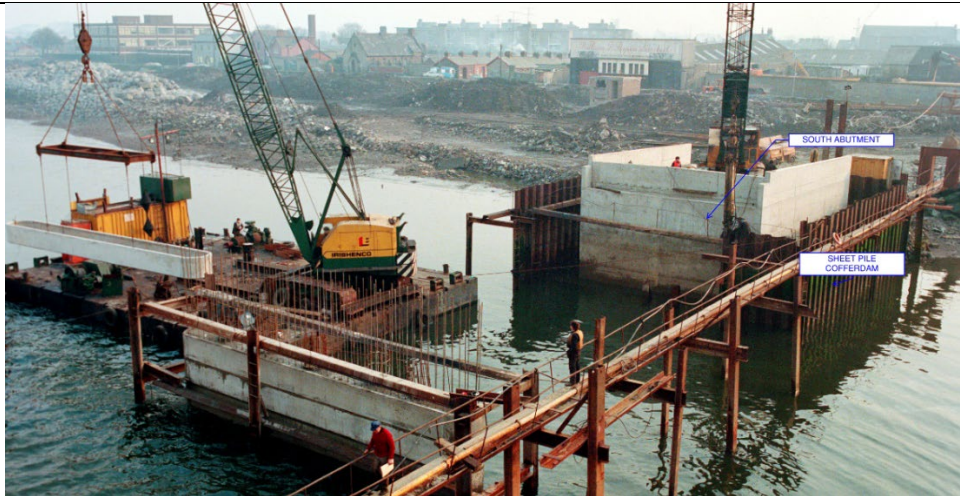
<p>Photograph from 1970s showing construction of the Tom Clarke Bridge and reclamation works along the south bank in advance of the toll road. Source: Roughan O'Donovan.</p>			
Proximity to development	Within development area. See Figure 1.2 in EIAR			
Likely Impacts	<ul style="list-style-type: none"> • SPAR Bridge will cross over site, supported by six in-water piers • SPAR will continue along the south shore as an elevated road supported on piles • Temporary relocation of Poolbeg Yacht and Boat Club Marina moorings will be secured by a series of weighted blocks off the NWQE, with no impacts on to the buried riverbed deposits and no impacts on to the NWQE • Capital dredging works will take place to facilitate new berths associated with the Maritime village • The Turning Circle proposed in front of Pigeon House Harbour will require capital dredging, and construction of a revetment for a portion close to the harbour • The Sludge Jetty and adjacent timber pier will be removed • Area N will be constructed on piles • Some element of capital dredging is anticipated associated with Area N

Reference	Site Name	Site Type	ITM Easting	ITM Northing
ADCO 01	Liffey	Riverbed	7181093	734292
Description	The Liffey channel within the development area has a silt bed over gravel. It has been impacted on by dredging, by the development of the quaysides on the south Port and by development of the Tom Clarke Bridge in the 1970s with the associated reclamation of the southern foreshore. The channel was inspected archaeologically for the ABR project and was recently inspected archaeologically for the 3FM project and is reported on in Appendix 15-5.			
Image/s

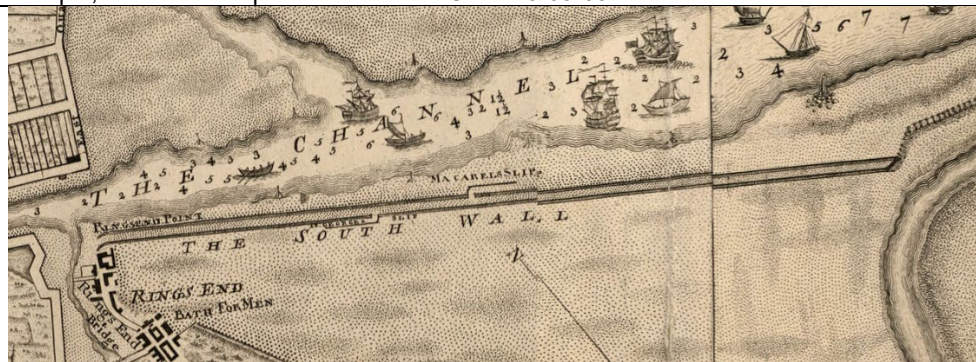
Detail from Rocque 1757, showing the South Wall as constructed prior to its completion in 1759. Note the two slipways attendant to the wall, referenced ADCO 04 and DCIHR

A Slipway is recorded off the south-facing side of the wall on Rocque's map of 1757, labelled St. George's Slip (ADCO 04 in this catalogue). A second slipway recorded by Rocque, Mackarel's Slip is recorded as DCIHR 19-09-001.

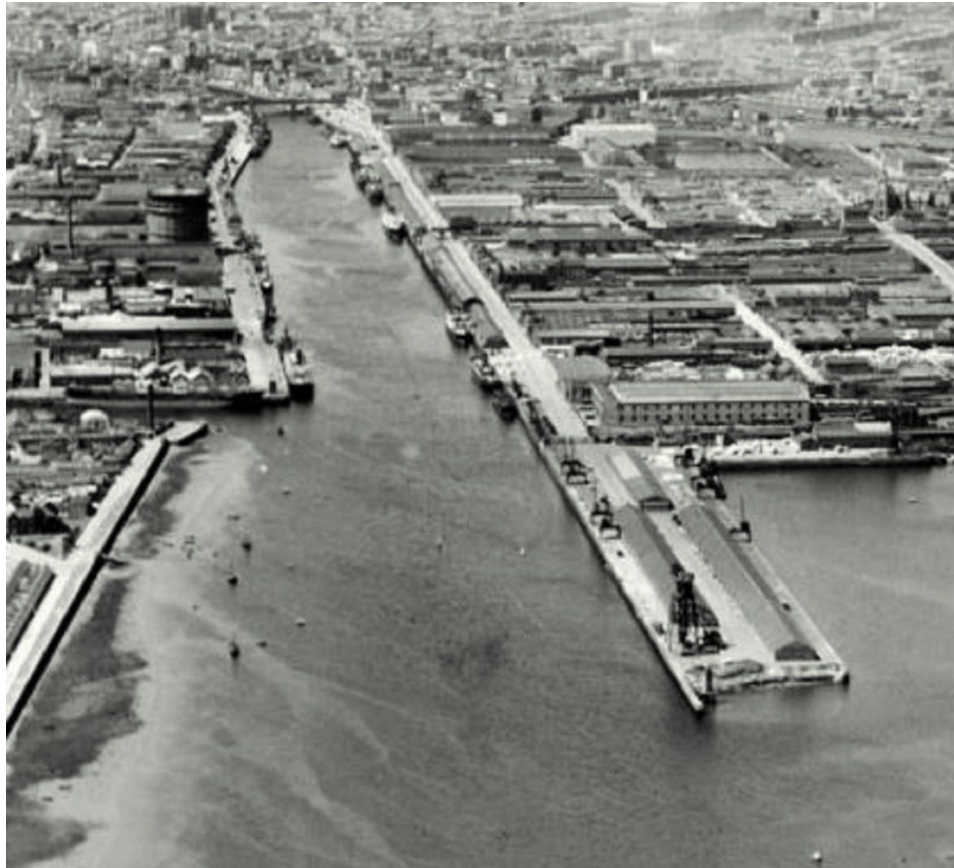
Detail from aerial photograph taken in early 1930s looking upriver, with the GSW/Pigeon House Road on the left, and the NWQE and Alexandra Basin on the right side

An aerial photograph taken in the early 1930s shows a slight outward kink into the quay wall upstream of Thorncastle Street, supporting the view that waterfront at the Liffey/Dodder confluence is a later addition. The photograph also shows the shallow nature of the channel against the base of the GSW and a series of floating moorings in the river much as moorings are present today at this location.

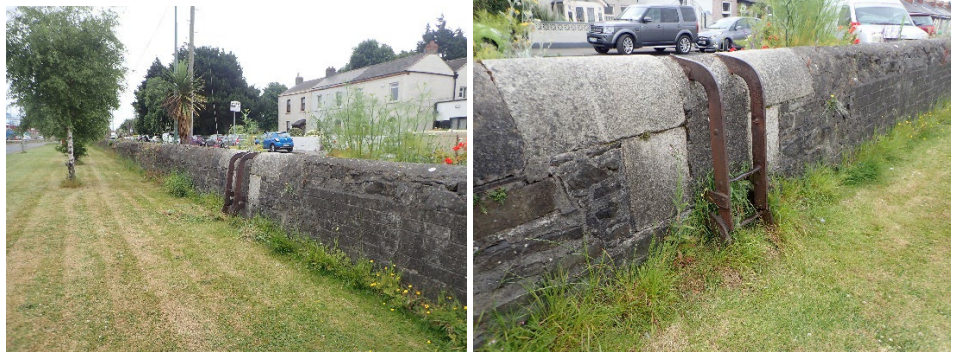
Two views of northern parapet looking south, showing quay wall ladder retained

The north-facing parapet of the sea wall survives today along York Road, where it can be seen as far west of St Patrick's Rowing Club, and as far east as the adjoining section of Pigeon House Road that runs alongside Ringsend Park. The parapet is the boundary wall between York Road and the R131 toll road. While there are several breaches in the wall along this stretch, it also retains a recessed vertical quay ladder.

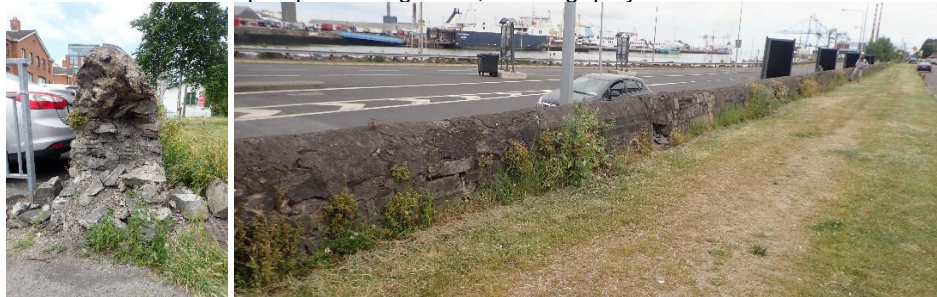
View showing breach in north-facing parapet, and view looking east along north-facing parapet from York Road

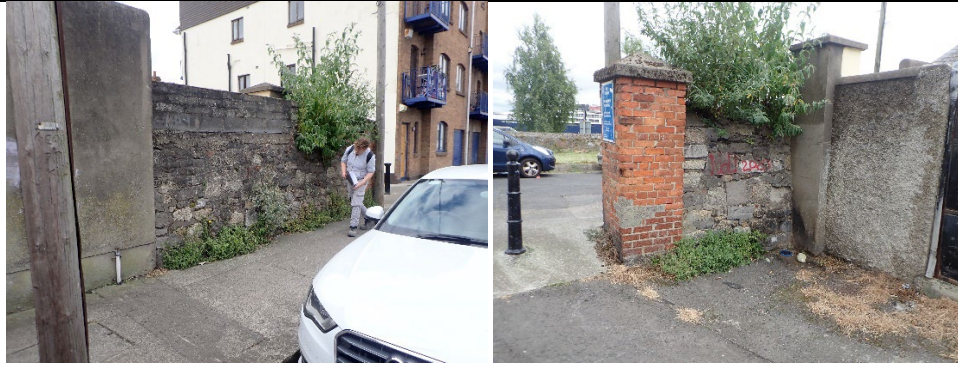
Views of surviving south parapet wall at junction of York Road and Pembroke Cottages

In contrast, the south-facing parapet is largely absorbed into the current building fabric, where the houses that front on to York Road are constructed directly on top of the parapet. However, a portion survives at the junction of York Road and Pembroke Cottages. Further elements survive as the boundary wall of Ringsend Park.

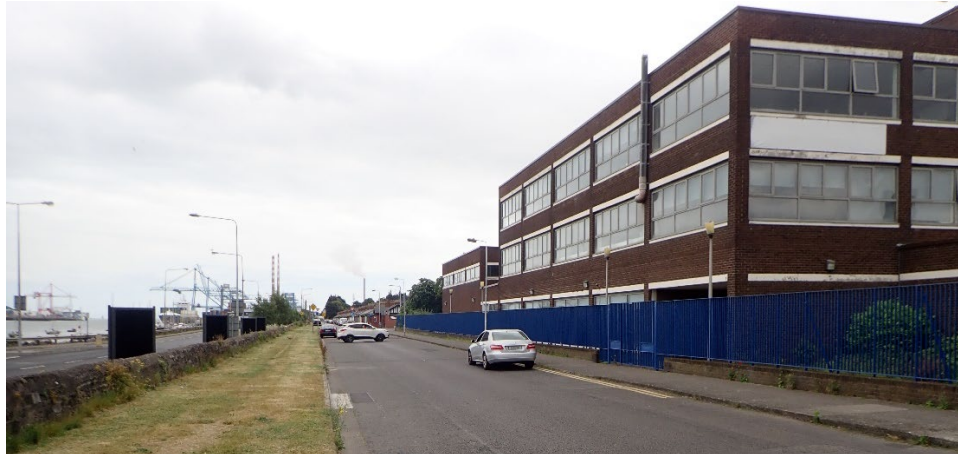
View looking east along York Road where the south-facing parapet does not survive above ground but is replaced with the curtilage fencing of Ringsend College

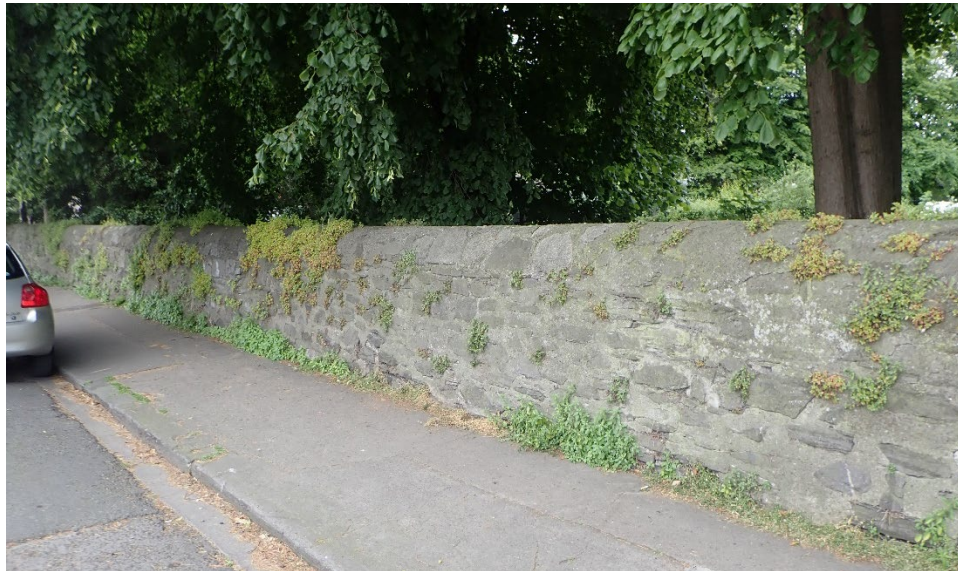
View looking east along Pigeon House Road where the south-facing parapet survives as the standing boundary wall with Ringsend Park

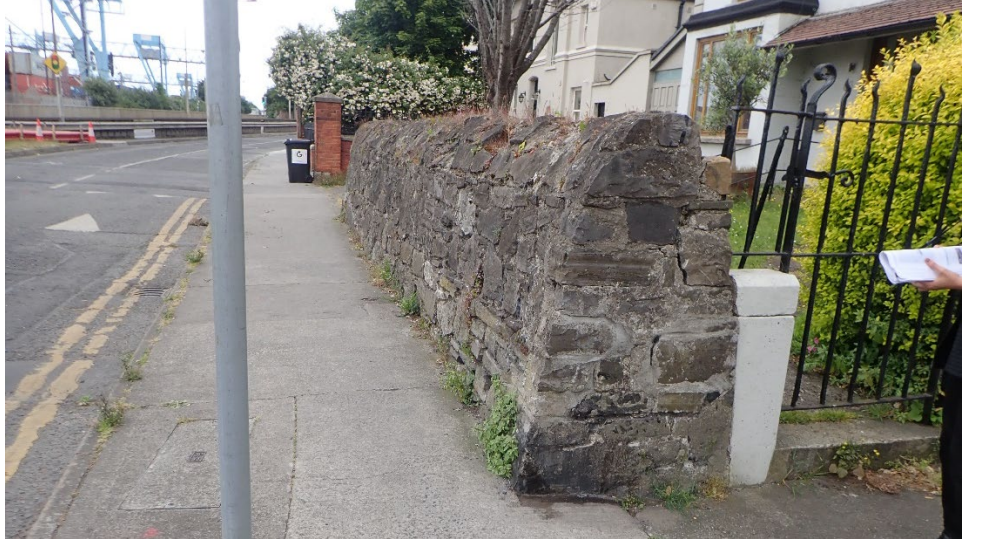
<p>Description</p>	<p>View looking east along Pigeon House Road where the south-facing parapet survives as the front garden boundary wall to residential properties at junction with Cambridge Avenue Poolbeg Yacht and Sail Club to MTL Yard: The R131 has breached the GSW and cuts across the sea wall at an oblique angle.</p> <p>Pigeon House Road continues to the east of the R131 and the front garden walls of the former coastguard cottages (RPS 6782–RPS6792, see below) follow the line of the southern parapet. In contrast, the northern parapet is not upstanding but is most probably underneath a low concrete retaining wall that serves as the boundary with the northern reach of the MTL yard.</p> <p>Within the MTL Yard, a length of the GSW is apparent where a green verge extends for c. 122m. The north-facing wall that retains the grassed area is the southern parapet of the GSW. The northern limit of the GSW does not survive upstanding across the Yard.</p>

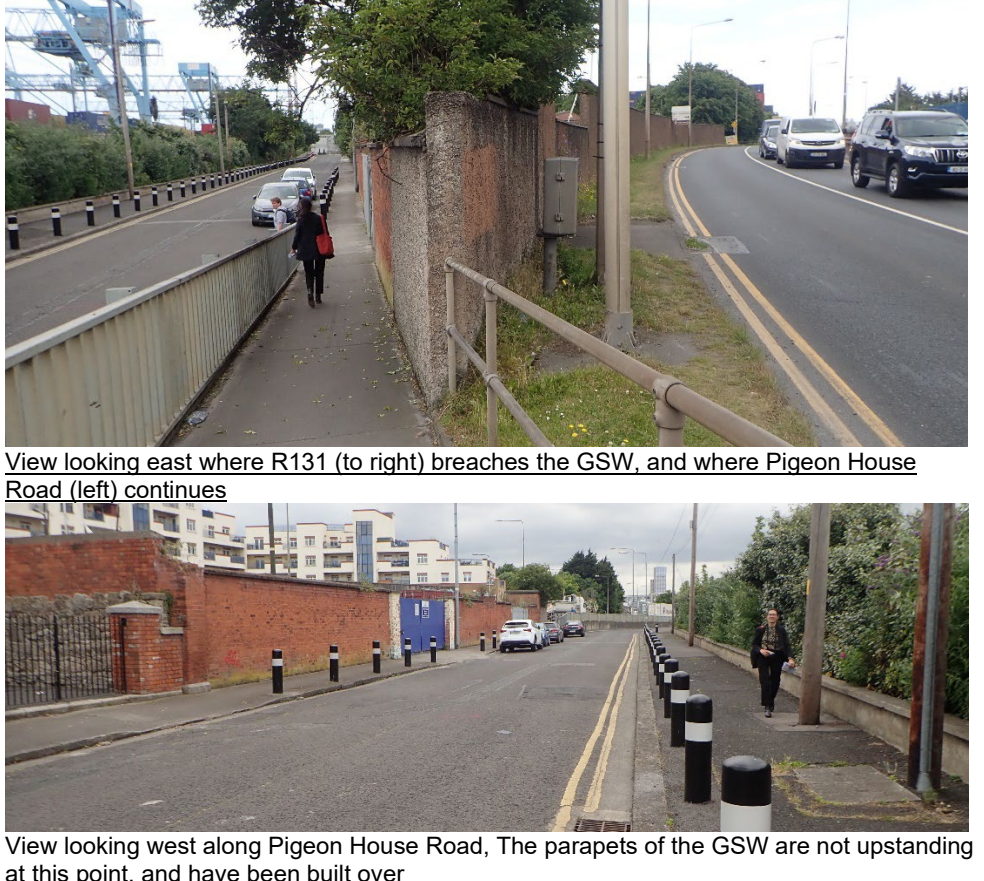
<p>View looking east where R131 (to right) breaches the GSW, and where Pigeon House Road (left) continues</p> <p>View looking west along Pigeon House Road, The parapets of the GSW are not upstanding at this point, and have been built over</p>

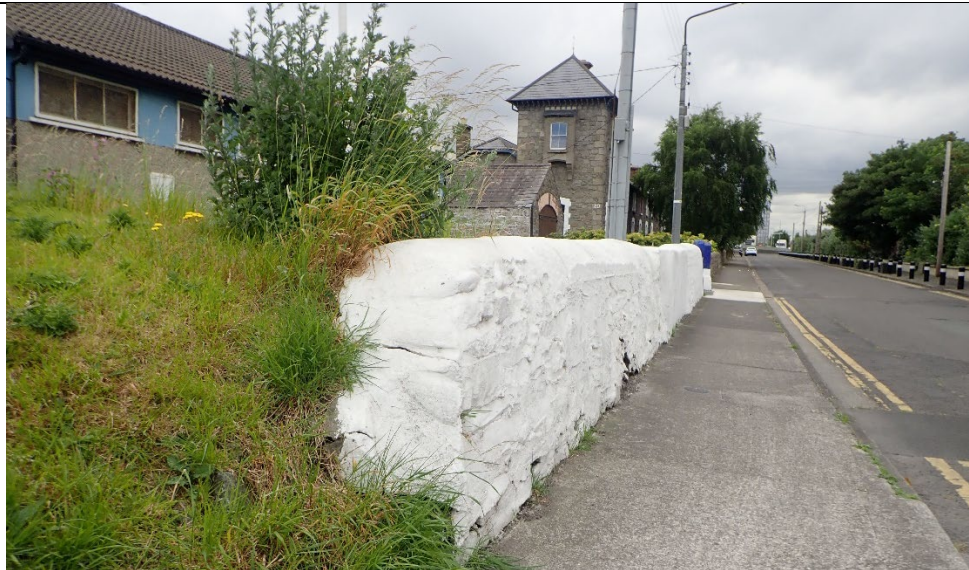
View looking west along Pigeon House Road, showing the southern parapet of the GSW as it survives serving as the boundary wall to the Ringsend Sea Scouts den

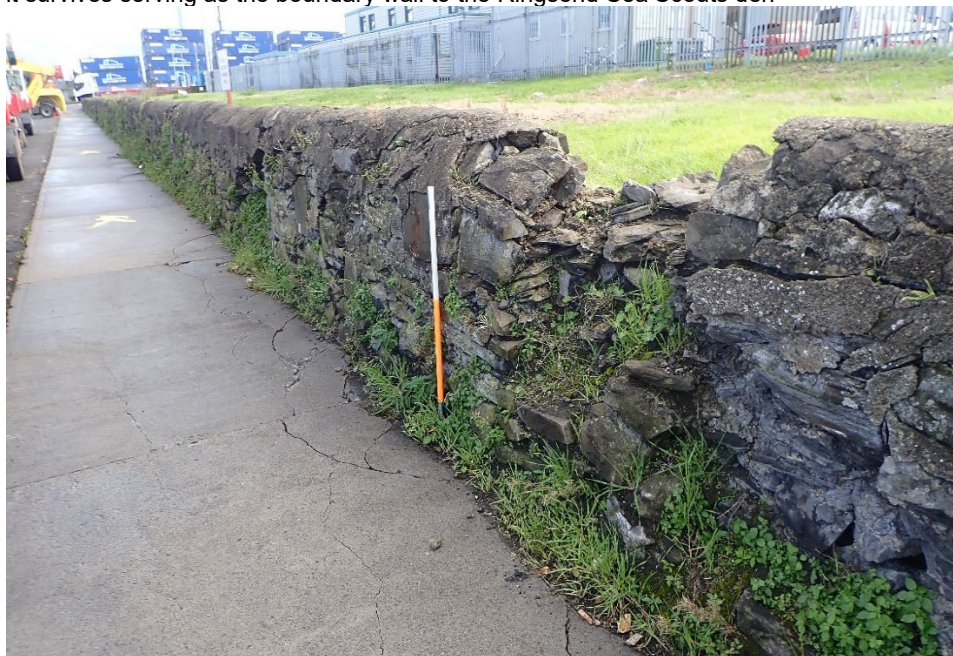
View looking east along upstanding southern parapet of the GSW that retains the north side of the grass verge in the MTL Yard

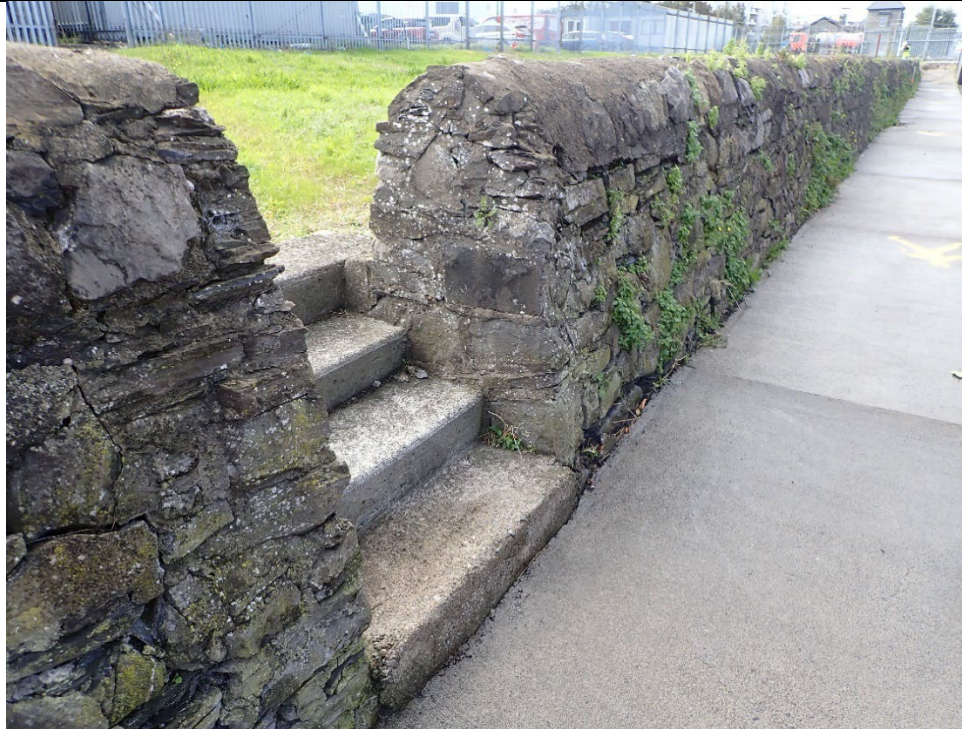
The south parapet of the GSW within the MTL Yard has been breached in several places, in this instance to insert step access

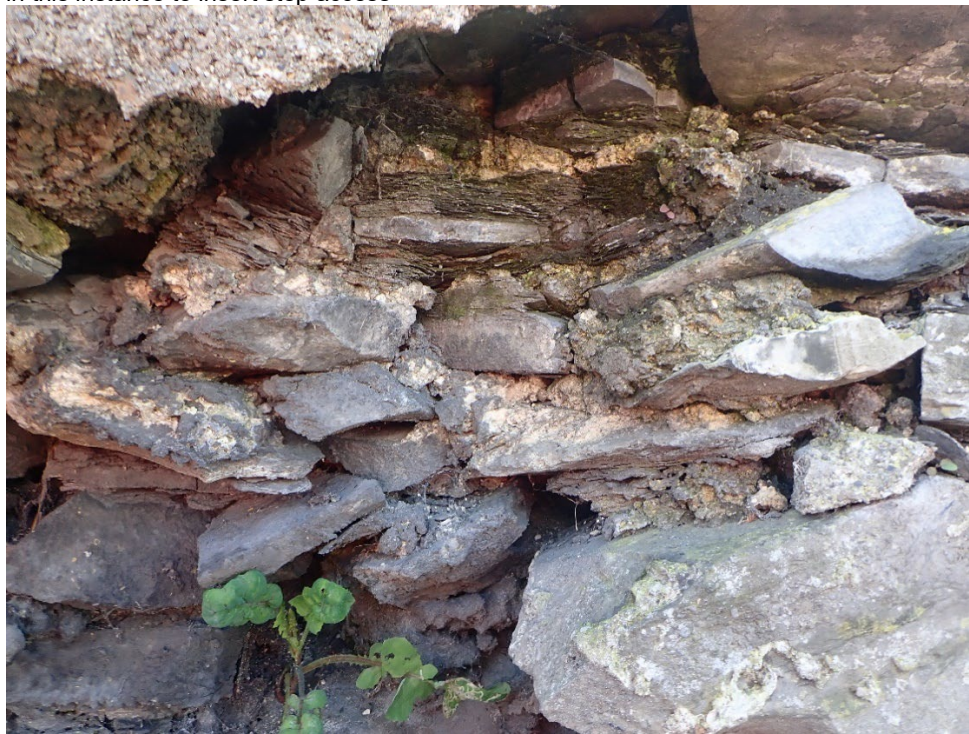
Detail showing fabric of the south parapet of the GSW in the MTL Yard where the wall core is exposed
