**BIOLOGICAL WATER QUALITY MONITORING OF THE RIVER
GREESE IN THE VICINITY OF TIRLÁN CO-OPERATIVE
SOCIETY FACILITY, BALLITORE, CO. KILDARE**

September 2023

REPORT PREPARED FOR FITZ SCIENTIFIC

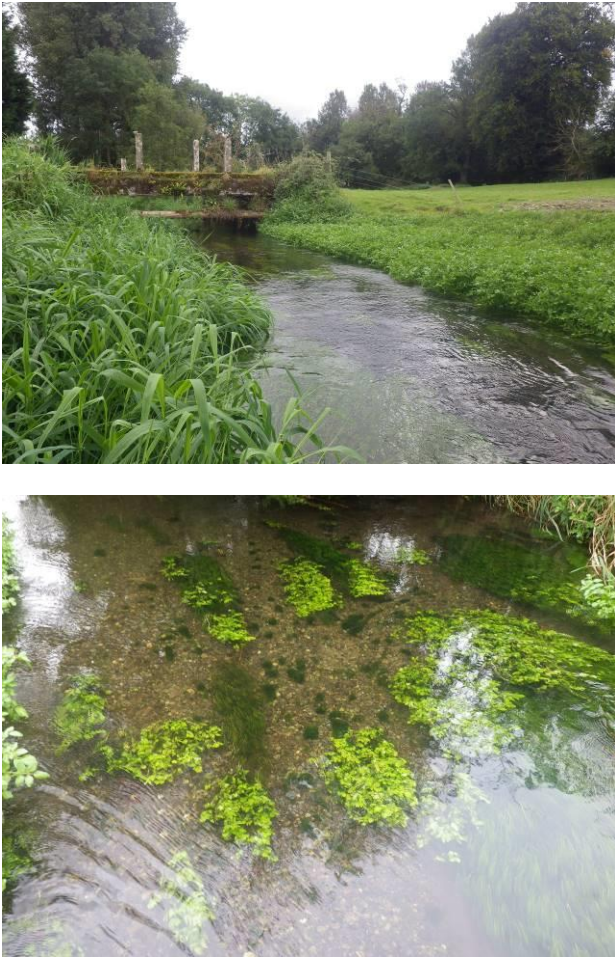
SITE SW1A

Site Location	u/s footbridge
Grid Reference	S 79632 96273
Site Photograph

Width (m)	8
Depth (cm)	40-50
Substrate (in order of dominance)	Gravel, Sand, Cobble
Flow Type	Deep riffle 25% Fast streamy glide 75%

Instream Vegetation	Filamentous algae 10% Bryophyta 1% <i>Ranunculus sp.</i> 20% <i>Nasturtium officinale</i> agg. 50% <i>Phalaris arundinacea</i> 5% <i>Apium nodiflorum</i> 20% <i>Callitriche sp.</i> 1%
Dominant Bankside Vegetation	Hawthorn, <i>Phalaris</i>
Summer Shade of Stream by Bankside Vegetation	5%
Salmonid Adult Habitat	Fair
Salmonid Nursery Habitat	Fair - Good
Salmonid Spawning Habitat	Fair
Lamprey Nursery Habitat	Fair - Good
Lamprey Spawning Habitat	Fair
Crayfish Habitat	Fair - Good
