## Ballyogan Landfill and Recycling Facility Monitoring Report: Biological Surface Water Quality Assessment 2022

Waste Licence Ref. No. W0015-01

Prepared for: Dun Laoghaire Rathdown County Council

**Date:** December 2022

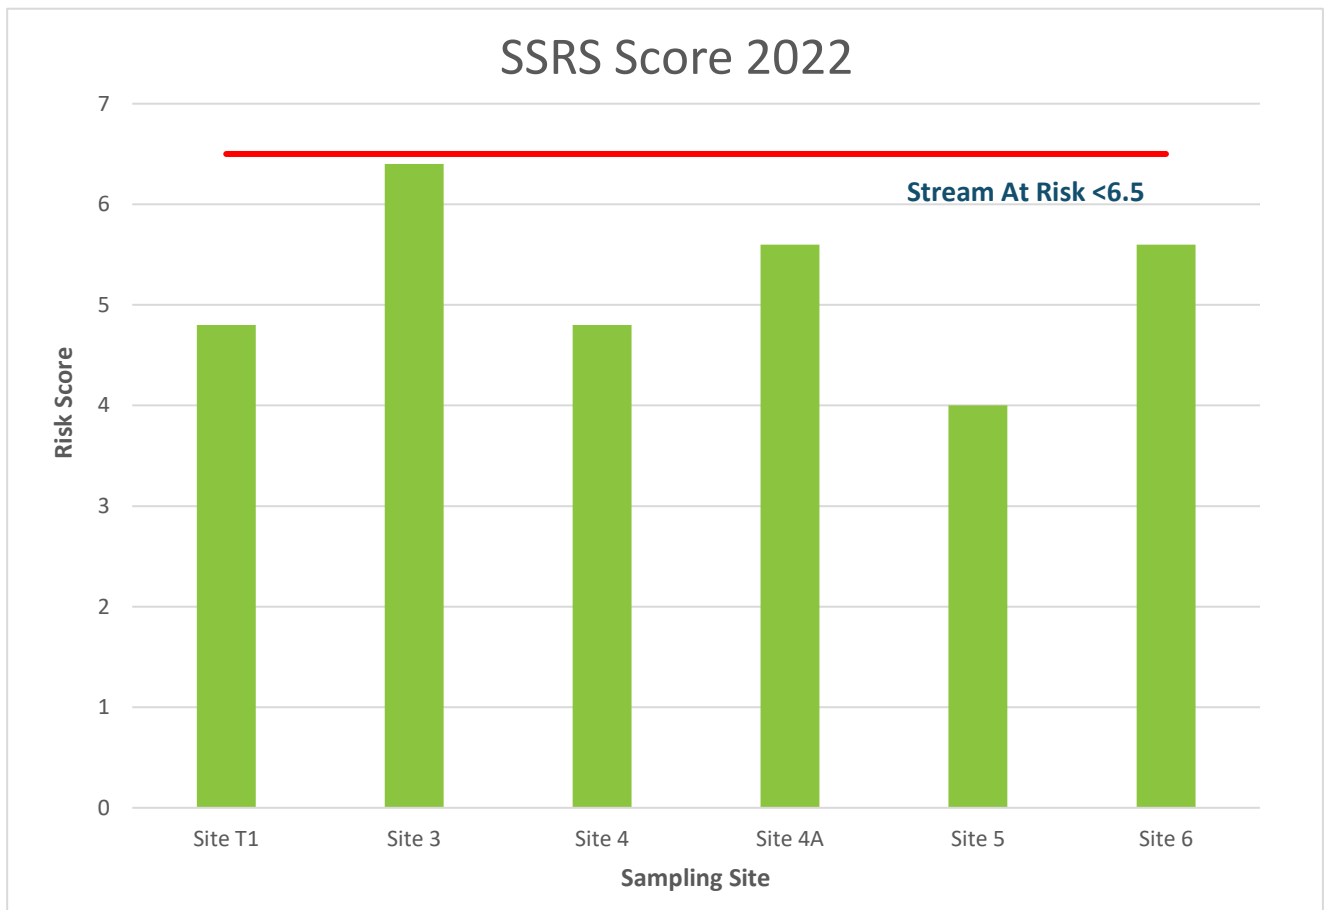
Scores	Site T1 (Upstream)	Site 3 (Upstream)	Site 4 (Upstream)	Site 4A (Upstream)	Site 5 (Downstream)	Site 6a (Downstream)
SSRS Score	4.8	6.4	4.8	5.6	4	5.6
SSRS Score Category	<6.5 stream at risk	<6.5 stream at risk	<6.5 stream at risk	<6.5 stream at risk	<6.5 stream at risk	<6.5 stream at risk
Equivalent Q Value Rating	Q3-4	Q3-4	Q3	Q3-Q4	Q3	Q3-4
Q Score Category	Moderate status	Moderate status	Moderate status	Moderate status	Moderate status	Moderate status

**Figure 3-1: Summary of SSRS Risk Scores for the Sampling Sites at Ballyogan in 2022**

The SSRS scores calculated in the current 2022 survey show sites T1–6a are all ‘at risk’. The 2022 results are similar to 2021 survey results and indicate improved quality at all sites compared to 2016, 2019 and 2020 results. None of the sites have moderate or good water quality that would be indicative of the ‘not at risk’ category in SSRS or Q4 ‘good status’ in Q-Value sampling. Thus, both methodologies of biological sampling have revealed poor - moderate water quality at all stream sites sampled in the vicinity of Ballyogan.

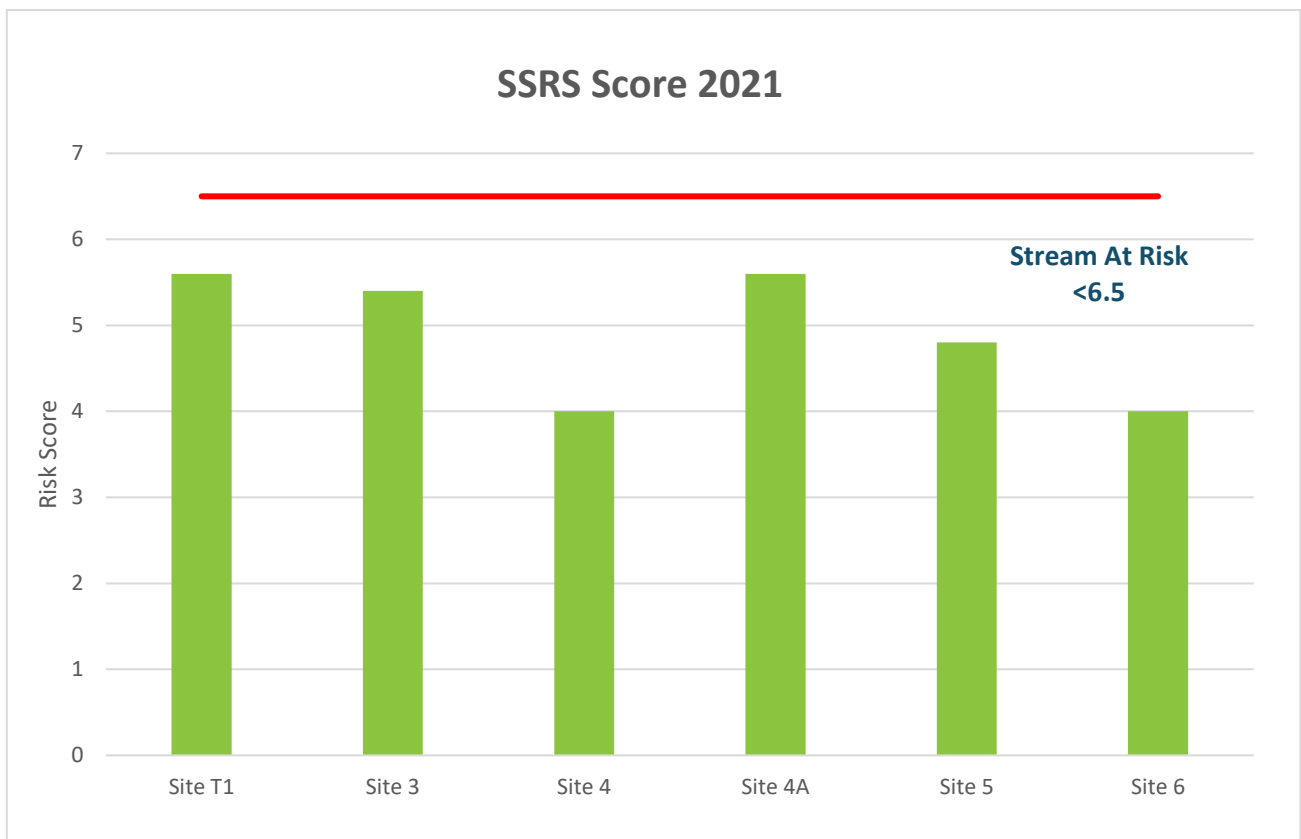
Scores	Site T1 (Upstream)	Site 3 (Upstream)	Site 4 (Upstream)	Site 4A (Upstream)	Site 5 (Downstream)	Site 6 (Downstream)
SSRS Score	5.6	5.4	4	5.6	4.8	4
SSRS Category	<6.5 stream at risk	<6.5 stream at risk	<6.5 stream at risk	<6.5 stream at risk	<6.5 stream at risk	<6.5 stream at risk
Equivalent Value Rating	Q3-4	Q3-4	Q3	Q3-Q4	Q3	Q3-4
Q Score Category	Moderate status	Moderate status	Moderate status	Moderate status	Moderate status	Moderate status

**Figure 3-2: Summary of SSRS Risk Scores for the sampling sites at Ballyogan in 2021**

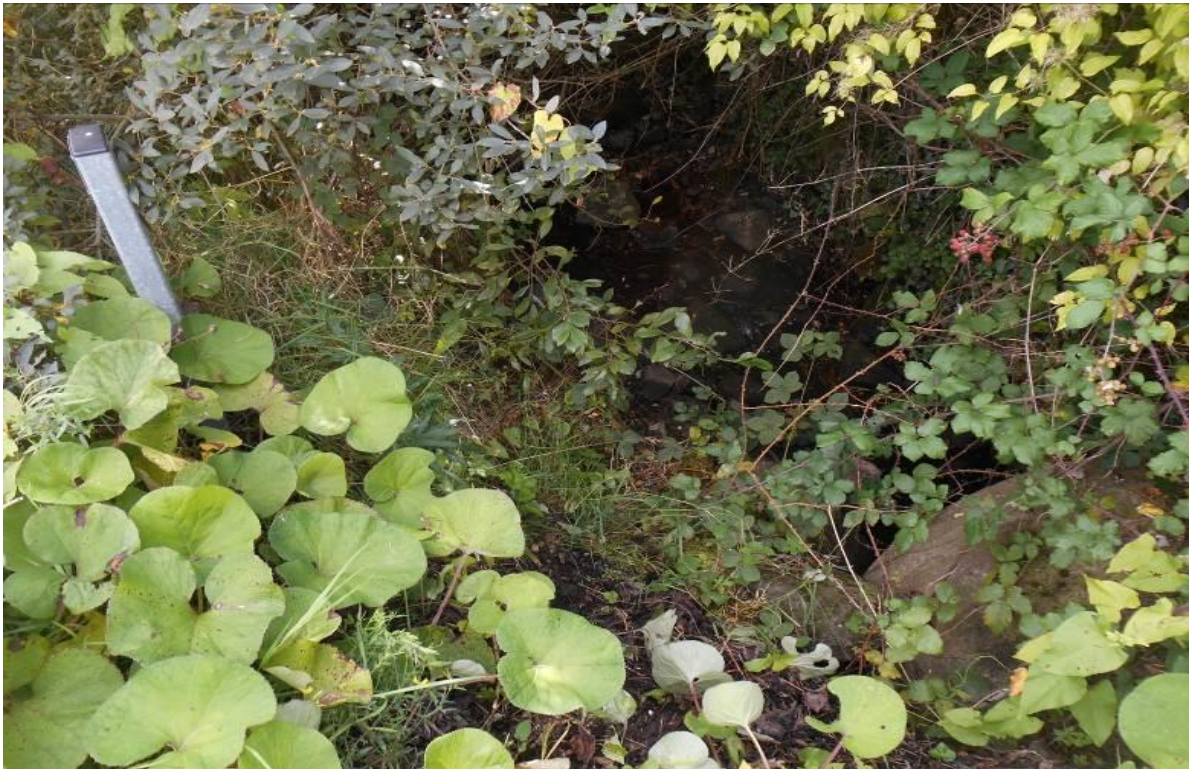
The site is located along a tributary stream on the western site perimeter just upstream of the confluence with the Ballyogan Stream. The streambed at this location consisted of bedrock, boulder, cobble, gravel and silt. Leaf litter was present and stream shading was high. The stream wet width was 0.8 m and the average depth was approximately 10 cm. Flow velocity was low and clear. This location was given a risk score of 4.8 or 'at risk'. The higher abundance of group 4 taxa accounted for the lower score than the score of 5.6 achieved in 2021. This site is shown on Figure 3.3, and the accompanying field sheet is available in Appendix 2.

Figure 3-3: Site T1 Sampling Location Photo

The 2022 biological results indicate “stream at risk” or moderate status (Q3-Q4) at the Western Tributary at Site T1, with an SSRS score of 4.8 recorded. As the Ballyogan Stream immediately upstream and downstream of its confluence with the western tributary has a moderate status Q-rating of Q3-Q4, it is clear that there is no biological impact from the landfill on the Ballyogan River via the Western Tributary.

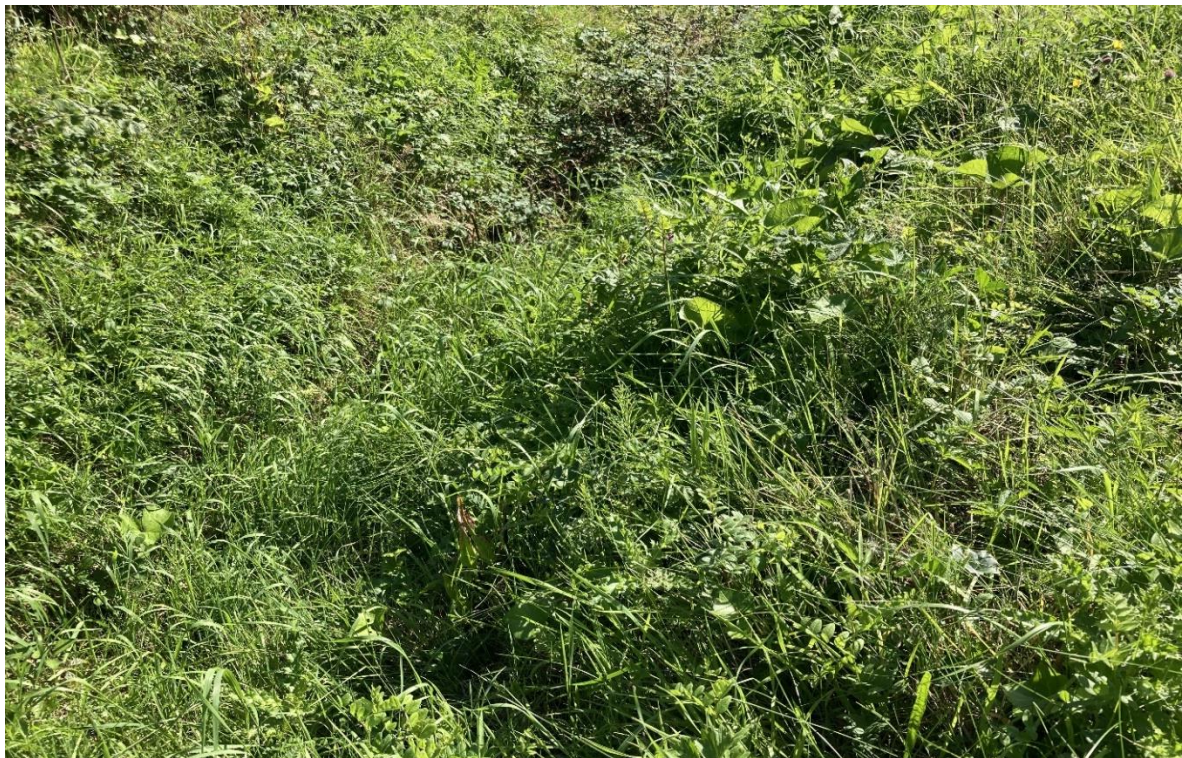
No flowing water and dense in stream vegetation at monitoring location T2 rendered conditions at this site less than optimal for SSRS or Q-rating assessment in 2022.

Figure 3-4: Site T2 Sampling Location Photo

No flow and dense in stream vegetation rendered conditions at this site less than optimal for SSRS or Q-rating assessment.

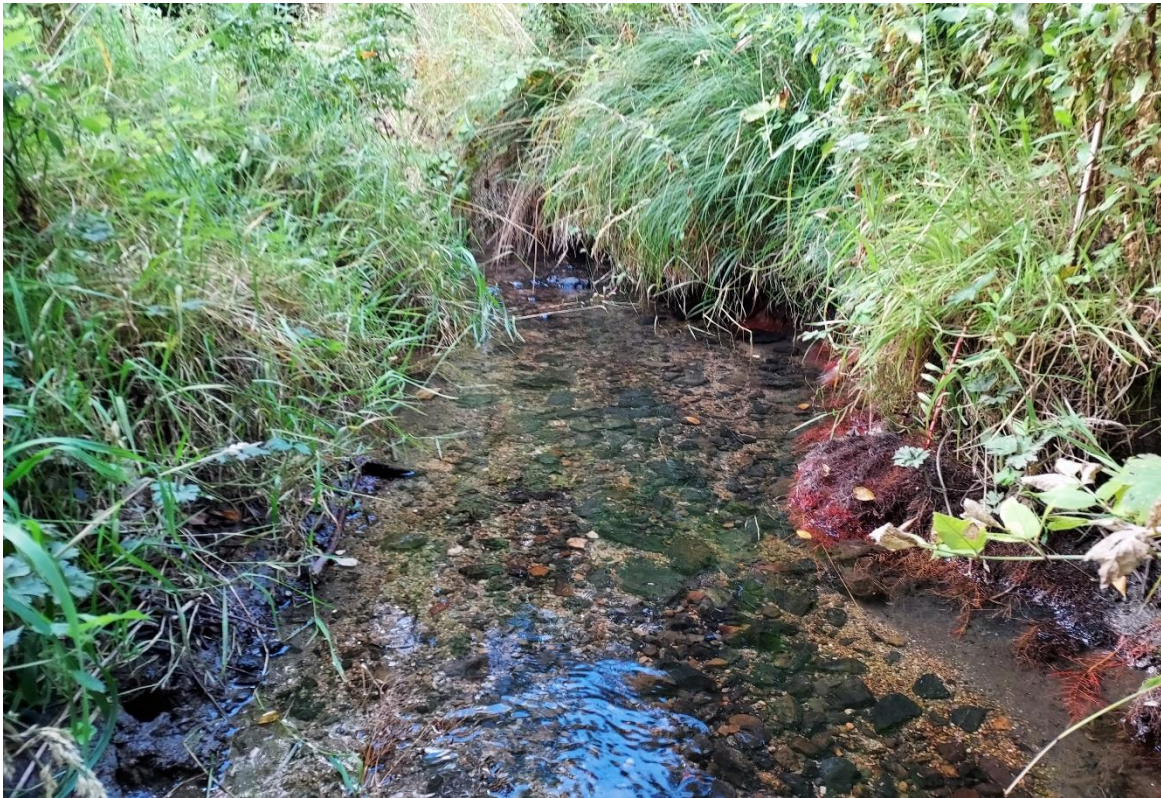
This site is located just northwest of the landfill, on Ballyogan Stream. The wet width was 1.6 m and the average depth was 15cm. The water was of moderate flow and clear. The streambed consisted of cobble, gravel and sand. There was leaf litter and low levels of siltation present. Shading was moderate. The land use in the surrounding environment is urban / residential. Construction works were ongoing at the Clay Farm residential development upstream. This location was given a risk score of 6.4 or 'at risk'. The presence of freshwater mayflies (Group 1), higher taxa numbers of group 3 invertebrates and reduced abundance of Group 4 taxa accounted for the higher score than the 2021 survey score of 5.4. This site is shown on Figure 3.5, and the accompanying field sheet is available in Appendix 2.

Figure 3-5: Site 3 Sampling Location Photo

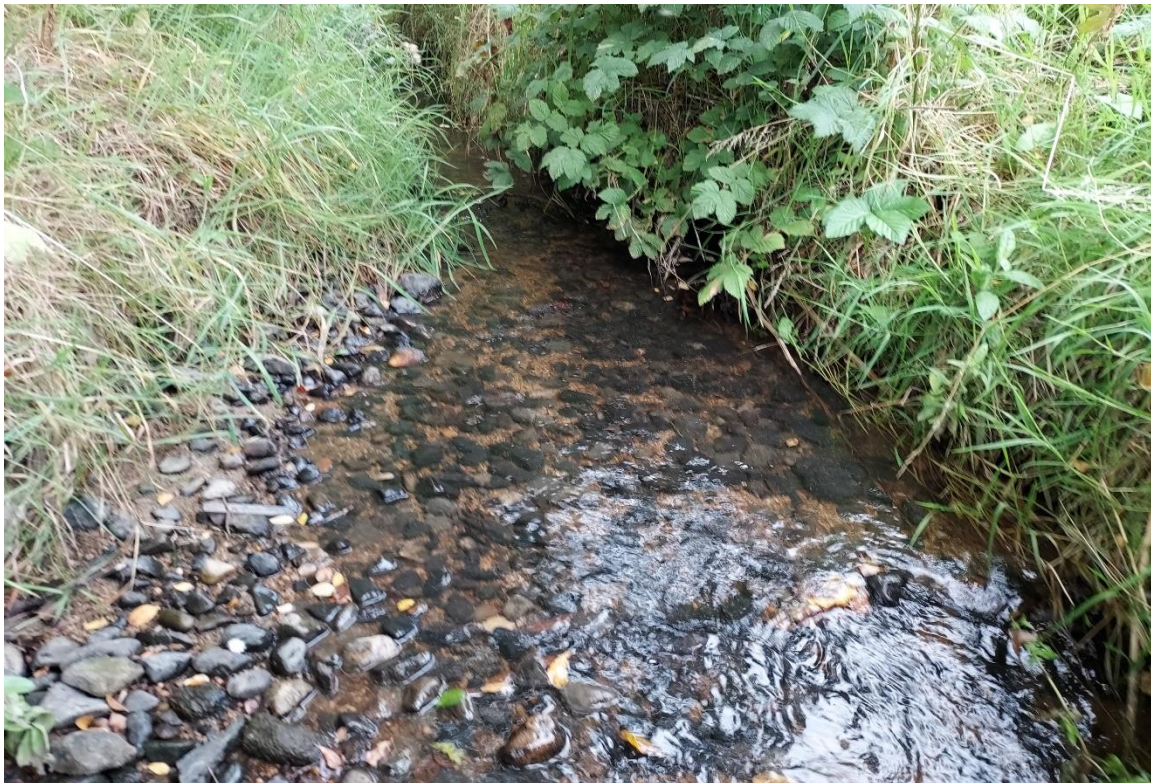
This site is located immediately northwest and upstream of the landfill, on Ballyogan Stream and downstream of Site 3. The bank wet width was 1.2m and the depth was 20cm. The water was clear and flow velocity was moderate. The main land use surrounding the site is urban. There was a low degree of shading at the site and the substrate was boulder, cobble, gravel and silt. Leaf litter was present. This location was given a risk score of 4.8 which is 'at risk'. The lower abundance of group 4 taxa accounted for the similar score to the 2021 result of 4.8. This site is shown on Figure 3.6, and the accompanying field sheet is available in Appendix 2.

Figure 3-6: Site 4 Sampling Location Photo

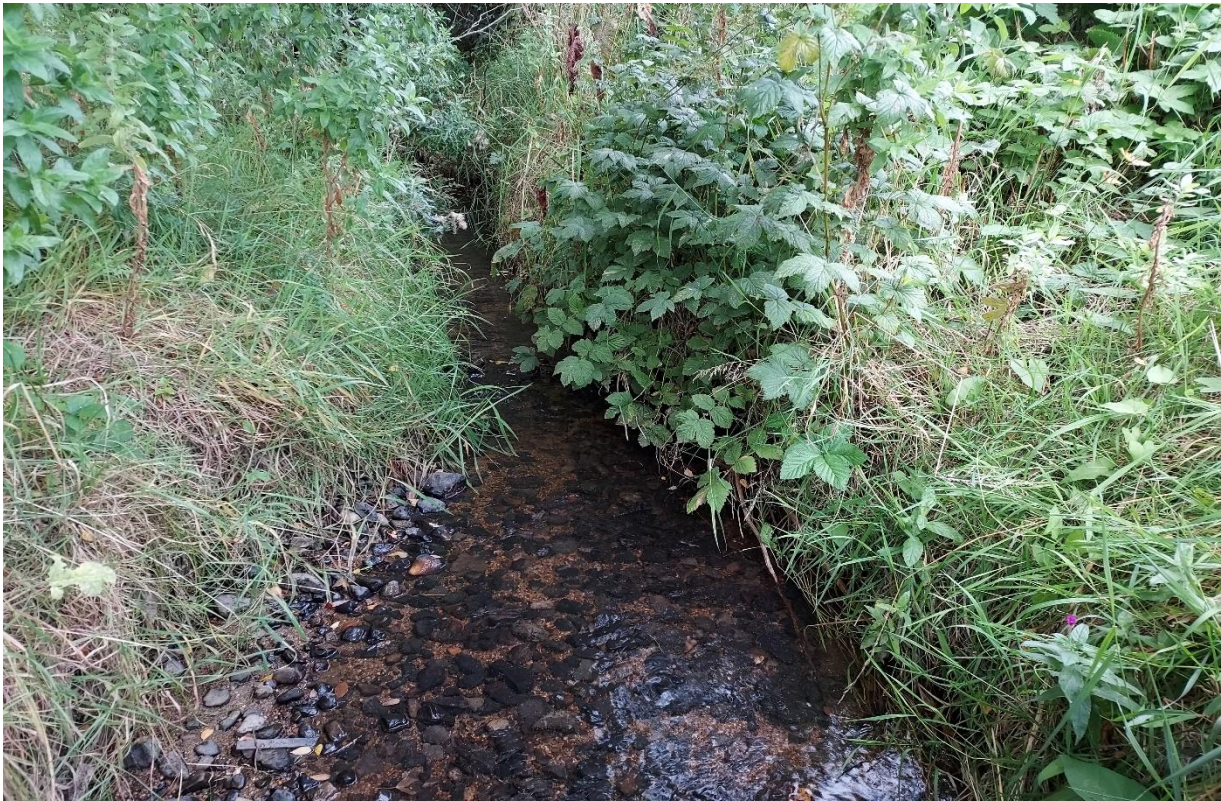
This site is located onsite within the north-western portion of the landfill, on the Ballyogan Stream and downstream of Sites 3, 4 and T1. The wet width was 1.2 m and the average depth was 20 cm. The flow velocity was low, and the water was clear. The substrate was boulder, cobble, gravel and sand. The level of shading was moderate. This location was given a risk score of 5.6 or 'at risk'. The presence of freshwater mayflies, higher taxa numbers of group 3 invertebrates, lower numbers of group 4 taxa (GOLD) and absence of Asellus (Group 5) accounted for the similar score to the 2021 survey of 5.6. This site is shown on Figure 3.7, and the accompanying field sheet is available in Appendix 2.

Figure 3-7: Site 4a Sampling Location Photo

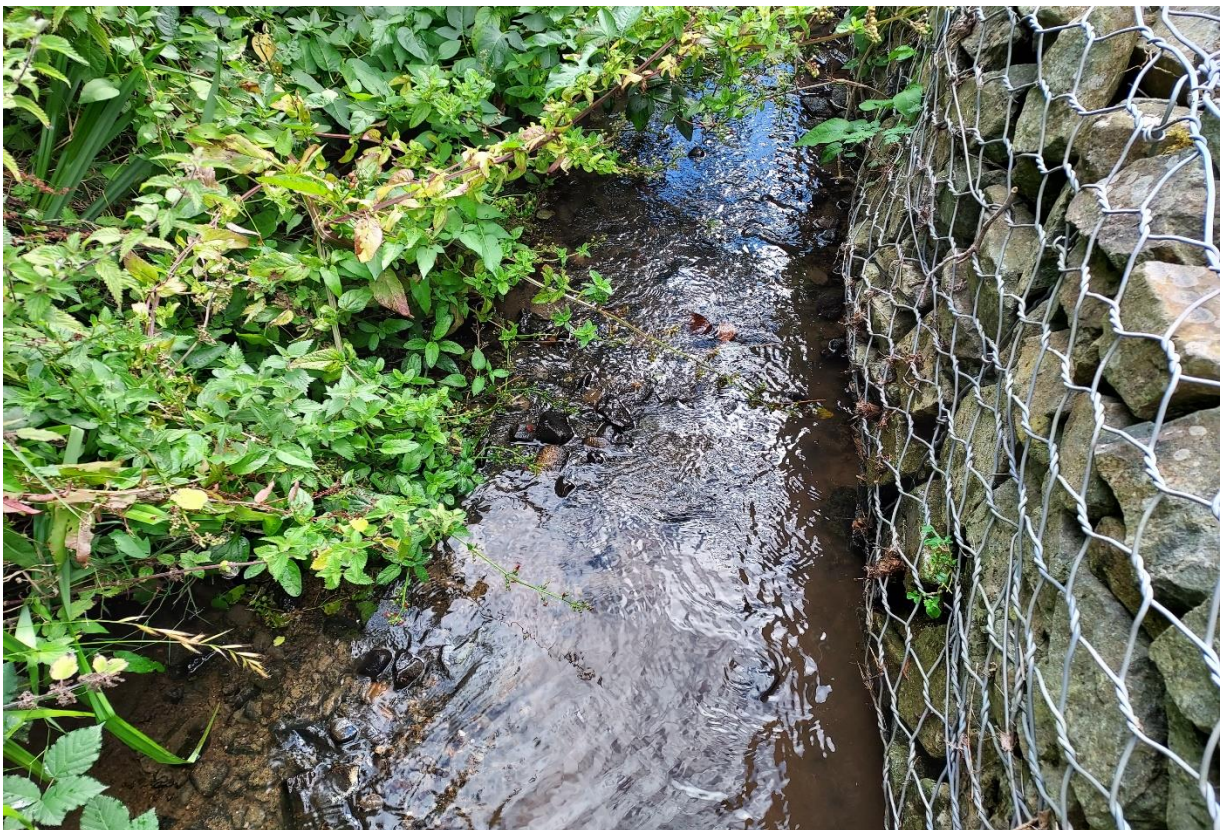
The site is downstream of the landfill culvert on Ballyogan Stream. The wet width was 1.7 m and the water depth was 15cm. The water flow was low, and the water was clear. The substrate was cobble, gravel and sand. There was leaf litter and low levels of siltation present. Construction works were ongoing upstream at the Clay Farm residential development. The stream shading was moderate. This location was given a risk score of 4 or 'at risk'. The presence of 'few' Asellus species within the invertebrate numbers accounted for a reduced score to the 2021 survey score of 4.8. This site is shown on Figure 3.8, and the accompanying field sheet is available in Appendix 2.

Figure 3-8: Site 5 Sampling Location Photo

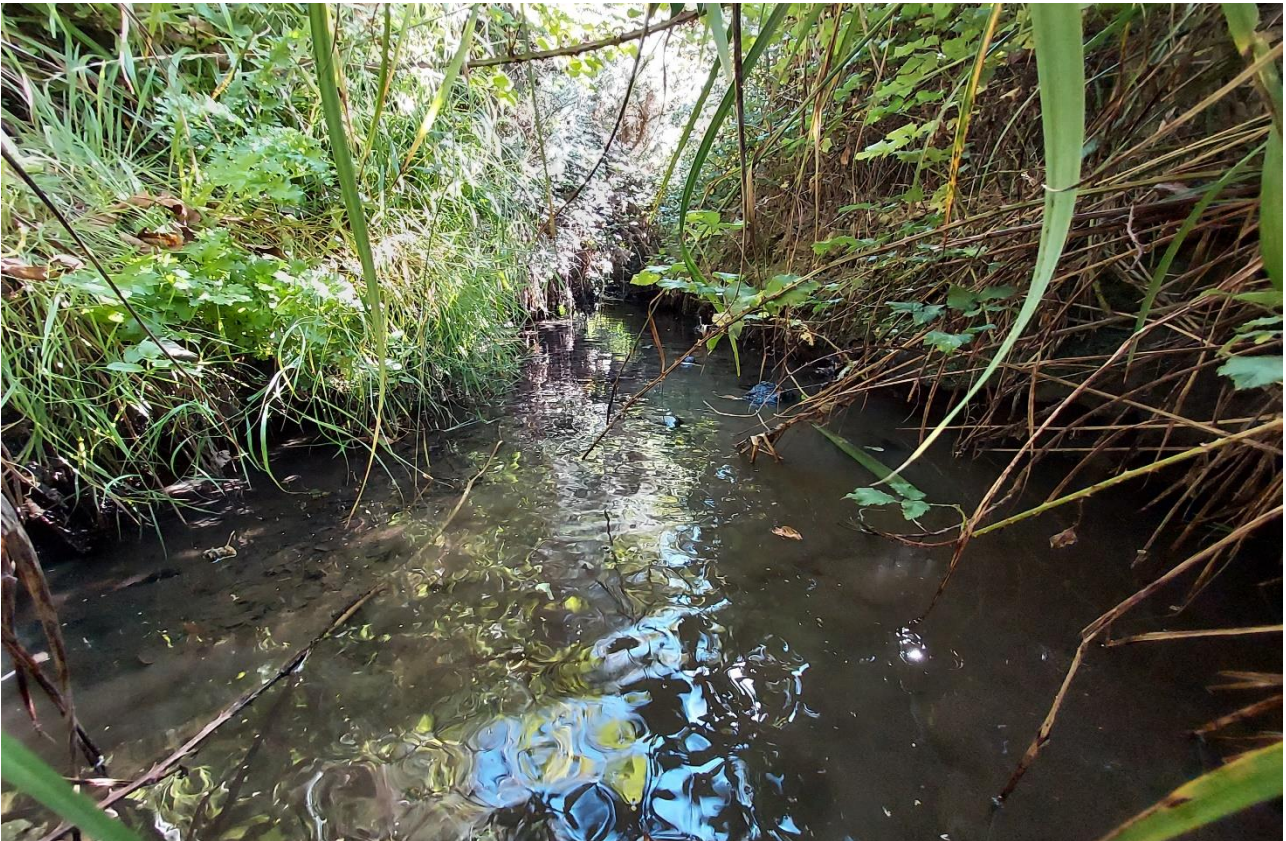
**Figure 3-9: Site 6a Sampling Location Photo**

This site is located northeast and downstream of the landfill, on the Ballyogan Stream. The stream wet width was 1.2 m and the average water depth was 20 cm. The stream substrate was boulder, cobble, gravel and sand. There was a moderate level of siltation and the depth of mud was 1-5 cm. Leaf litter was present and stream shading was moderate. This location was given a risk score of 5.6 or 'at risk'. The presence of a higher numbers of Trichoptera (Group 3) and lower GOLD (Group 3) species abundance accounted for the higher score than the 2021 survey result of 4. This site is shown on Figure 3.9, and the accompanying field sheet is available in Appendix 2.
