## Hydrogeological Investigation of Groundwater and Plume Dynamics at Kinsale Road Landfill and its Environs, Cork City

**Project Title:** Hydrogeological Investigation of Groundwater and Plume Dynamics at Kinsale Road Landfill and its Environs

**Status:** Final Version

**Client:** Cork City Council

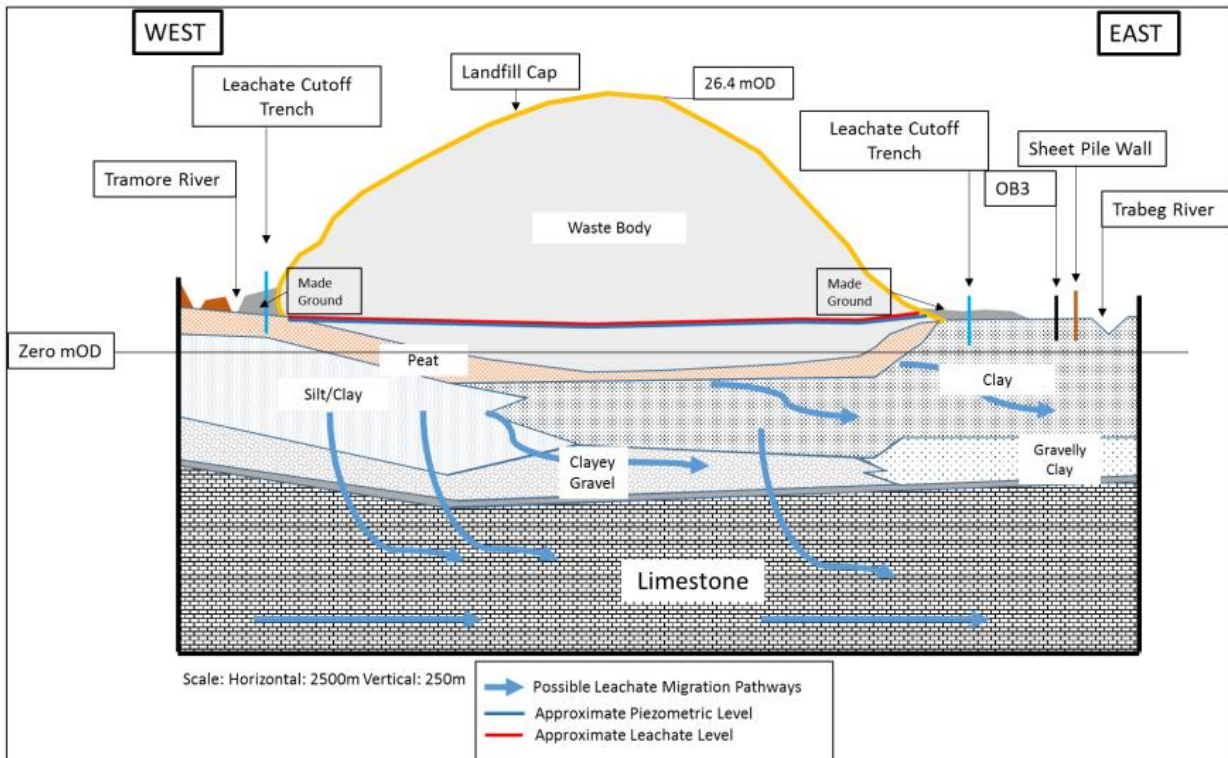
Figure 9 West- East hydrogeological CSM (adapted from OCM 2015).

In general, under the site groundwater flow is moving to the south-east. In the southern portion of the landfill where the regionally important limestone aquifer meets the poorly productive silt/mudstones groundwater flows to the east. The contact between the two aquifer types forms a barrier to groundwater and leachate movement and causes the groundwater to travel east discharging eventually into the Douglas Estuary and Cork Harbour. In the portion of the site to the south underlain by the silt/mudstones groundwater is believed to flow from south to north discharging into the Tramore River.

The groundwater levels for the NW wells series for the top of bedrock are generally at similar elevations. The OB well series which are overburden/subsoil wells generally have lower elevations than the NW well series which would indicate an upward hydraulic gradient.

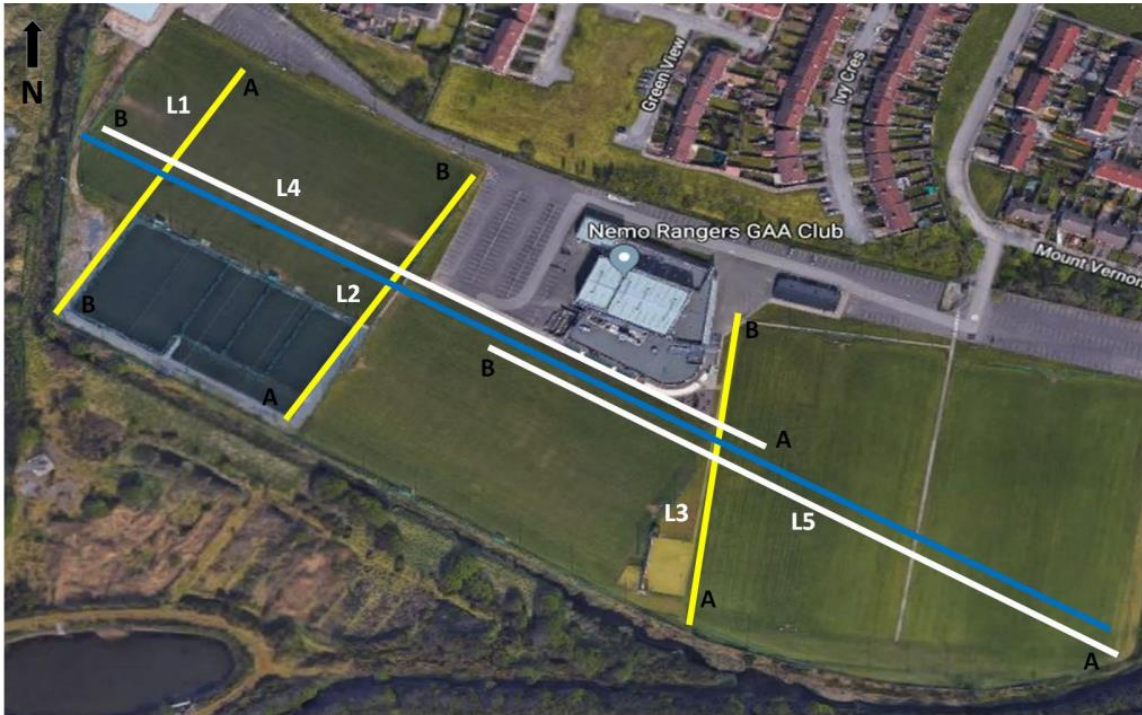
Geophysical Survey Lines Conducted on the Nemo Rangers Grounds (Profile Lines 1-5)

L1, L2 & L3 – Yellow	Blue line – Extent of survey area
L4 & L5 – White

Geophysical surveys in the form of 2D Resistivity (*Appendix B*) were conducted on the southern grounds at Nemo Rangers as shown below and in *Appendix E*. The profiles generated penetrate down to 25m below ground level. The profiles do not display any signature of contamination of the subsurface within the 25m profile (*Appendix F*). Profile Lines conducted close to site show no indication of offsite contamination migration and profile lines that were conducted further east display similar results. This section outlines the profile lines conducted through 2D resistivity with resistivity measured in Ohms/m: For clarity, larger versions of the profile lines are available in *Appendix H*.

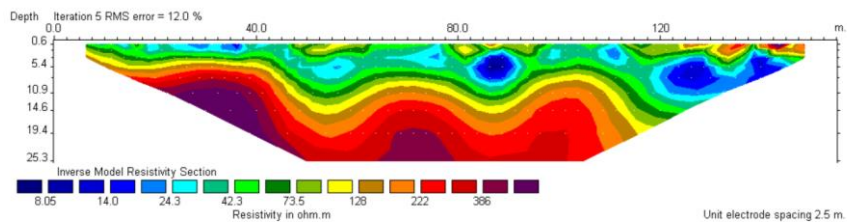
Profile Line 1

Competent Limestone (WA) bedrock is met at depths from 9-15m, overlain by a gravel layer. This is verified through ground truthing using the borehole logs for the now buried groundwater monitoring wells in Nemo Rangers (*Appendix H*). The borehole wells are situated adjacent to Line 1 prior to being buried and destroyed (due to development of the grounds). The borehole logs verify the bedrock to be Waulsortian Limestone (WA) with overlaying sediments comprised of clay and/or peat. There is no indication of contamination present.

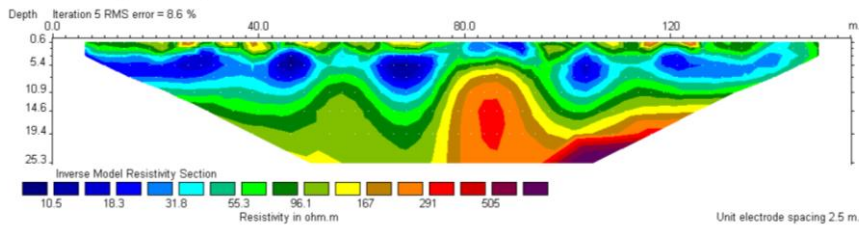
Profile Line 2

This profile is situated ~150m parallel to the south east of Line 1. The Profile displays similar lithological succession with variations seen with depth due to the undulating nature of the Waulsortian Limestone (WA) bedrock. The areas of low resistivity display identical characteristics to that of Profile Line 1. Due to the position of Line 2 in relation to Line 1, it is concluded that there is no evidence of leachate contamination present.

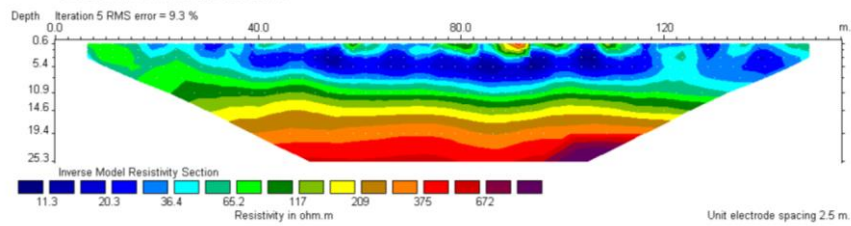
Profile Line 3

This profile shows limited undulation of the bedrock topography, indicating that this line is likely to be in the Cuskinny member of the Kinsale Sandstone/siltstone formation. This was preceded by fractured bedrock or a gravel layer with the overlaying sediment comprising of made ground, clay and peat. There is no indication of contamination present

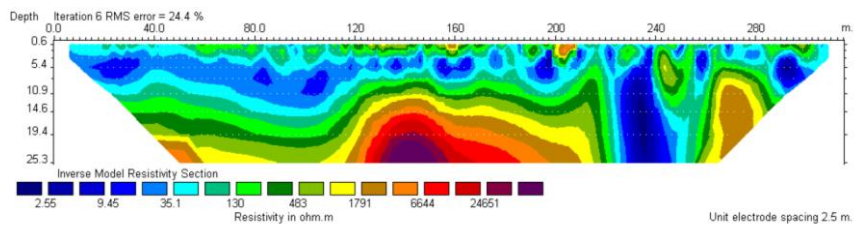
Profile Line 4

Due to the high error level of this line section, the interpretation of this profile can only be used to verify the presence of the faulted contact between the Waulsortian Limestone (WA) and the Cuskinny Member. This is displayed as the vertical area of Low resistivity present to the right of the profile line section.

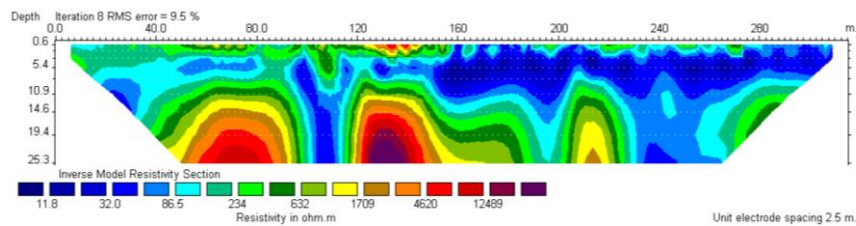
Profile Line 5

This line displays the faulted contact of the undulating Waulsortian Limestone (WA) bedrock and the bedrock Cuskinny member of the Kinsale Sandstone/siltstone formation. This boundary shows a strike slip movement with pressure existing between the 2 blocks. To the right of this fault, the overlaying sediment of clay/peat and/or made ground is consistent throughout. There is no indication of contamination present.

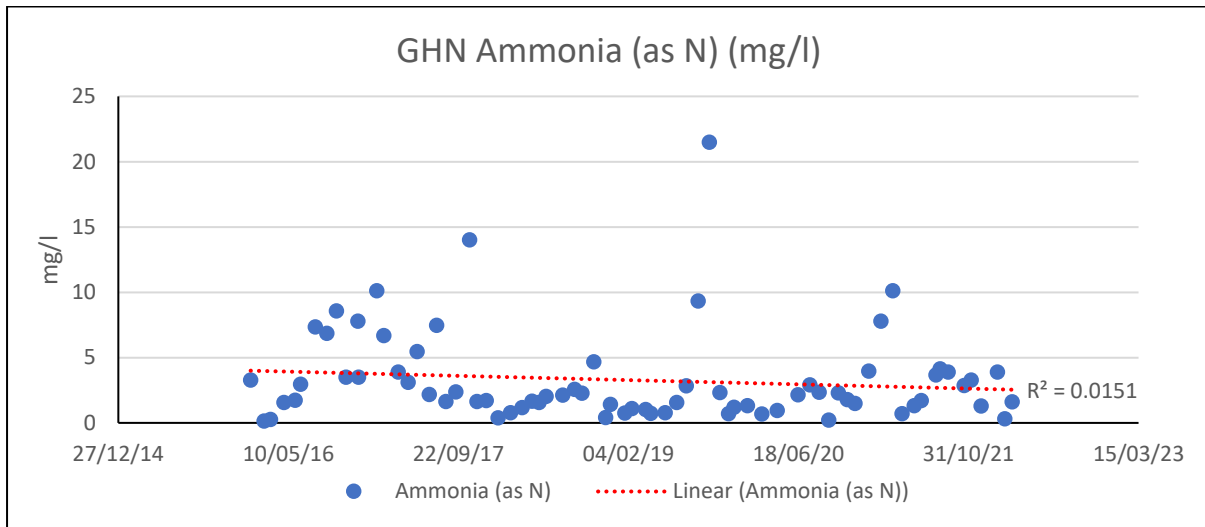
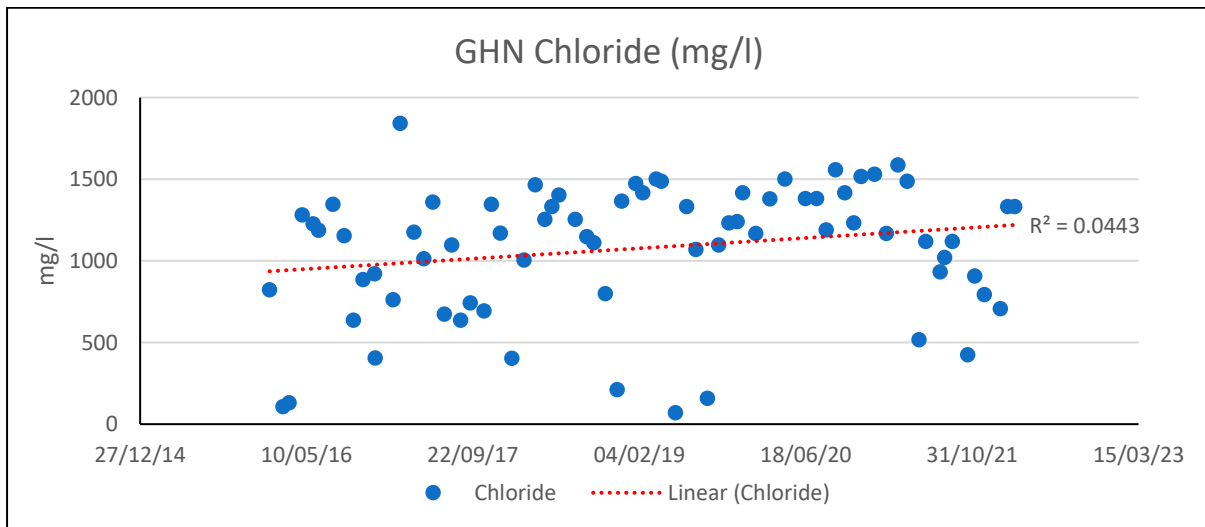
Figure 11 Ammonia and Chloride levels at the Greenhills North Deep Well

Chemical interpretation of the groundwater wells at GHS and GHN showed strong characteristics of contamination by a diffuse, chloride dominant leachate plume at the Northeast perimeter of the site (*Appendix C*). Due to the increasing trends in chloride, all be it a slight increase with  $R^2$  at 0.0443 and 0.05540 observed historically and with levels at present being greater than that of previous years it could be suggested that the longevity of the plume at Greenhills is on the rise. However, this is a weak correlation and statistically insignificant. It cannot be concluded that the plume is on the rise, but rather that it seems to be stable. (*Figures 11 and 12 and Appendix D*).

Due to the increasing trends in chloride, all be it a slight increase with R<sup>2</sup> at 0.0443 and 0.05540 observed historically and with levels at present being greater than that of previous years it could be suggested that the longevity of the plume at Greenhills is on the rise However, this is a weak correlation and statistically insignificant. It cannot be concluded that the plume is on the rise, but rather that it seems to be stable. (*Figures 11 and 12 and Appendix D*)

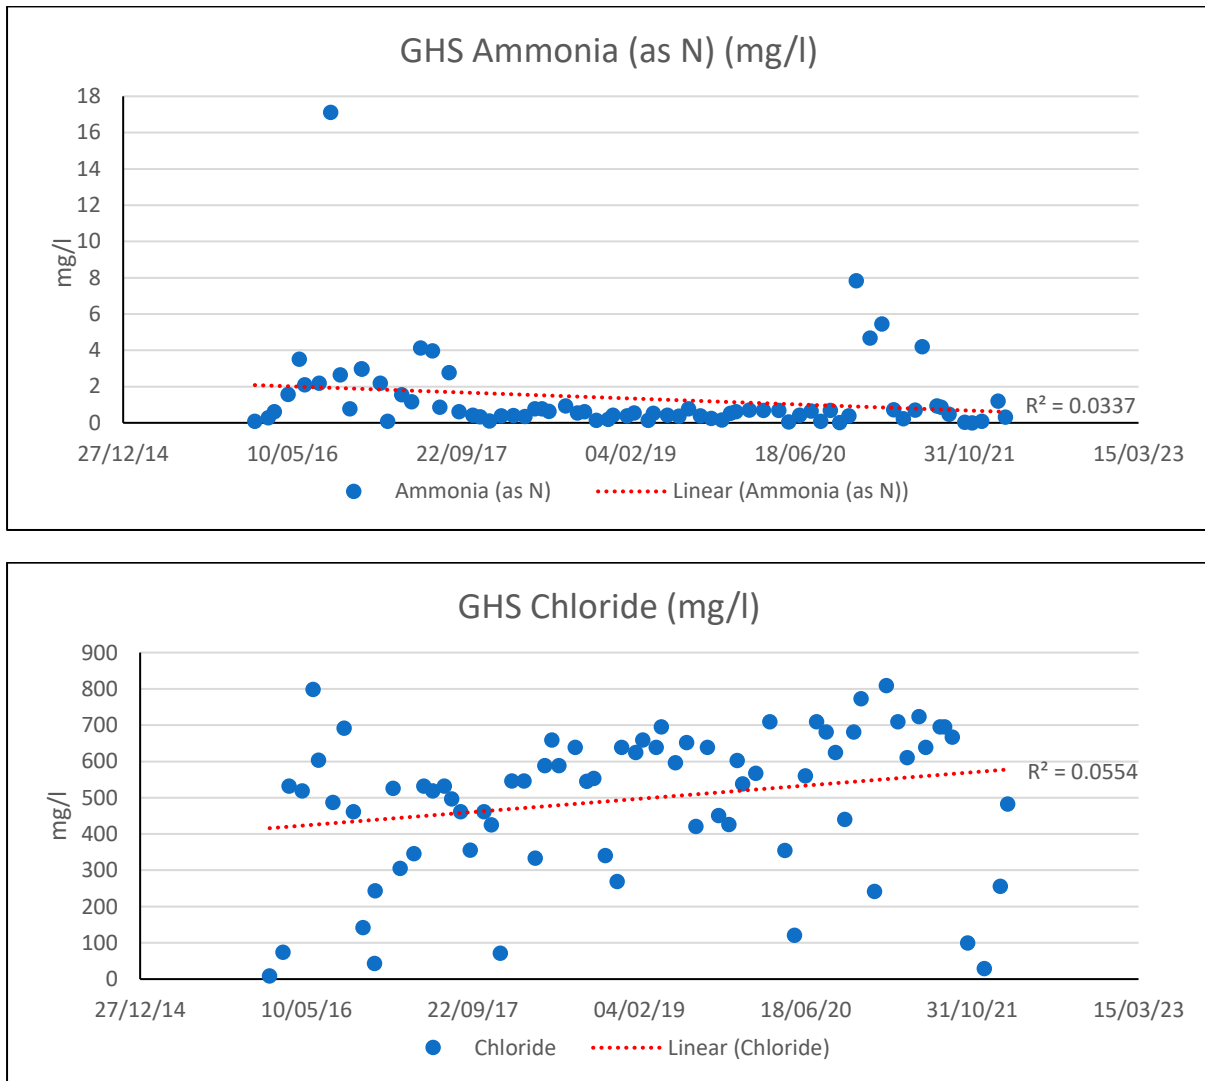
Figure 12 Ammonia and Chloride levels at the Greenhills South Deep Well

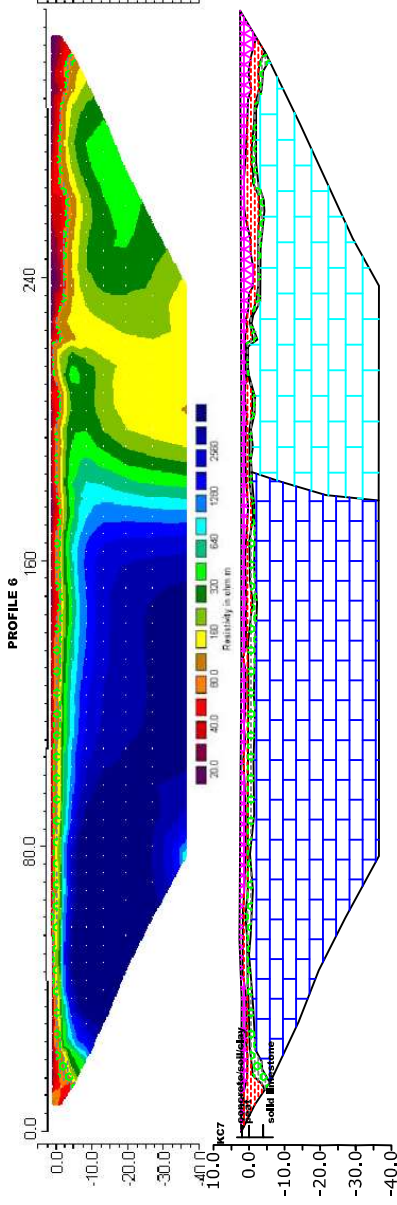
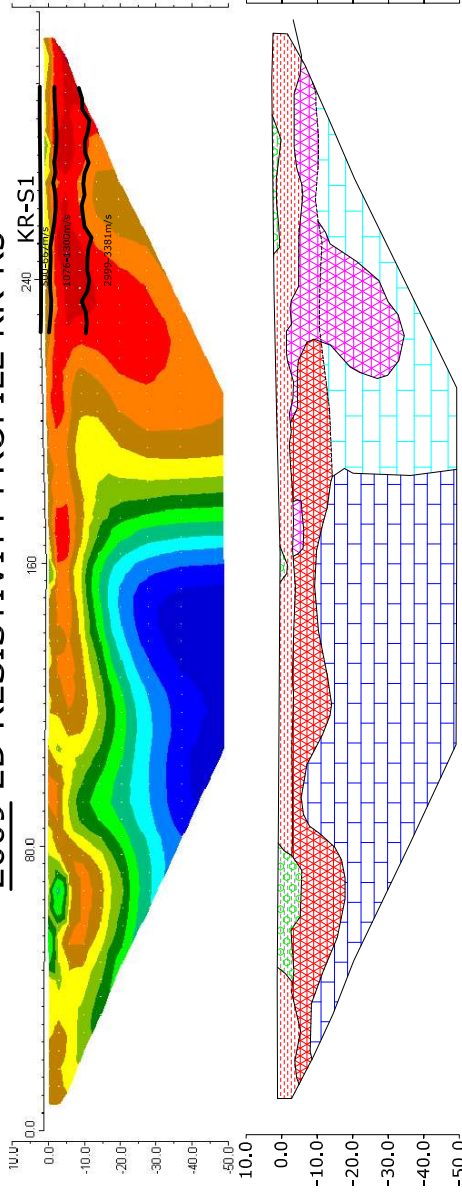
2009 2D RESISTIVITY PROFILE KR-R3

2009 profile KR-R3 replicates 2003 2D Res 6. Both profiles and interpretations are presented on Drawing 9241\_KR\_01: Figure 4. 2009 profile KR-R3 suggest that there is a significant infiltration of leachate into the bedrock.

North 2003 2D RESISTIVITY PROFILE 6 South

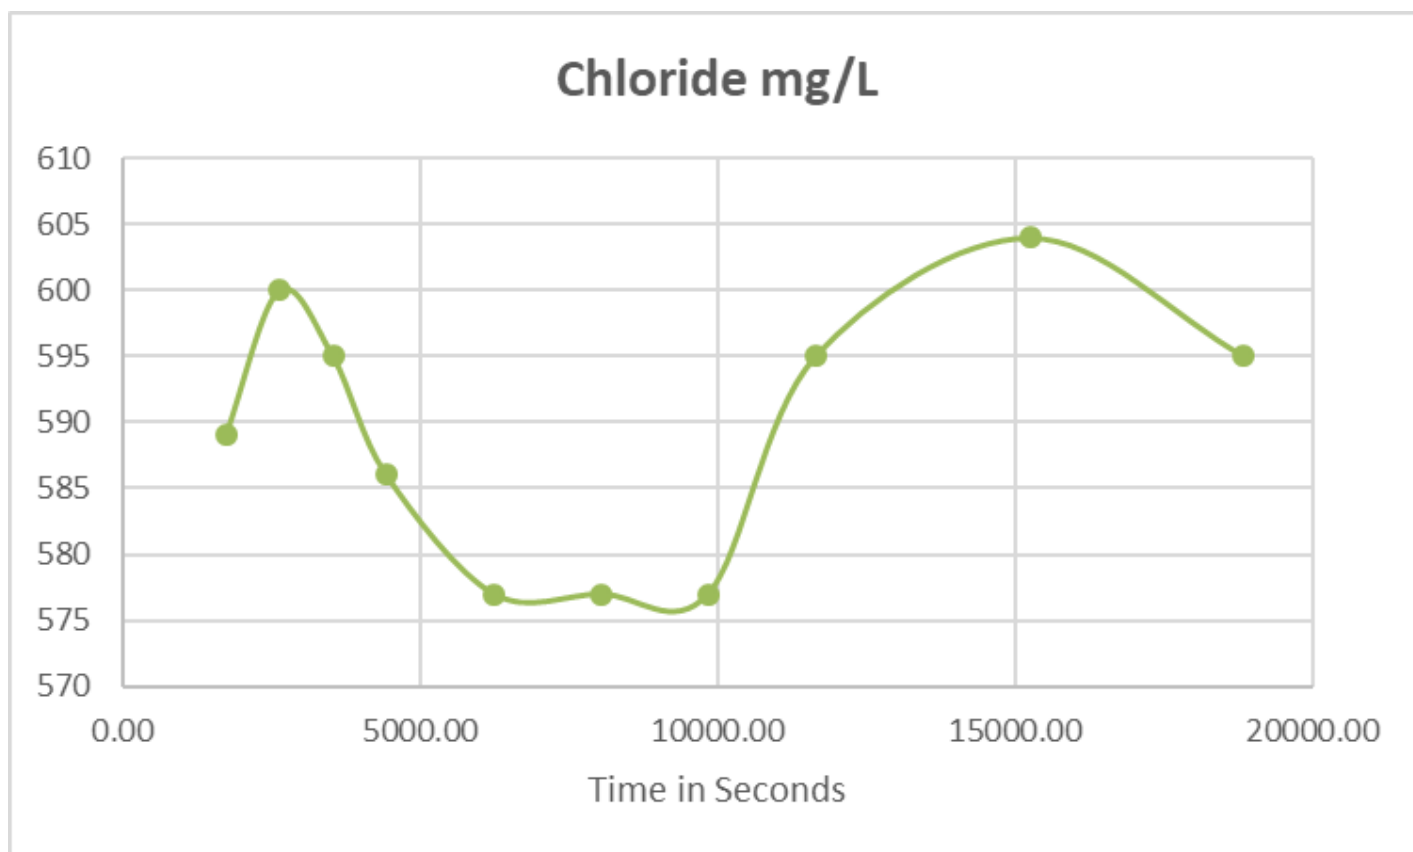
Chloride Data for Pumping Tests of Greenhills South

Figure depicting Pumping Tests conducted on 18/07/2018 10am-4pm

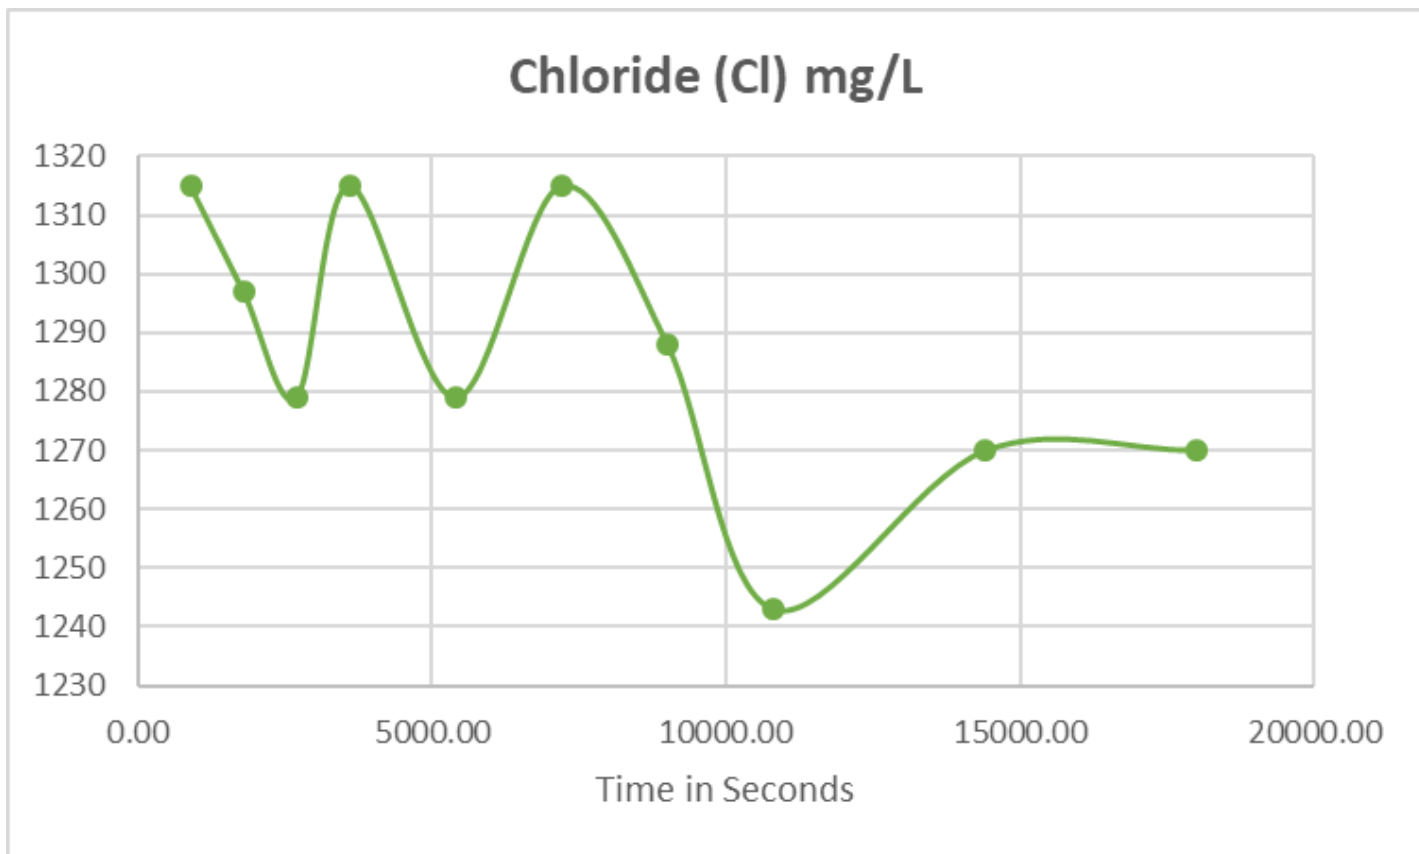
Chloride Data for Pumping Tests of Greenhills North

Figure depicting Pumping Tests conducted on 19/07/2018 10am-4pm

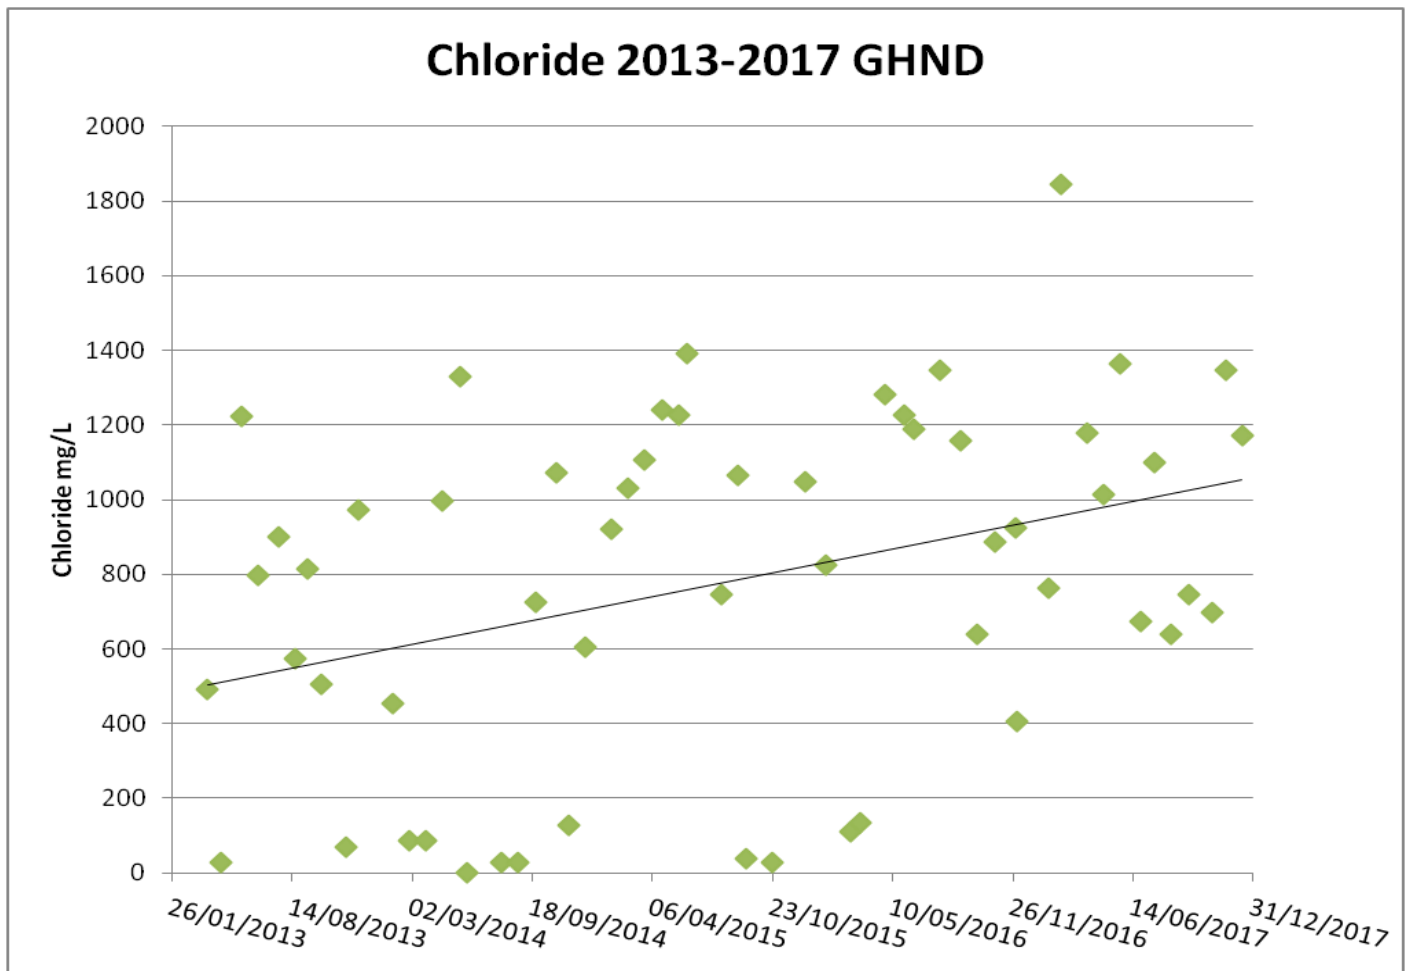
Figure depicting Groundwater Sampling for Chloride 2013-2017 Greenhills North Deep

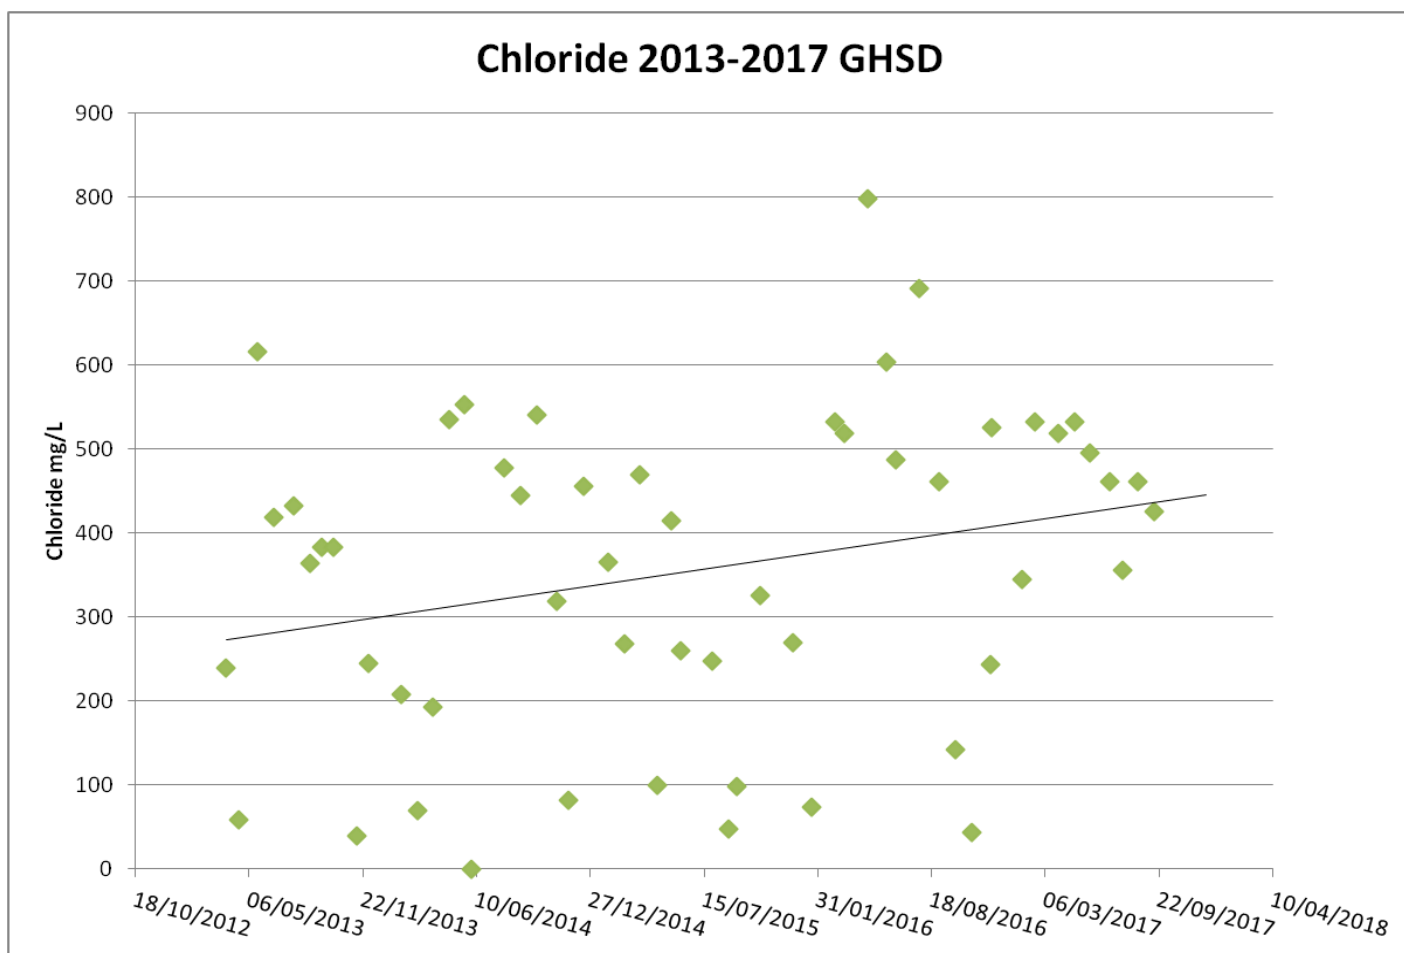
Figure depicting Groundwater Sampling for Chloride 2013-2017 Greenhills South Deep

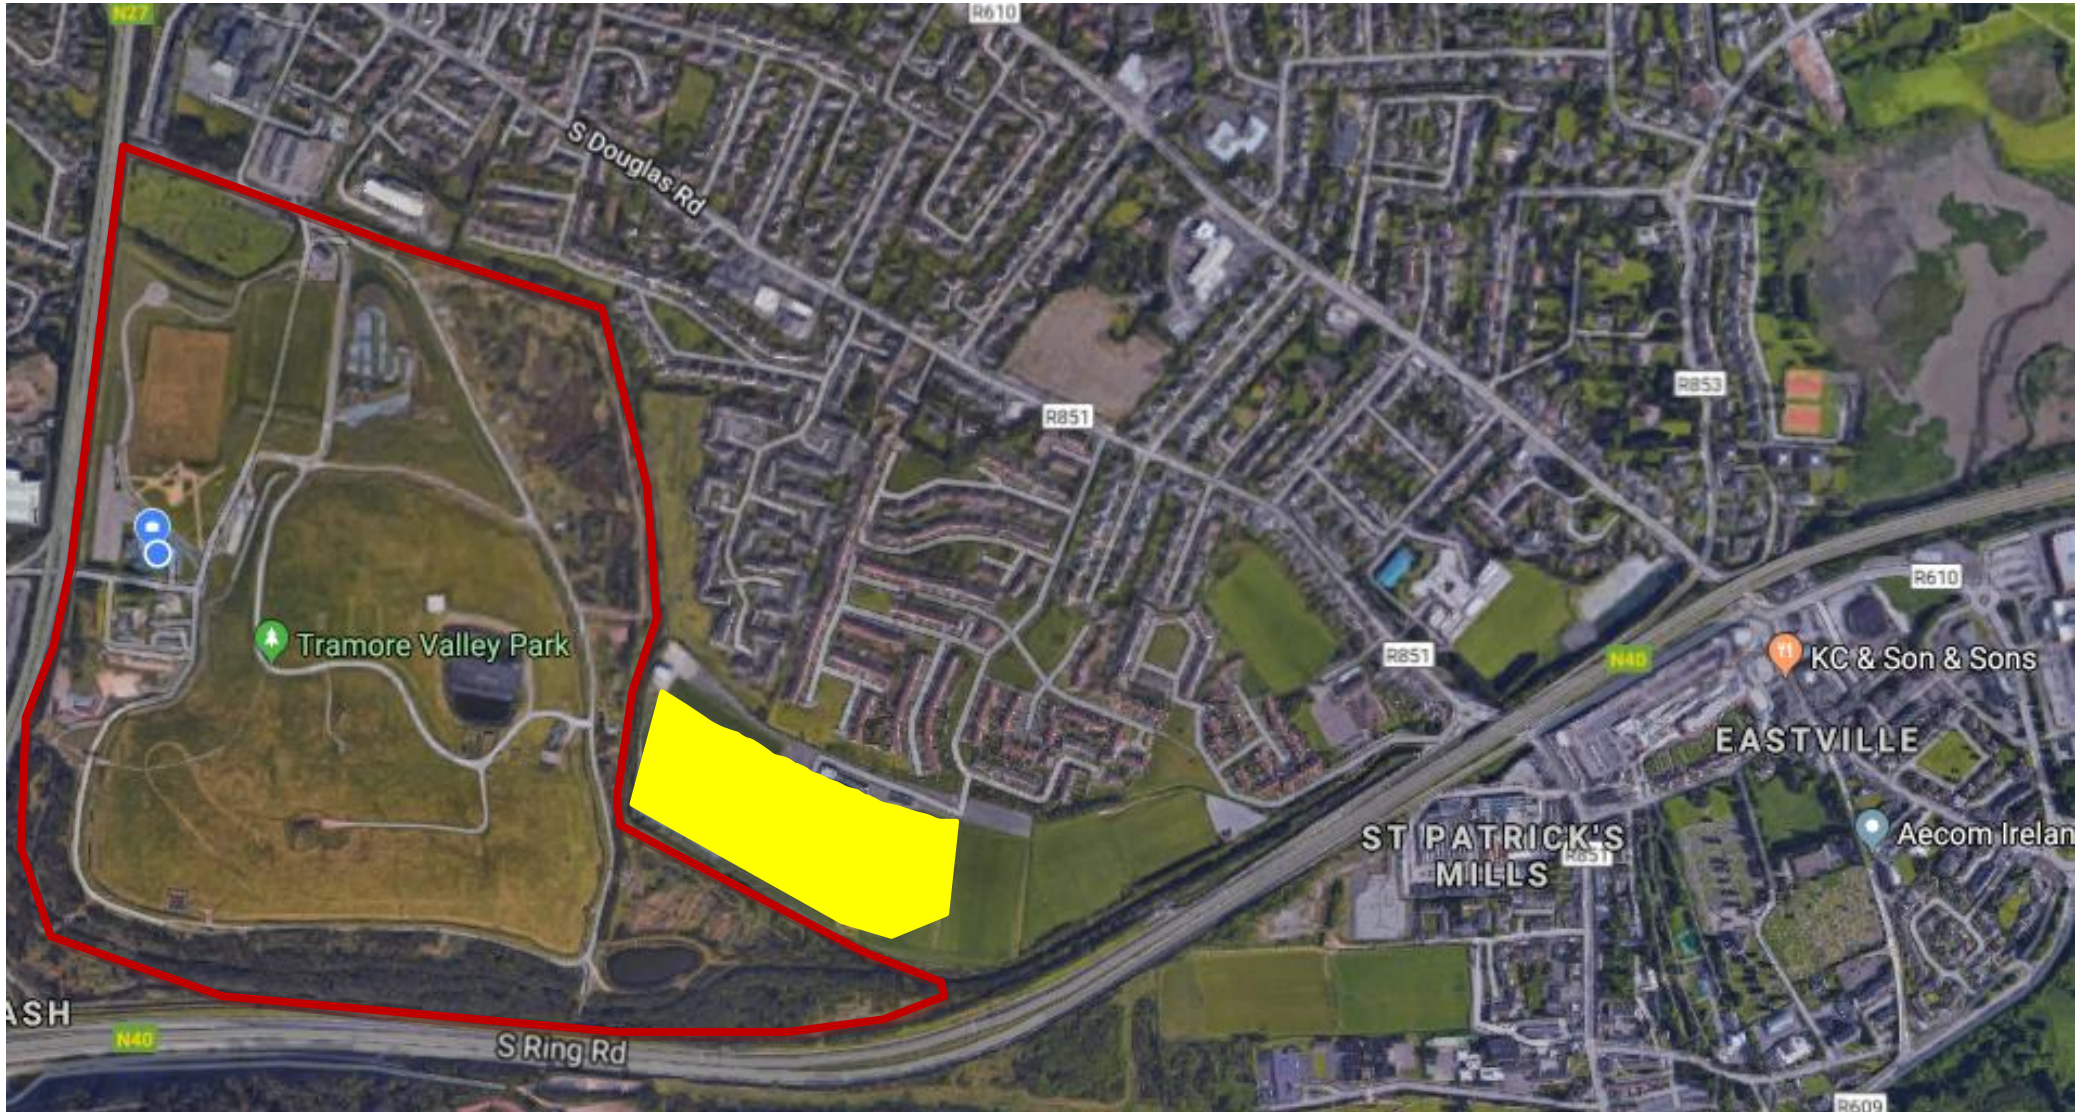
**APPENDIX E – GEOPHYSICAL SURVEYS - LOCAL SETTING AND POSITIONS**

*Local setting where the geophysical survey was carried out (Yellow) in relation to the Kinsale Road Landfill Site boundary (Red)*

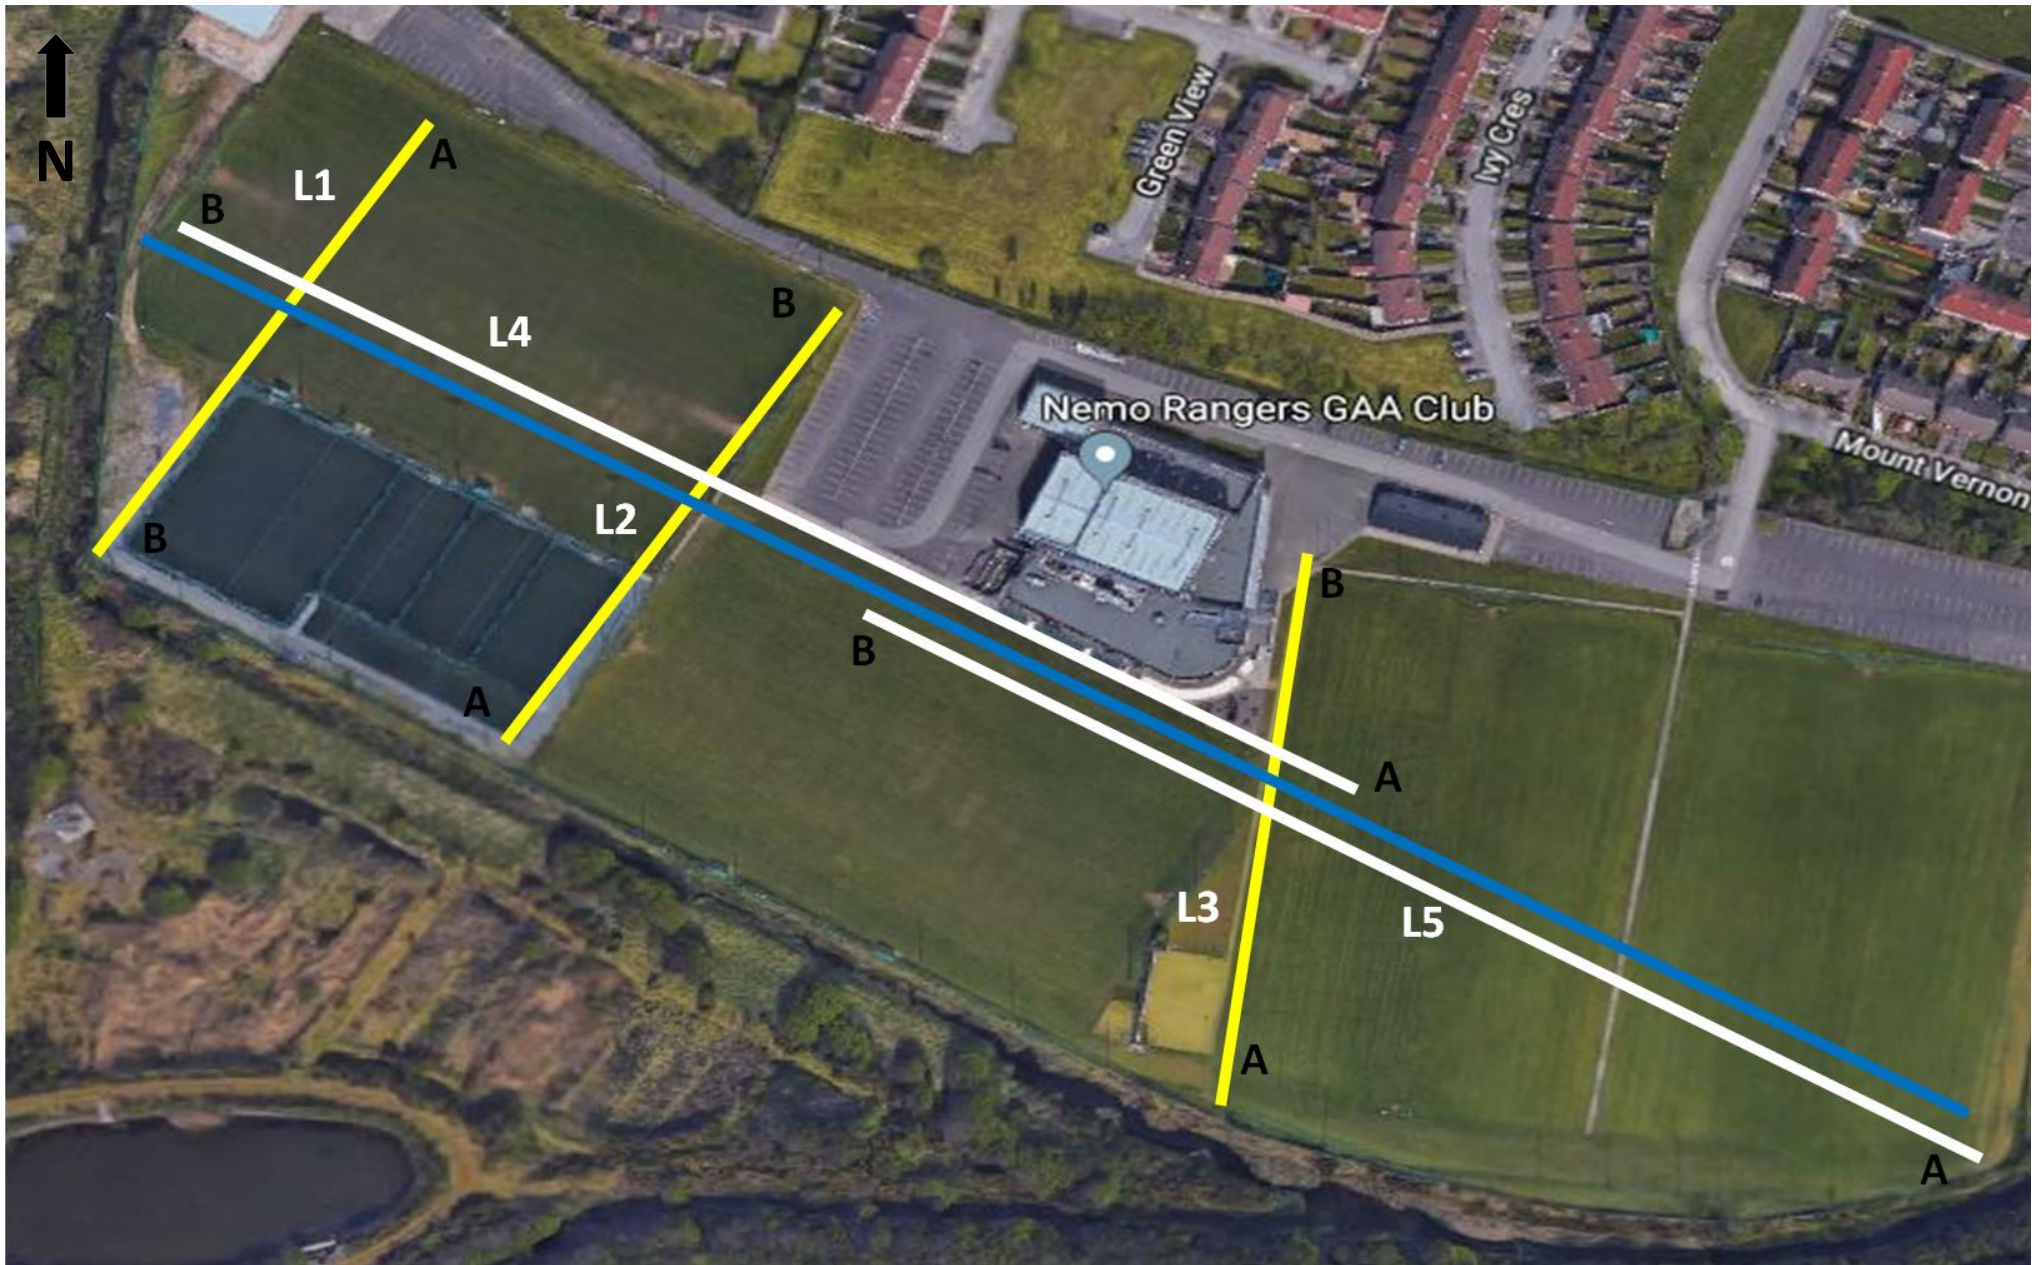
Geophysical Survey Lines Conducted on the Nemo Rangers Grounds (Profile Lines 1-5)

L1, L2 & L3 – Yellow	Blue line – Extent of survey area
L4 & L5 – White

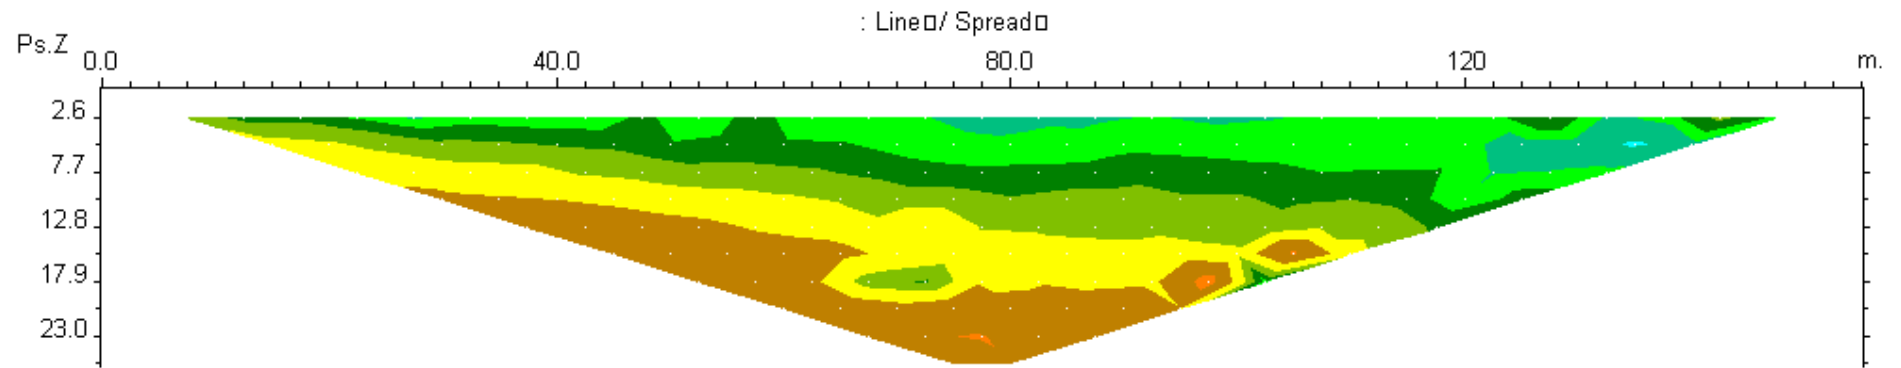
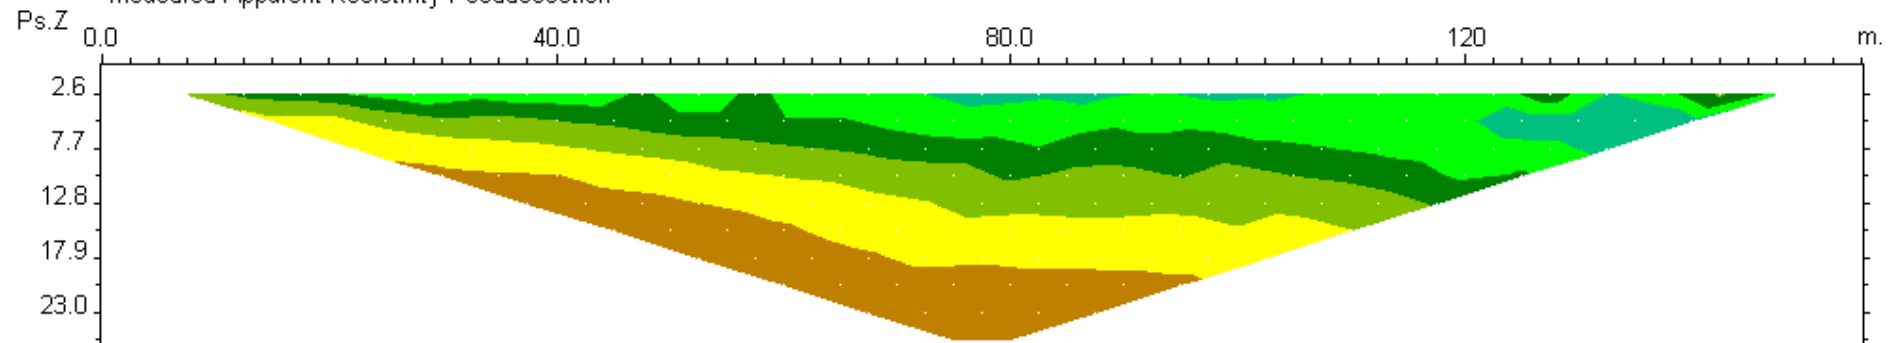
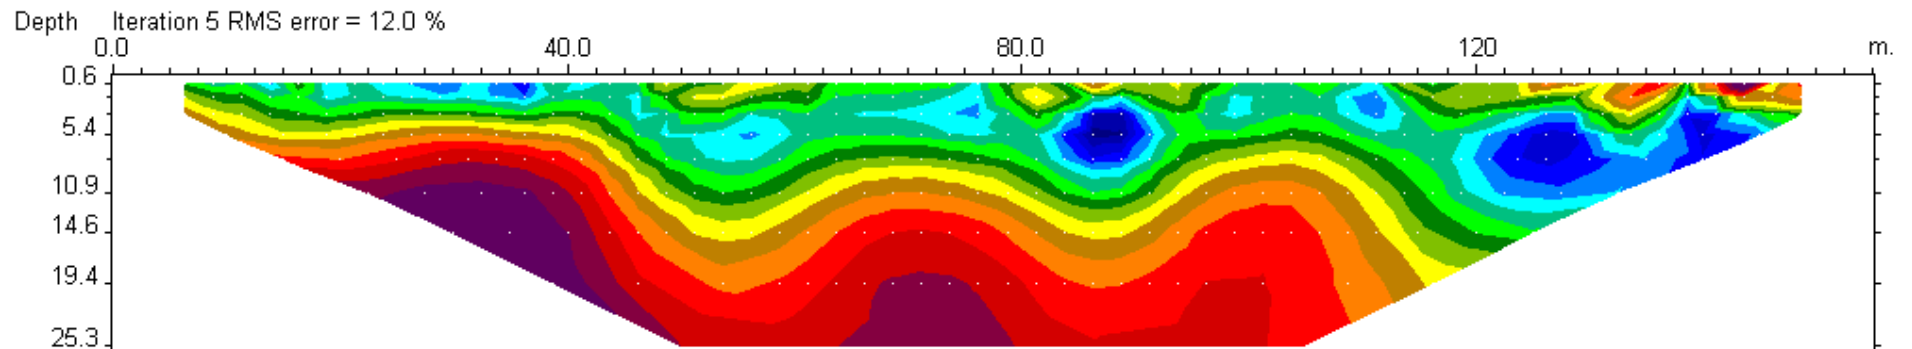
Line 1

Measured Apparent Resistivity Pseudosection

Calculated Apparent Resistivity Pseudosection

Inverse Model Resistivity Section

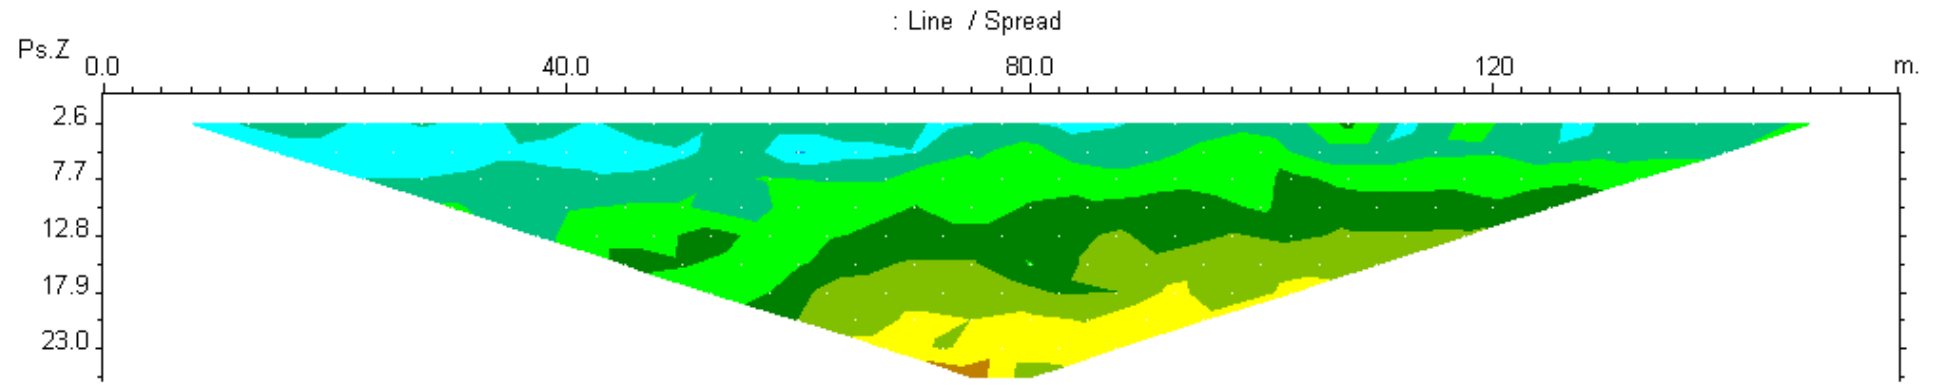
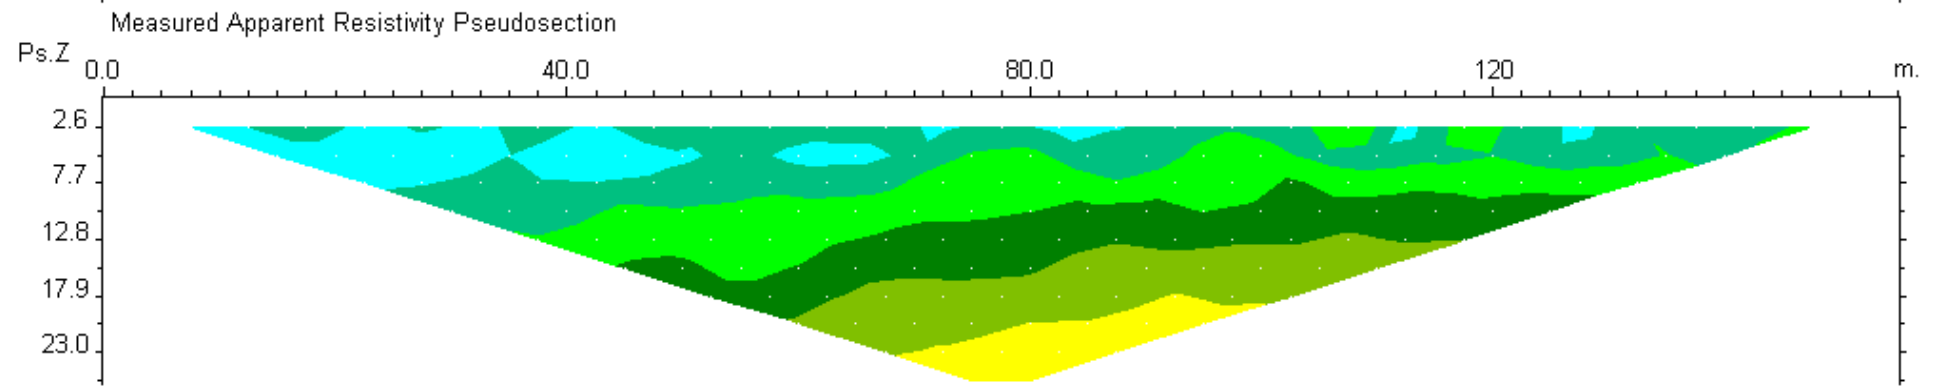
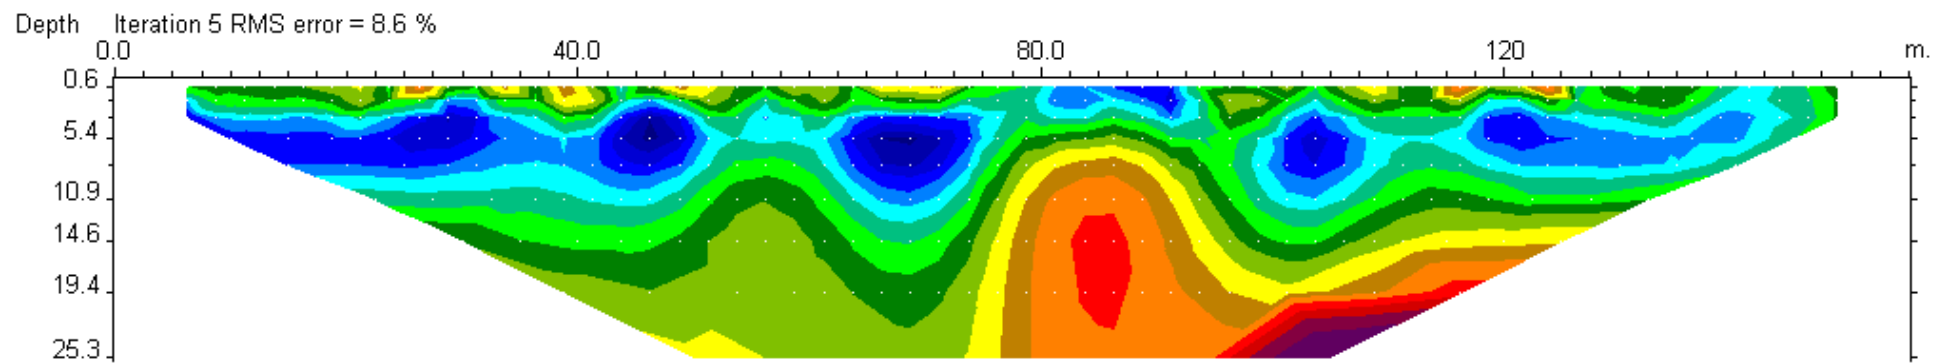
Line 2

Unit electrode spacing 2.5 m.
