## Hydrogeological Investigation of Groundwater and Plume Dynamics at Kinsale Road Landfill and its Environs, Cork City

**Project Title:** Hydrogeological Investigation of Groundwater and Plume Dynamics at Kinsale Road Landfill and its Environs

**Status:** Final Version

**Client:** Cork City Council

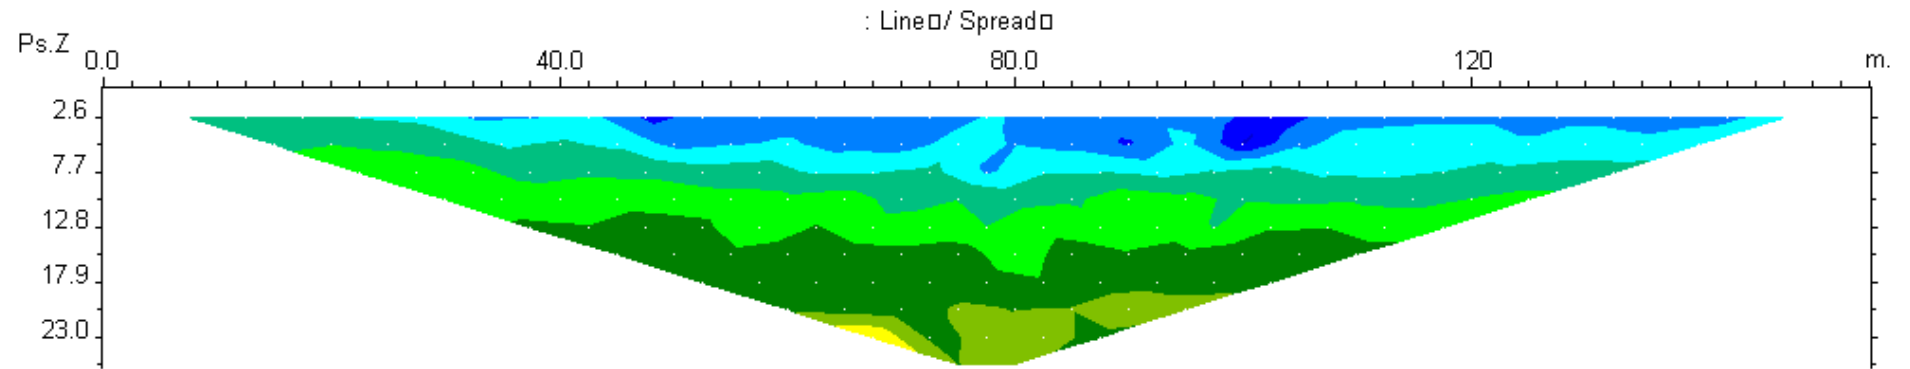
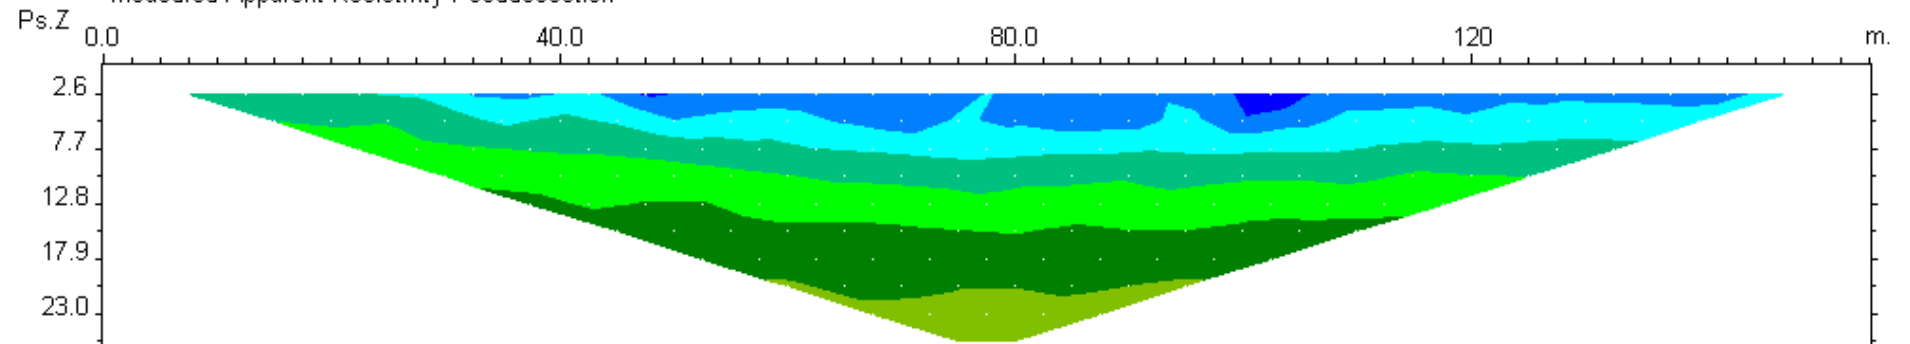
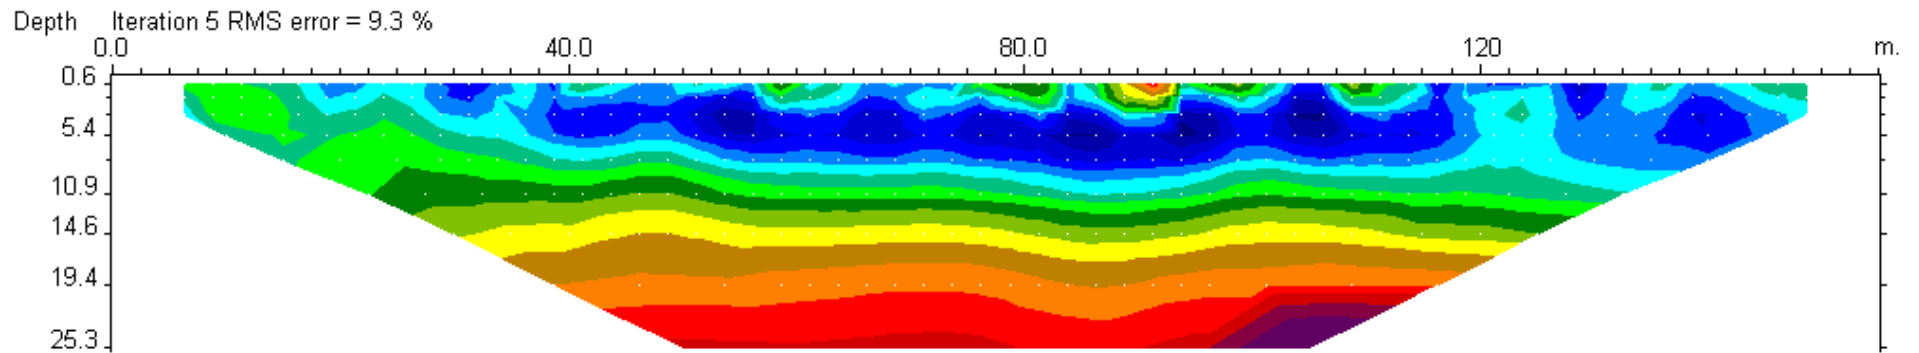
Line 3

Measured Apparent Resistivity Pseudosection

Calculated Apparent Resistivity Pseudosection

Inverse Model Resistivity Section

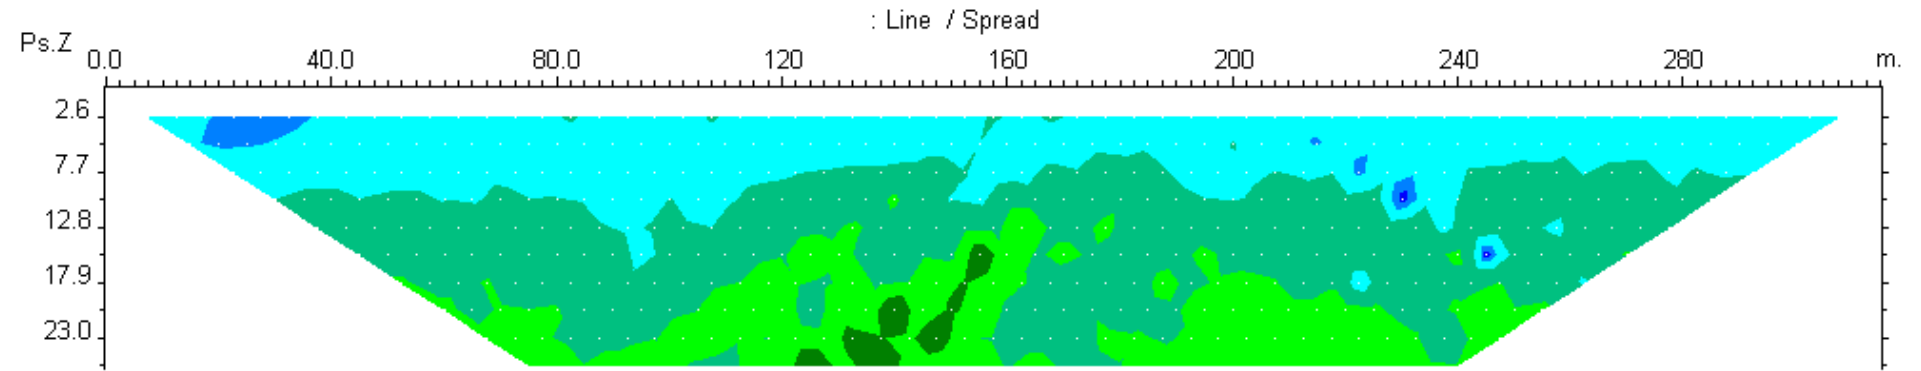
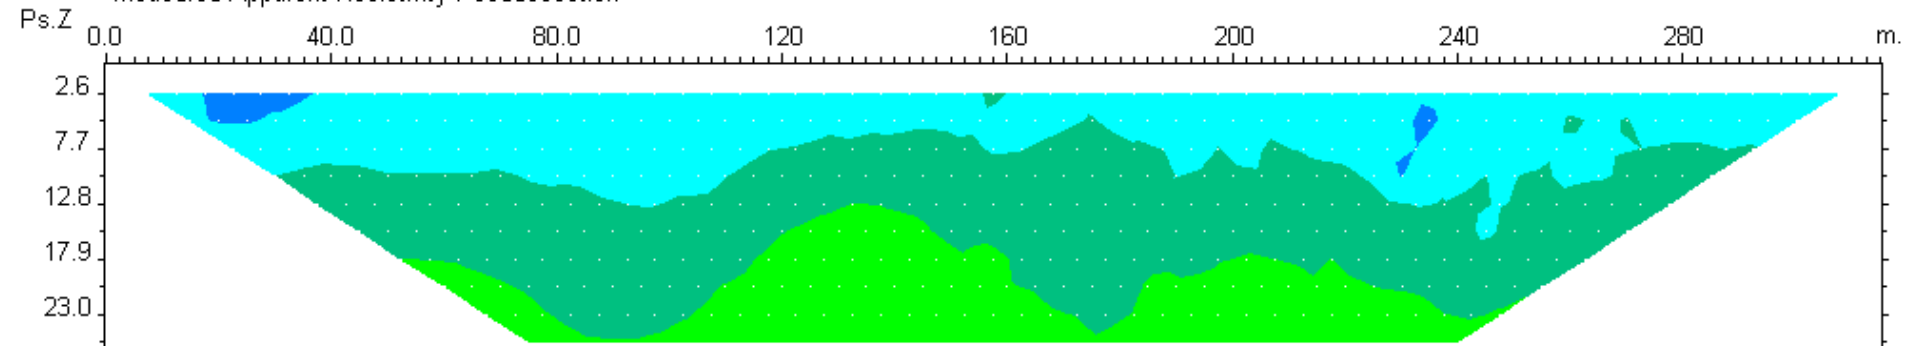
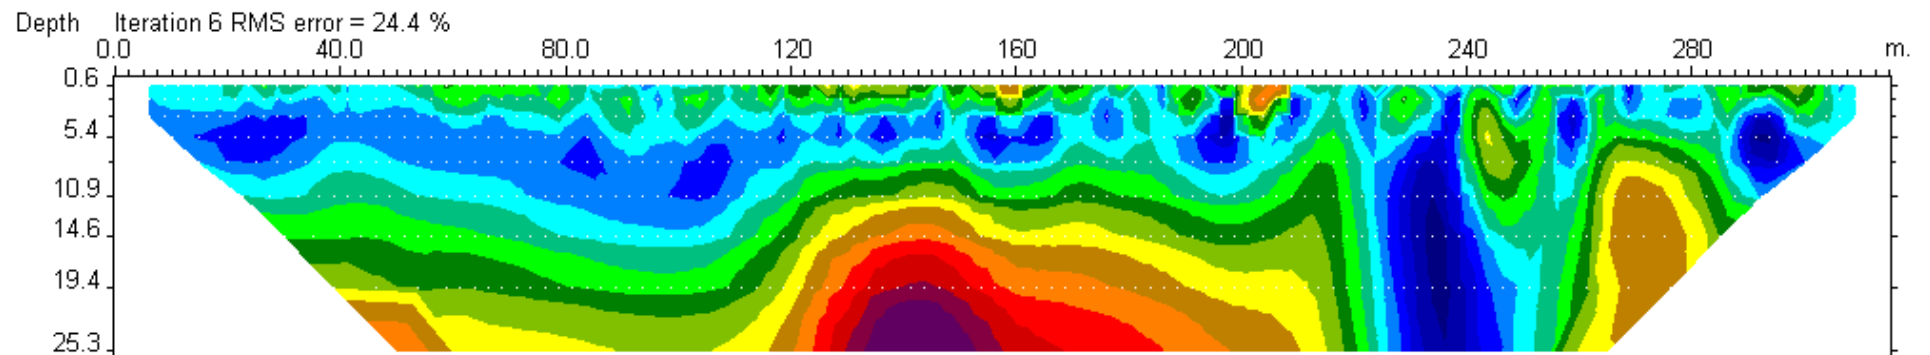
Line 4

Measured Apparent Resistivity Pseudosection

Calculated Apparent Resistivity Pseudosection

Inverse Model Resistivity Section

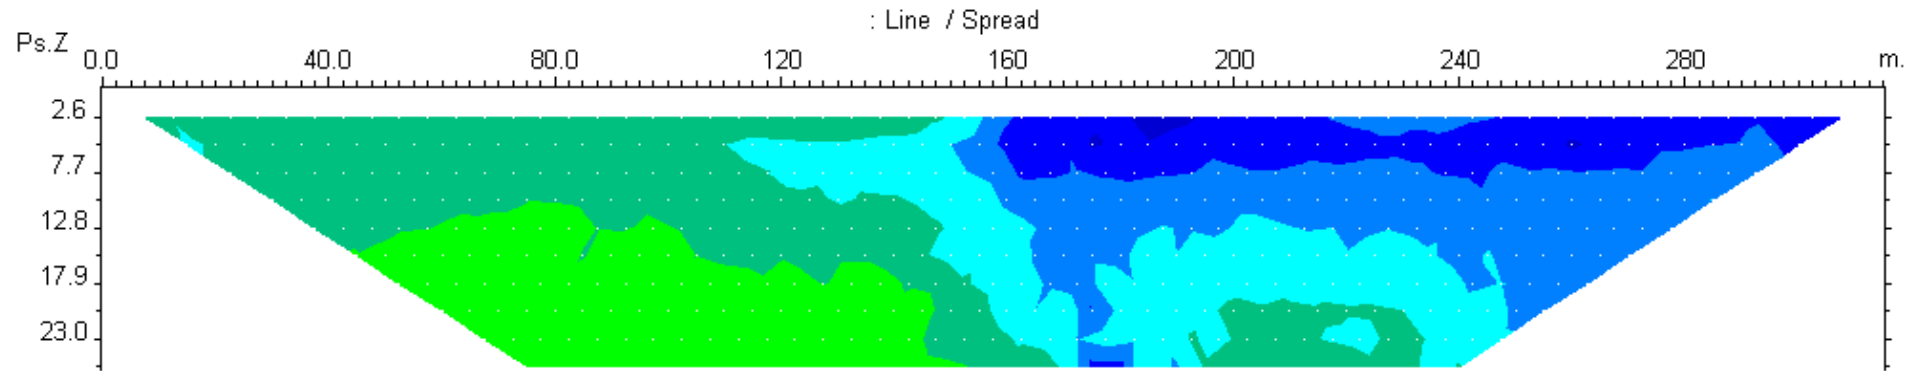
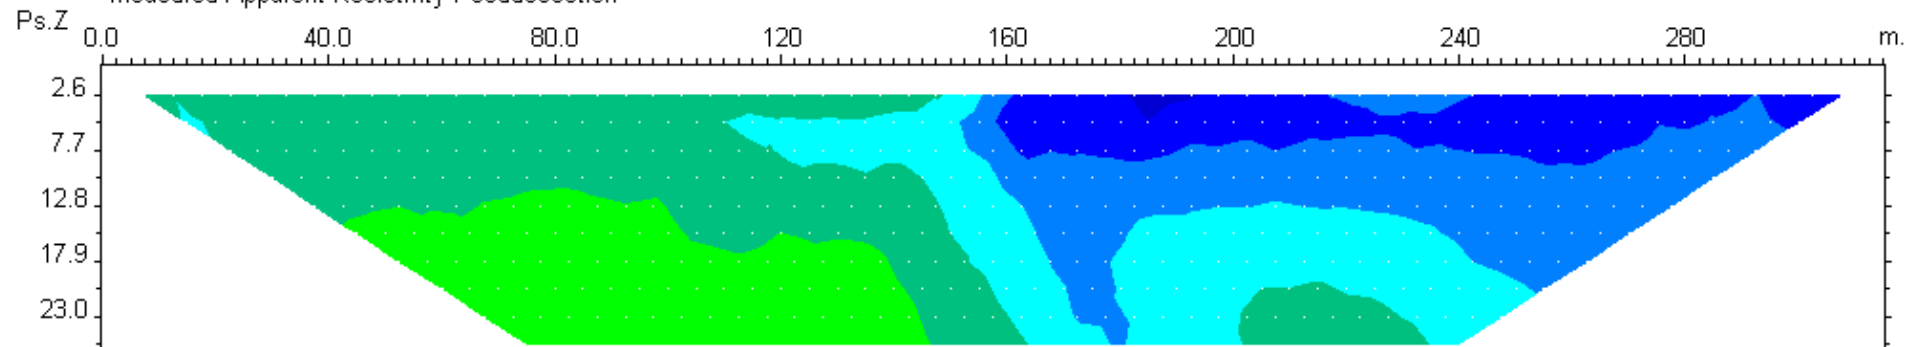
Line 5

Measured Apparent Resistivity Pseudosection

Calculated Apparent Resistivity Pseudosection

Inverse Model Resistivity Section

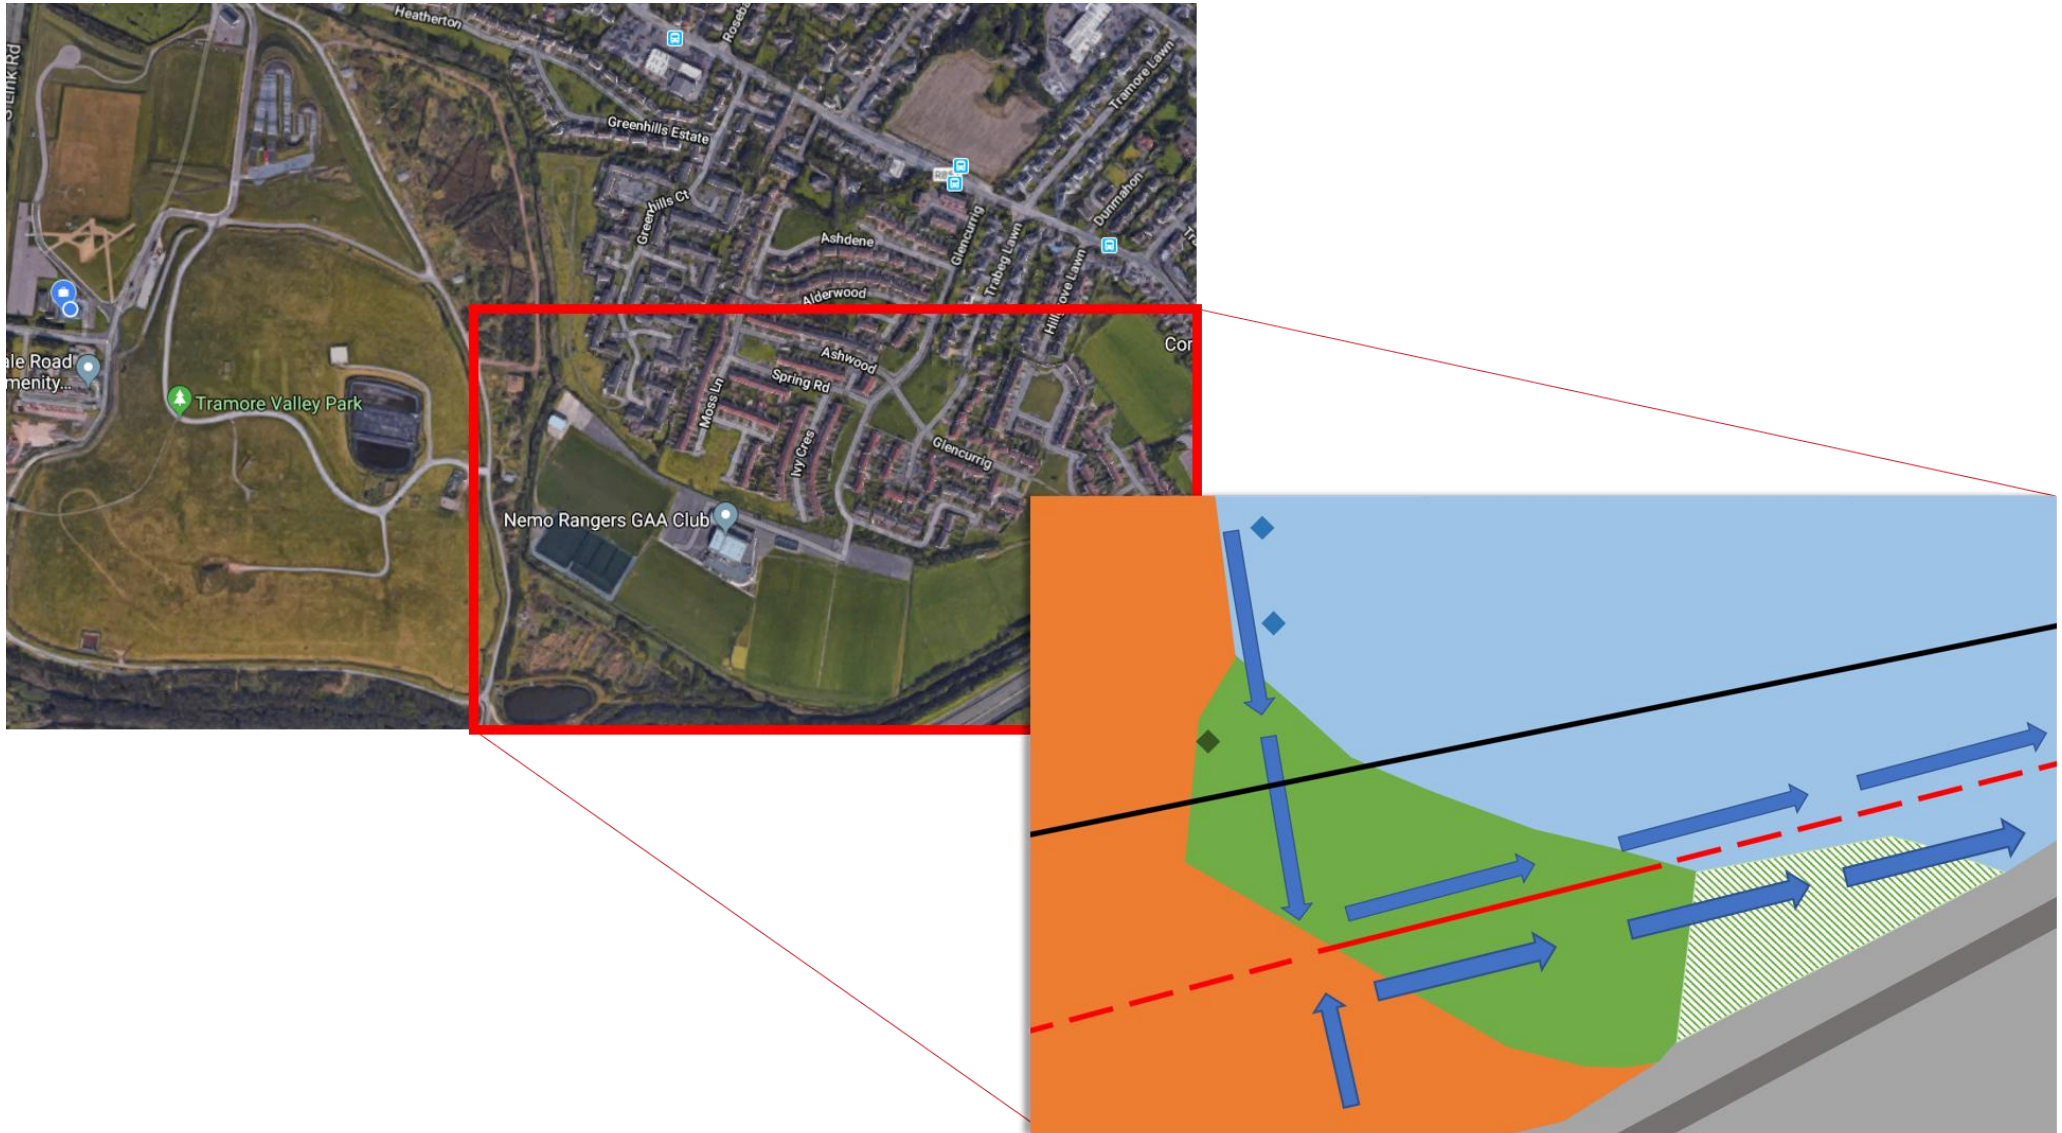
*Figure: Position of the Conceptual Block Model to the east of Kinsale Road Landfill Site/Tramore Valley Park*
