RIVER ECOLOGY ASSESSMENT REPORT

**GROVE TURKEYS LTD
SMITHBOROUGH
CO. MONAGHAN**

LICENCE NO. P0832-01

Date:	17 th July 2023	Prepared By:	Martin O'Looney, BSc.
Report Number:	SSRS_21930	Checked:	Mike Fraher, BSc.

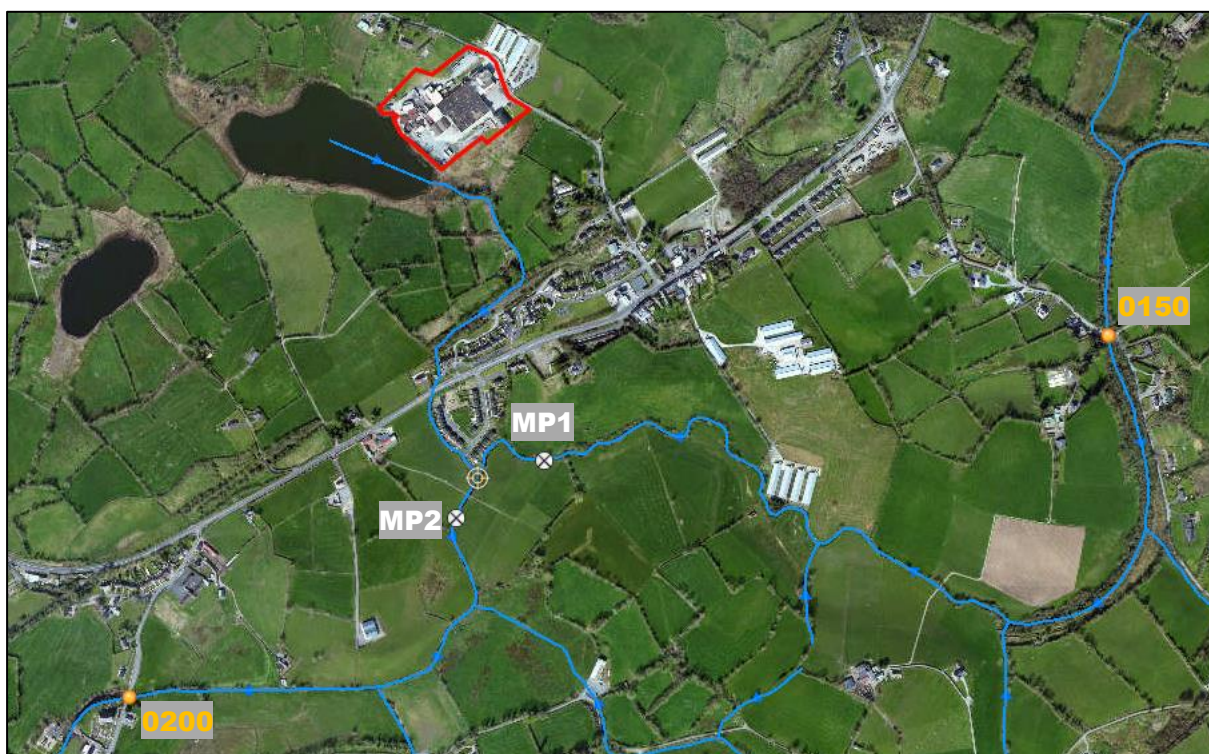
Figure 2.1: Magherney River, EPA Monitoring Stations and Survey Stations

The Magherarney River IE_NW_36_1082 (36M01) (catchment area 66.6 km²) rises at Drumloo Lough, west of Scotstown, Co Monaghan, and flows for approximately 16.2 km before meeting the River Finn at Derryleggan, Co. Monaghan.

The discharge from the Smithborough UWWTP (D0464-01) [E264465,N318871] is located approximately 1km downstream of the discharge from the Grove Turkeys facility.

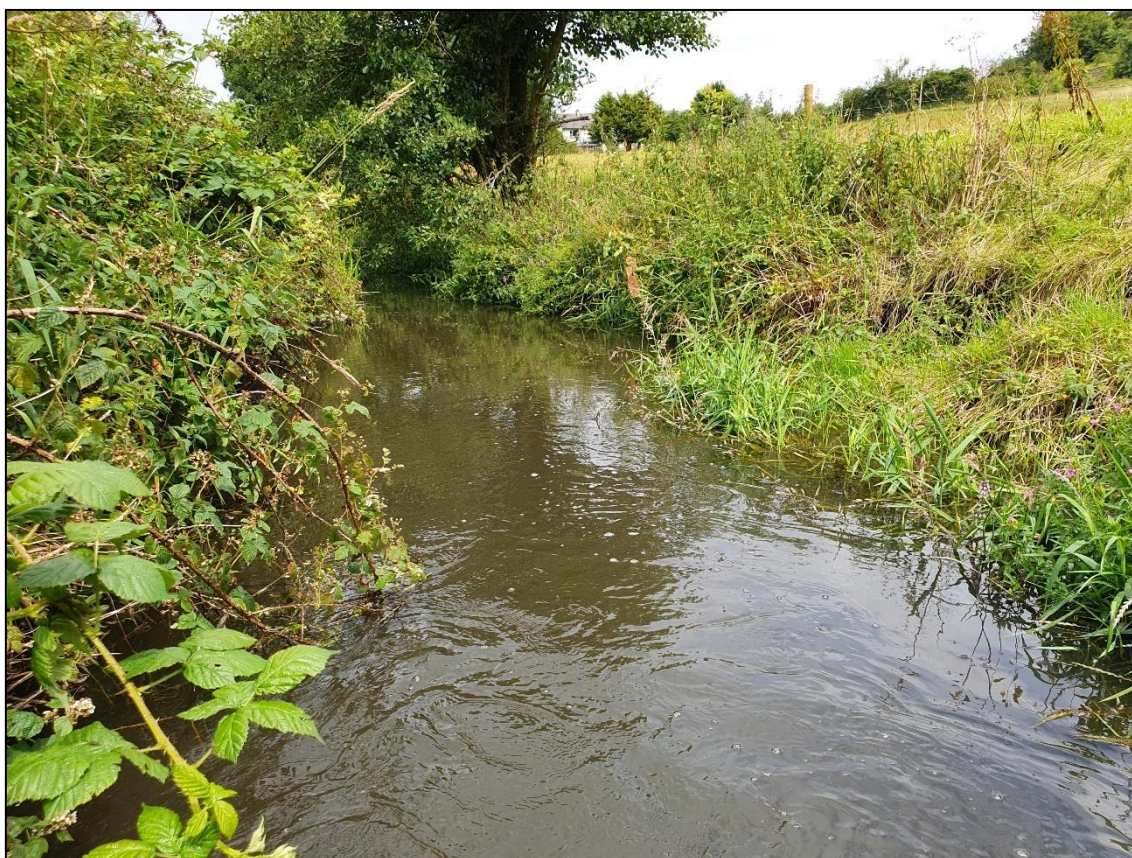
Figure 3.1: Monitoring Point 1

Monitoring Point 1 is located approximately 35m upstream of the discharge point. It is west of the Meadows Housing Estate. The EPA monitoring location “*Br E of Smithborough*” (Station code RS36M010150) is located approximately 2.2 km upstream of this monitoring point. In 2020, this monitoring position has been moved closer to the discharge point.

Low DO levels are primarily due to the monitoring areas. The monitoring locations are within or closely downstream of pool type areas, with no significant riffle area in close proximity upstream. Therefore, the DO within the river at these locations are not being readily replenished.

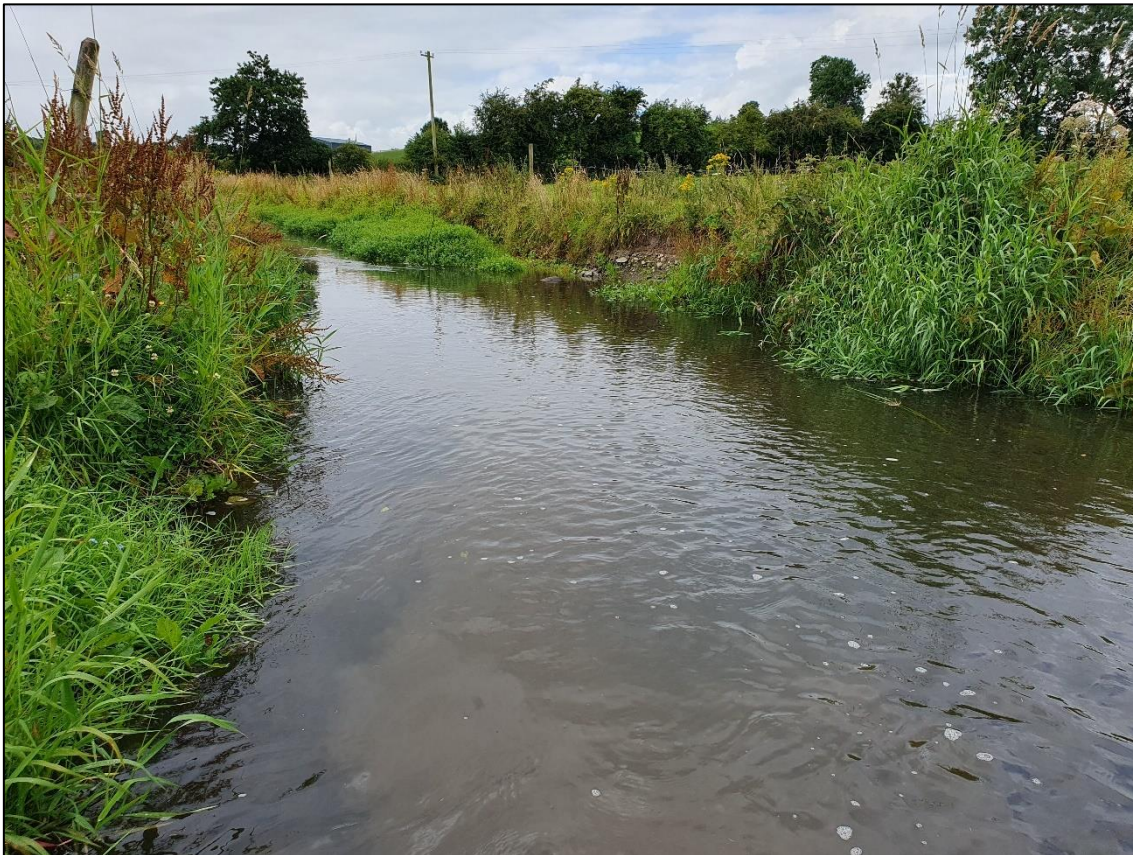
Figure 3.2: Monitoring Point 2

Monitoring Point 2 is located 100m downstream of the discharge point. It is East of the Meadows Housing Estate. The EPA monitoring location “*Magherarney Br*” (Station code RS36M010200) is located approximately 950m downstream of this monitoring point.

Following the dredging of this section of river several years ago, the substrate of the river continues to change significantly, year on year. Since 2019, a large earth island in the centre of the channel has decomposed and earth deposits are now present on the edges of the channel. In 2023, sections of muddier substrate had a fair cover of sand and fine gravels.

While MP1 and MP2 are similar. It is noted that there are slight differences which may influence the populations at each site. The stream width is wider at MP2, with slightly slower flow and a higher degree of siltation. It is also noted that MP2 was previously subject to widening and there is more pronounced bank erosion and areas of muddy substrates which would provide habitat for pollution tolerant species.
