# Biological Survey for the Ballineen Stretch of the River Bandon

Acorn water Ltd.  
Glasslyn Rd.,  
Bandon,  
Co. Cork

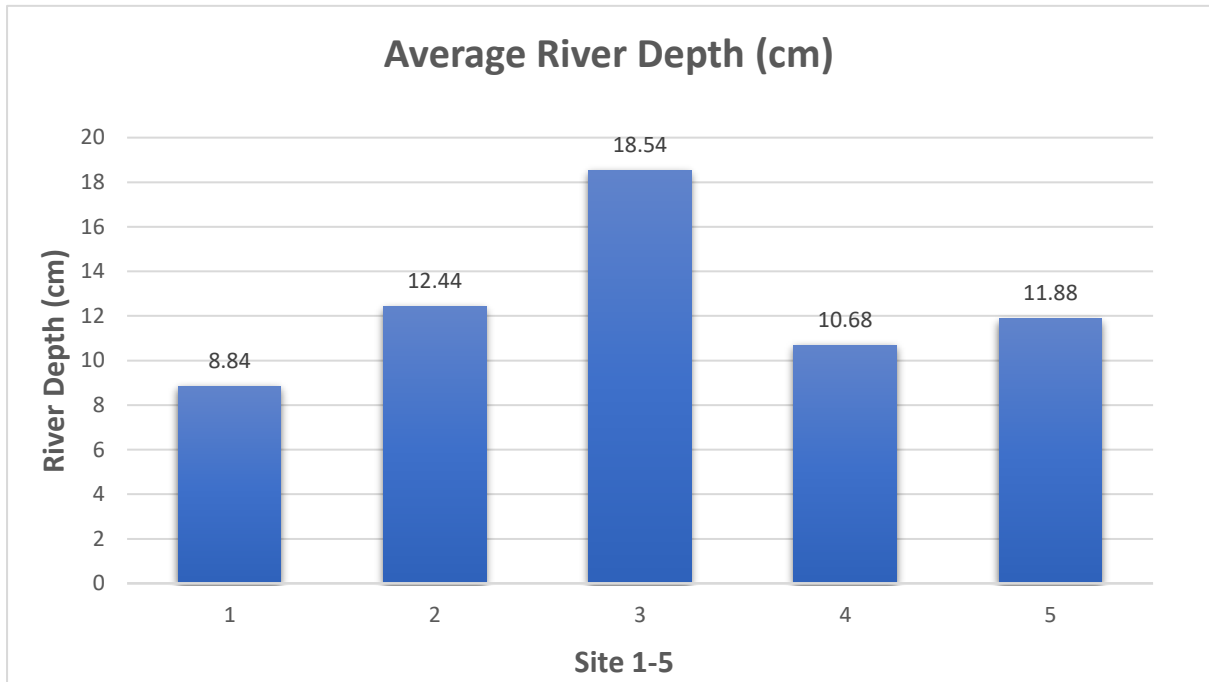
Figure 4. A bar chart of the average depth of the river for the five sampling sites.

The decrease in water quality is therefore likely traced back to intensified agriculture thus increasing the likeliness of eutrophication along with the notable shallow depth of this stretch of river. This observation makes this section of the river more susceptible to nutrient pollution with a lower volume of water allowing an increase of light penetration for photosynthesis. This increase of light penetration and the low average depth of the river allows algal and macrophyte growth to flourish.

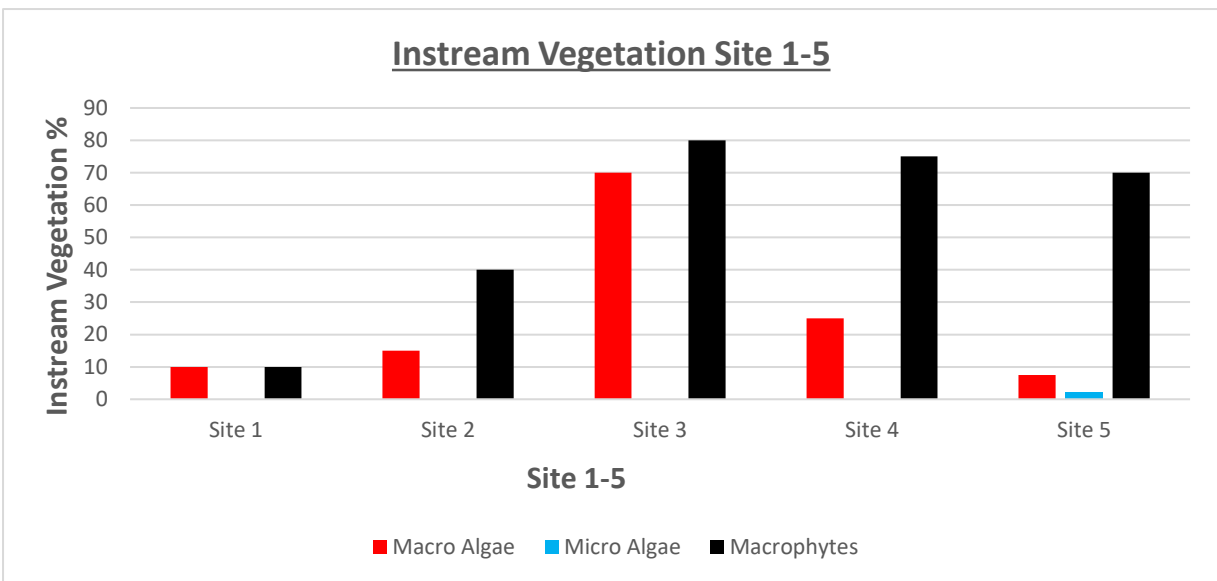
Figure 7. A bar chart of the in-stream vegetation percentage for the five sites

(Conroy *et al.* 2016). Nutrient pollution was evident at all sites with higher orthophosphate levels and an increase in macrophyte growth. Macrophyte species such as *Ranunculus aquatilis* known as white water-crow foot was present in all sites and excessive in sites 3, site 4 and site 5.

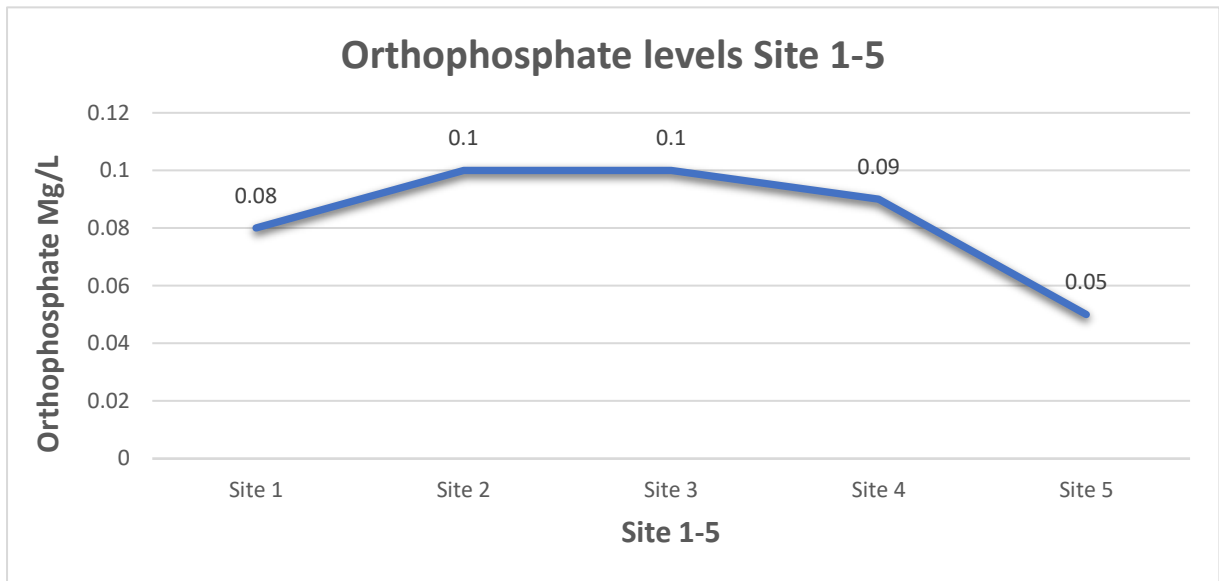
Figure 10. A line graph of the orthophosphate levels for the five sites

The scoring systems for BMWP and ASPT were updated and continue to fall into the excellent Quality categories at all sites. Orthophosphate levels measured at all sites were above the 0.035 Mg/L limit as referred to by the EPA. This is likely to have a significant impact on the river conditions and evidence of nutrient pollution can be seen from the instream vegetation habitat assessment results. All sites both upstream and downstream are substantially greater than the EPA recommendations for orthophosphate levels. Concentrations of phosphate consistently greater than 0.035 mg/L are likely to lead to nutrient pollution. Orthophosphate (OP) or 'soluble reactive phosphorus' is bioavailable to freshwater organisms and the exceedance of the OP standard has been identified as the single largest cause of water bodies not achieving 'good ecological status' in the UK and Ireland, under the European Union Water Framework Directive. High OP concentrations lead to reduced sensitive invertebrate populations in freshwater river catchments (Everall *et al*, 2018).

It would be recommended to liaise with farmers with land adjacent to the river and to advise them to observe buffer strips and to not let their cattle access the river. Further monitoring of orthophosphate levels is recommended along this section of the river and at the discharge point of Carbery Waste Water Treatment Plant to ensure stable conditions in respect to the EPA guidelines. These range of factors on the river Bandon influence its moderate and unsatisfactory status as described by the WFD, until these pressures are identified and eliminated it is unlikely that the status of the river Bandon will improve.
