Killurin Landfill

2019 Updated Hydrogeological Risk Assessment

Report for:
Wexford County Council

Report No.:
BRE14016Rp03A01

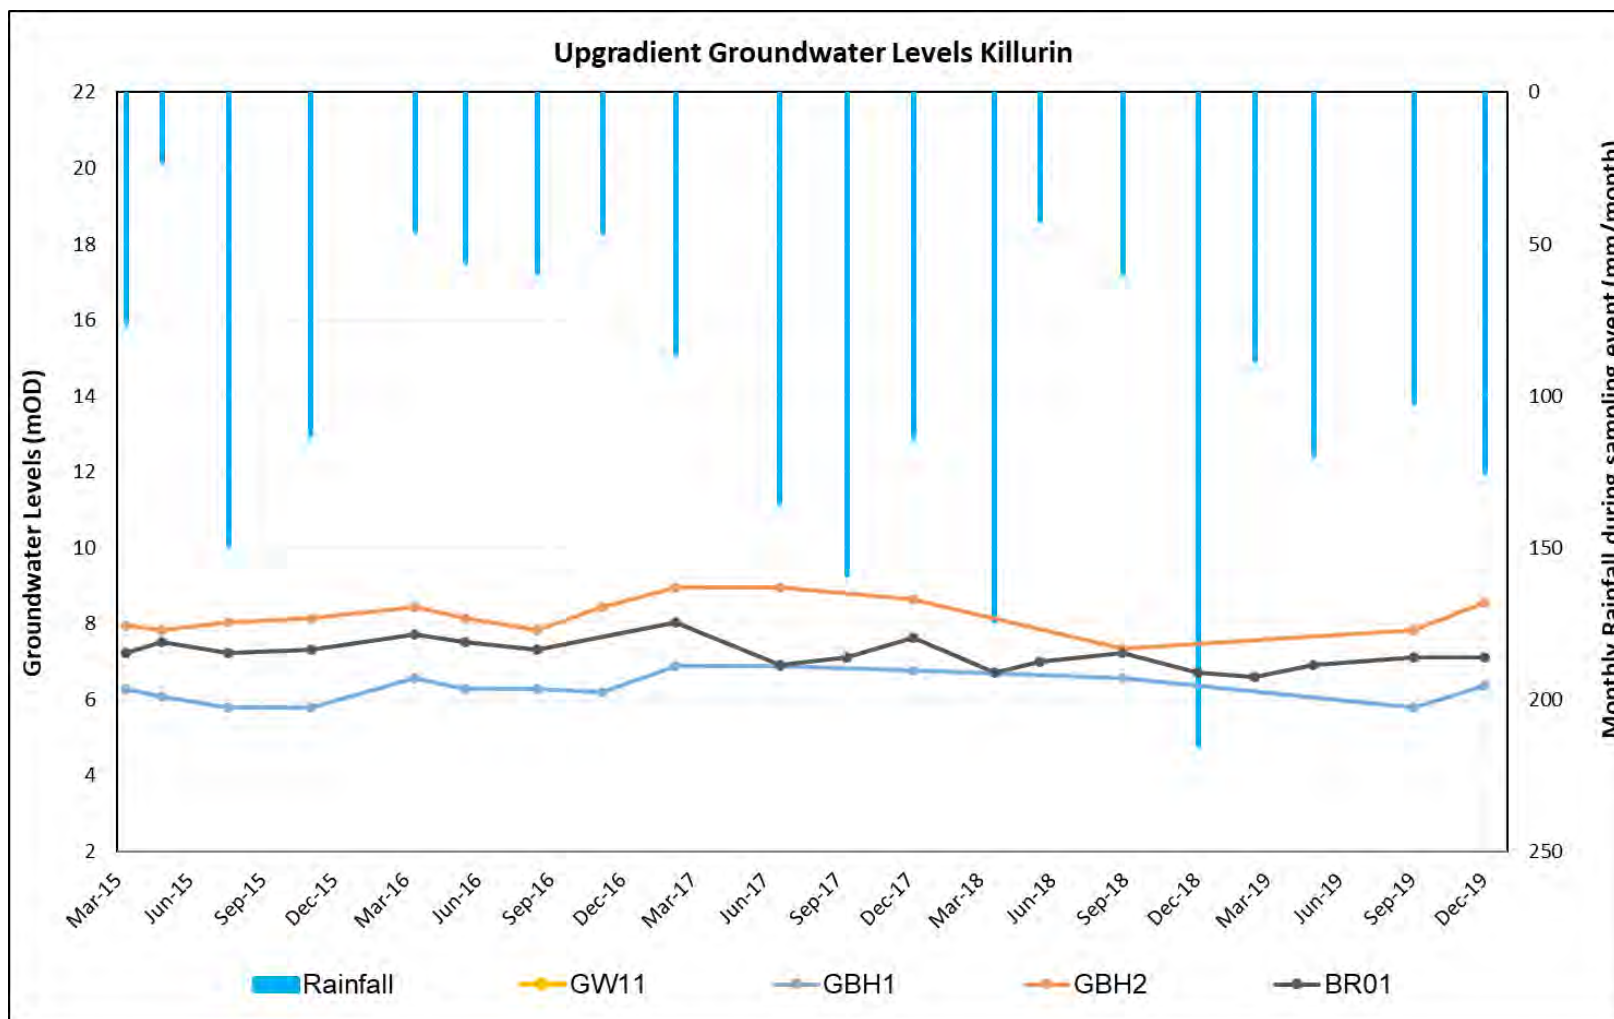
Figure 6.1 Upgradient Groundwater Levels

- Groundwater levels remain broadly consistent over time, with only minor variations identified attributed to prevailing climatic conditions. During the drier months groundwater levels gradually decrease. During wetter periods where prolonged rain was recorded, levels of groundwater were noted to rise slightly over a number of months. It is noted that over time, groundwater levels within the downgradient wells recorded a slightly reducing trend over time i.e. within GW1, BR02, BR03, GW9, GW23 and GW24.

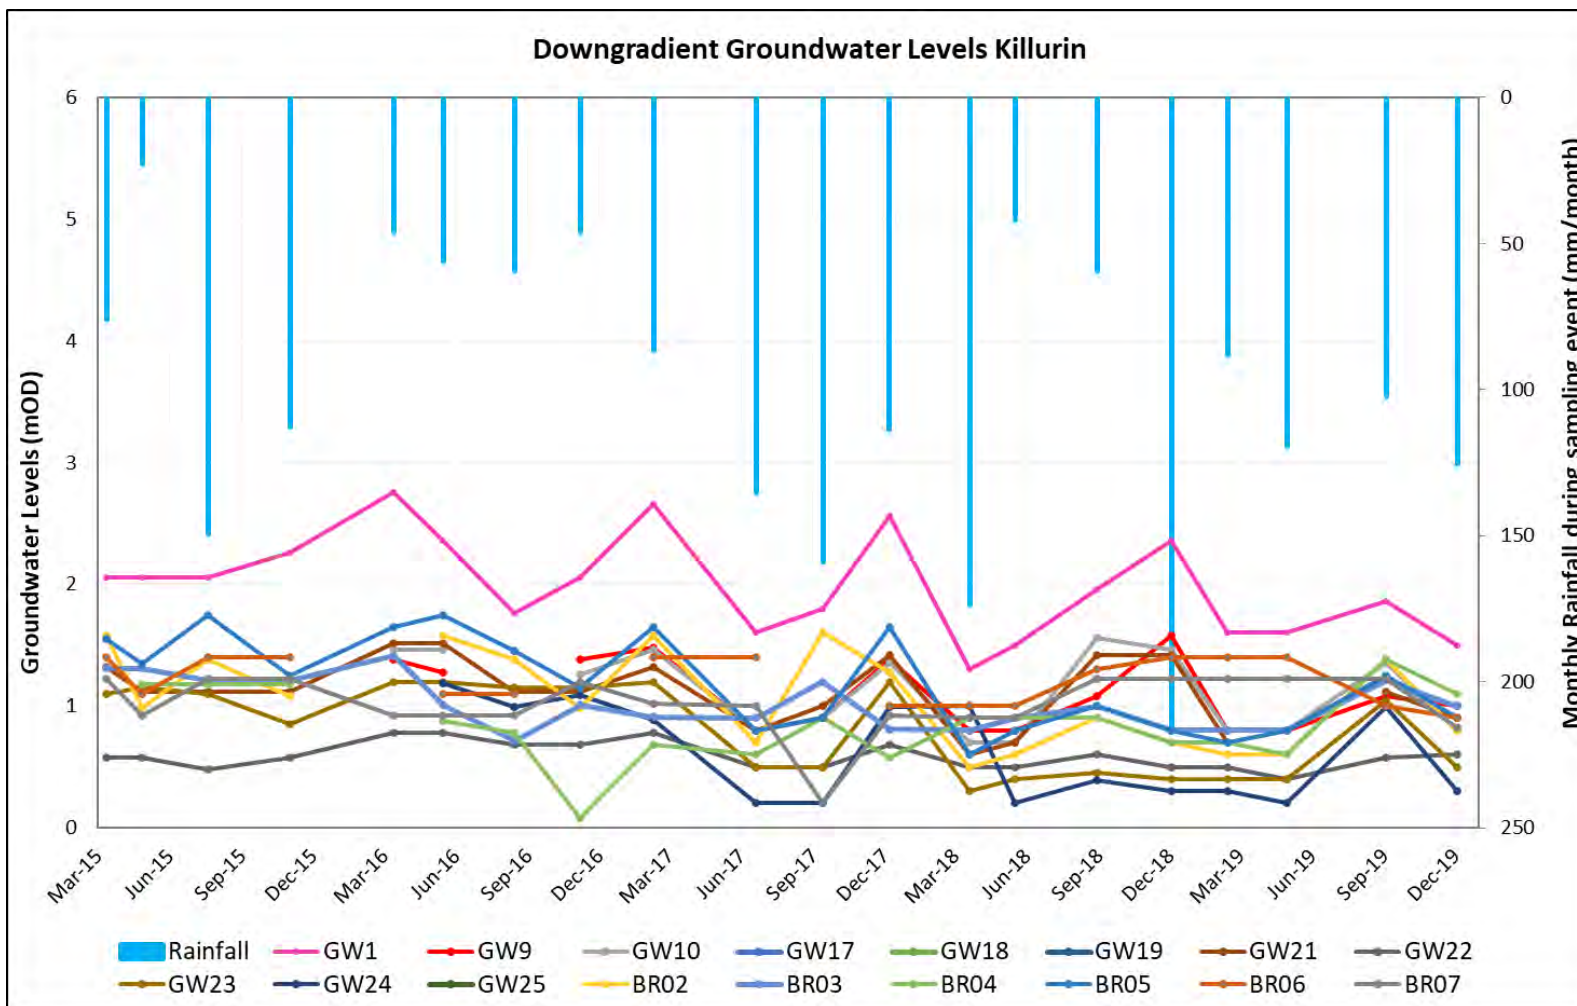
Figure 6.2 Downgradient Groundwater Levels

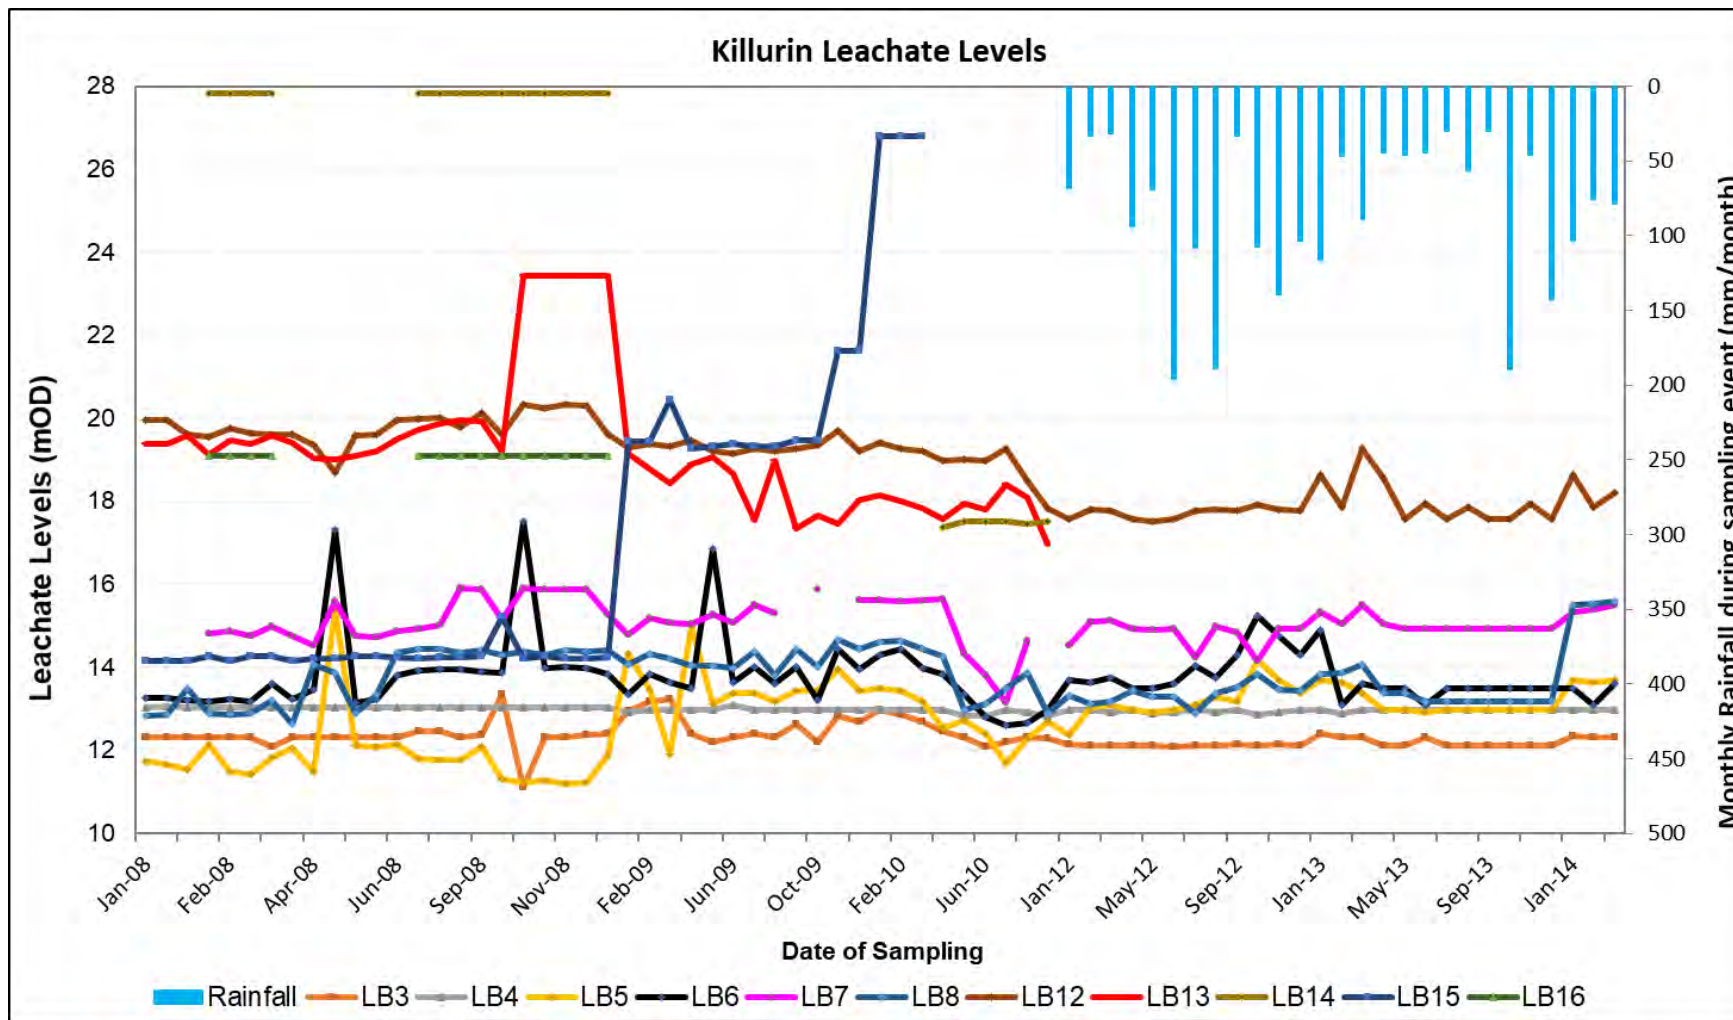
Figure 6.3 Historical Leachate Levels 2008-2014 (LB wells)

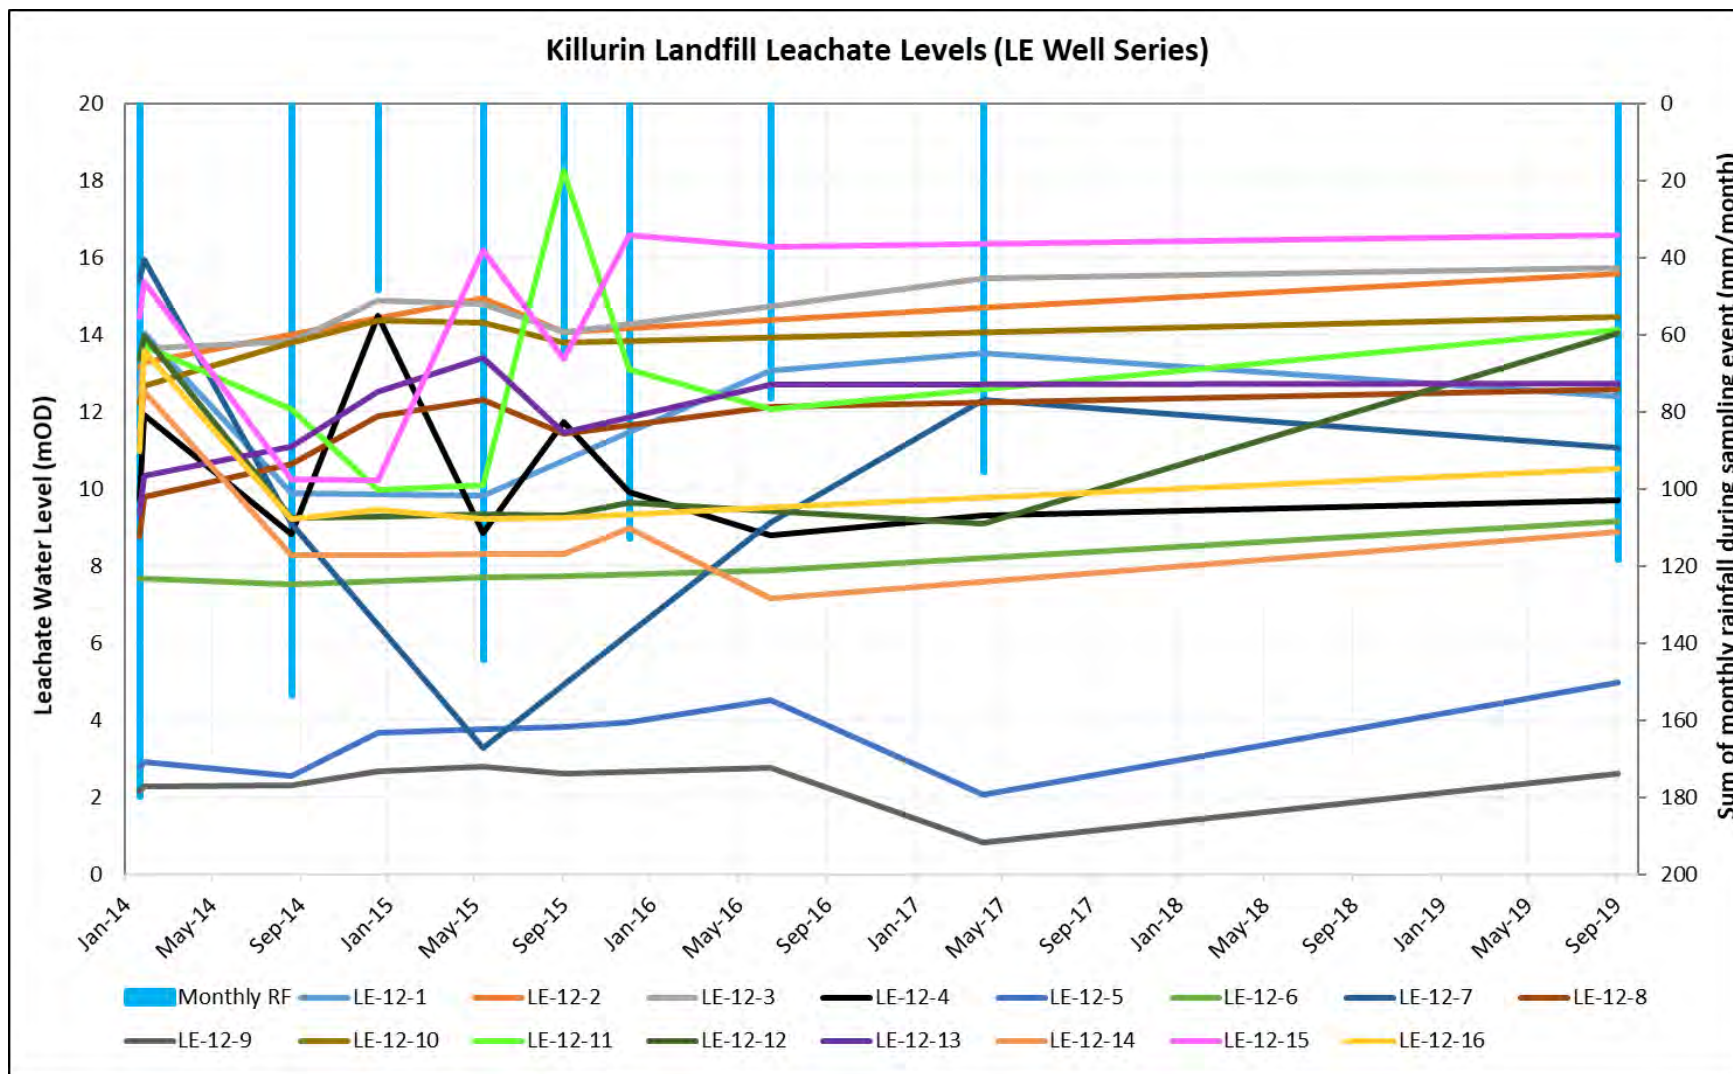
Figure 6.4 Current Leachate Levels (LE wells)

The current leachate levels between 2014 and 2019 (LE well series) are presented on Figure 6.4 below. (also see Appendix E).

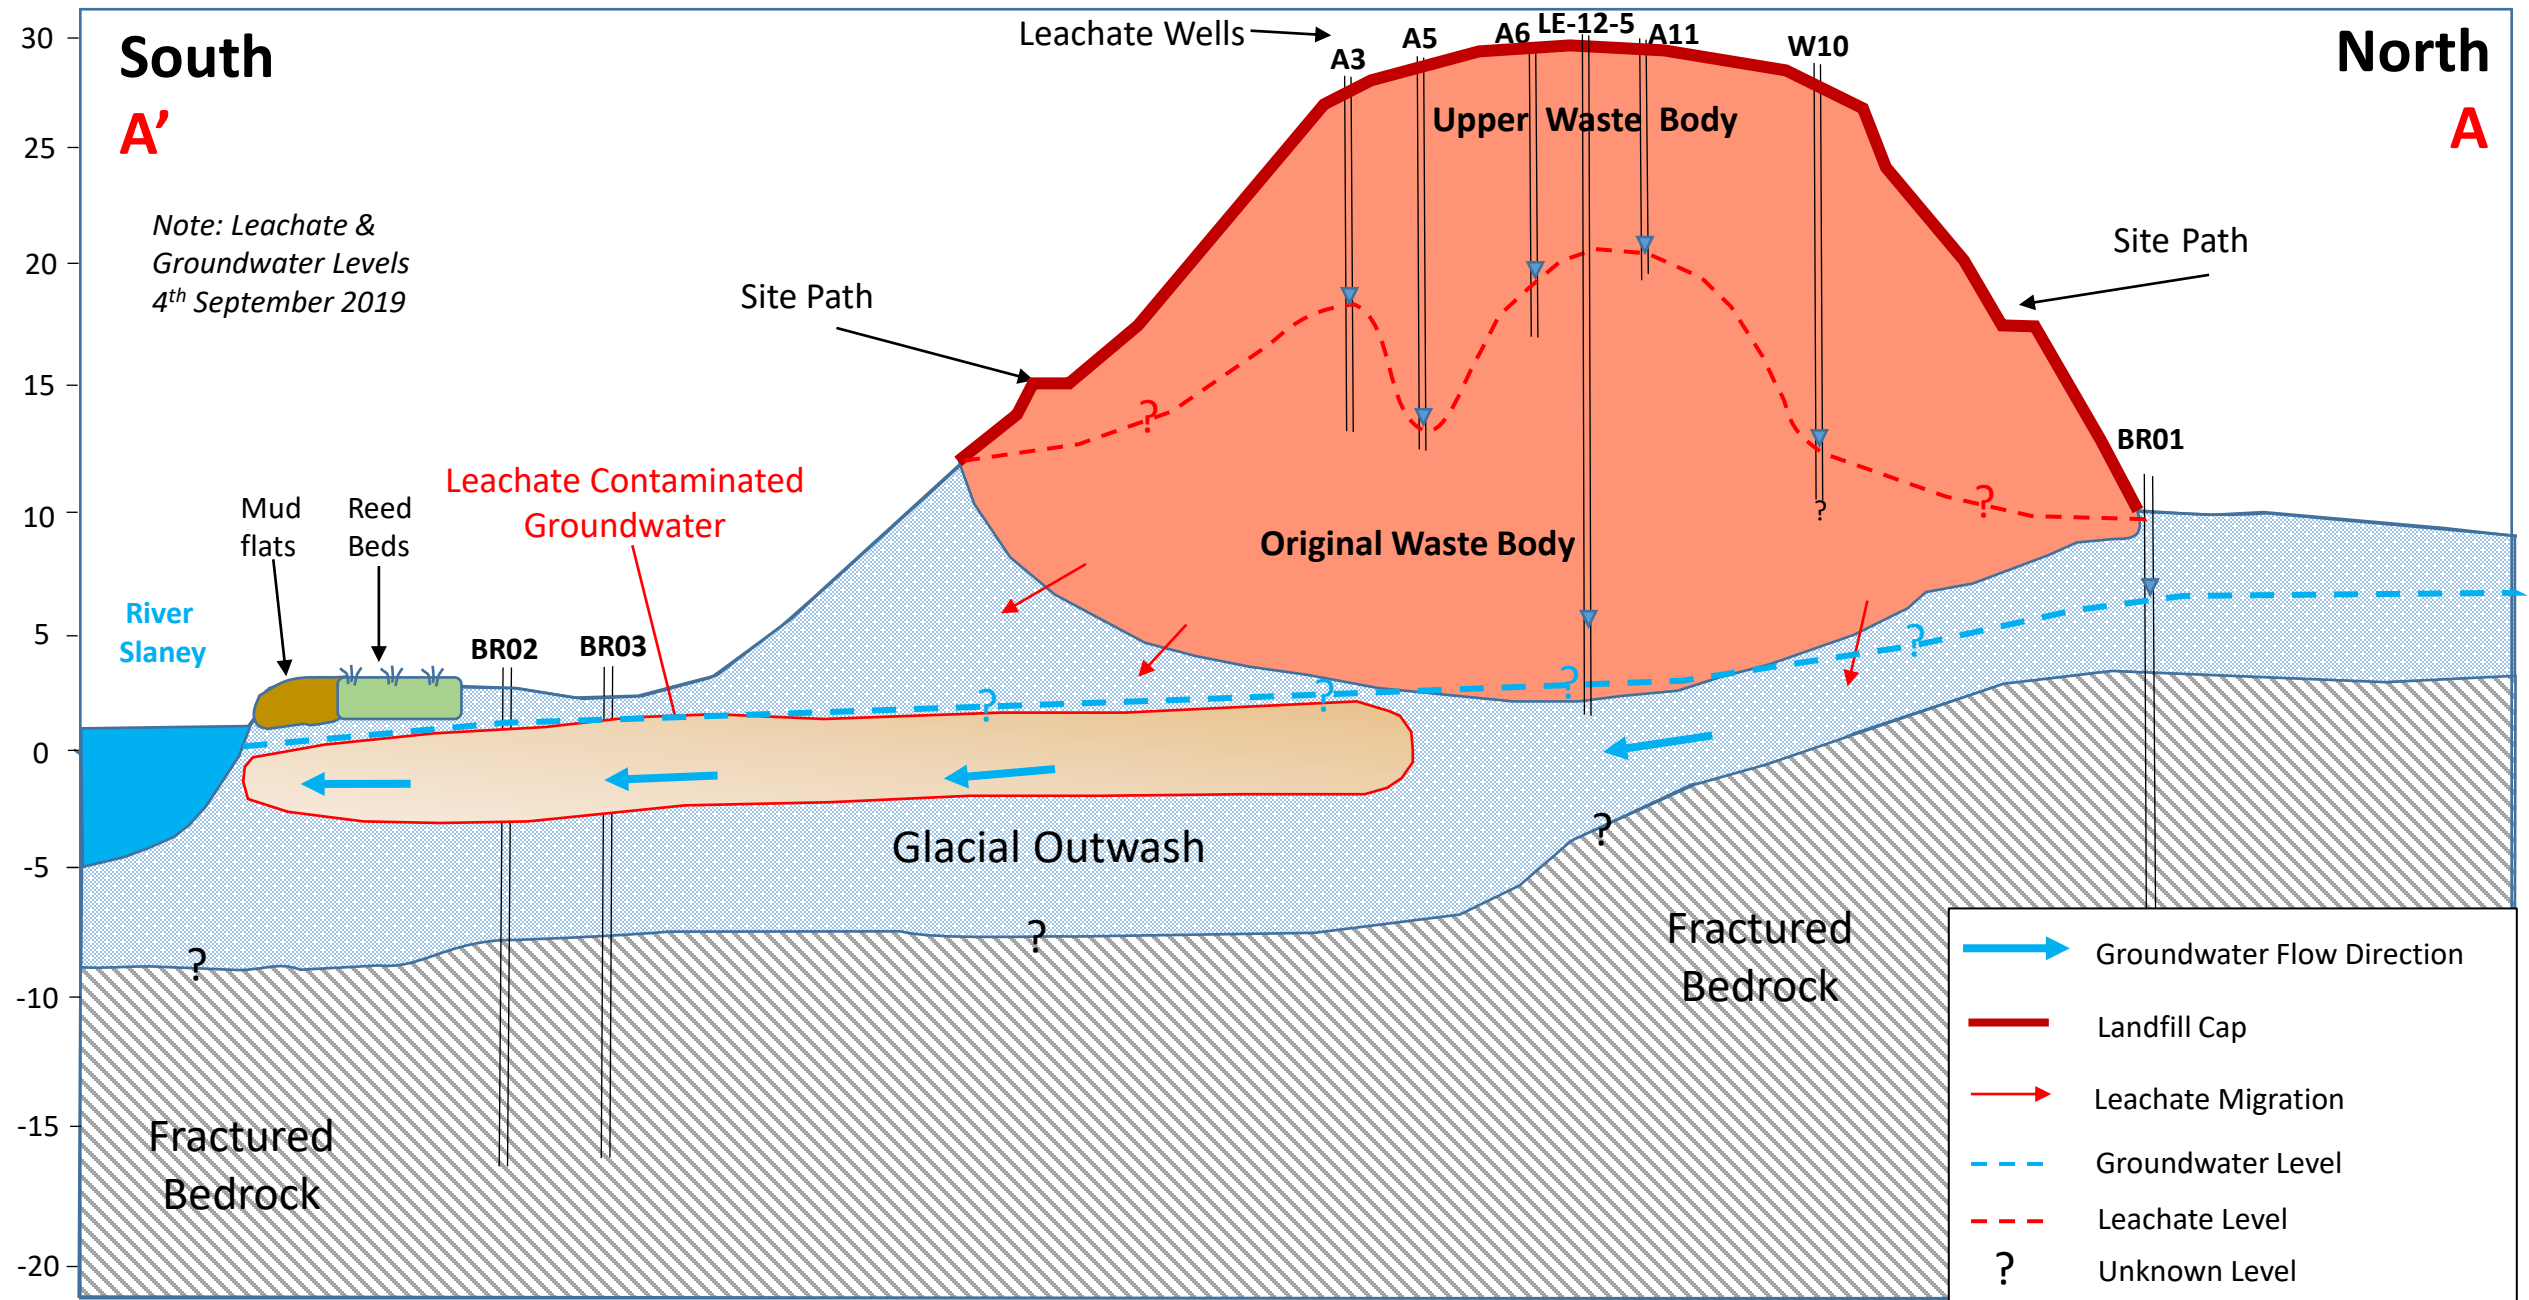
Figure 7 - Killurin Landfill Cross-Section A – A'

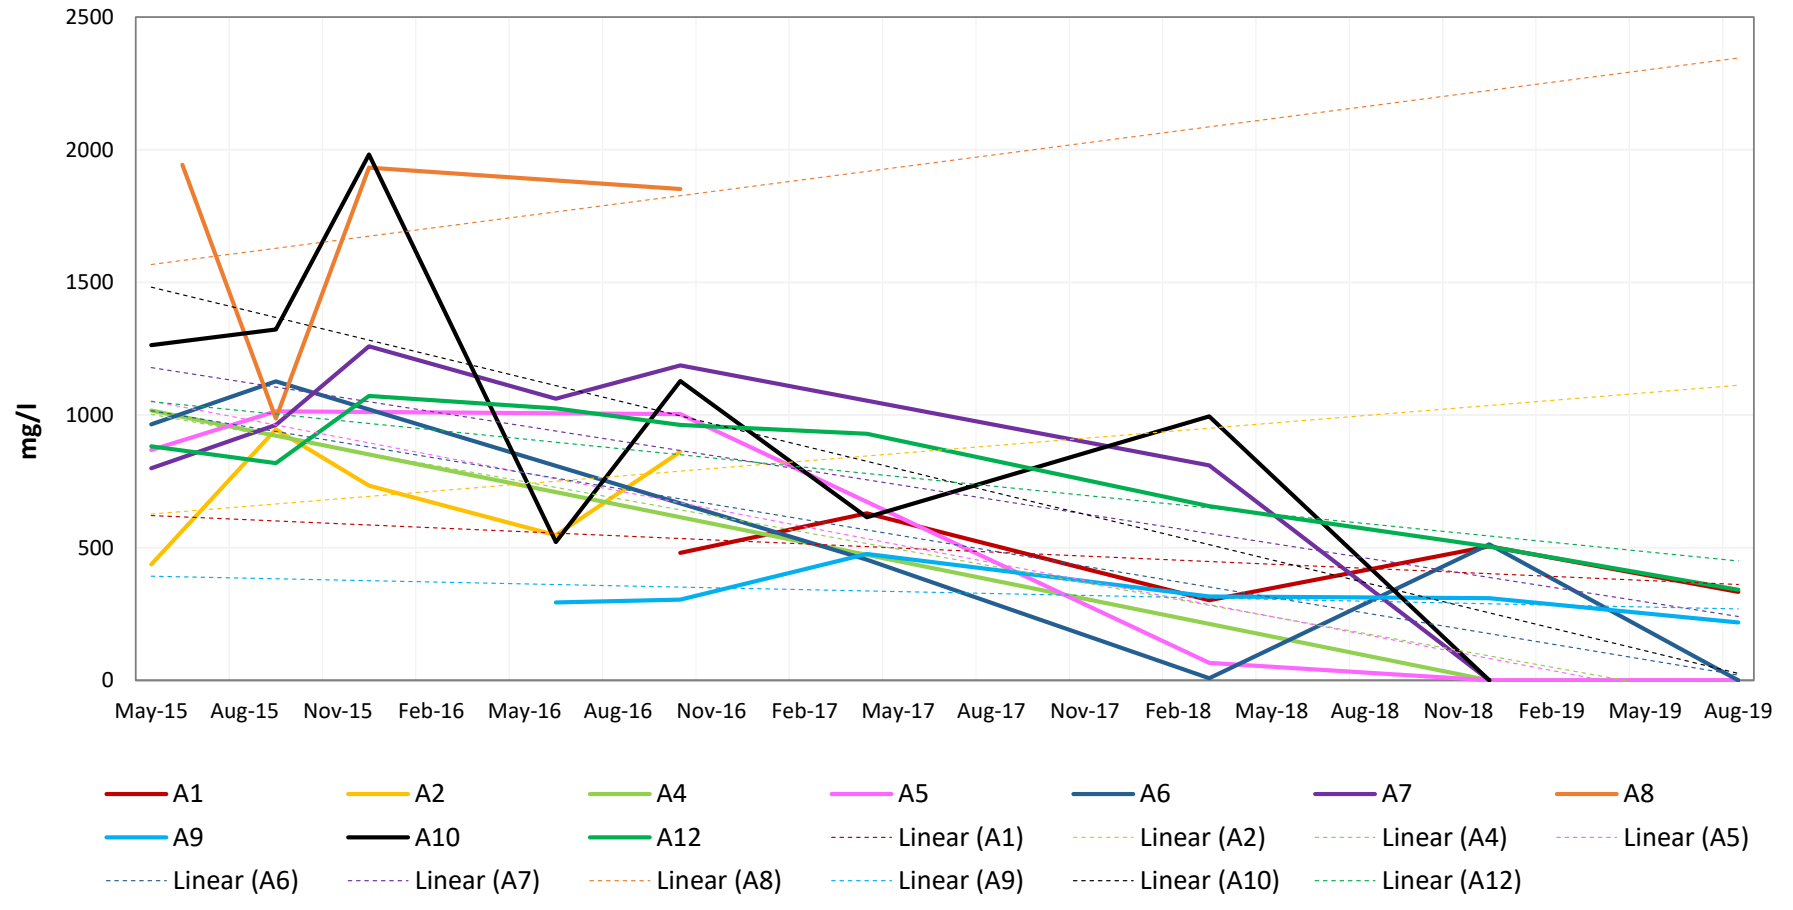
Ammoniacal Nitrogen (A-Wells)

WELL ID No.	Ammoniacal Nitrogen Trend (Increasing / Reducing / Stable)	No. of monitoring rounds (2015-2019)	Last monitoring round
A1	Reducing	5	Aug-19
A2	Stable / Increasing slightly / limited data	5	Oct-16
A4	Reducing	1	Aug-19
A5	Reducing	6	Aug-19
A6	Reducing	5	Aug-19
A7	Reducing	7	Aug-19
A8	Stable / Increasing slightly / limited data	4	Oct-16
A9	Reducing	6	Aug-19
A10	Reducing	8	Dec-18
A12	Reducing	9	Aug-19
W1	Stable	10	Aug-19
W5	Reducing	7	Aug-19
W10	Reducing	8	Aug-19
W12	Reducing	9	Aug-19
W13	Stable / Increasing slightly	8	Jun-18
W27	Increasing slightly	7	Aug-19
W31	Reducing slightly	6	Dec-18
W33	Stable	6	Aug-19
W34	Increasing	9	Aug-19
W35	Increasing	8	Aug-19
W36	Increasing	8	Aug-19
W37	Overall reducing, spike in Aug-19	6	Aug-19
W38	Stable	5	Aug-19
W39	Reducing slightly	6	Jun-18
W40	Stable	9	Aug-19
W41	Stable	8	Aug-19
W42	Reducing	7	Dec-18
W43	Reducing	8	Aug-19
W44	Reducing	5	Mar-18
W45	Reducing	9	Aug-19
LE12-1	Reducing	8	Aug-19

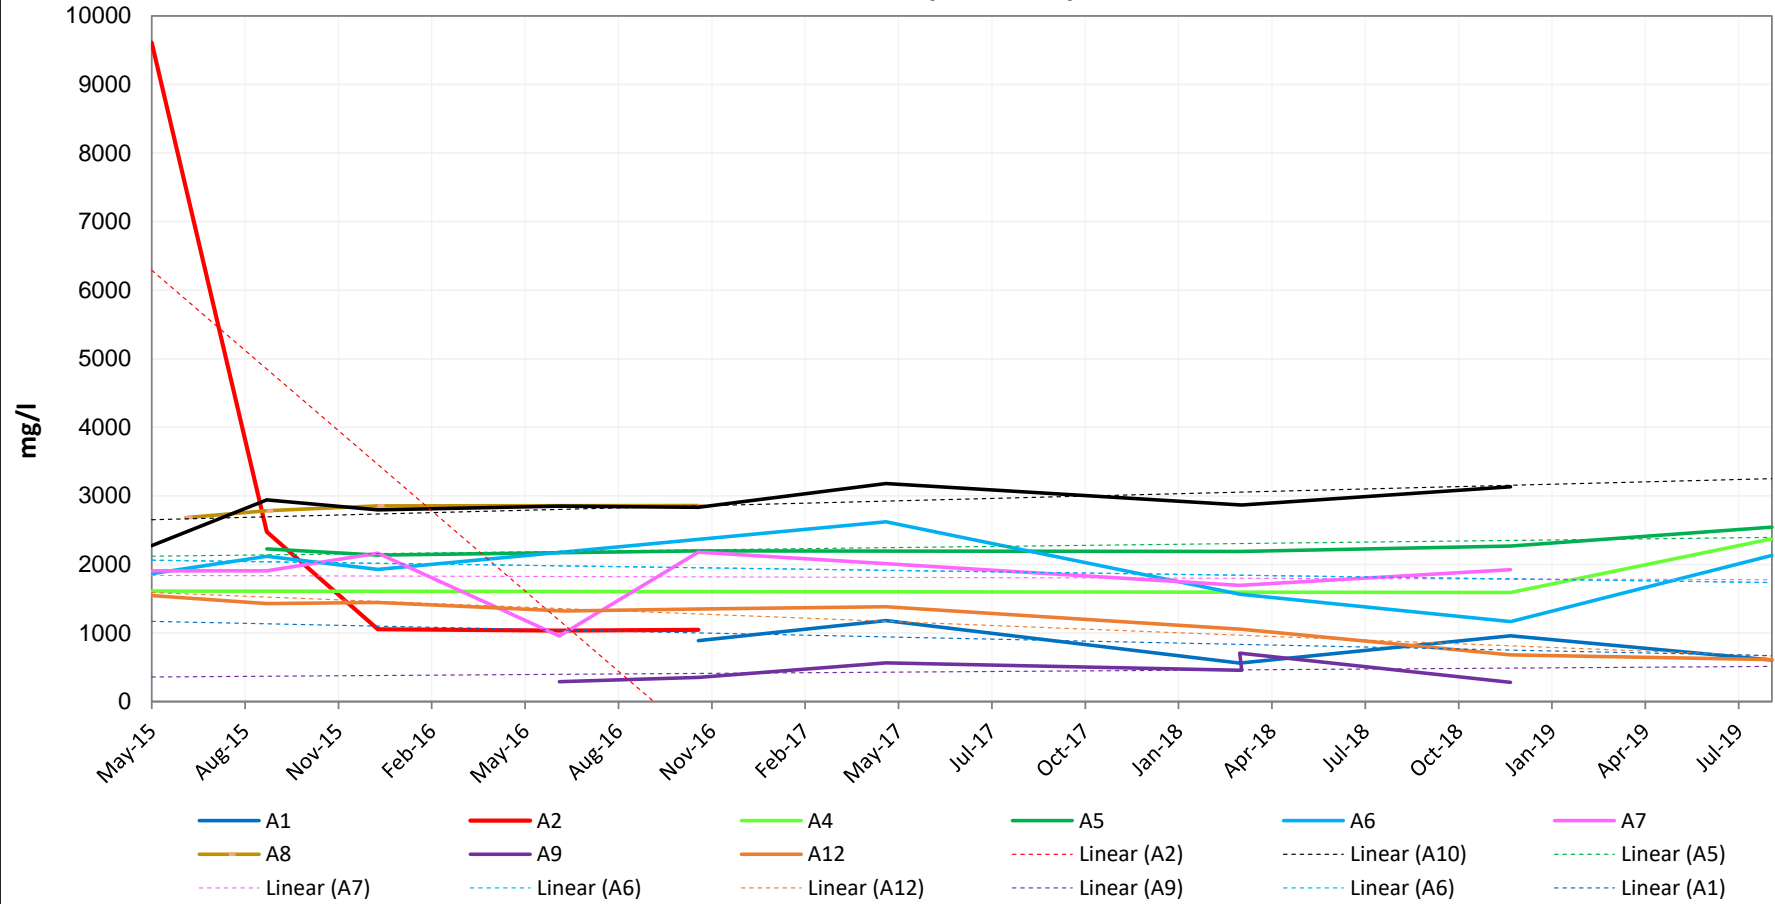
Chloride Trends (A- Wells)

WELL ID No.	Chloride Trend (Increasing / Reducing / Stable)	No. of monitoring rounds (2015-2019)	Last monitoring round
A1	Reducing slightly	5	Aug-19
A2	Reducing	5	Oct-16
A4	Stable/increasing slightly	3	Aug-19
A5	Stable	6	Aug-19
A6	Reducing	7	Aug-19
A7	Stable	7	Dec-18
A8	Stable / increasing slightly	4	Oct-16
A9	Stable / increasing slightly	6	Dec-18
A10	Increasing slightly	8	Dec-18
A12	Reducing	9	Aug-19
W1	Stable/one-off spike Dec-18	10	Aug-19
W5	Stable / Increasing due to one-off spike Aug-19	8	Aug-19
W10	Reducing	8	Aug-19
W12	Reducing	10	Aug-19
W13	Stable	8	Jun-18
W27	Stable	8	Jun-18
W31	Stable	6	Dec-18
W33	Stable/Reducing	6	Aug-19
W34	Increasing+	9	Aug-19
W35	Increasing+	8	Aug-19
W36	Increasing	8	Aug-19
W37	Overall reducing, spike in Aug-19	6	Aug-19
W38	Stable	5	Aug-19
W39	Reducing	6	Jun-18
W40	Stable	9	Aug-19
W41	Stable	8	Aug-19
W42	Stable/Reducing	7	Dec-18
W43	Stable	8	Aug-19
W44	Reducing (spike Apr-17)	5	Mar-18
W45	Reducing	9	Aug-19
