FORMER GASWORKS, DOCK ROAD, LIMERICK

Groundwater Monitoring Visit No. 41 - September 2021

PROJECT NO. 70049885

OUR REF. NO. 70049885 / 11877

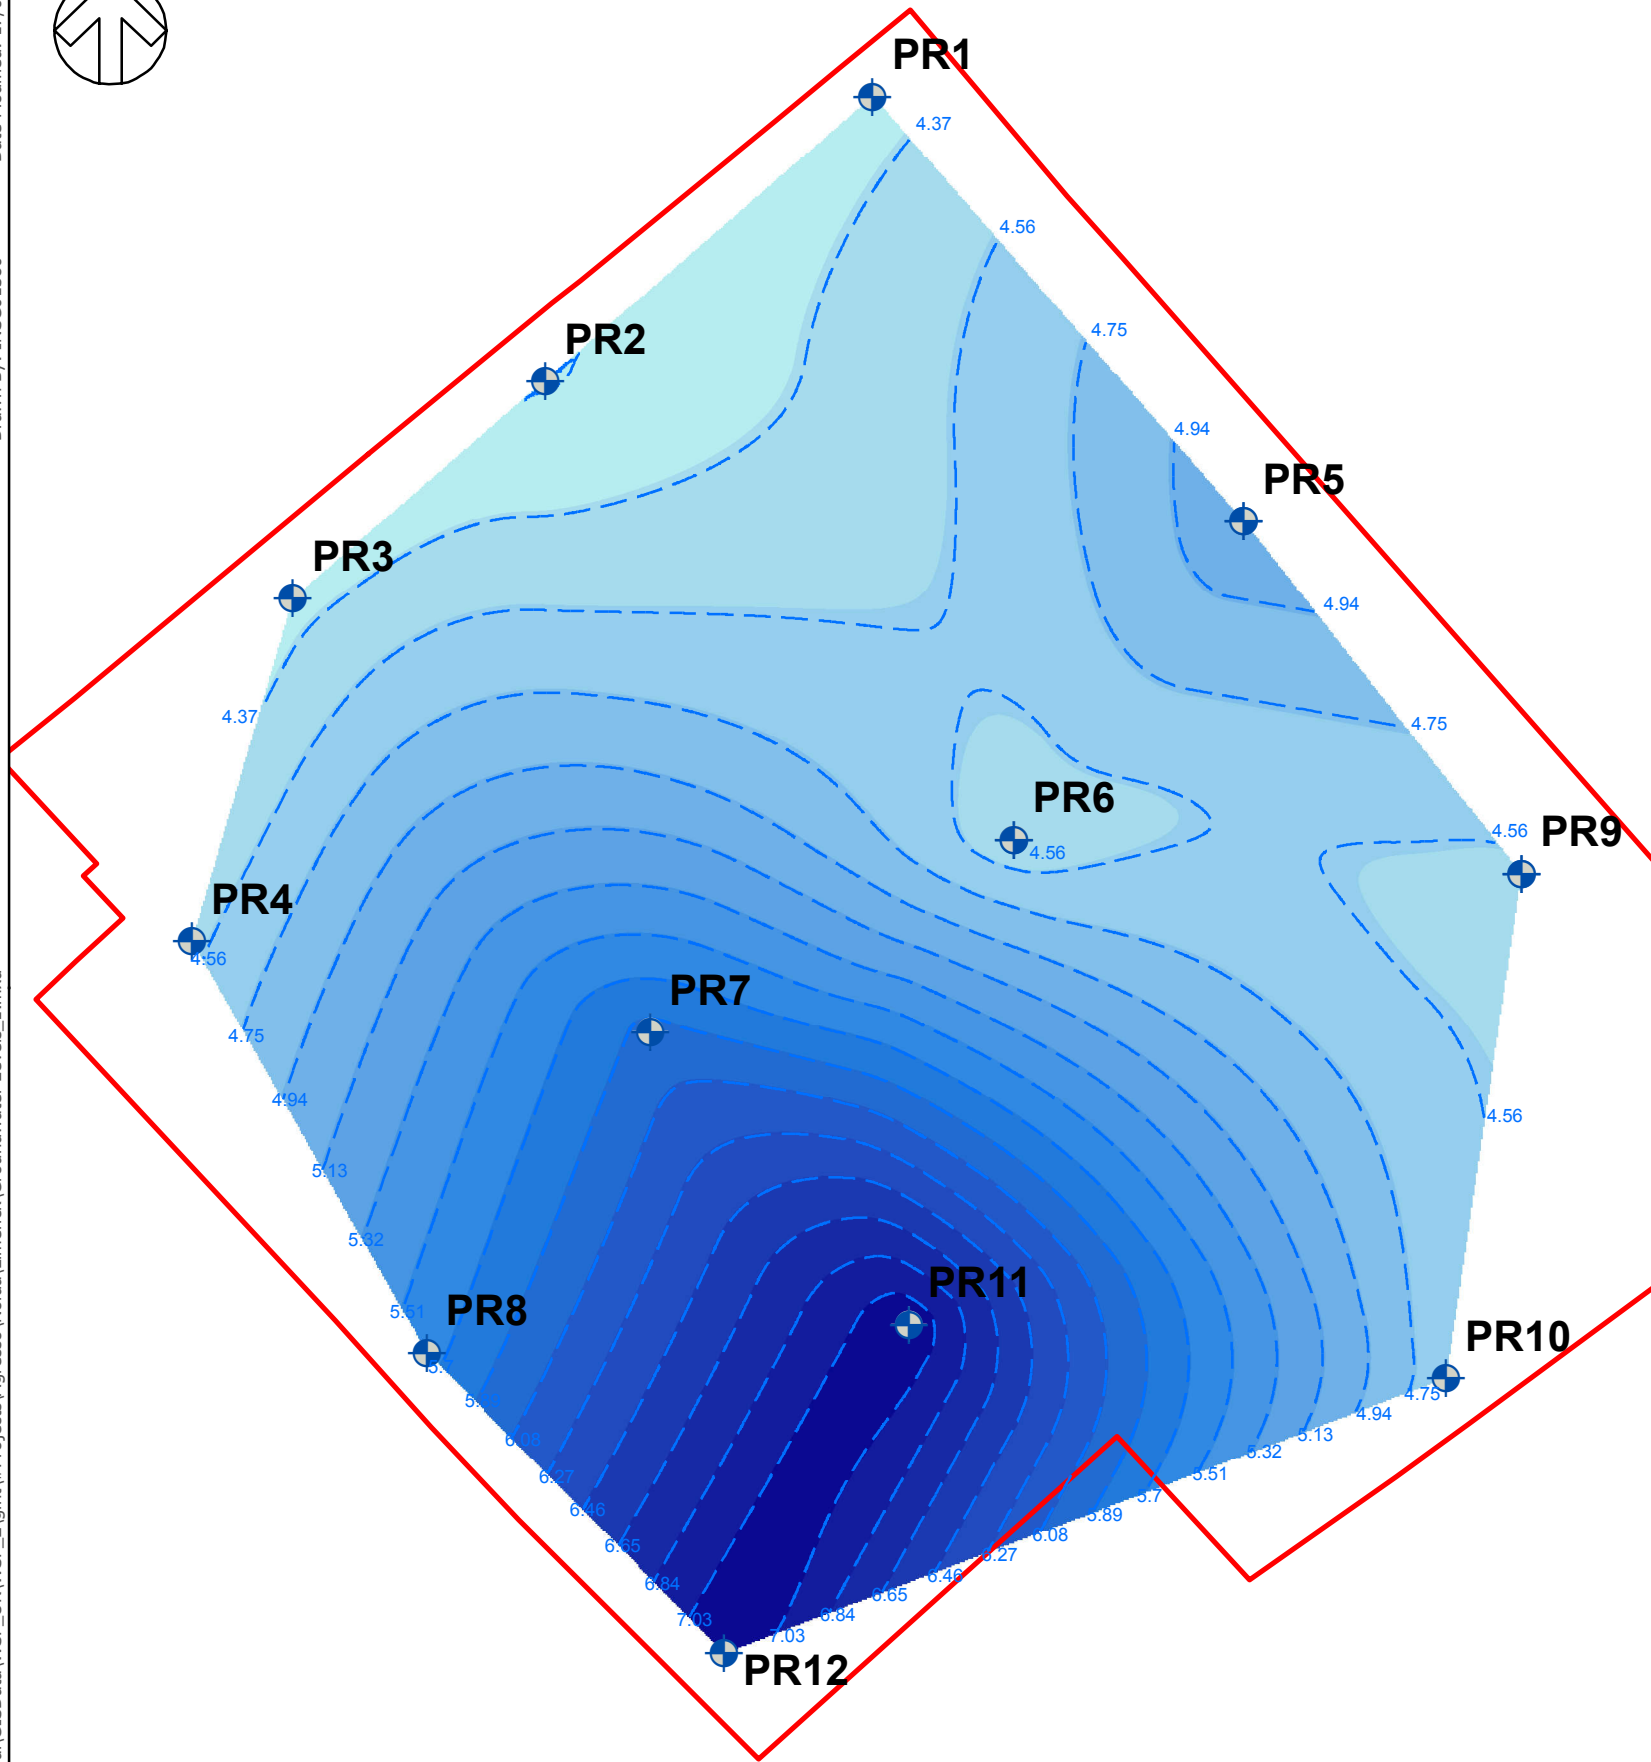
Similarly to pre-remediation groundwater plots, the September 2021 groundwater plot presented as Drawing 70049885/OD/2021/03 in **Appendix A** indicates that the source of groundwater beneath the site corresponds to Source 1, described above; groundwater appears to accumulate in the south of the site (cell J08 / location of PR11). Flow is in an approximately north westerly direction, as would be expected close to the River Shannon.
