**BIOLOGICAL MONITORING OF SURFACE WATER QUALITY IN
THE VICINITY OF GORTADROMA LANDFILL, COUNTY
LIMERICK**

August 2022

REPORT PREPARED FOR LIMERICK CITY & COUNTY COUNCIL

Client	Limerick City & County Council
Project	Gortadroma Landfill, County Limerick: Biological assessment of surface water quality
Report No	22104/F
Date	05/09/2022
Status	Final
Prepared by	Helena Twomey BA(Mod), PhD
Reviewed by	Bill Quirke BSc, MSc, MCIEEM

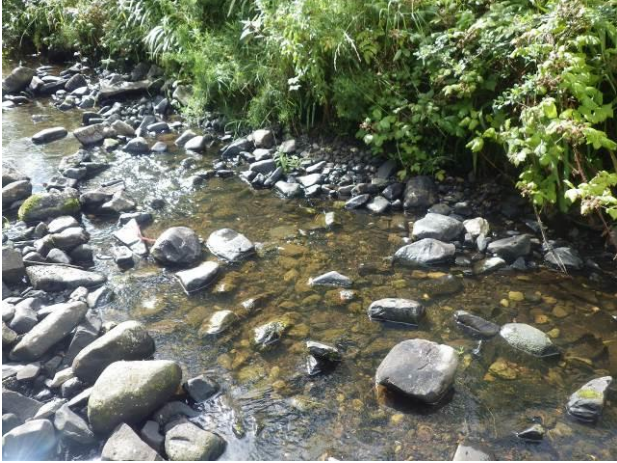
Site Code	A
Grid reference	R 22744 41572
Site Location	Upstream of bridge north of Glensharold
Site Photograph

The invertebrate community at this site tabulated below merits a Q-rating of Q4 indicating unpolluted conditions and Good ecological quality.

Width	4-5 m
Depth	8-15 cm
Substrate	Cobble, Gravel, Sand, Large Rocks (Heavy silt plume)
Flow Type	Riffle 45% Glide 55%
Instream Vegetation	Filamentous algae 20%; Bryophyta <5%
Dominant Bankside Vegetation	Gorse, Himalayan Balsam, Bramble, Blackthorn, Montbretia, Willow
Estimated % summer Cover of Stream by Bankside Vegetation	5%
Trout Adult Habitat	Poor
Trout Nursery Habitat	Good
Trout Spawning Habitat	Fair
Comments	Water slightly coloured

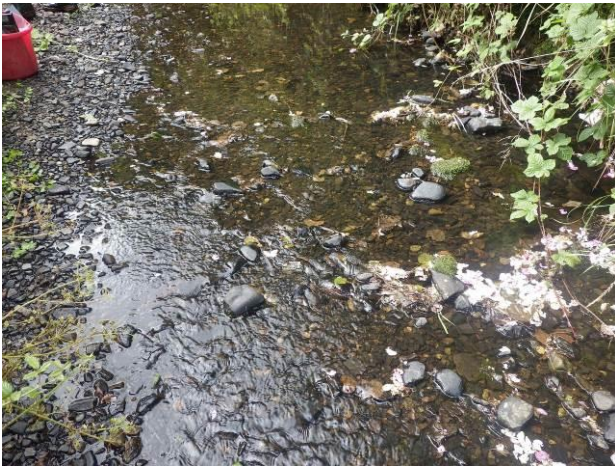
Site Code	B
Grid Reference	R 22403 43089
Site Location	Upstream of landfill and upstream of small stream/drain flowing from landfill extension area.
Site Photograph

The invertebrates recorded at Site B and tabulated below merit a Q-rating of Q4 indicating unpolluted conditions and Good ecological quality.

Width	3-4 m
Depth	5-12 cm
Substrate	Gravel, Cobble, Sand, Mud (Heavy silt plume)
Flow Type	Riffle 40% Glide 60%
Instream Vegetation	Bryophyta <1%
Dominant Bankside Vegetation	Bramble, Grass, Himalayan Balsam, Alder, Oak, Willow
Estimated % summer Cover of Stream by Bankside Vegetation	20%
Trout Adult Habitat	Poor
Trout Nursery Habitat	Fair - Good
Trout Spawning Habitat	Fair – Good
Comments	Water slightly coloured

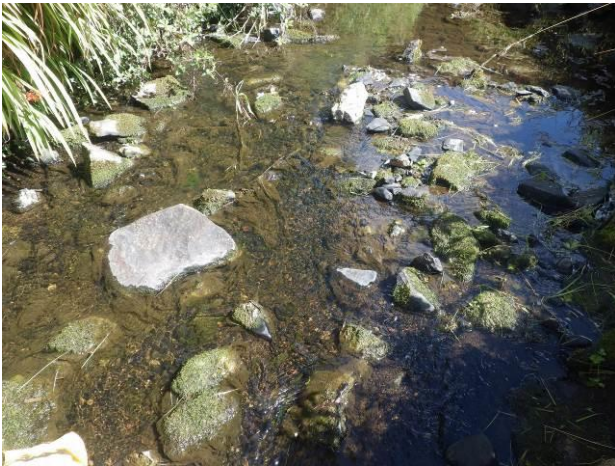
Site Code	C
Grid Reference	R 21715 43154
Site Location	Just downstream of landfill and just downstream of bridge
Site Photograph

The invertebrates recorded at Site C are tabulated below. The site is given a Q-rating of Q4 indicating unpolluted conditions and Good ecological quality.

Width	4-5 m
Depth	6-12 cm
Substrate	Cobble, Gravel, Mud, Sand, Large Rocks; Heavy silt plume
Flow Type	Riffle 45% Glide 55%
Instream Vegetation	Filamentous algae (silty) 50%; <i>Phalaris arundinacea</i> 5%; Bryophyta <1%
Dominant Bankside Vegetation	Hawthorn, Conifer, Ash, Nettle, Grass, Bramble, Montbretia, Himalayan Balsam
Estimated % summer Cover of Stream by Bankside Vegetation	5%
Trout Adult Habitat	Poor
Trout Nursery Habitat	Fair-Good
Trout Spawning Habitat	Fair
Comments	Water slightly coloured

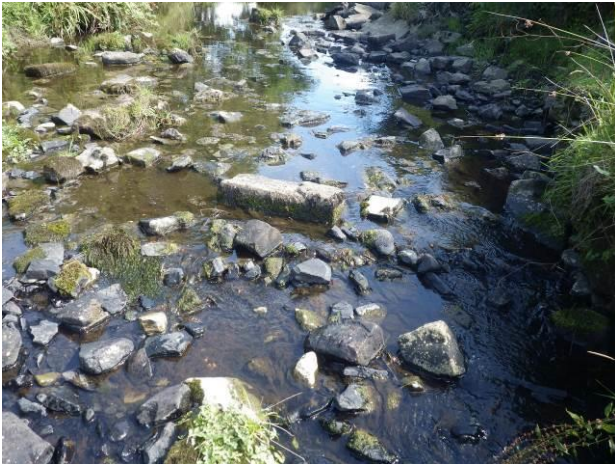
Site Code	D
Grid Reference	R 21387 43129
Site Location	Upstream of bridge, downstream of tributary.
Site Photograph

The invertebrates recorded at Site D are tabulated below. The site is given a Q-rating of Q3-4 indicating slightly polluted conditions and Moderate ecological quality.

Width	6-7 m
Depth	6-12 cm
Substrate	Cobble, Large Rocks, Gravel, Mud (Heavy silt plume)
Flow Type	Riffle 30% Glide 70%
Instream Vegetation	Filamentous algae (silted) 60%; Bryophyta 5%
Dominant Bankside Vegetation	Grass, Bramble, Rush
Estimated % summer Cover of Stream by Bankside Vegetation	5%
Trout Adult Habitat	Poor-Fair
Trout Nursery Habitat	Fair-Good
Trout Spawning Habitat	Poor-Fair

A Q-rating of Q3-4 (Moderate ecological quality) was recorded at Site D which is a further c.300m downstream of the landfill. Give the Good ecological quality (Q4) recorded at Site C immediately downstream of the landfill, the lower rating of Q3-4 cannot be driven by the landfill. As a significant tributary flows to the White River just upstream of Site D, the lower Q-rating at the site is most likely due to a change in water quality in this tributary. Future inclusion of a Q-rating site on this tributary just upstream of the confluence would be useful to clarify the factors driving the Q-rating at Site D, and is therefore recommended.
