**Biological Assessment of the Water Quality of
the Rivers Funshion and Gradoge in the Vicinity of
Discharge from the Dairygold Plant at Mitchelstown**

September 2020

Pascal Sweeney B.Sc., M.Sc.

Sweeney Consultancy,

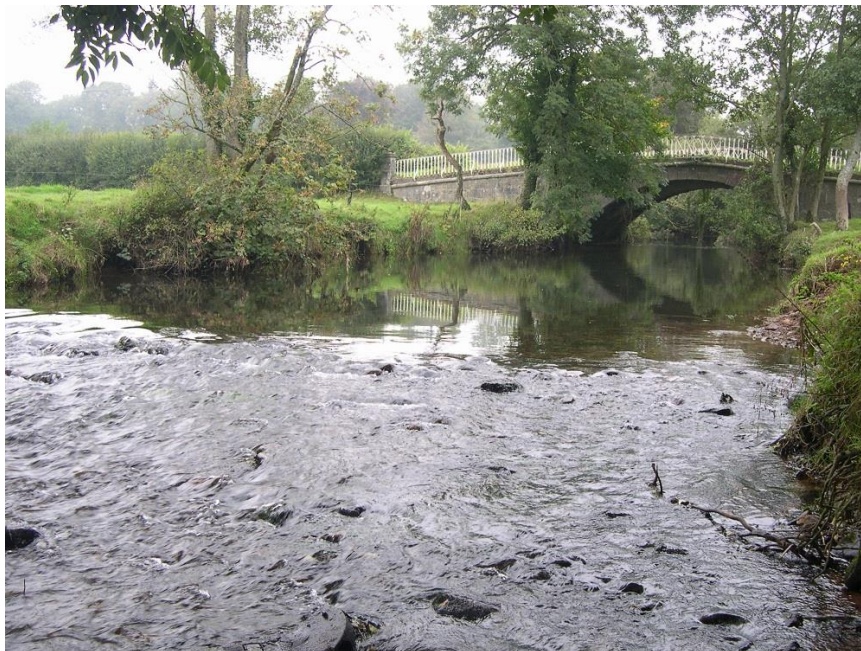
Photo 1: Funshion Site 1

Funshion Site 1. The fauna of this site is dominated by Group C (Relatively Pollution Tolerant) species, the two most abundant taxa being *Baetis rhodani* and Simuliidae. Group A (Very Pollution Sensitive) is represented by low numbers of the flat mayfly nymph, *Rhithrogena sp.* From Group B (Relatively Pollution Sensitive), the stonefly *Leuctra sp.* is common and a single specimen from the caddis family Glossiphonidae was found. No Group D (Very Pollution Tolerant) taxa were found and tubificid worms from Group E (Most Pollution Tolerant) were present in low numbers. With only a few specimens from Group A and some Group B, no Groups D and few Group E representation in a fauna dominated by Group C, this invertebrate community indicates a Q-value of **Q3-4**.

Site	Funshion Site 1
Watercourse	River Funshion
EPA River Code	18/F/05
EPA Site Code	None
	Downstream of Site 0100
GPS Reading	R8065 1430
Location	30m downstream Ballyarthur Br.
Photograph No.	1
Wet Width (m)	10
Sampling depth (m)	0.2
Flow	Riffle: 50%
	Glide: 50%
Substrate	Cobble: 50%
	Coarse Gravel: 30%
	Fine Gravel: 10%
	Sand: 10%
Instream Vegetation	<i>Vaucheria sp.</i> : 10%
	<i>Fontinalis antipyretica</i> : 5%
	<i>Ranunculus sp.</i> 10%
Shade	Moderate

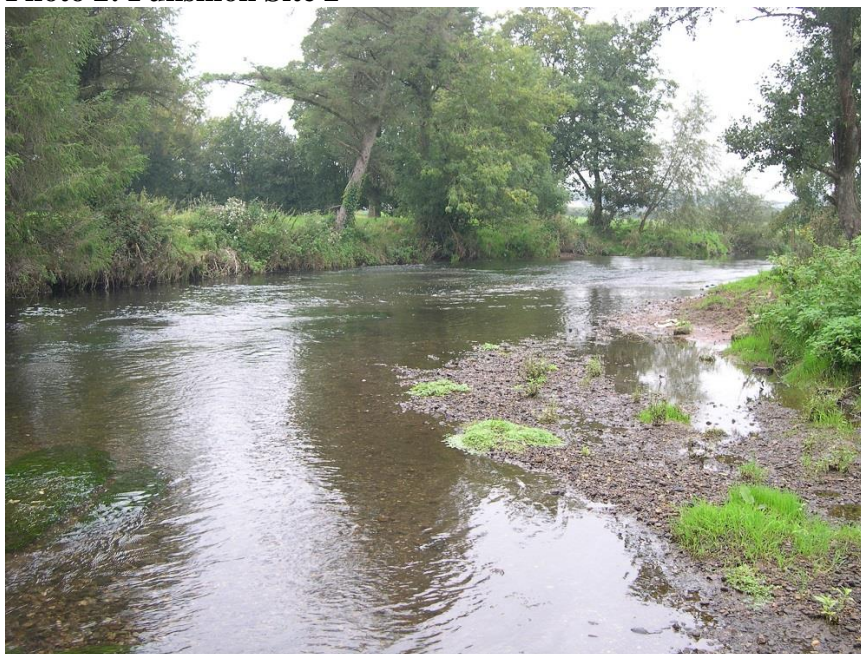
Photo 2: Funshion Site 2

Funshion Site 2. Group C is also dominant here with the mayfly nymph, *Baetis rhodani* the most abundant, while Simuliidae and *Gammarus sp.* are common in occurrence. Group A is represented by low numbers of *Ecdyonurus sp.* *Leuctra sp.* (Group B) is common in occurrence here also. Single specimens of the leech, *Erpobdella sp.* and the water slater, *Asellus sp.* from Group D were found. This faunal composition with a low representation of Group A, Group C dominant, Groups B and D represented and Group E absent indicates a Q-value of **Q3-4**

Site	Funshion Site 2
Watercourse	River Funshion
EPA River Code	18/F/05
EPA Site Code	None
	Upstream of Site 0200
GPS Reading	R7941 1363
Location	330m d/s of treated effluent discharge
Photograph No.	2
Wet Width (m)	12
Sampling depth (cm)	0.4
Flow	Riffle: 100%
Substrate	Cobble: 20%
	Coarse Gravel: 25%
	Fine Gravel: 25%
	Sand: 20%
	Silt: 10%
Instream Vegetation	<i>Vaucheria sp.</i> : 10%
	<i>Cladophora sp.</i> : 10%
	<i>Fontinalis antipyretica</i> : 5%
	<i>Ranunculus sp.</i> 30%
Shade	Light

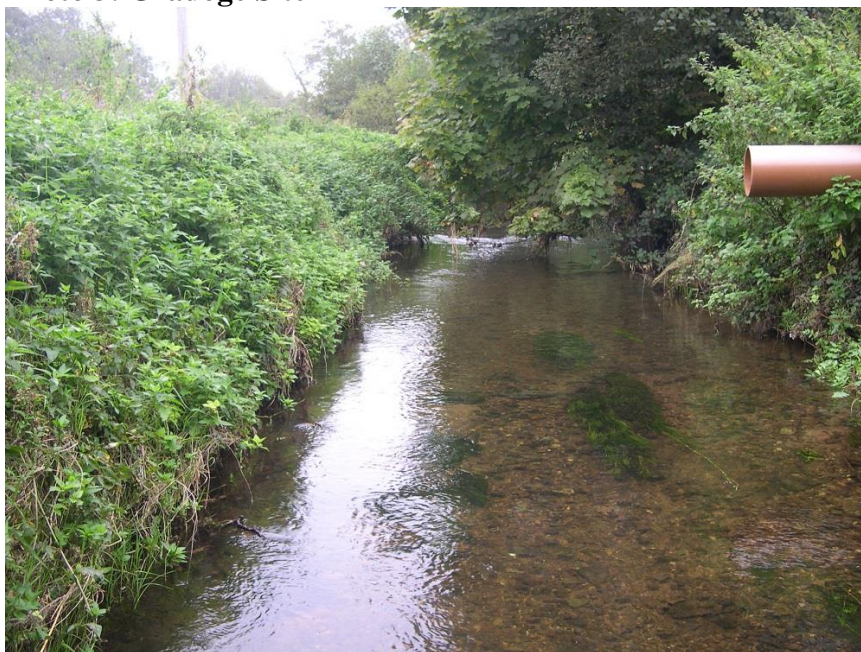
Photo 3: Gradoge Site 1

Gradoge Site 1. The fauna of this site is dominated by Group C species. The two most abundant taxa are *Baetis rhodani* and *Gammarus duebeni*. Group A is represented by low numbers of the flat mayfly *Ecdyonurus sp.*. Group B is represented by a single specimen of *Leuctra sp.* Low numbers of the snail *Radix balthica* from Group D were found and Group E was absent. With low numbers of Group A taxa, a single specimen from Group B, low numbers from Group D and Group E absent in a fauna dominated by Group C, this invertebrate community indicates a Q-value of **Q3-4**.

Site	Gradoge Site 1
Watercourse	Gradoge River
EPA River Code	18/G/13
EPA Site Code	None
	Downstream of Site 0100
GPS Reading	R8178 1308
Location	u/s of Clonmel Rd. Surface water discharge
Photograph No.	3
Wet Width (m)	3
Sampling depth (cm)	0.4
Flow	Riffle: 80%
	Glide 20%
Substrate	Cobble: 10%
	Coarse Gravel: 250%
	Fine Gravel: 25%
	Sand: 40%
Instream Vegetation	<i>Cladophora sp.</i> 1%
	<i>Phalaris arundinacea</i> 2%
	<i>Fontinalis antipyretica</i> : 5%
	<i>Callitriche sp.</i> 1%
	<i>Ranunculus sp.</i> 10%
Shade	Moderate

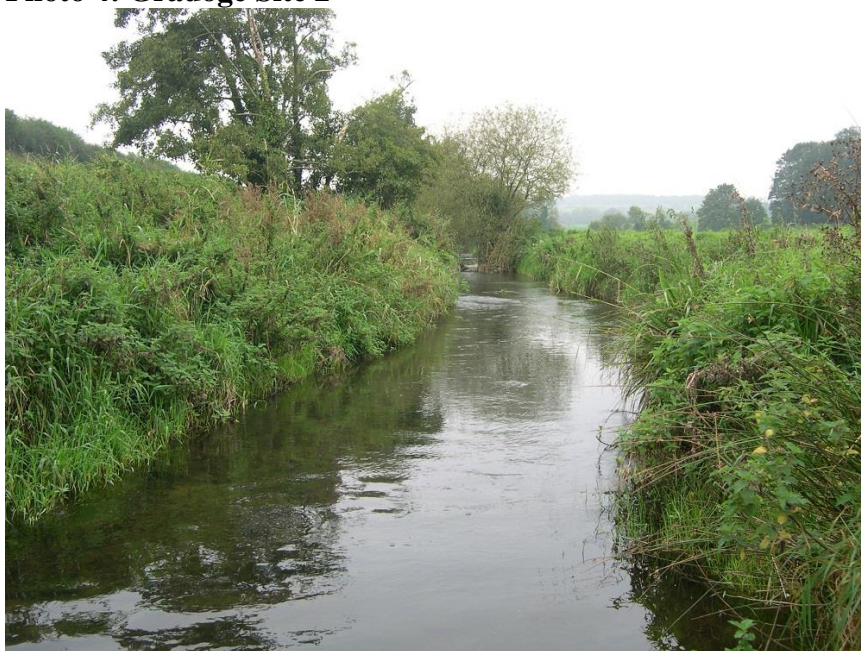
Photo 4: Gradoge Site 2

Gradoge Site 2. Groups A and B taxa are absent from this site. Group C dominates, with black-fly larvae (Simuliidae) the most abundant. Group D is poorly represented and Group E is absent. The fauna of this site indicates a Q-value of **Q3**.

Site	Gradoge Site 2
Watercourse	Gradoge River
EPA River Code	18/G/13
EPA Site Code	0200
GPS Reading	R7980 1368
Location	50m u/s confluence with R. Funshion
Photograph No.	4
Wet Width (m)	5
Sampling depth (m)	0.3
Flow	Fast Glide: 100%
Substrate	Cobble: 20%
	Coarse Gravel: 25%
	Fine Gravel: 10%
	Sand: 40%
	Silt: 5%
Instream Vegetation	<i>Vaucheria sp.</i> : 10%
	<i>Cladophora sp.</i> : 5%
	<i>Fontinalis antipyretica</i> : 5%
	<i>Callitriche sp.</i> 5%
	<i>Ranunculus sp.</i> 30%
	<i>Apium nodiflorum</i> 1%
Shade	Light

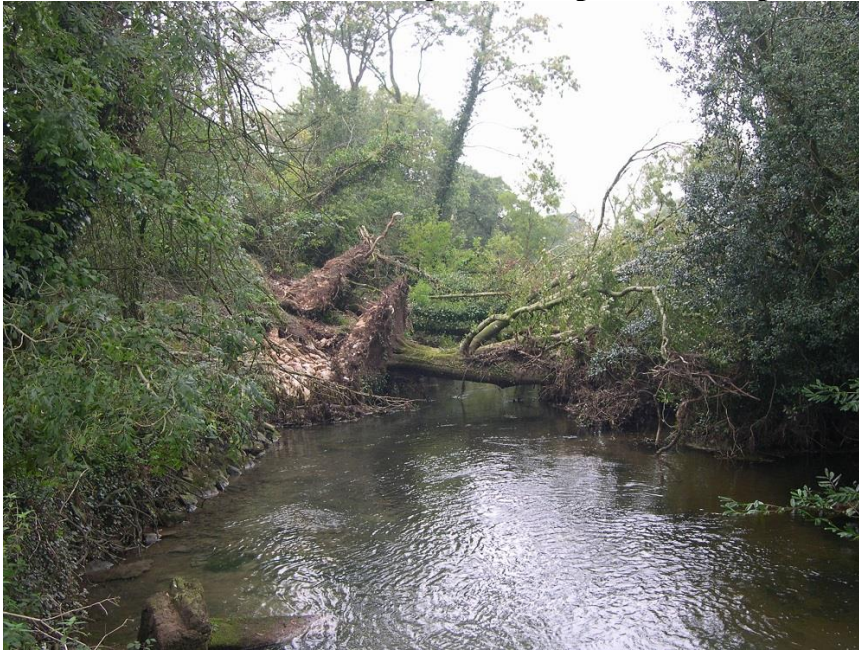
Compared to previous years, some extra silt was noted at Funshion Site 2. This was almost certainly due to erosion of steep banks, following collapse of trees and exposure of root plates, caused by the storms of August 2020 (Photo 5).

Photo 5: Trees windblown by August 2020 storms lying across Funshion between outfall and Funshion Site 2. Exposed root plates on steep bank causing silt runoff.
