BASKETSTOWN LANDFILL, COUNTY MEATH

**BIOLOGICAL MONITORING OF SURFACE WATER
QUALITY OF THE CLONEYMEATH/KNIGHTSBROOK
RIVER AND THE 'DRUMARD' STREAM/DRAIN**

October 2020

REPORT PREPARED FOR MEATH COUNTY COUNCIL

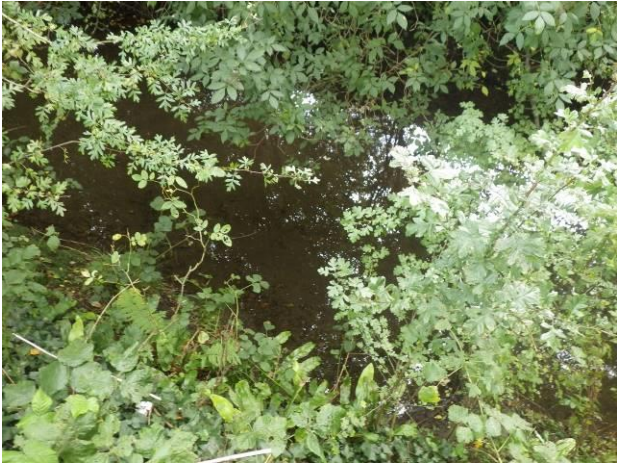
Site Code	Basketstown 1
Site Location	Grid reference N 85890 51274
Site Photograph

This site is situated on the 'Drumard' Stream/Drain c.50m upstream of its confluence with the drain flowing from the landfill site. The 'Drumard' Stream/Drain here constitutes a very slow flowing drain. The Q-rating method is not strictly applicable at such a slow flowing site, but the invertebrate community tabulated below is indicative of seriously polluted conditions and Bad ecological quality, and is given a tentative Q-rating of Q2(t).

Width	3 m
Depth	5-10 cm
Substrate	Mud
Flow Type	Slow glide
Instream Vegetation	None recorded
Dominant Bankside Vegetation	Hawthorn, Elder
Estimated % summer Cover of Stream by Bankside Vegetation	80%
Trout Adult Habitat	None
Trout Nursery Habitat	None
Trout Spawning Habitat	None

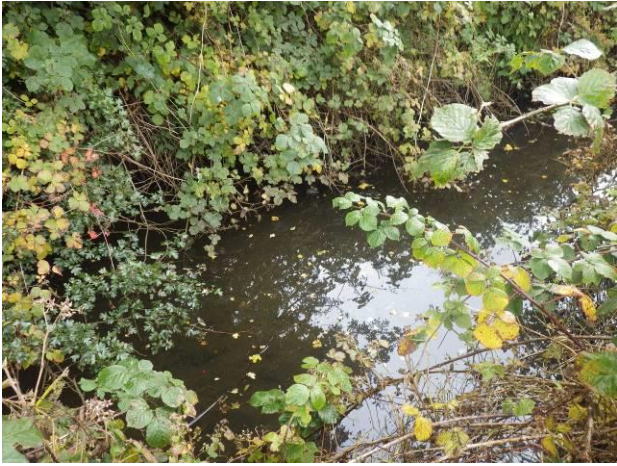
Site Code	Basketstown 2
Site Location	Grid Reference N 85801 51237
Site Photograph

This site is situated on the 'Drumard' Stream/Drain c.50m downstream of its confluence with the drain flowing from the landfill site. The Q-rating method is not strictly applicable at such a slow flowing site, but the invertebrate community tabulated below is indicative of seriously polluted conditions and Bad ecological quality, and is given a tentative Q-rating of Q2(t). which is slightly improved since 2019.

Width	3-4 m
Depth	15 cm
Substrate	Mud
Flow Type	Very Slow Glide 100%
Instream Vegetation	None
Dominant Bankside Vegetation	Hawthorn, Bramble, Ivy
Estimated % summer Cover of Stream by Bankside Vegetation	60%
Trout Adult Habitat	None
Trout Nursery Habitat	None
Trout Spawning Habitat	None

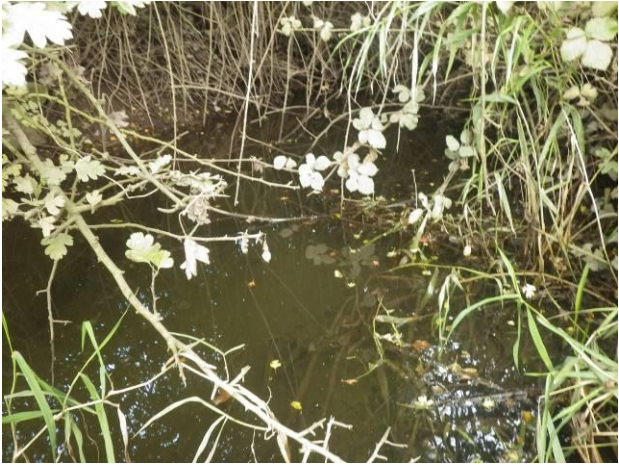
Site Code	Basketstown 3
Site Location	N 84006 50188
Site Photograph

This site is situated on the 'Drumard' Stream/Drain River c.2km downstream of its confluence with the drain flowing from the landfill site and just upstream of the confluence with the Knightsbrook River. Taking the habitat into account, the invertebrate community tabulated below is given a tentative Q-rating of Q2-3(t), indicating moderately polluted conditions and Poor ecological quality, a deterioration compared with Q3 in 2019.

Width	3 m
Depth	50 cm
Substrate	Mud, Sand
Flow Type	Glide 100%
Instream Vegetation	<i>Phalaris arundinacea</i> <1%
Dominant Bankside Vegetation	Hawthorn, Bramble
Estimated % summer Cover of Stream by Bankside Vegetation	60%
Trout Adult Habitat	None
Trout Nursery Habitat	None
Trout Spawning Habitat	None

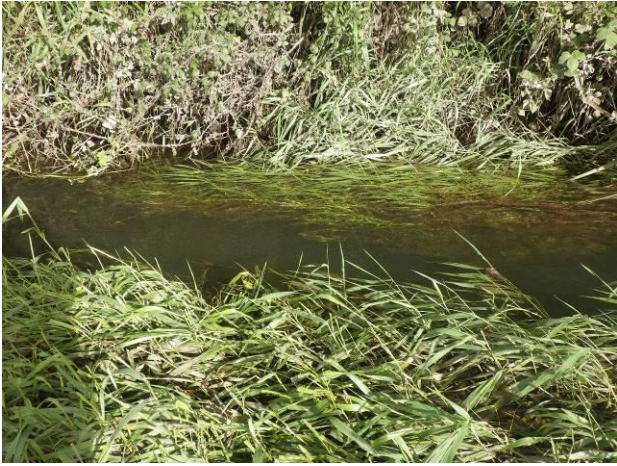
Site Code	Basketstown 4
Site Location	N 84011 50182
Site Photograph

This site is situated on the Knightsbrook/Cloneymeth River upstream of its confluence with the 'Drumard' Stream/Drain. Taking into account the nature of the habitat, the invertebrate community tabulated below merits a Q-rating of Q2-3 indicating moderately polluted conditions and Poor ecological quality.

A photograph showing a narrow stream with dark water. The banks are heavily vegetated with tall green grasses and other plants. The water reflects the surrounding greenery.
Width	3.5 m
Depth	1 m
Substrate	Mud, Sand, Gravel
Flow Type	Glide 100%
Instream Vegetation	<i>Phalaris arundinacea</i> 60%
Dominant Bankside Vegetation	Hawthorn, Bramble
Estimated % summer Cover of Stream by Bankside Vegetation	20%
Trout Adult Habitat	None
Trout Nursery Habitat	None
Trout Spawning Habitat	None

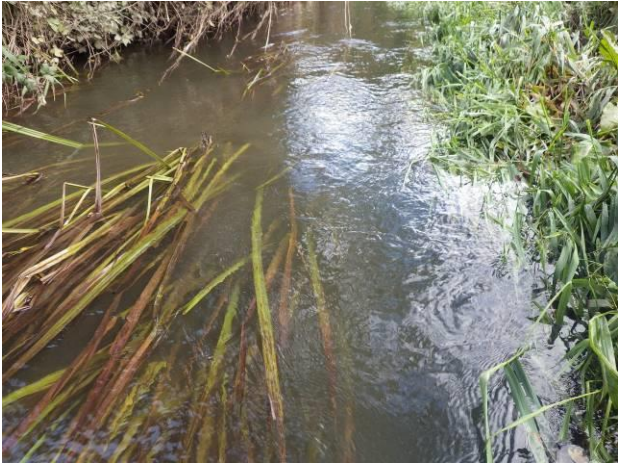
Site Code	Basketstown 5
Site Location	N 83991 50189
Site Photograph

This site is situated on the Knightsbrook/Cloneymeach River downstream of its confluence with the 'Drumard' Stream/Drain. Taking into account the nature of the habitat, the invertebrate community tabulated below merits a Q-rating of Q2-3 indicating moderately polluted conditions and Poor ecological quality.

Width	4-5 m
Depth	50-60 cm
Substrate	Mud, Sand, Gravel, Cobble (Heavy siltation)
Flow Type	Glide 100%
Instream Vegetation	<i>Sparganium erectum</i> 40% <i>Phalaris arundinacea</i> 20%
Dominant Bankside Vegetation	Hawthorn, Ash, Briar
Estimated % summer Cover of Stream by Bankside Vegetation	15%
Trout Adult Habitat	Poor-Fair
Trout Nursery Habitat	Poor
Trout Spawning Habitat	None

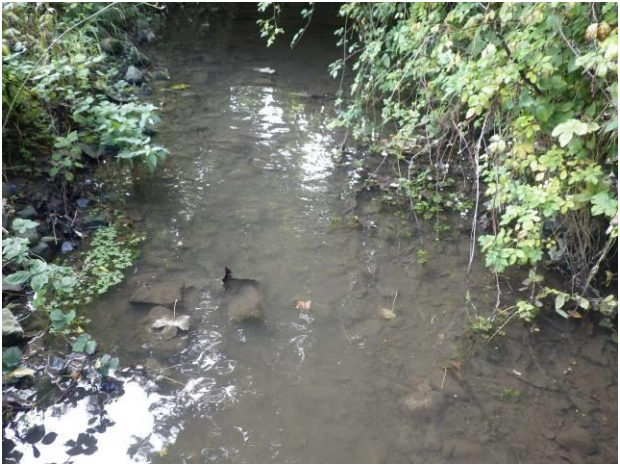
Site Code	07K02-0200
Site Location	Grid Reference N 85992 49147
Site Photograph

Cloneymeath Bridge North East Channel. Location shown on Map 1 (N.B. This channel is not shown on the 1:50,000 Discovery series map). The invertebrate community tabulated below merits a Q-rating of Q2-3 and is indicative of moderately polluted conditions and Poor ecological quality, a slight deterioration compared with 2019.

Width	4 m
Depth	10 cm
Substrate	Mud, Gravel, Sand, Cobble (Heavy siltation)
Flow Type	Glide 100%
Instream Vegetation	<i>Apium nodiflorum</i> <5% <i>Lemna minor</i> <5%
Dominant Bankside Vegetation	Ash, Oak, Hawthorn
Estimated % summer Cover of Stream by Bankside Vegetation	40%
Trout Adult Habitat	None
Trout Nursery Habitat	None
Trout Spawning Habitat	None

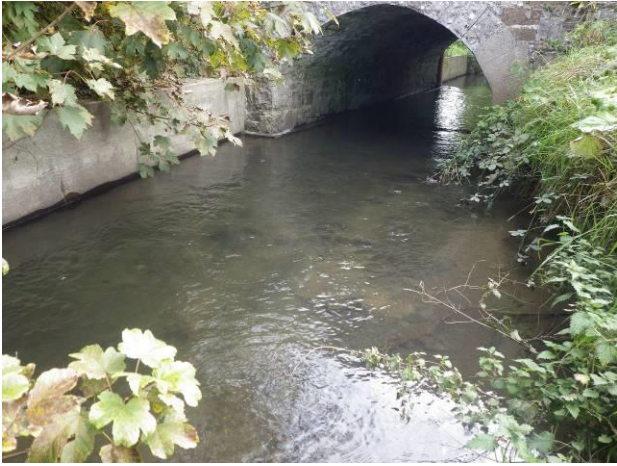
Site Code	Cloneymeth Bridge South-West
Site Location	Grid reference N 85784 4873
Site Photograph

This site is located at Cloneymeath Bridge as shown on Discovery Series Map. This site appears to be on what is now the main channel of the Cloneymeath River. The invertebrate community tabulated below merits a Q-rating of Q3 indicating moderately polluted conditions and Poor ecological quality.

Width	4-5 m
Depth	10-15 cm
Substrate	Cobble, Gravel, Mud (Heavy siltation)
Flow Type	Glide 70% Riffle 30%
Instream Vegetation	None
Dominant Bankside Vegetation	Hawthorn, Bramble, Sycamore
Estimated % summer Cover of Stream by Bankside Vegetation	30%
Trout Adult Habitat	Poor
Trout Nursery Habitat	Fair-Good
Trout Spawning Habitat	Poor-Fair

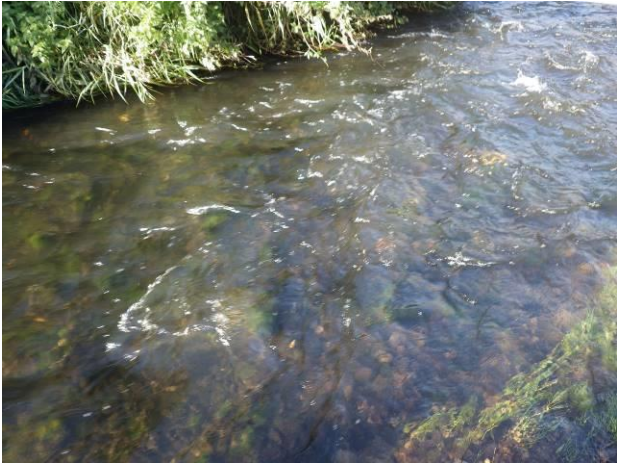
Site Code	07K02-0300
Site Location	Grid reference N 83311 50870
Site Photograph

This site is located just upstream of Dangan Bridge and c.1km downstream of the confluence of the Cloneymeth River with the 'Drumard' Stream/Drain. The invertebrate community tabulated below merits a Q-rating of Q3 indicating moderately polluted conditions and Poor ecological quality.

Width	3-4 m
Depth	15-20 cm
Substrate	Cobble, Gravel, Sand, Mud (Heavy Siltation)
Flow Type	Riffle 80% Glide 20%
Instream Vegetation	Filamentous algae 50% Bryophyta 5% <i>Phalaris arundinacea</i> 5%
Dominant Bankside Vegetation	Grass, Blackthorn, <i>Phalaris arundinacea</i> , Bramble, Nettle
Estimated % summer Cover of Stream by Bankside Vegetation	5%
Trout Adult Habitat	Poor-Fair
Trout Nursery Habitat	Good
Trout Spawning Habitat	Poor-Fair

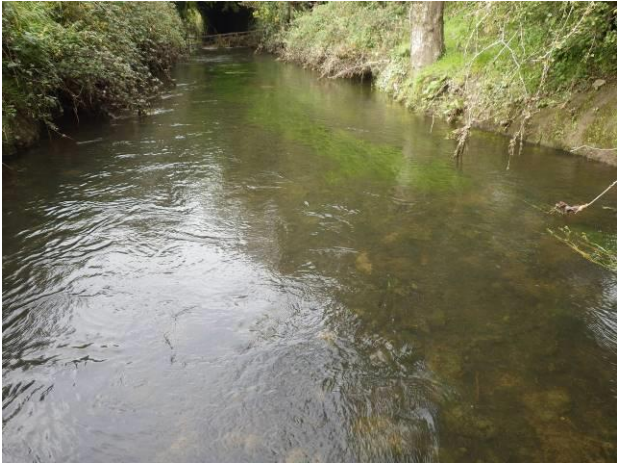
Site Code	07K02-0360
Site Location	Grid reference N 80332 52181
Site Photograph

This site is situated c.5 km downstream of the confluence of the 'Drumard' Stream/Drain with the Cloneymeath River. The invertebrate community tabulated below merits a Q-rating of Q3 indicating moderately polluted conditions and Poor ecological quality.

Width	7-8 m
Depth	25-35 cm
Substrate	Cobble, Gravel, Sand, Mud
Flow Type	Riffle 40% Glide 60%
Instream Vegetation	Algae 10% <i>Ranunculus sp.</i> 10%
Dominant Bankside Vegetation	Hawthorn, Bramble
Estimated % summer Cover of Stream by Bankside Vegetation	10%
Trout Adult Habitat	Fair
Trout Nursery Habitat	Fair-Good
Trout Spawning Habitat	Fair

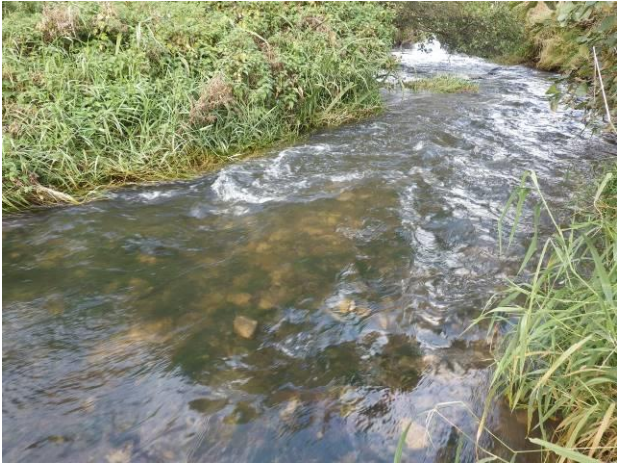
Site Code	07K02-0500
Site Location	Grid reference N 82998 56337
Site Photograph

This site is located just upstream of the Boyne confluence and c.12 km downstream of the confluence of the 'Drumard' Stream/Drain with the Cloneymeath River. The sample area was limited due to high flow conditions. The invertebrate community tabulated below merits a Q-rating of Q3 indicating moderately polluted conditions and Poor ecological quality.

Width	8 m
Depth	15-30 cm
Substrate	Cobble, Gravel, Sand (Moderate siltation, Calcified)
Flow Type	Glide 30% Riffle 70%
Instream Vegetation	Filamentous algae 10% Bryophyta 10% <i>Phalaris arundinacea</i> 10%
Dominant Bankside Vegetation	<i>Phalaris arundinacea</i> , Alder
Estimated % summer Cover of Stream by Bankside Vegetation	5%
Trout Adult Habitat	Fair-Good
Trout Nursery Habitat	Fair-Good
Trout Spawning Habitat	Poor-Fair
Comment	Limited sample area due to high flow conditions
