**Biological Assessment of the Water Quality of  
the Rivers Funshion and Gradoge in the Vicinity of  
Discharge from the Dairygold Plant at Mitchelstown**

*June 2018*

*Prepared by:  
Pascal Sweeney M.Sc., MCIEEM,  
Sweeney Consultancy,  
Rahan,  
Mallow  
Co. Cork.  
Tel. 022/26780*

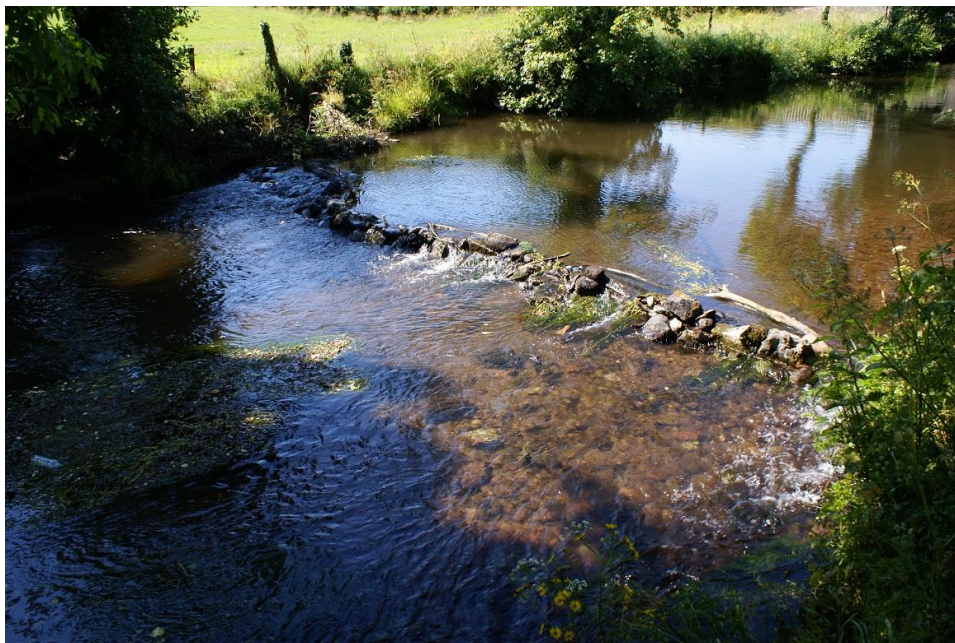
**Funshion Site 1**

**Funshion Site 1. 30m downstream Ballyarthur Bridge.** This is the next bridge downstream of EPA Station 0100 (approximately 650m downstream). Results from this site give information on the water quality of the River Funshion upstream of the confluence of

the Gradoge River and the discharge point of the combined Dairygold treated effluent and the Mitchelstown WWTP effluent.

**Funshion Site 1.** While the fauna of this site is dominated by Group C (Relatively Pollution Tolerant) species, with *Baetis rhodani* and *Gammarus duebeni* the most abundant species present, five species from Group A (Very Pollution Sensitive) are present. However, of these five Group A species, only the flat mayfly nymph, *Rhithrogena sp.*, is common in occurrence, meaning that the site cannot qualify for a Q-value of Q4-5. On the Q-value scale, this site it is at the upper end of **Q4**.

Site	Funshion Site 1
Watercourse	River Funshion
EPA River Code	18/F/05
EPA Site Code	None
	Downstream of Site 0100
GPS Reading	R8065 1430
Location	30m downstream Ballyarthur Br.
Photograph No.	1
Wet Width (m)	10
Sampling depth (m)	0.2
Flow	Riffle: 100%
Substrate	Cobble: 60%
	Coarse Gravel: 20%
	Fine Gravel: 10%
	Sand: 10%
Instream Vegetation	<i>Cladophora sp.</i> 2%
	<i>Batrachospermum sp.</i> 1%
	<i>Fontinalis antipyretica:</i> 2%
	<i>Platyhypnidium riparoides:</i> 1%
	<i>Lemna minor:</i> 2%
	<i>Ranunculus sp.</i> 10%
Shade	Moderate

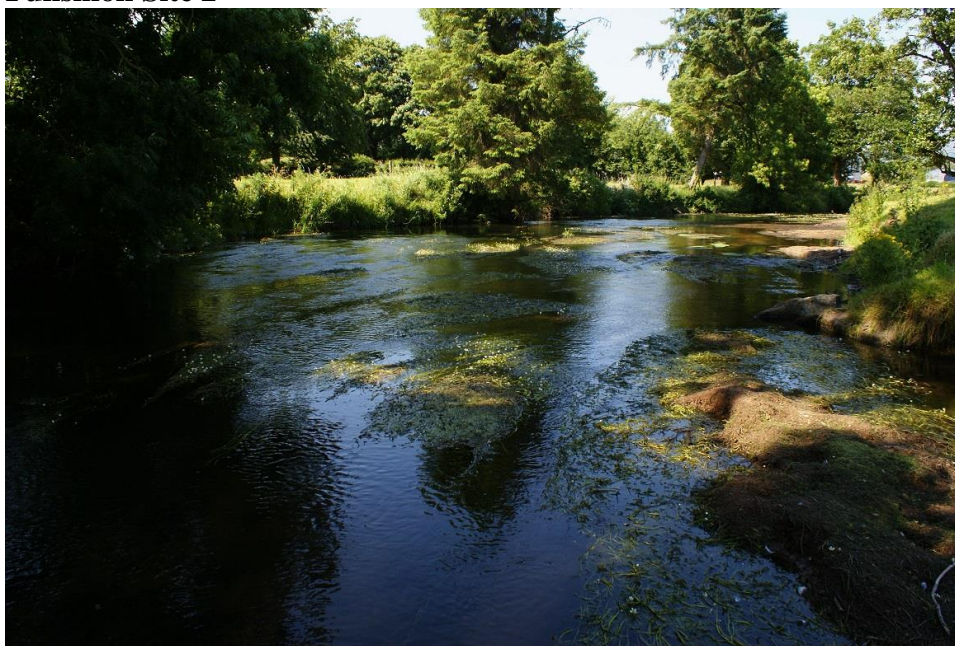
**Funshion Site 2**

**Approximately 250m downstream of the treated effluent outfall.** The site is approximately 250m upstream of EPA Station 0200. Results establish the water quality status of the R. Funshion downstream of all discharges from Dairygold, as well as from the Mitchelstown WWTP and other urban runoff from Mitchelstown.

**Funshion Site 2.** Group C is also dominant here, and Group A is represented by low numbers of three species. A few specimens of tubificid worms from Group E (Most Pollution Tolerant) were also found. This faunal composition just qualifies for a Q-value of **Q4**.

Site	Funshion Site 2
Watercourse	River Funshion
EPA River Code	18/F/05
EPA Site Code	None
	Upstream of Site 0200
GPS Reading	R7941 1363
Location	330m d/s of treated effluent discharge
Photograph No.	2
Wet Width (m)	12
Sampling depth (cm)	0.2
Flow	Riffle: 100%
Substrate	Cobble: 30%
	Coarse Gravel: 30%
	Fine Gravel: 25%
	Sand: 10%
	Silt: 5%
Instream Vegetation	<i>Lemanea sp.</i> 5%
	<i>Cladophora sp.</i> 2%
	<i>Fontinalis antipyretica</i> : 3%
	<i>Phalaris arundinacea</i> 1%
	<i>Ranunculus sp.</i> 70%
	<i>Apium nodiflorum</i> 1%
Shade	Light

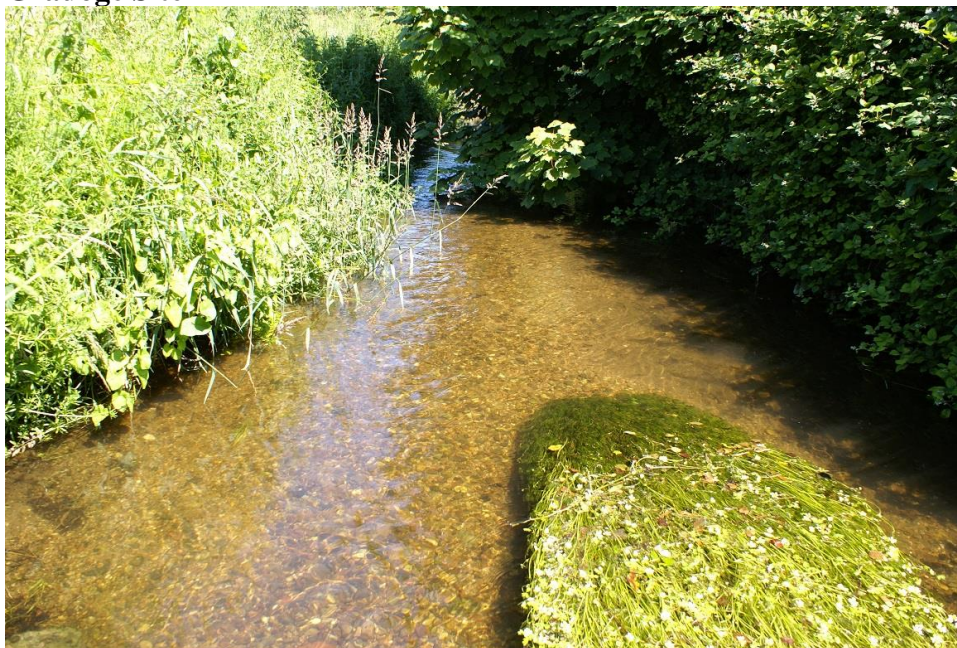
**Gradoge Site 1**

**Gradoge Site 1. Approximately 40m upstream of the surface water discharge at the Clonmel road.** Results from this site give information on the water quality of the Gradoge River upstream of surface runoff from the Dairygold plant.

**Gradoge Site 1.** Three Group A species were found here, but only a few nymphs of *Ecdyonurus sp.* and single specimens of *Rhithrogena sp.* and *Isoperla sp.* Group B (Less Pollution Sensitive) is absent. Group C dominates the fauna, while only single specimens from both Group D and Group E were found. The low representation of Group A in a fauna dominated by Group C indicates a Q-value of **Q3-4**.

Site	Gradoge Site 1
Watercourse	Gradoge River
EPA River Code	18/G/13
EPA Site Code	None
	Downstream of Site 0100
GPS Reading	R8178 1308
Location	40m u/s of Clonmel Rd. Surface water discharge
Photograph No.	3
Wet Width (m)	3
Sampling depth (cm)	0.2
Flow	Riffle: 50%
	Glide 50%
Substrate	Cobble: 10%
	Coarse Gravel: 40%
	Fine Gravel: 30%
	Sand: 20%
Instream Vegetation	<i>Cladophora sp.</i> 1%
	<i>Fontinalis antipyretica</i> : 1%
	<i>Phalaris arundinacea</i> 3%
	<i>Ranunculus sp.</i> 10%
Shade	Moderate

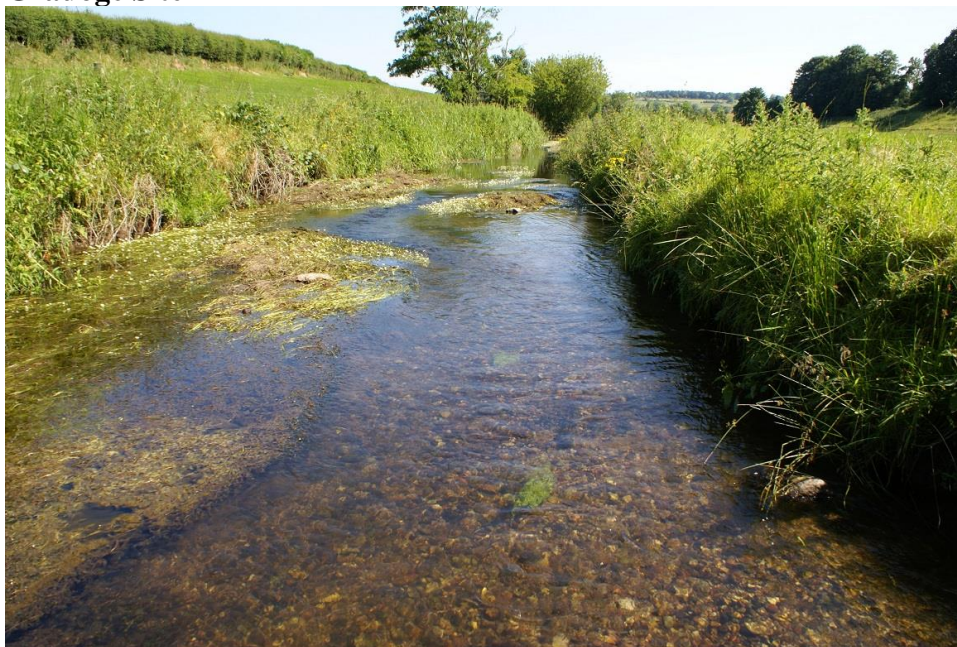
**Gradoge Site 2**

**Gradoge Site 2. Approximately 50m upstream of the confluence with the River Funshion (EPA Station 18/G/13/0200).** Results from this site give information on the water quality of the Gradoge River downstream of the Dairygold surface water/cooling water discharges, as well as urban surface water runoff from Mitchelstown.

**Gradoge Site 2.** The fauna of this site is very similar to that of Gradoge Site 1 and is also indicative of a Q-value of **Q3-4**.

Site	Gradoge Site 2
Watercourse	Gradoge River
EPA River Code	18/G/13
EPA Site Code	0200
GPS Reading	R7980 1368
Location	50m u/s confluence with R. Funshion
Photograph No.	4
Wet Width (m)	5
Sampling depth (m)	0.25
Flow	Fast Glide: 100%
Substrate	Cobble: 40%
	Coarse Gravel: 30%
	Fine Gravel: 15%
	Sand: 5%
	Silt: 10%
Instream Vegetation	<i>Cladophora sp.</i> 2%
	<i>Fontinalis antipyretica:</i> 2%
	<i>Callitriche sp.</i> 2%
	<i>Ranunculus sp.</i> 30%
	<i>Potamogeton crispus</i> 5%
	<i>Apium nodiflorum</i> 3%
Shade	Light
