# Dumping at Sea Annual Environmental Report (AER) 2025

Permit Register Number: S0026-02

Permit Holder: Aughinish Alumina Limited

## Annual Environmental Report 2025

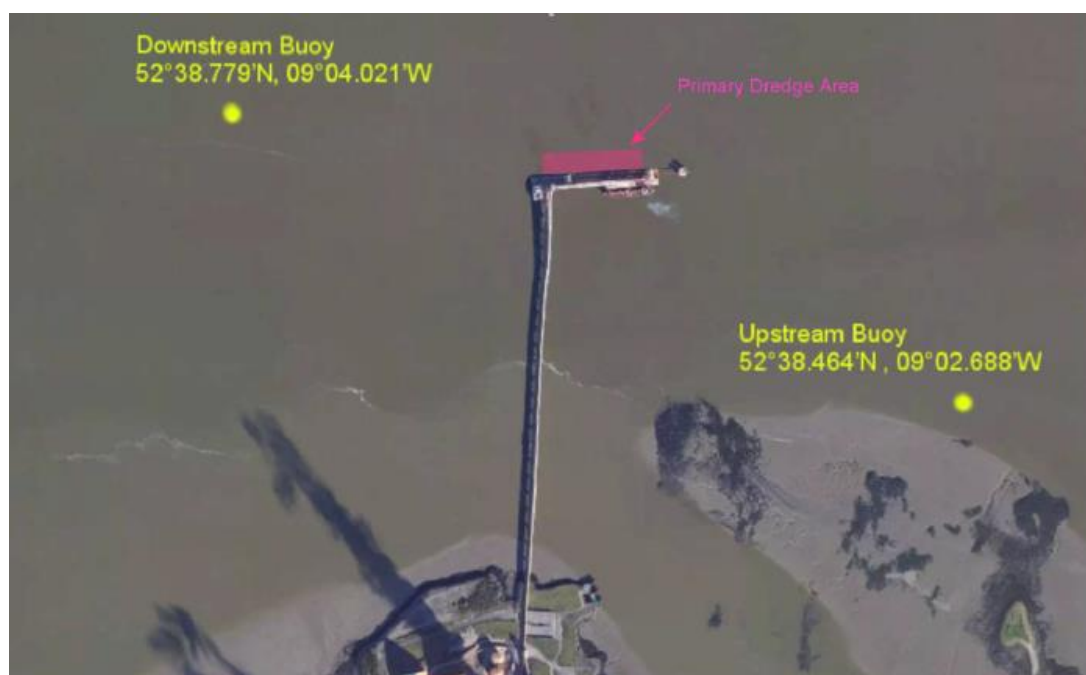
Figure 1: Location of continuous monitoring buoys

The continuous monitoring was carried out at the monitoring buoys illustrated in Figure 5.1.

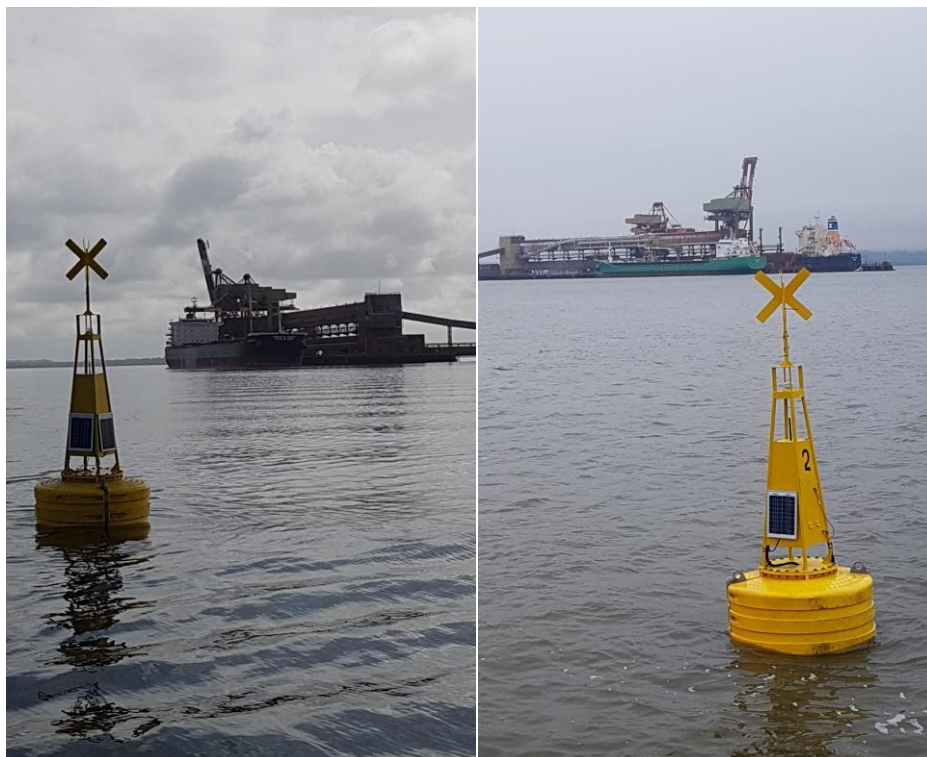
*Figure 1 – IDS DB150 Data buoys similar to those deployed at Aughinish (downstream left, Upstream right)*

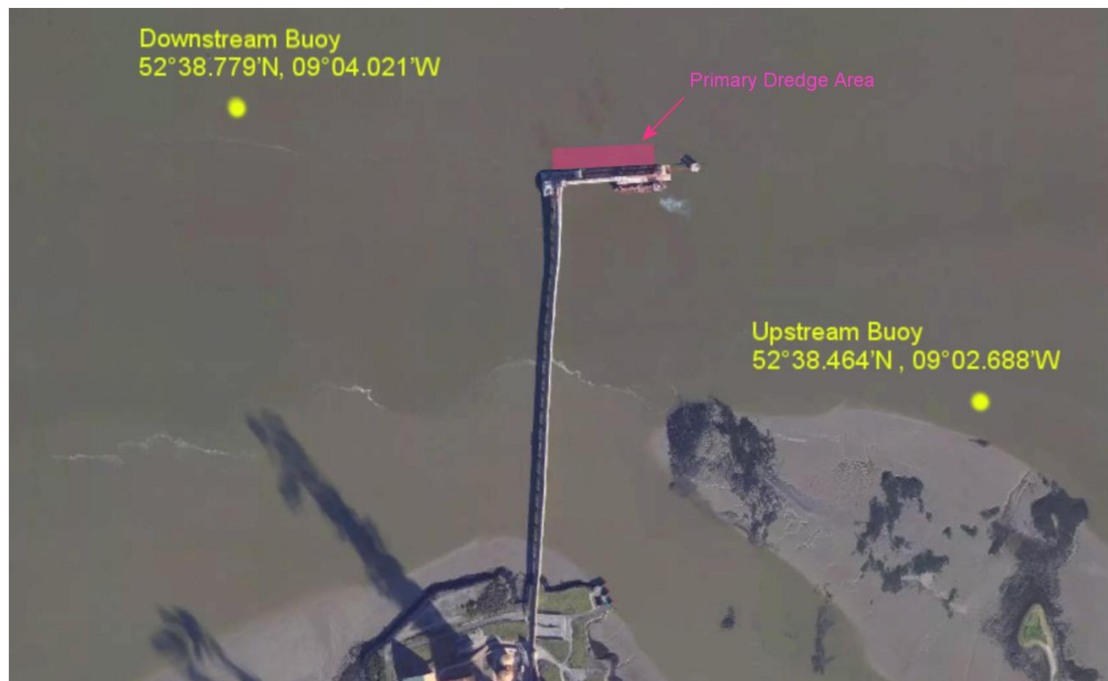
IDS deployed two IDS DB150 data buoys at the locations shown in Figure 2. Both systems were fitted with Ponsel Nephelometers. Calibration data for the instruments have been provided separately to this report. The buoys were solar powered and the data acquisition system is the IDS DataPOD with GSM/GPRS. Both Systems were fitted with an IDS LGWiper for antifouling purposes, and these were programmed to wipe every hour and synchronised so as not to interfere with sampling.

The systems were deployed on 1<sup>st</sup> July 2025 on a chain mooring with 1.1 Tonne anchor weights. This original mooring design was selected so that the buoys could be deployed safely from the IDS contracted vessel.

Figure 2 – Site Map showing position of the deployed buoys and the primary dredge area.

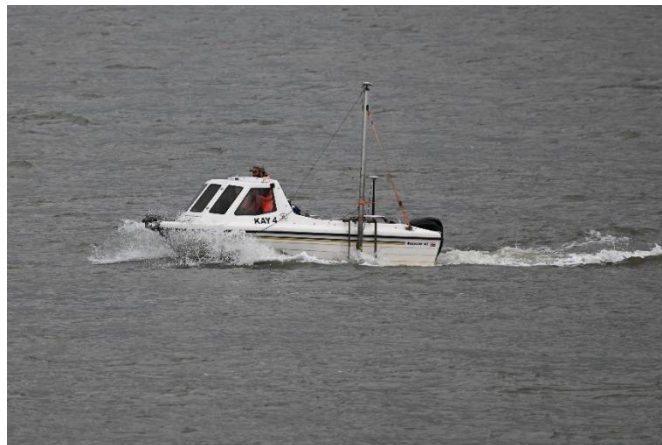
The geophysical surveys were conducted by Hydromaster Ltd. and involved using a Norbit Winghead multibeam echosounder (MBES) to map the seabed pre and post dredging operations at Dredge Sites A and B. This equipment operates at a frequency of 400kHz. There is no sound output data for this equipment publicly available. As per the licence requirements, a 20-minute ramp-up before start of full noise output was carried out. Due to the operational parameters of the equipment a progressional build-up of power was not possible. To avoid damage to the equipment a ramp-up was implemented where the equipment was turned on and off for five minutes sequentially, for 20-minutes, before continuous noise output began. All geophysical survey operations were conducted from a 4.3m small boat, the *Warrior* (see Figure 2).

*Figure 2. The 'Warrior' conducting a geographical survey using a multibeam echosounder (MBES) in Dredge Area A.*

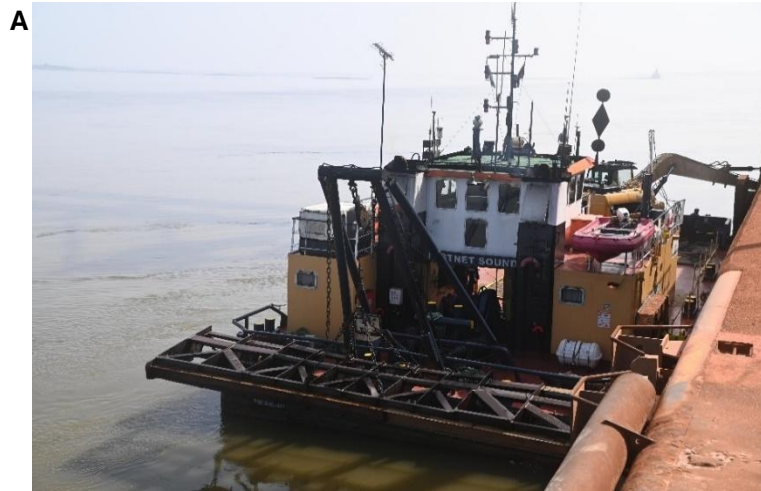
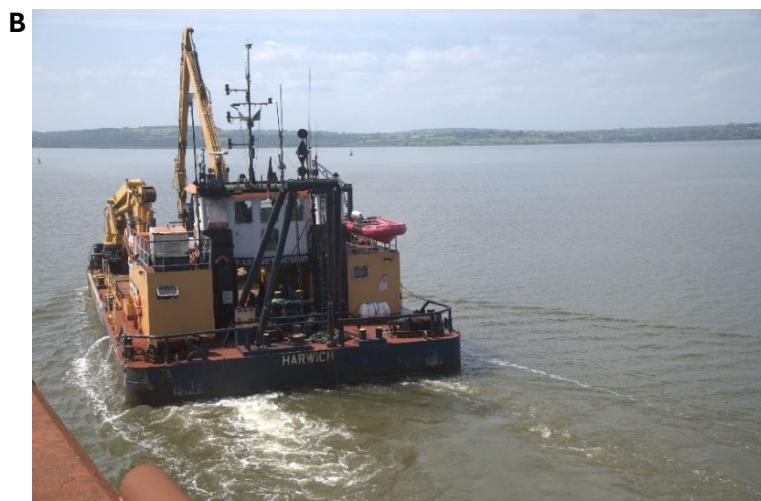
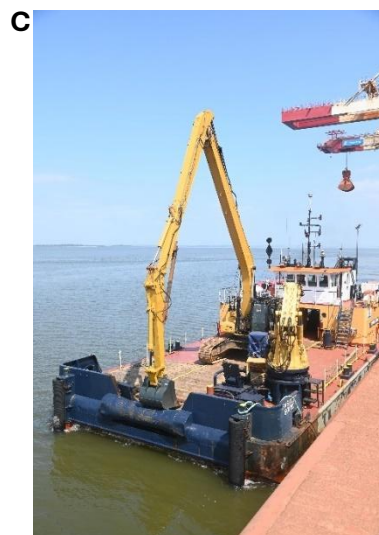
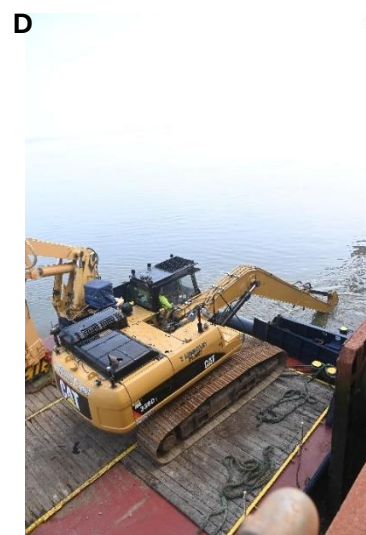
At Dredge Site B the area was excavated during hours of high tide and day light hours. Ploughing operations were also restricted to outside of low tide. Operations were not possible to be continuous on a 24/7 basis due to the tidal restrictions. When operations stopped during the night for more than 30-minutes they did not commence again until the next day, subject to 30 minute pre-watch by the on duty MMO. All dredging operations were conducted from the *Fastnet Sound*, a utility vessel (length 27.05m, width 10.8m), which can be seen in Figure 3.

Figure 3. Ploughing operations at the Aughinish Alumina marine terminal jetty. (A) the bed levelling unit is raised here, this is used for ploughing operations, (B) the Fastnet Sound carrying out ploughing operations, the bed levelling unit is dropped to the sea bed (C) & (D) excavating operations being conducted from the Fastnet Sound by the long arm tracking machine.

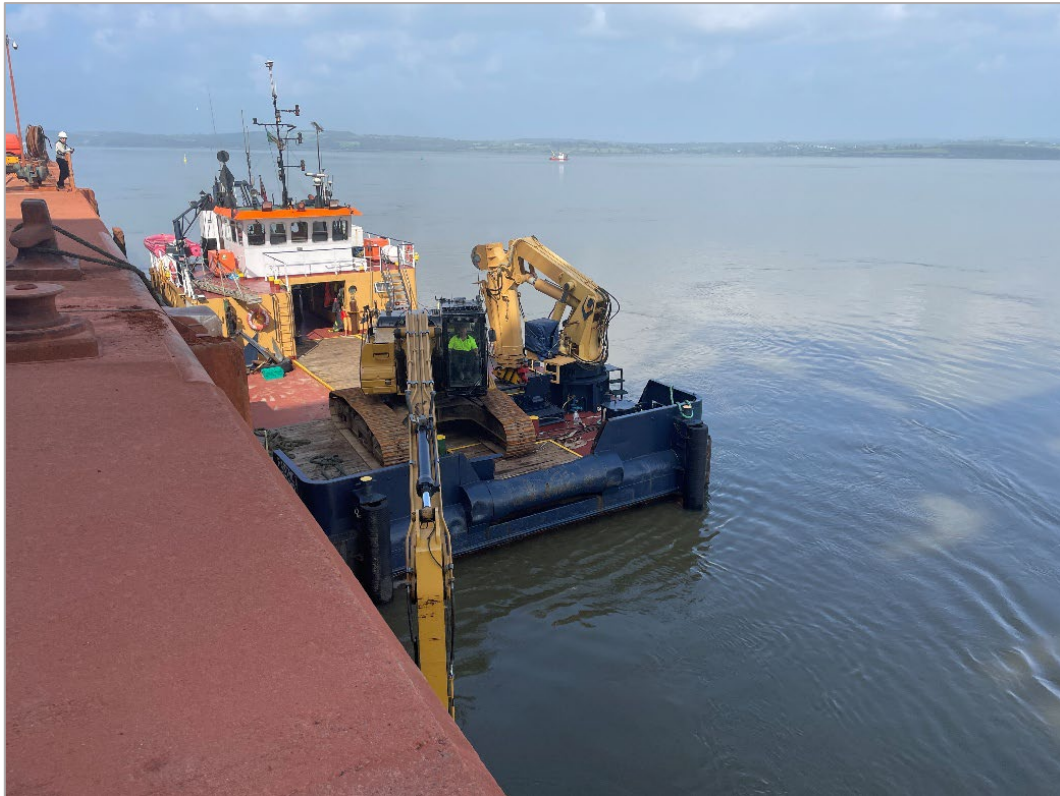
Area A was dredged for a total of nine days and Area B (Cells) was dredged for five days. Nothing of archaeological significance was discovered. In Area B there was occasional modern debris found.

*Plate 1: Area A machine dredging*

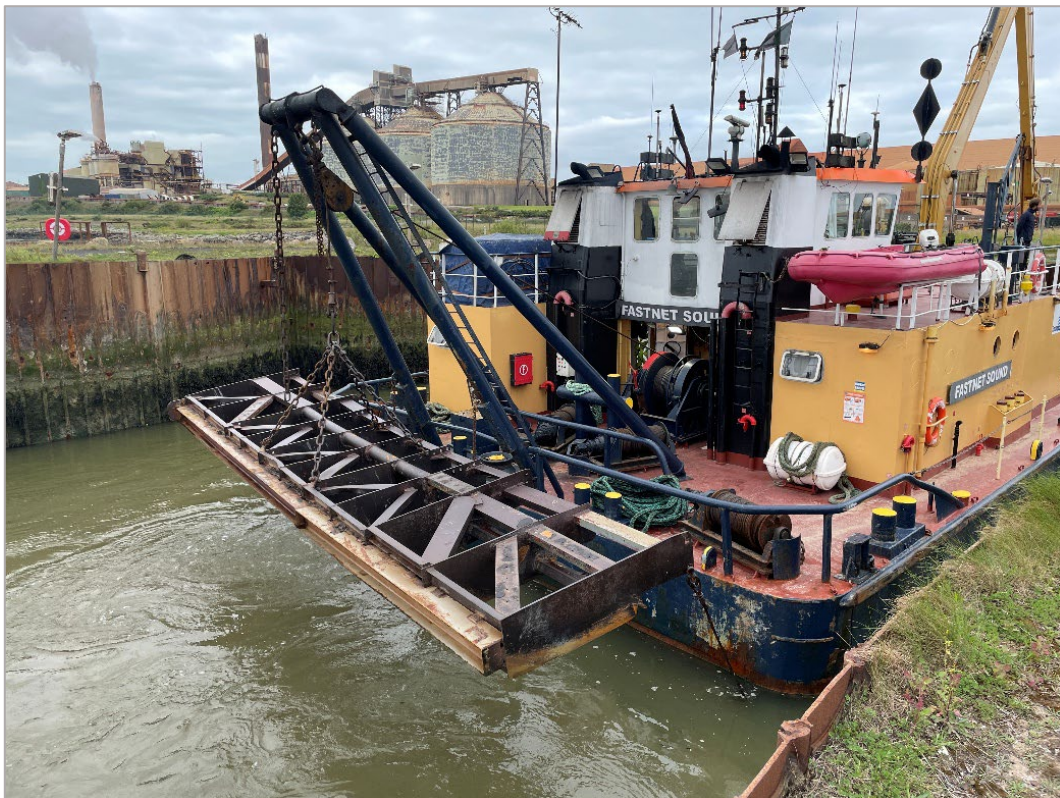
*Plate 2: Area B (Cells) with plough dredge in view*
