Irish Cement Ltd.  
Integrated Pollution Control License Register Number P0030-04.

# AQUATIC MONITORING OF THE RIVER NANNY NEAR DULEEK, CO. MEATH

## 2018 Report

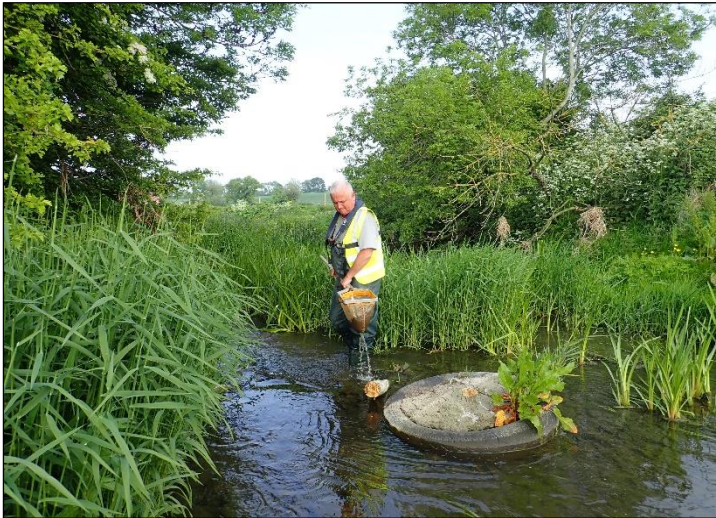
**Plate 1** Kick sampling at Site N1: receptor riffle site. Site was heavily silted with excessive algae growths.

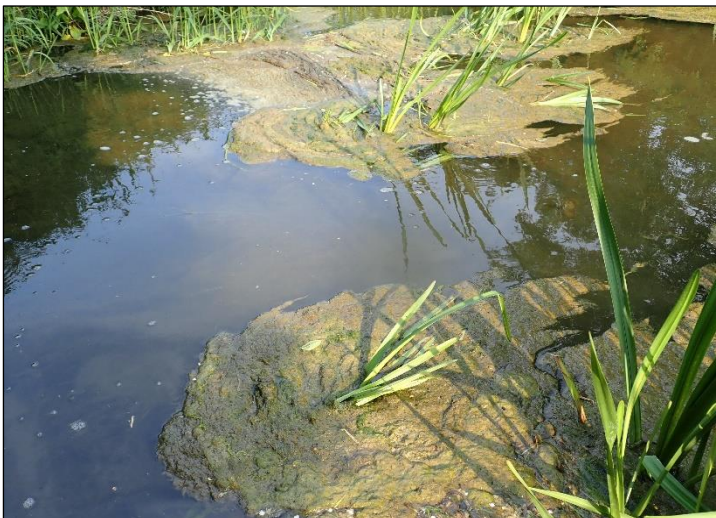
**Plate 2** River Nanny was visibly polluted at all sites; excessive algae growths and siltation at Site N1.

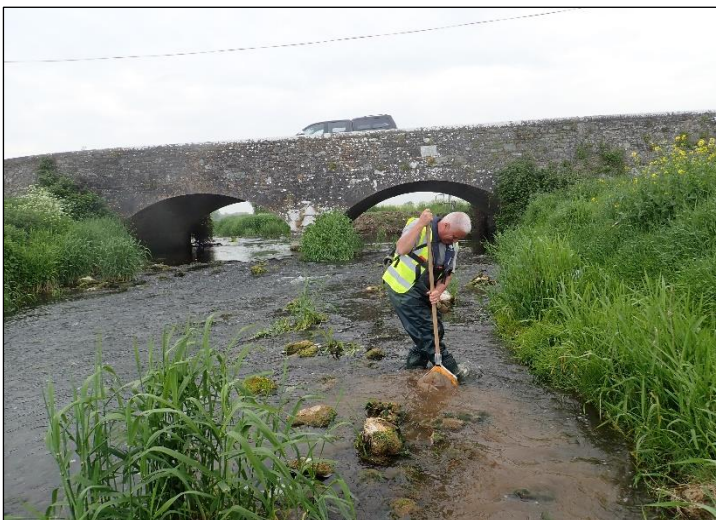
**Plate 3** Kick sampling at Site N6: reference riffle site. Note plume of silt.

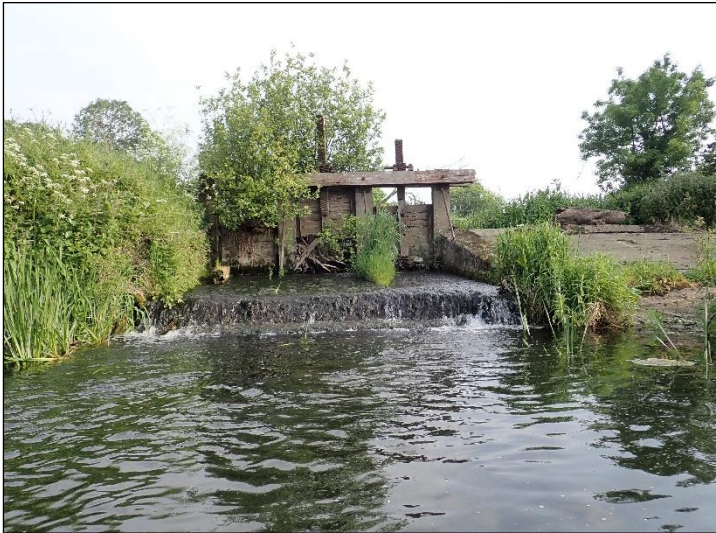
**Plate 4** Weir upstream of Site N1 ponds water and also reduces the flow at Site N1.

Overall the entirety of the study area showed extreme siltation. This is made worse at sites N2 and N3 due to the presence of the weir which causes ponding increasing siltation even more at these sites. Previous wet years have brought silt down the river which during the drought when samples were taken had settle along this stretch and river flow was not enough to dislodge it. Toxicology testing was carried out on two different aquatic species both from trophic levels using trade effluent from the Irish Cement plant. Toxicology test results showed that the effluent is non-toxic to the organisms tested. It is considered therefore that the discharge from the Irish Cement plant to the River Nanny does not adversely affect the aquatic ecology within the River Nanny. This is supported by the results of the macroinvertebrate analyses.

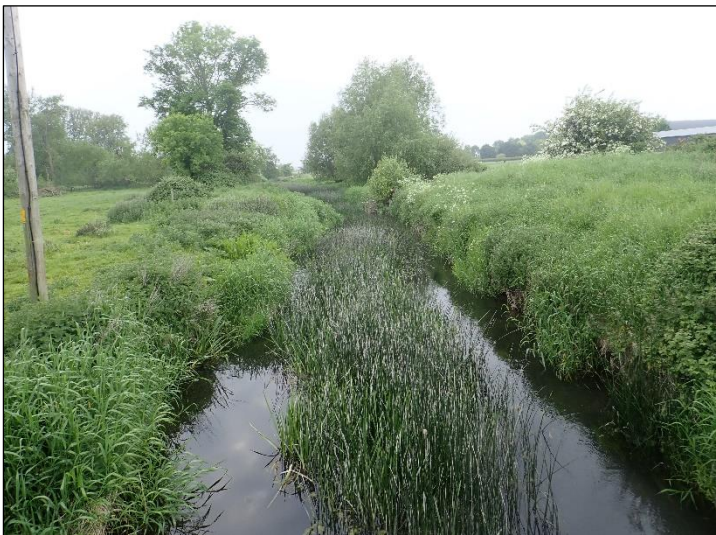
**Plate 5** River Nanny old headrace which diverts water around site N1.

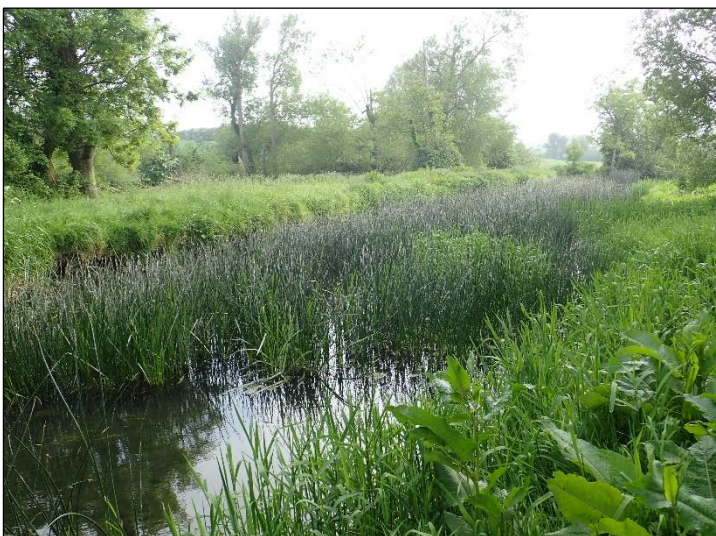
**Plate 6** River Nanny at Site N2 which is partially ponded by weir. Excessive in-stream growth of reeds apparent. Site was also heavily silted with excessive algae growths.

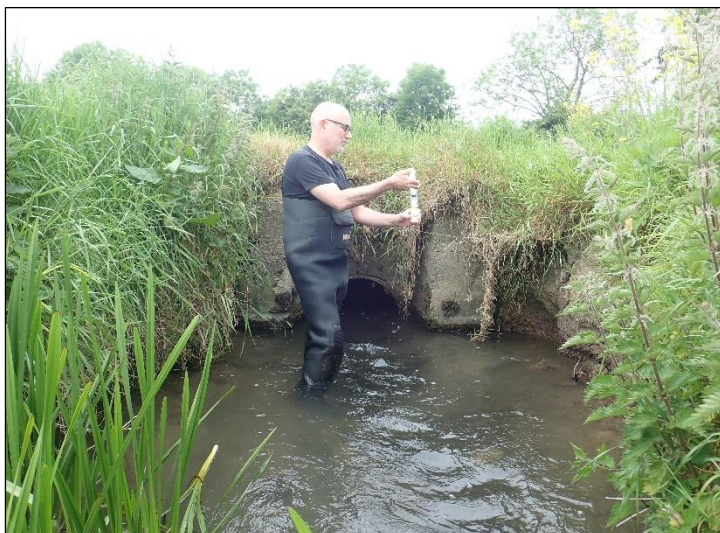
**Plate 7** Irish Cement trade effluent outfall to the River Nanny. The outfall stream was visibly cleaner than the receiving water.

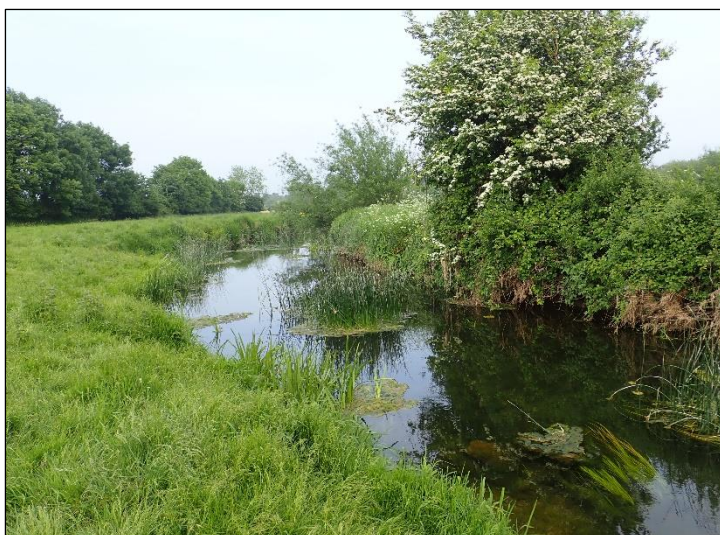
**Plate 8** River Nanny, Site N5. There was less reed growth upstream of the outfall, but it was considered that this was related to flows and depths (and the ponding influence of the weir).

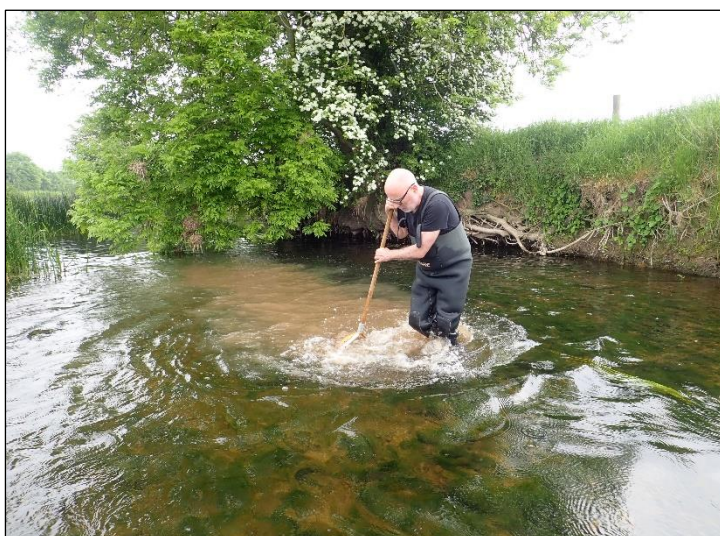
**Plate 9** River Nanny, Site N4. Again, note the plume of silt

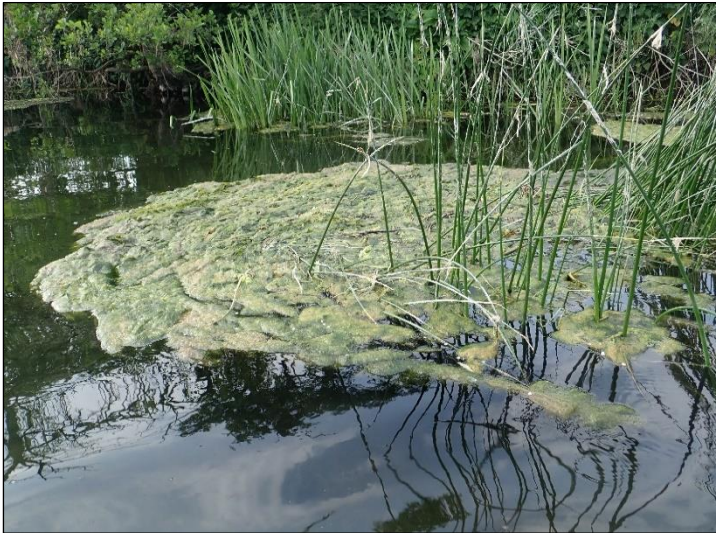
**Plate 10** Excessive filamentous algae growth was recorded at all sites.

All the BMWP scores were less than 100 which is indicative of unsatisfactory water quality. The reduced BMWP scores coincided with observations of filamentous algal growth and excessive siltation along the surveyed stretch of the river. Filamentous algae growth and heavy siltation was recorded at all sites. BMWP scores are proportional to family diversity and the highest score of 90 was at Site N5, corresponding to the category 'Good' and 'Clean but slightly impacted' conditions using BMWP interpretation. It is noted however those macroinvertebrate assemblages in lowland limestone rivers are usually high with respect to BMWP sometimes even in polluted circumstances. Therefore, this interpretation of macroinvertebrate diversity may be misleading. Water quality at all these locations are categorised as 'Moderate'/'Moderately impacted' with the exception of N6 which like N5 was categorised as 'Good' and 'Clean but slightly impacted'. The Average Score per Taxon (ASPT) which is a function of the BMWP score is deemed to more accurately gauge water quality. An ASPT of more than 5.5 is thought to reflect good water quality. Overall, analyzing the ASPT scores over the study area does not point to a significant decrease in water quality at Sites N1, N2 and N3 with reference to Sites N4, N5 and N6.

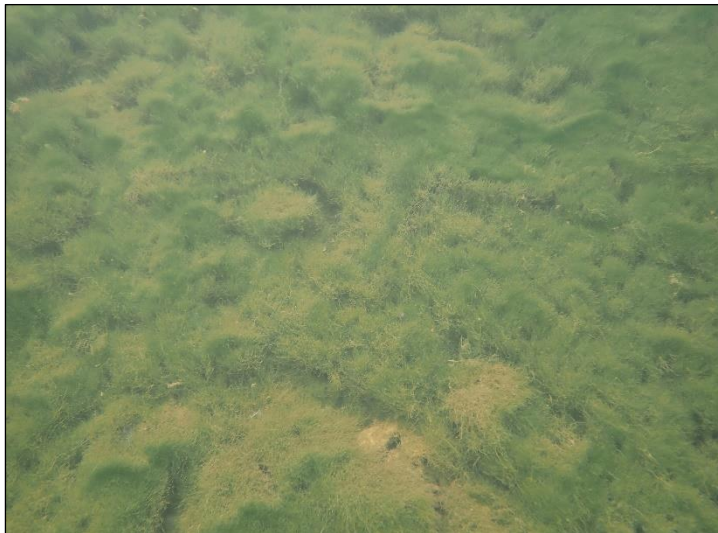
**Plate 16** Typical river substrate at Site N3, downstream of the outfall.

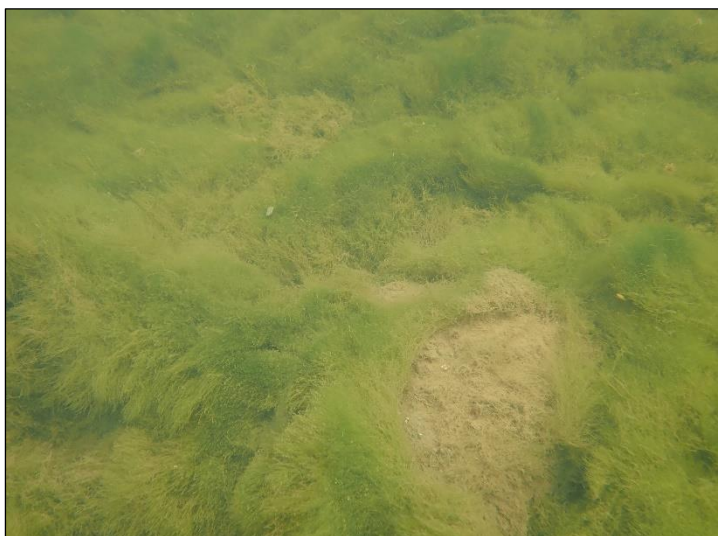
**Plate 17** Typical river substrate at Site N4, upstream of the outfall.

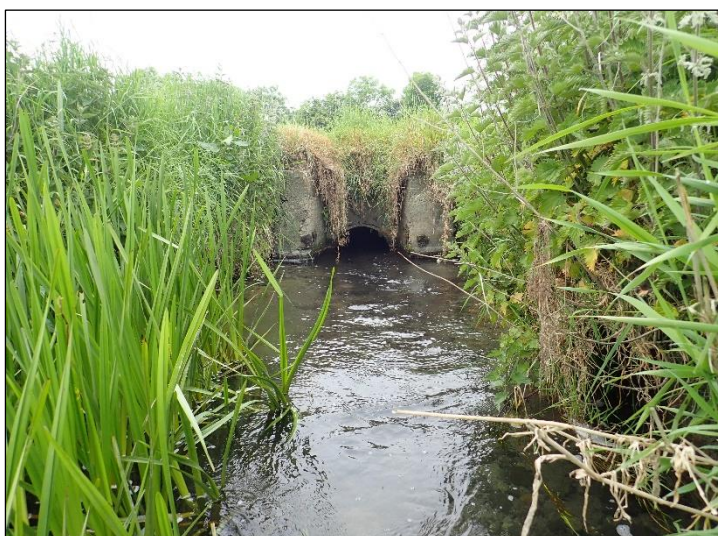
**Plate 18** The outfall stream was visibly cleaner than the receiving water.

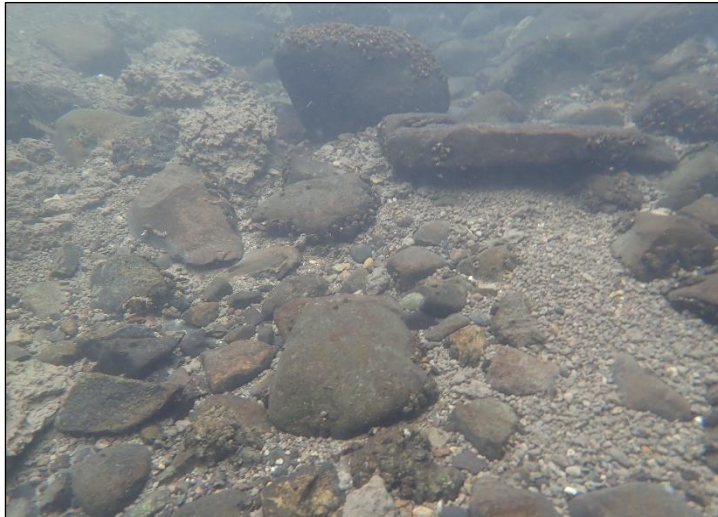
**Plate 19** The outfall had clearly better water quality than the River Nanny with relatively clean substrate and no excessive siltation and algal growths present. Good numbers of caddisfly larvae on the stones.

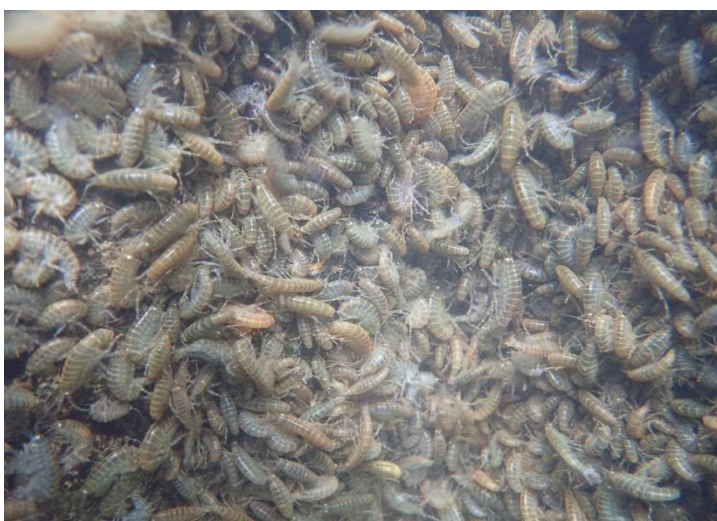
**Plate 21** Significant numbers of *Gammarus spp.* on the wall of the outfall. They were trying to migrate upstream into the pipe – presumably due to the better water quality in the outfall – but the flow from the pipe was too high for them to enter so they accumulated downstream like this.

The high BMWP scores and family abundances at sites N5 and N6 can be attributed to the high quality of physical habitat present here with a pronounced riffle and complex substrate that is not present in the other sites due to several reasons one of which is the presence of a weir between sites N2 and N1 with causes artificial ponding around sites N2 and N3 and an increase in emergent vegetation. Also due to the weir, site N1 doesn't receive the full flow of the river and at the time of sampling due to low water levels was only receiving half flow. This difference in physical habitat makes the sites less comparable. In and around the discharge point there was no algal growth and no siltation. Thousands of *Gammarus deubini* were attempting to migrate up the discharge pipe which can be seen from Plate 21. There were also good numbers of Caddisfly larvae on

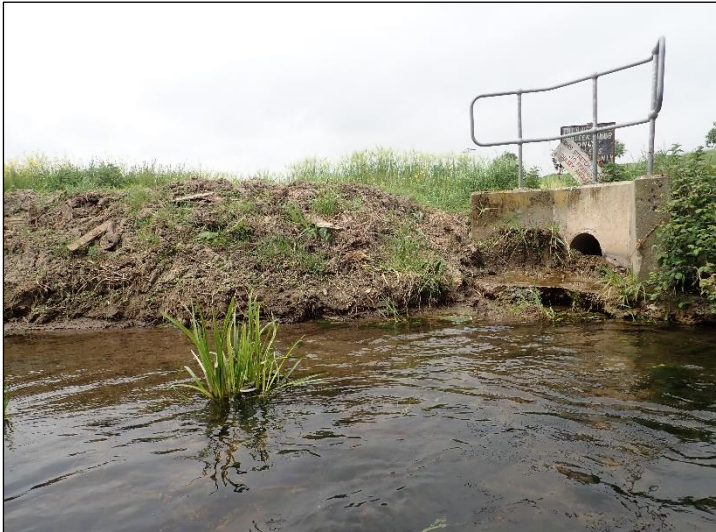
**Plate 22** Bank maintenance works on the River Nanny upstream of Site N6.

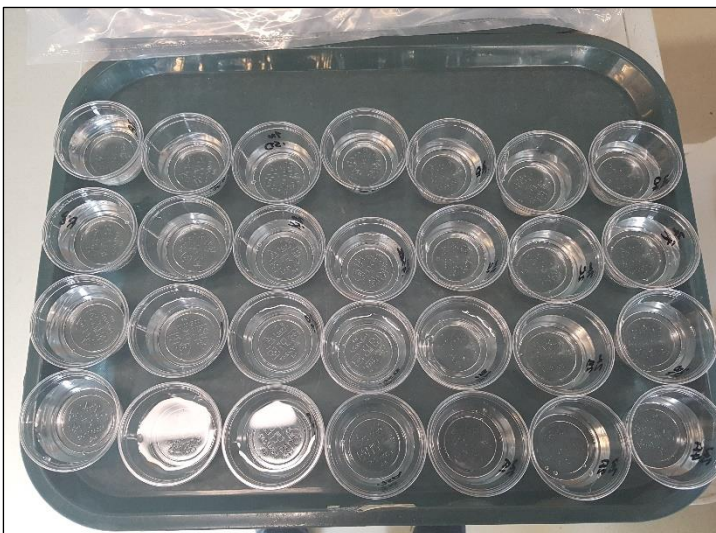
**Plate 23** *Daphnia magna* 48 h EC<sub>50</sub> test

This test was deemed to be valid given that there was greater than 90% survival in the controls indicating that the animals and testing conditions were satisfactory (UK Environment Agency, 2007). Survival across the concentration series of effluent was between 95 and 100% demonstrating that the effluent is non-toxic to *D. magna*. No LC<sub>50</sub> value was generated for this bioassay due to the non-toxic nature of the effluent. Results of this bioassay are displayed in Figure 2. Water quality measurements in the test chambers remained within normal limits for the duration of the bioassay. These data are presented in Appendix 4. The *Daphnia magna* 48 h EC<sub>50</sub> test is shown in Plate 23.

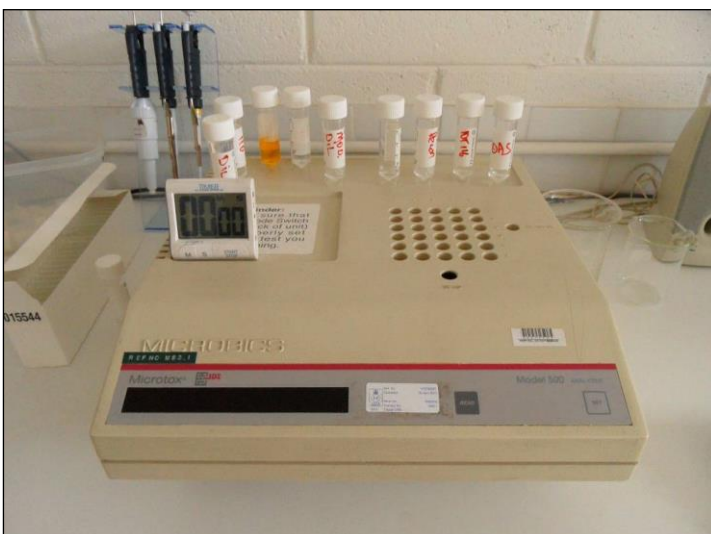
**Plate 24** Temperature controlled photometer apparatus used to test for bioluminescence of *Vibrio fischeri* in the 30 min EC<sub>50</sub> test.

The Microtox bioassay carried out was deemed to be valid. A reference toxicant test was carried out before actual testing of samples took place to ensure that the bacterium and reagents were suitable for testing. The reference toxicant using the Zinc++ ion determined an EC<sub>50</sub> of 1.3 mg Zn<sup>++</sup>/L after 15 minutes exposure. This is within the guideline range of 0.6-2.2 mg Zn<sup>++</sup>/L as specified by the Microtox manufacturer (Azur Environmental, 1995). These data are presented in Appendix 5. Equipment used for this test is shown in Plate 24.
