**BIOLOGICAL WATER QUALITY MONITORING OF THE RIVER
GREESE IN THE VICINITY OF GLANBIA IRELAND FACILITY,
BALLITORE, CO. KILDARE**

Client	Fitz Scientific
Project	Biological monitoring of water quality of the River Greese in the vicinity of Glanbia Ireland facility, Ballitore, Co. Kildare
Report No.	21103/F
Date	30/09/21
Status	Final
Prepared by	Helena Twomey BA(Mod), PhD
Reviewed by	Bill Quirke BSc, MSc, MCIEEM

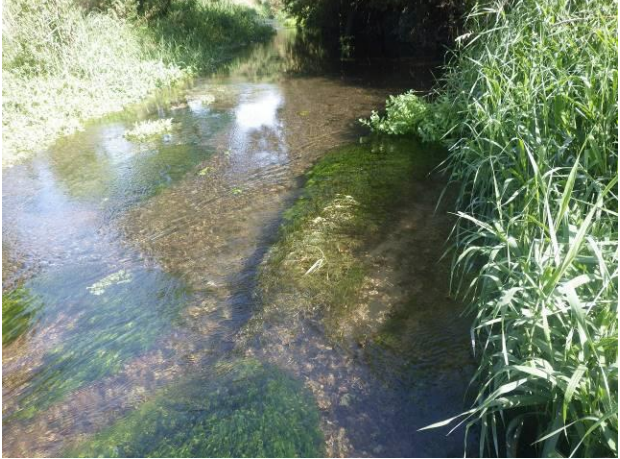
SITE SW1A

Site Location	u/s footbridge
Grid Reference	S 79625 96272
Site Photograph

Width (m)	8
Depth (cm)	15-20
Substrate (in order of dominance)	Gravel, Sand
Flow Type	Riffle 10% Glide 90%
Instream Vegetation	Filamentous algae 5% <i>Ranunculus penicillatus subsp. penicillatus</i> 20% <i>Nasturtium officinale</i> agg. 10% <i>Veronica anagallis-aquatica/catenata</i> 5% <i>Phalaris arundinacea</i> 5%
Dominant Bankside Vegetation	Hawthorn, <i>Phalaris</i>
Summer Shade of Stream by Bankside Vegetation	5%
Salmonid Adult Habitat	Fair
Salmonid Nursery Habitat	Fair - Good
Salmonid Spawning Habitat	Fair
Lamprey Nursery Habitat	Fair - Good

Lamprey Spawning Habitat	Fair
Crayfish Habitat	Fair - Good

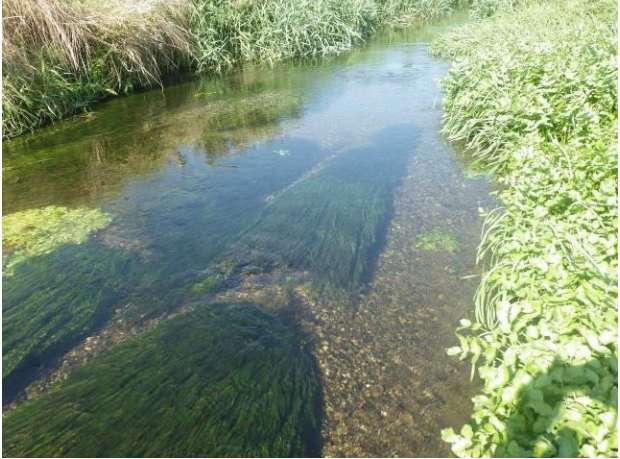
SITE SW3

Site Location	c.100m d/s bridge
Grid Reference	S 79681 95938
Site Photograph

Width (m)	7
Depth (cm)	25 - 40
Substrate (in order of dominance)	Gravel, Sand, Silt
Flow Type	Glide 100%
Instream Vegetation	<i>Ranunculus penicillatus subsp. penicillatus</i> 30% <i>Veronica anagallis-aquatica/catenata</i> <5% <i>Glyceria fluitans</i> agg. 10% <i>Apium nodiflorum</i> 10% <i>Nasturtium officinale</i> agg. 5% <i>Callitriche</i> sp. <5% <i>Phalaris arundinacea</i> <5% <i>Lemna minor</i> <1% <i>Oenanthe fluviatilis</i> <1%
Dominant Bankside Vegetation	<i>Phalaris</i> , <i>Apium</i> , Watercress
Summer Shade of Stream by Bankside Vegetation	<5%
Salmonid Adult Habitat	Good - Fair
Salmonid Nursery Habitat	Poor - Fair

Salmonid Spawning Habitat	Fair - Poor
Lamprey Nursery Habitat	Fair
Lamprey Spawning Habitat	Poor - Fair
Crayfish Habitat	Fair - Good
