Pipe, Tank & Groundwater Assessment

Cooligboy Pig Farm, Cooligboy, Timoleague,
Co. Cork.

Date: 17th January 2022

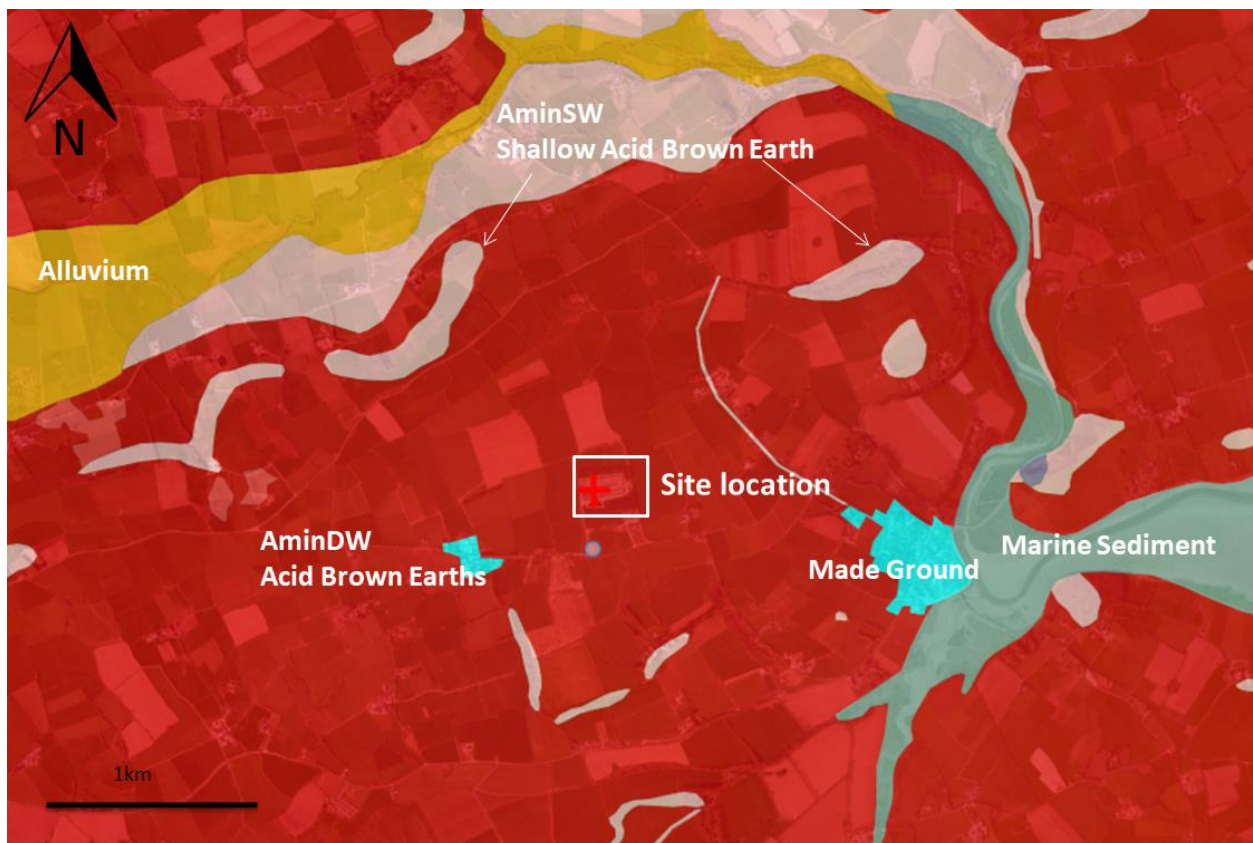
Figure 2: Regional Soil Mapping (EPA, 2021)

The EPA/Teagasc soil mapping shows that the site is situated on AminDW, which is described a deep, acidic, well drained mineral, derived from mainly non-calcareous parent materials. AminSW lies to the north and in pockets around the site. This is defined as acidic, shallow, well drained mineral, derived from non-calcareous parent materials and can include some outcropping rock (EPA, 2021).

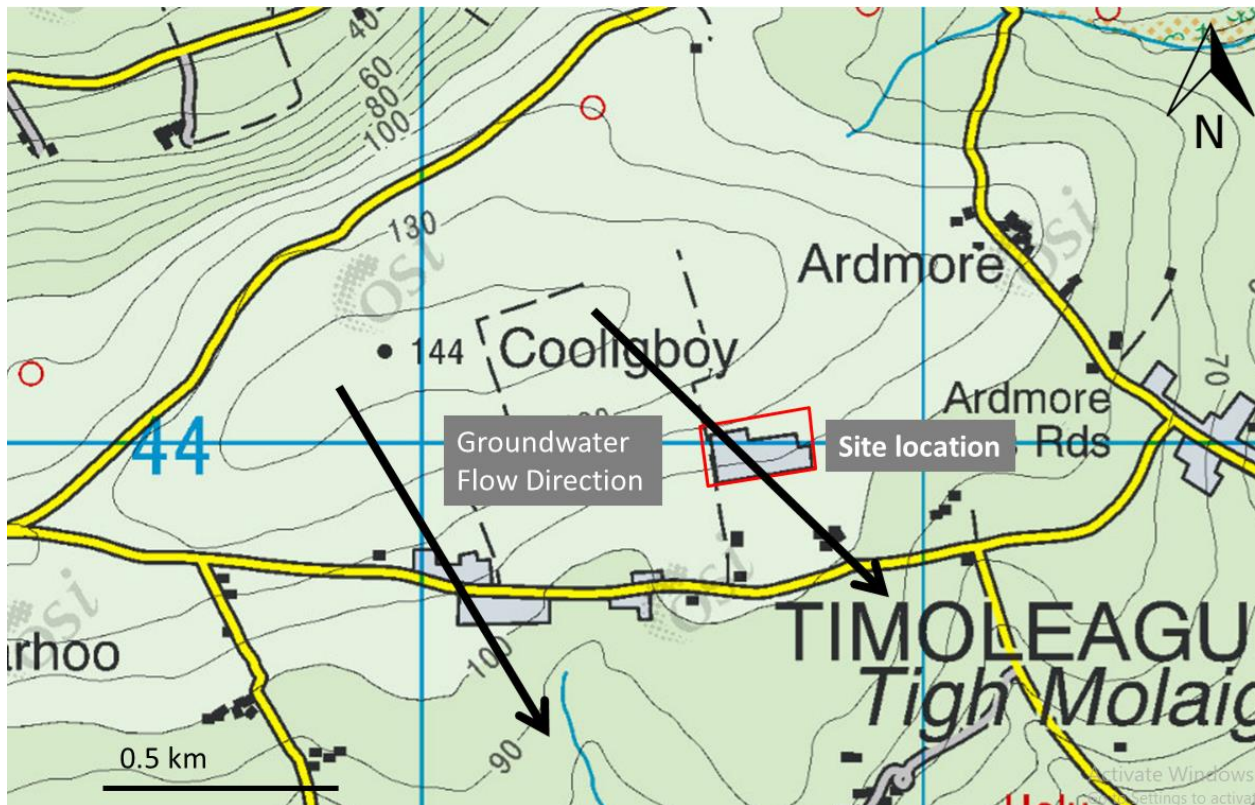
Figure 6: Groundwater Flow Map (OSI, 2021)

There was no current information available on the groundwater levels across the site. However, the groundwater flow direction has been inferred from OSI topographical mapping. The groundwater flow direction is understood to be towards the south-southeast at the site, towards the Argrideen River. The

previous tank and pipeline assessment (June 2010), used water level monitoring in wells AGW1 and AGW4 which confirmed this flow direction.

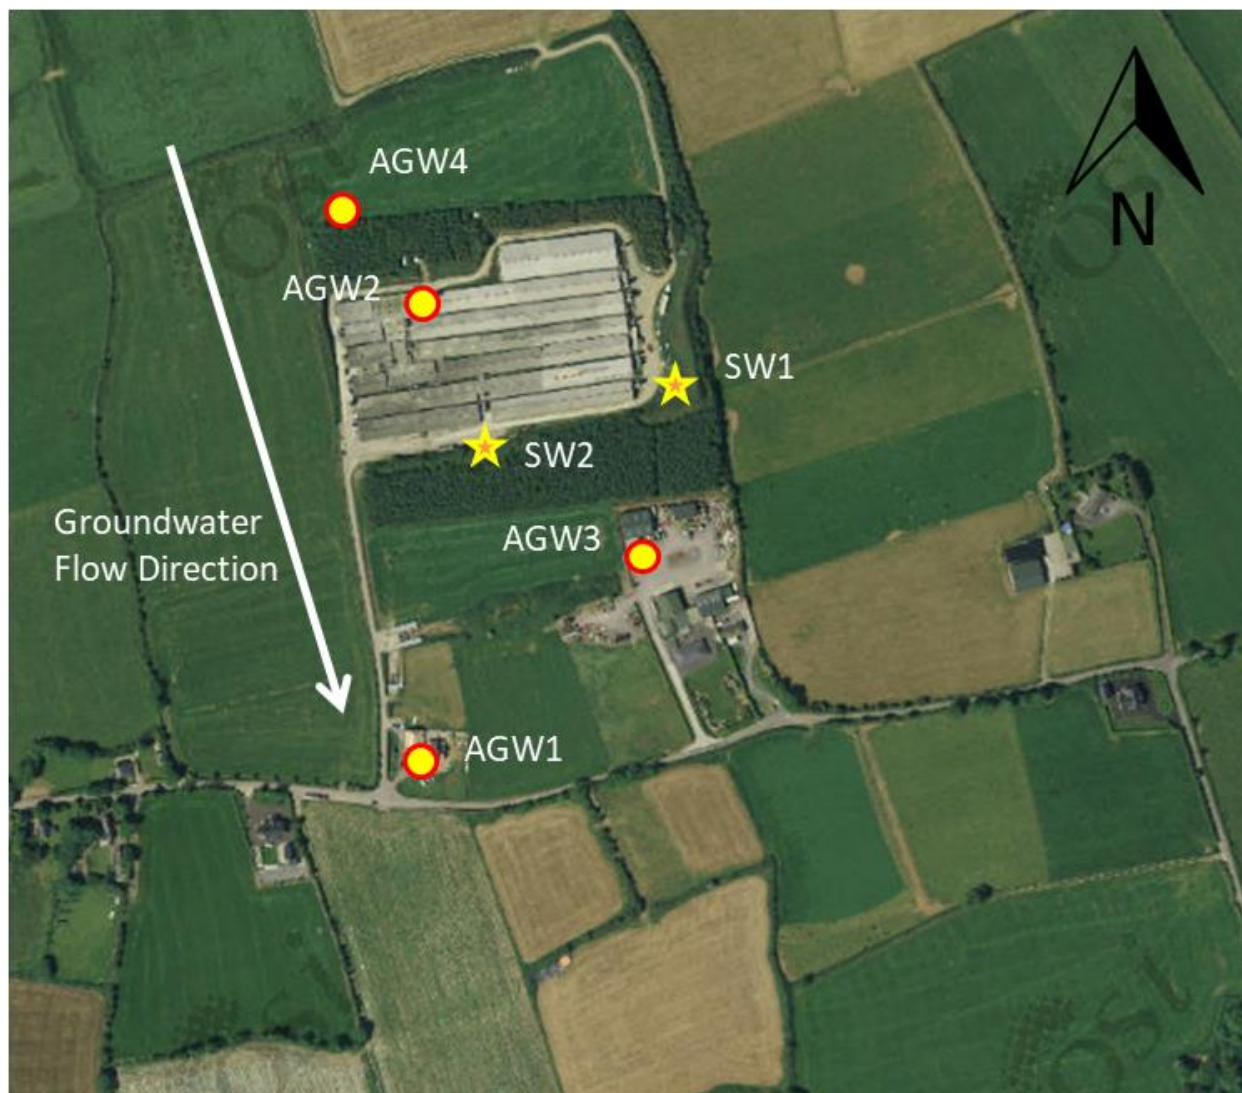
Figure 7: Site Wells (OSI, 2021)

AGW4 is located up-gradient of the piggery site, and can be considered to be representative of background water quality.

AGW1 & 3 are located down-gradient of the site at 218m and 152m respectively to the south of the main pig houses, and are located adjacent to Martin O Donovan's family dwelling, and they are in constant use for farm and domestic supplies. These could detect contamination originating from the piggery operations within the zone of contribution of the well.

AGW2 is the main production well for the site and located along the site's hydraulic mid-gradient, and can detect leaks or spills from tanks on-site because of a developed ZOC.

Surface water is monitored on site at two storm water monitoring points (SW1 and SW2). Their locations are shown in Figure 7 above. SW1 and SW2 have been in place since 2006 and 2013 and measure chemical oxygen demand (COD) quarterly.

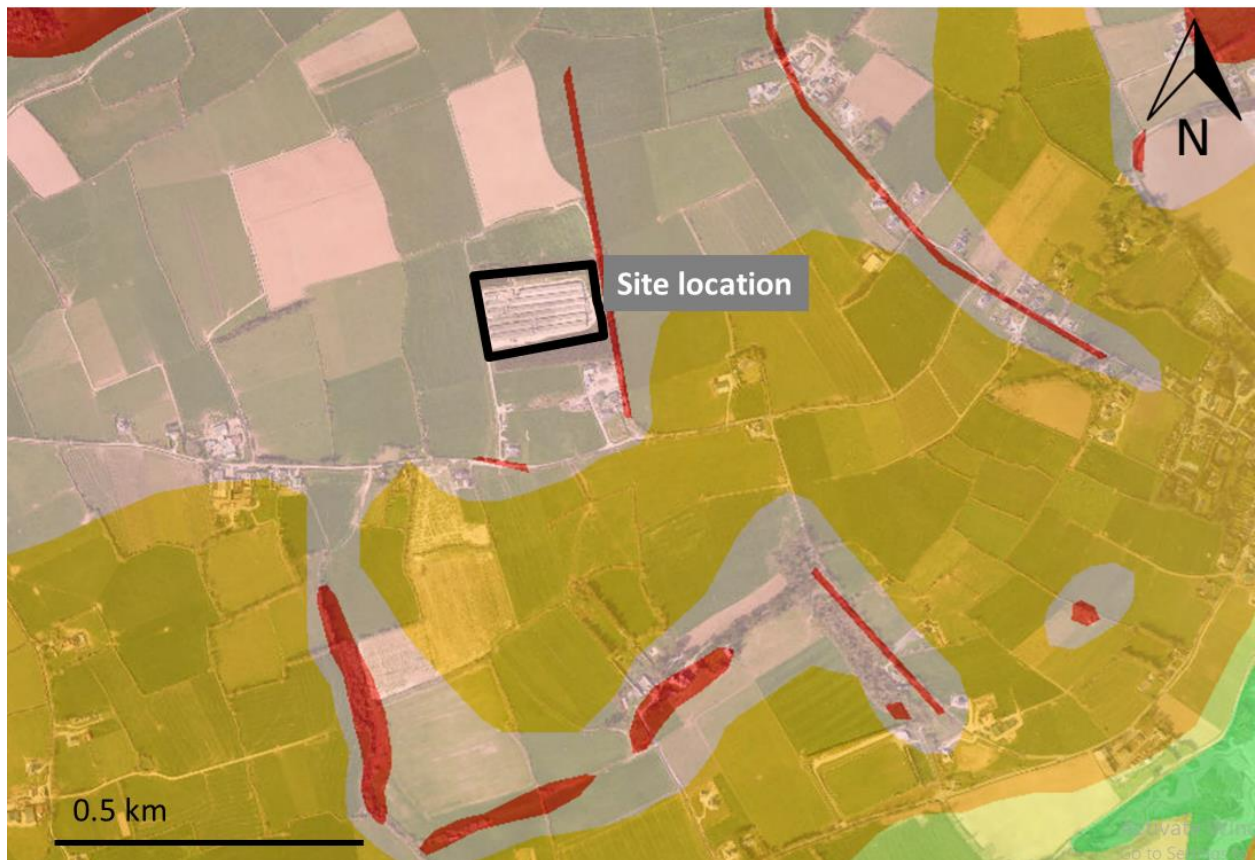
Figure 8: Groundwater Vulnerability Mapping (GSI, 2021)

The GSI Groundwater Vulnerability Mapping was reviewed. The piggery site sits within an area of **Extreme Vulnerability** (GSI, 2021).

These classifications typically indicate that the depth to bedrock is at within 0-3 m of the surface. Logs for the wells onsite indicate that the true depth to bedrock is between 4.6 m - 3.7m (Table 7).

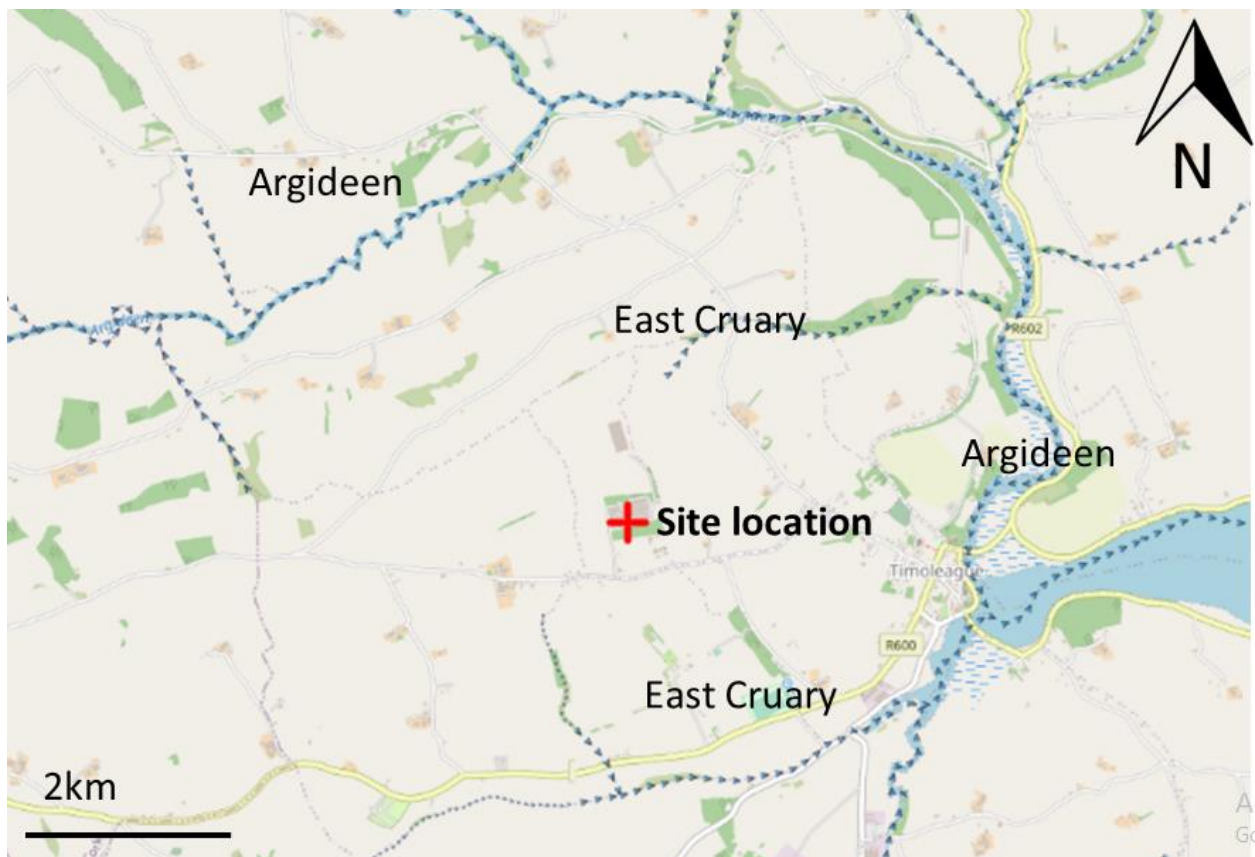
Figure 9: Hydrological features around the site (EPA, 2021).

The Argideen River is the main drainage feature in the area surrounding the piggery site, and is located 1.61 km north and then curves around to be 1.44 km to the east of the site. Several smaller tributaries to the river are closer to the site, including the East Cruary tributaries. The Argideen River flows towards the west and south and widens towards the sea to the south.
