Cutaway Bog Decommissioning and Rehabilitation Plan

Knappoge Bog

Two Year Review

October 2025

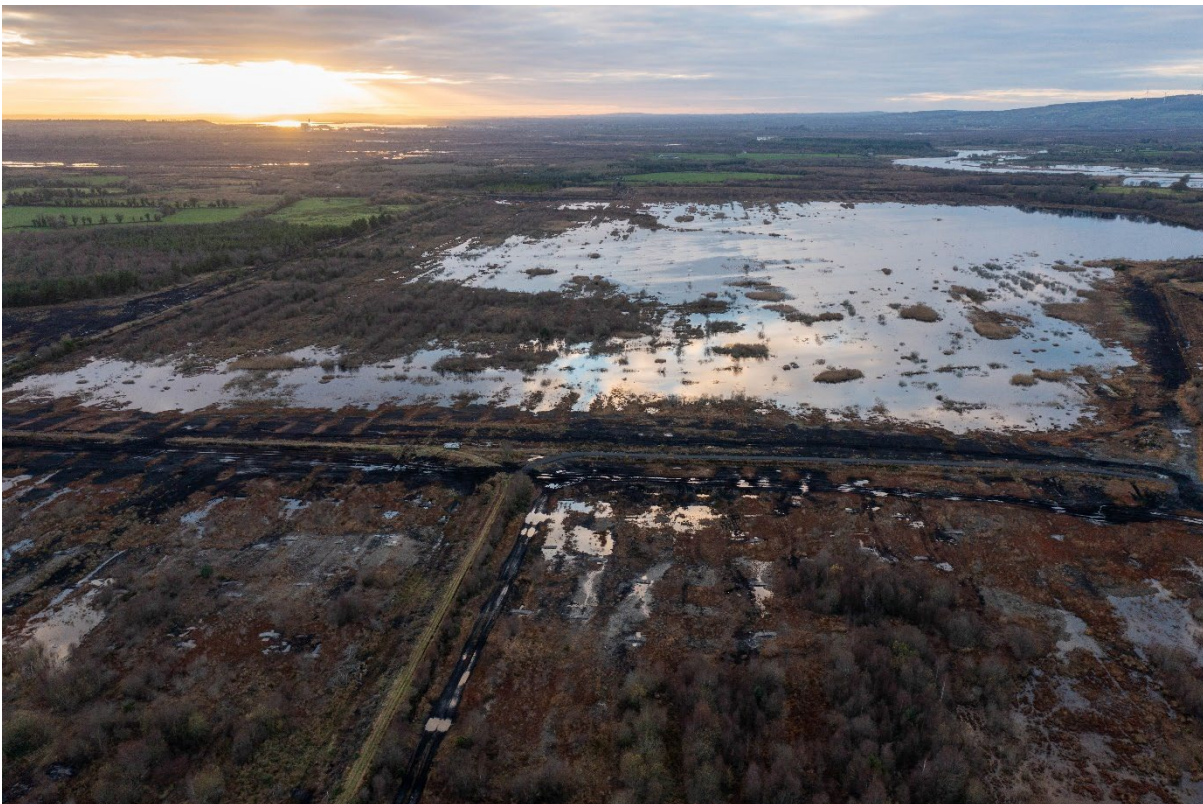
Figure 7.2.1. Knappoge Bog rehabilitation measures – December 2022.

The rehabilitation measures were substantially completed in Knappoge Bog at the end of July 2023. The following figures show some typical images of the rehabilitation measures carried out in Knappoge Bog.

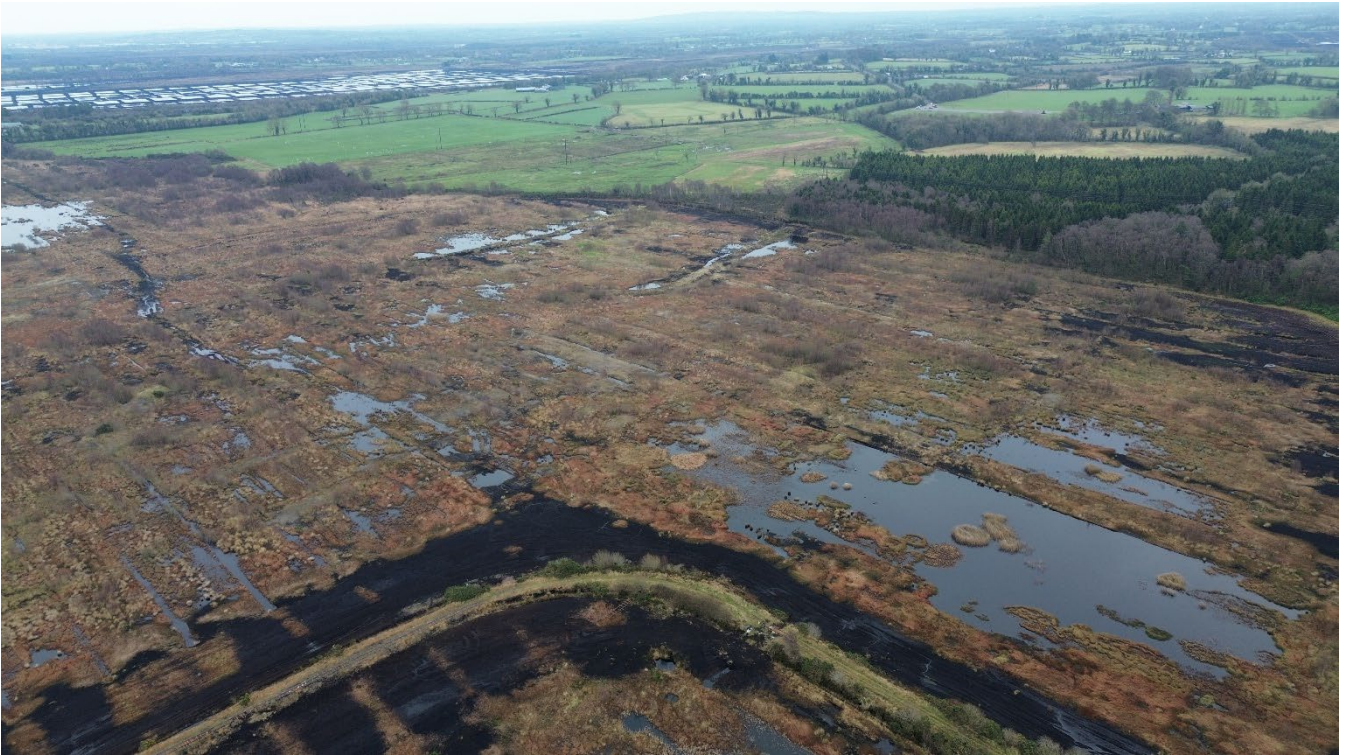
Figure 7.2.2. Knappoge Bog rehabilitation measures – December 2024.

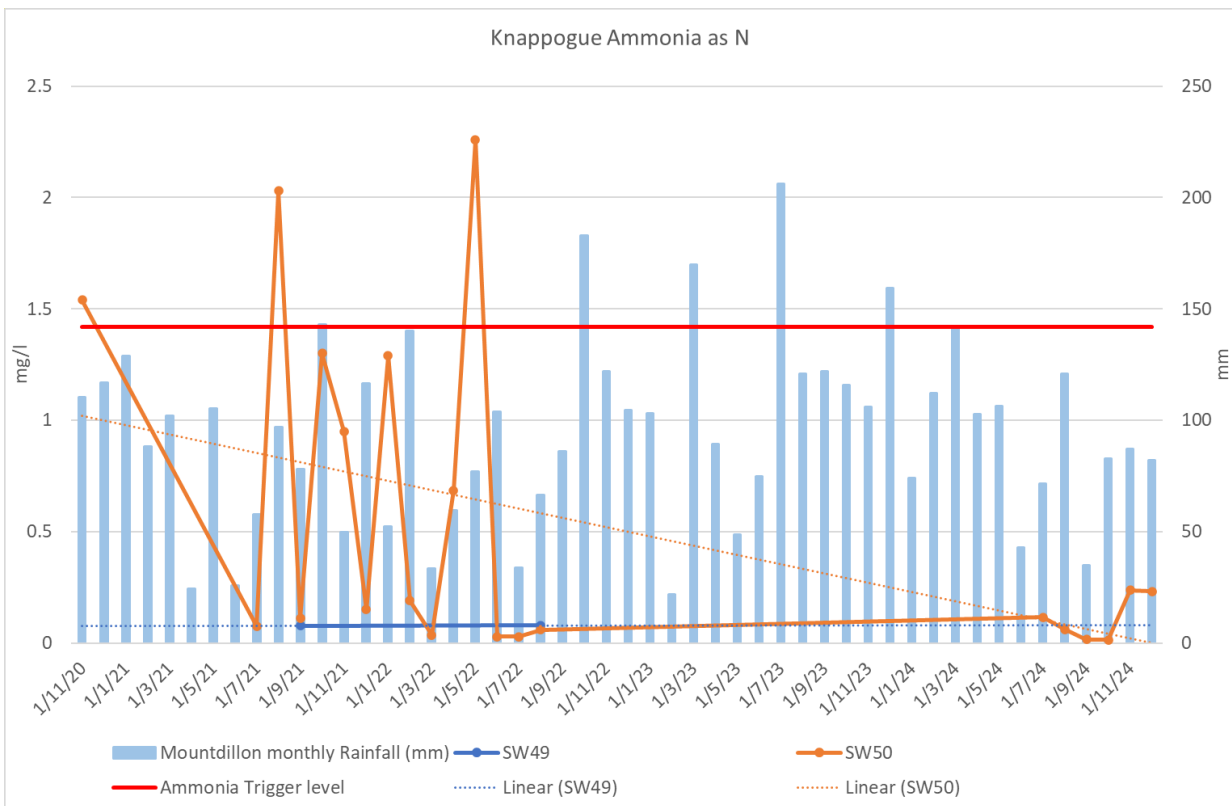
Figure 7.3.1. Knappogue Ammonia monitoring results.

Water quality monitoring commenced in August 2020 and is scheduled to cease 2 years after the completion of rehabilitation at this bog. This monitoring programme may be extended and frequency amended if trends need to be tracked beyond the 2 years. As required under the rehabilitation plan approval conditions, annual water quality monitoring results were submitted to the Agency in August 2023 for the period up to December 2022, with the 2023 results submitted in 2024. These indicated the trends highlighted below, with the majority of relevant parameters indicating no increase in concentration and some showing an improving downward trend. Suspended solids are averaging under 5mg/l from the two emission points measured, with pH showing a slight increasing trend, but would be expected over the longer term to become more acidic as the rehabilitation expands and extends. Apart from initial peaks in Ammonia above the trigger levels in mid-2022, levels seem to have stabilised a lot lower with COD also dropping, despite trending observed in other bogs to the contrary.

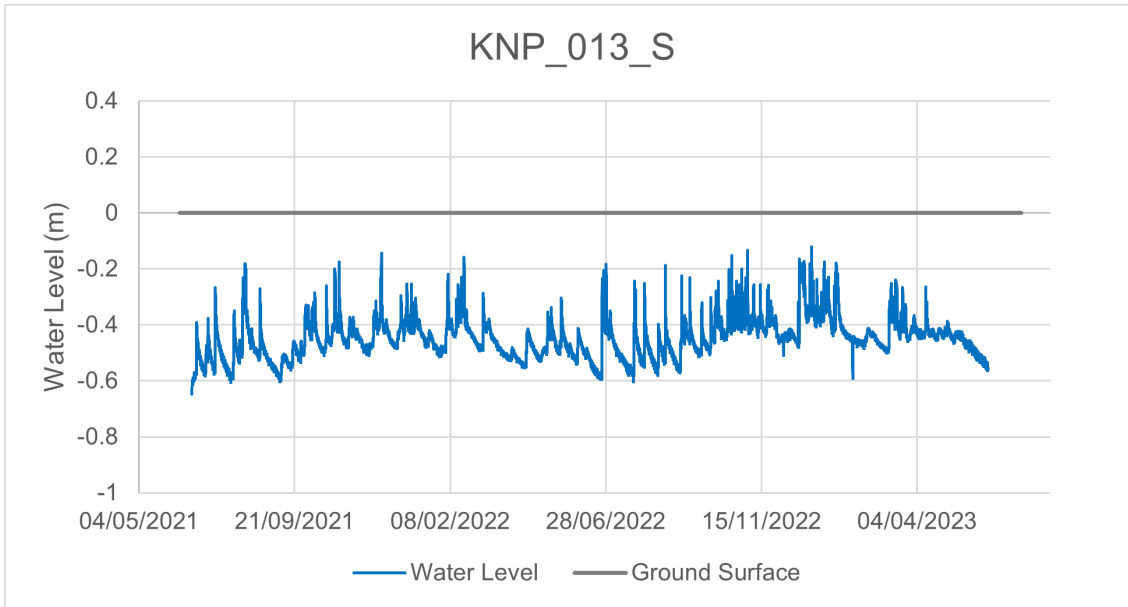
Figure 7.4.2 Hydrograph of the Monitoring Well at KNP_013_S

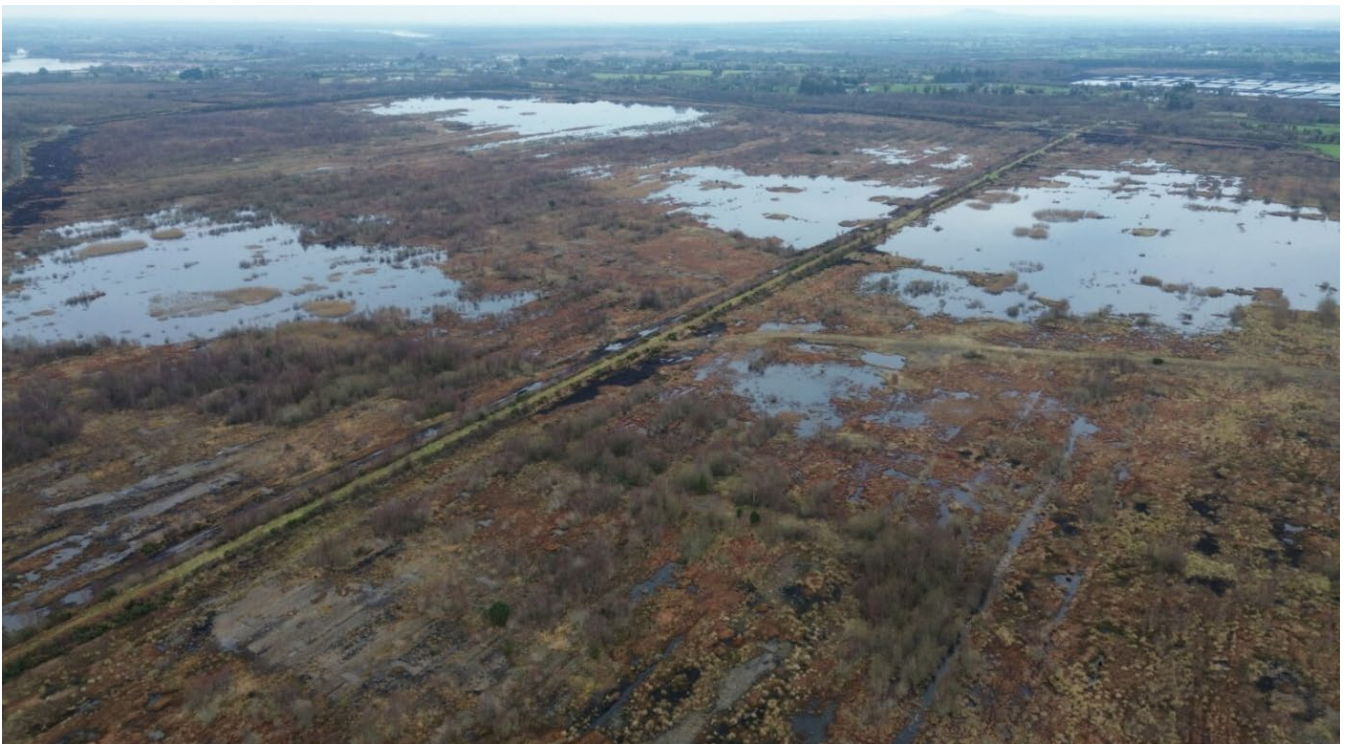
Figure 7.5.1. Typical habitats across Knappoge including large areas of open water and wetland, with fen, along with pioneer vegetation and scrub in drier sections. Most of the site is now colonised. The greenway will be constructed along the former industrial railway (December 2024).
