**A Biological Assessment of the Water Quality of
the River Nore**

May 2019

Prepared by:
Pascal Sweeney M.Sc., MCIEEM,
Sweeney Consultancy,
Rahan,
Mallow
Co. Cork.
Tel. 022/26780

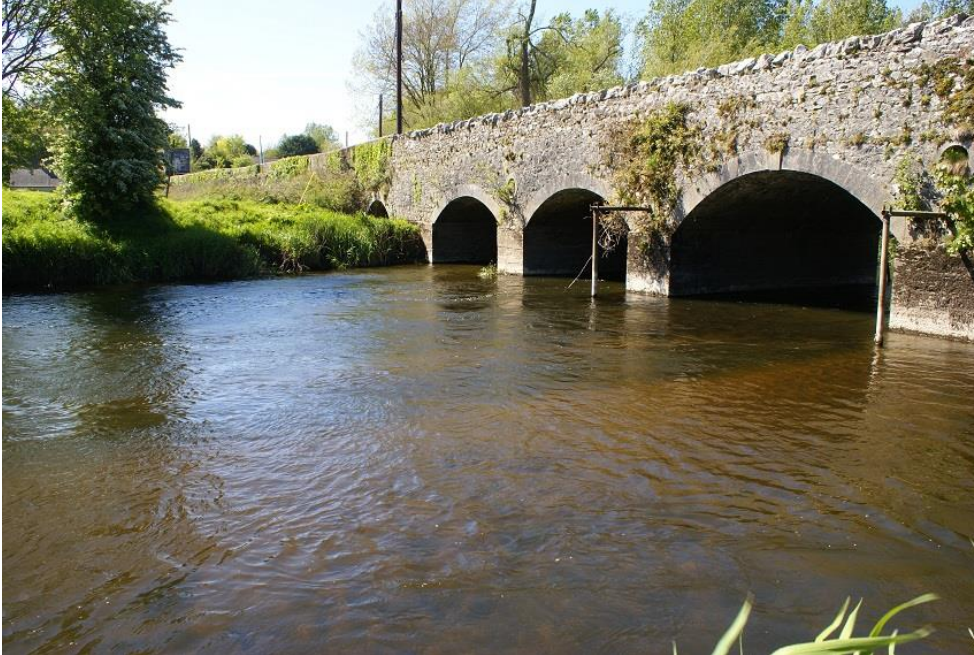
Site 1. Tallyho Bridge

At Site 1, four Group A (pollution sensitive) taxa are common in occurrence: *Isoperla grammatica*, *Heptagenia sulphurea*, *Ecdyonurus sp.* and *Ephemera danica*. Group B (relatively pollution sensitive) is represented by low numbers of *Lepidostoma hirtum*, Glossosomatidae and *Baetis muticus*. Thirteen Group C (relatively pollution tolerant), taxa are present here, but none in high abundance. Group D (pollution tolerant) and Group E (most pollution tolerant) are absent. With four Group A species well represent and Groups D & E absent, this site qualifies for Q-value of **Q4-5**.

Watercourse	River Nore
EPA River Code	15/N/01
Site Code	1
Grid Reference	S4234 7622
EPA Station	1300
Location	Immediately downstream of Tallyho Bridge. Middle to right side of channel.
Substrate (in order of occurrence)	1. Cobble 2. Sand 3. Gravel
Sampling Depth (cm.)	55
Flow Type	Riffle: 50% Glide: 50%
Instream Vegetation (% Cover)	<i>Cladophora sp.</i> 1% <i>Fontinalis antipyretica</i> 5% <i>Ranunculus sp.</i> 1%

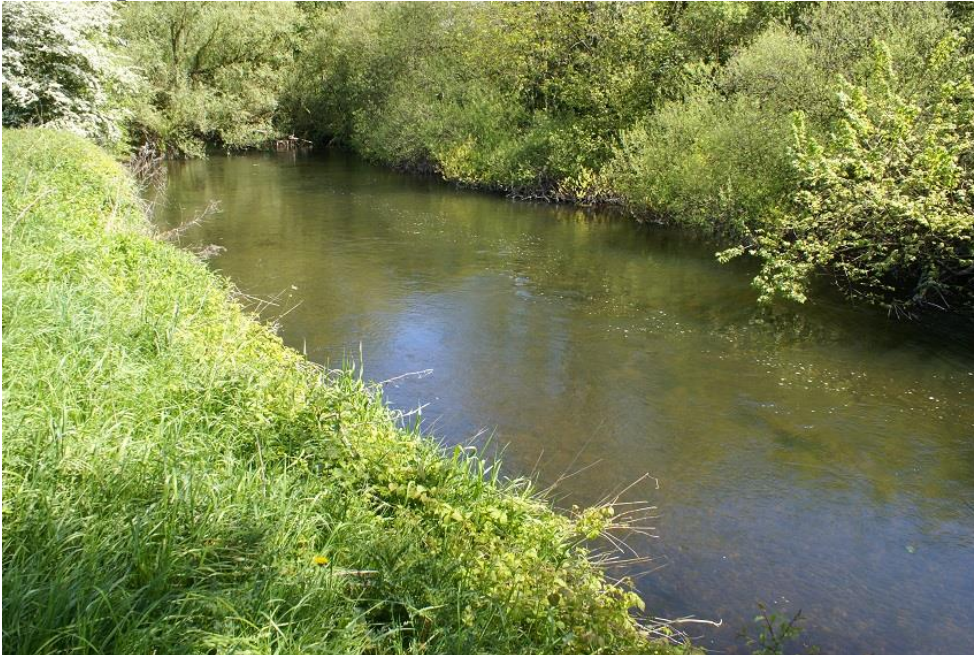
Site 2. Upstream of water intake

Watercourse	River Nore
EPA River Code	15/N/01
Site Code	2
Grid Reference	S4441 7273
Location	300 metres upstream of water intake. Right hand side of watercourse.
Substrate (in order of occurrence)	1. Cobble (mostly embedded) 2. Sand 3. Gravel
Sampling Depth (cm.)	60
Flow Type	Fast Glide: 100%
Instream Vegetation (% Cover)	<i>Vaucheria sp.</i> 1% <i>Fontinalis antipyretica</i> 5% <i>Ranunculus sp.</i> 5%

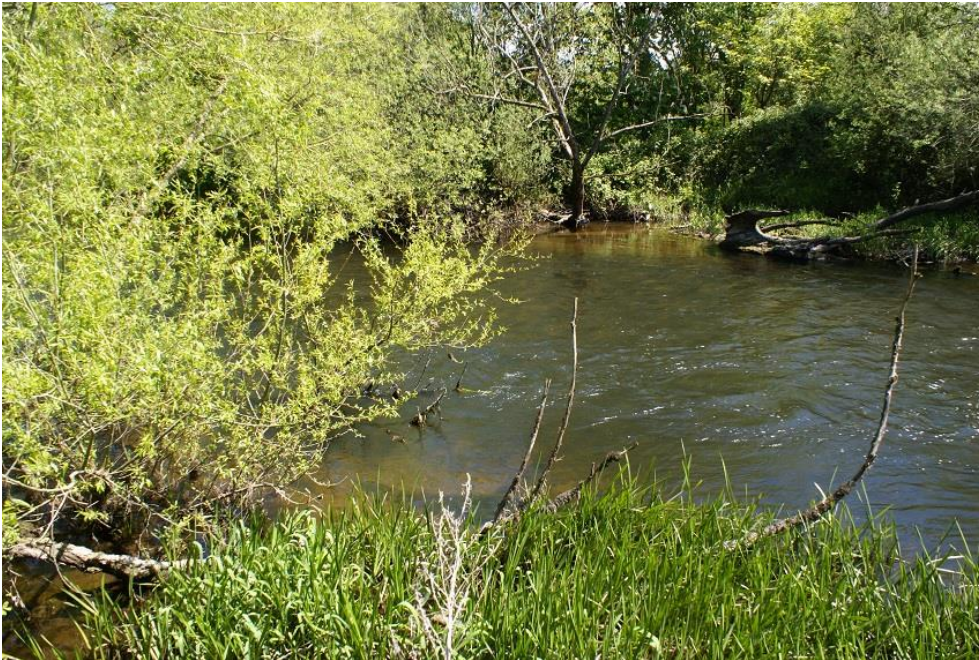
Site 3. Downstream of effluent outfall

Watercourse	River Nore
EPA River Code	15/N/01
Site Code	3
Grid Reference	S4404 7229
Location	100 metres downstream of treated effluent outfall.
Substrate (in order of occurrence)	1. Cobble (mostly embedded) 2. Sand 3. Gravel
Sampling Depth (cm.)	50
Flow Type	Riffle: 100%
Instream Vegetation (% Cover)	<i>Cladophora sp.</i> 1% <i>Fontinalis antipyretica</i> 5% <i>Ranunculus sp.</i> 1%

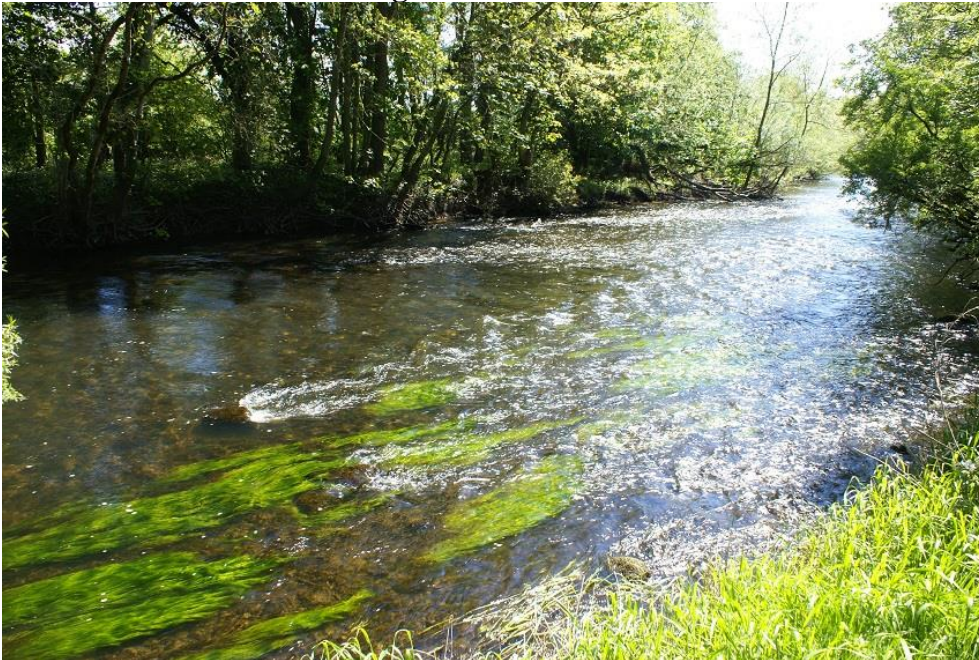
Site 4. Downstream of cooling water

Watercourse	River Nore
EPA River Code	15/N/01
Site Code	4
Grid Reference	S4397 7208
Location	30 metres downstream of former cooling water outfall. Right hand side of channel, out from slack flow.
Substrate (in order of occurrence)	1. Cobble (mostly embedded) 2. Sand 3. Gravel
Sampling Depth (cm.)	50
Flow Type	Riffle: 60% Glide: 40%
Instream Vegetation (% Cover)	<i>Cladophora sp.</i> 1% <i>Fontinalis antipyretica</i> 25% <i>Ranunculus sp.</i> 5%

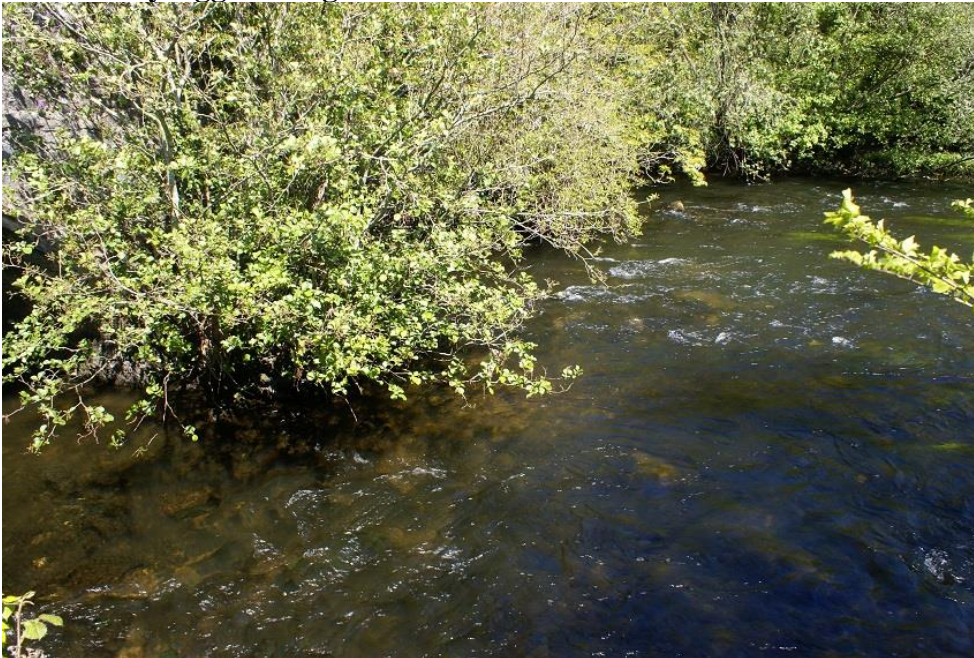
Site 5. Ballyragget Bridge

Watercourse	River Nore
EPA River Code	15/N/01
Site Code	5
Grid Reference	S4452 7082
EPA Station	1450
Location	Immediately downstream of Ballyragget Bridge. Right side of channel.
Substrate (in order of occurrence)	1. Cobble (mostly embedded) 2. Gravel 3. Sand
Sampling Depth (cm.)	30
Flow Type	Riffle: 100%
Instream Vegetation (% Cover)	<i>Cladophora</i> 1% <i>Fontinalis antipyretica</i> 25% <i>Ranunculus sp.</i> 5%

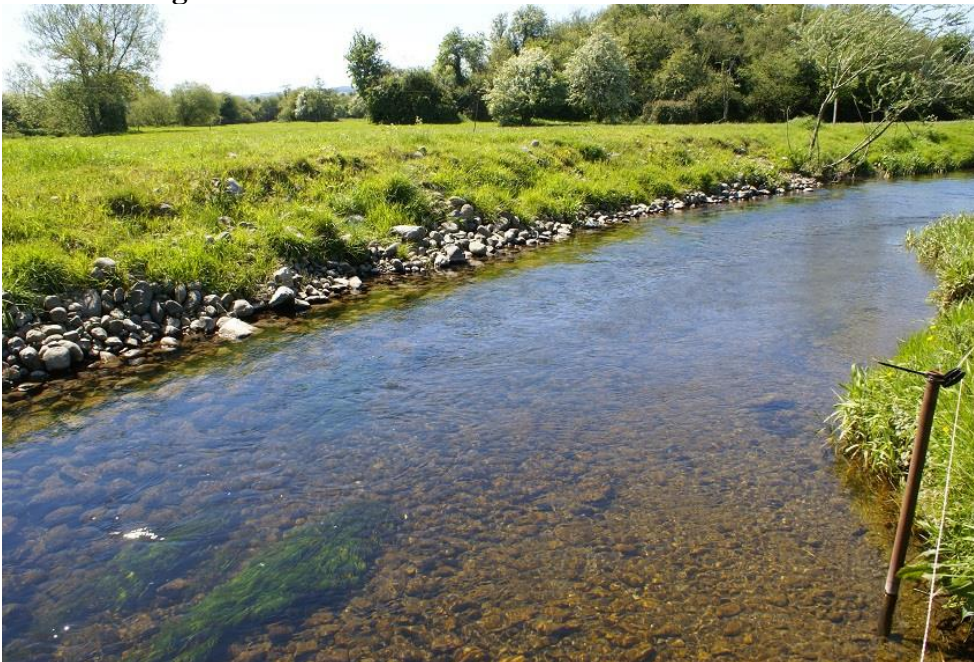
Site 6. Owveg River

Watercourse	Owveg River
EPA River Code	15/O/01
Site Code	6
Grid Reference	S4407 7377
Location	Riffle area 200 metres upstream of the confluence with the River Nore.
Substrate (in order of occurrence)	1. Cobble 2. Gravel
Sampling Depth (cm.)	30
Flow Type	Riffle: 100%
Instream Vegetation (% Cover)	<i>Ranunculus sp.</i> 5%
Comments	Cattle have access to this part of the Owveg River.
