Fenit Deep Water Berth Maintenance Dredging MMO Report

PERMIT NO.: S0007-03

DATE: May 2021

CLIENT: Kerry County Council

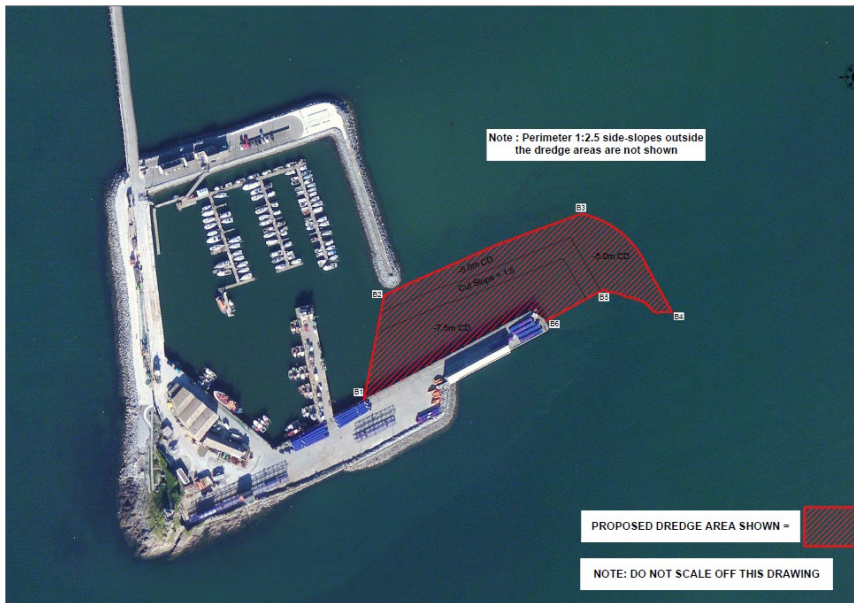
The outer manoeuvring area was dredged to a depth of -5.0m below C.D. with a slope down to -7.5m below C.D. for the commercial shipping channel and berth.

Figure 2 Dredging areas in Fenit Harbour, image from Dutch Dredging Method Statement.

A ten-year plan for maintenance dredging is in place to remove the annual build-up of sediment in Fenit Harbour; the last maintenance dredging took place in 2016. For the 2021 phase of dredging, 60,000m³ of material was removed. A plough was utilized to move material from difficult-to-reach areas into a better position for the dredger. A maximum of 3,000m³ of material is allowed for disposal per 24-hour period.

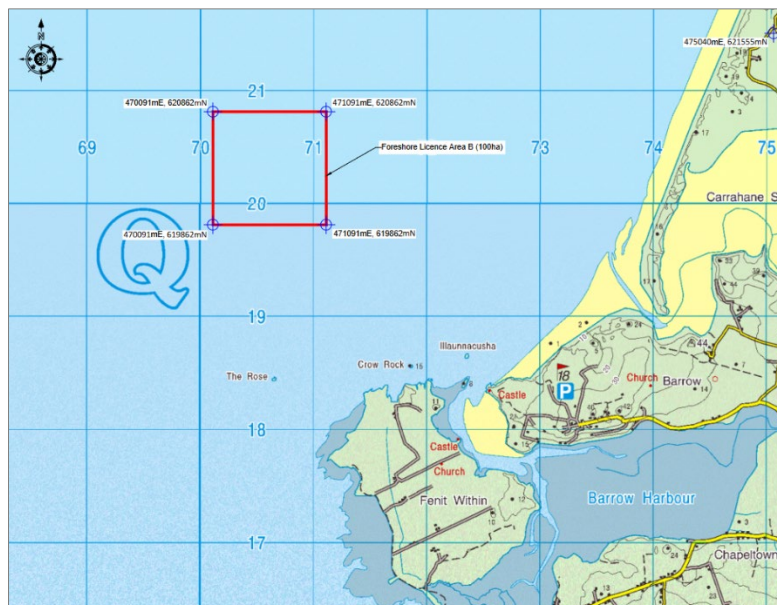
Figure 3 Location of disposal at sea.

Disposal at sea took place in an area of c.100ha, located 3km west of the coast at Carrahan Lower townland and approximately 1.5km north-northwest of Fenit Island in the outer part of Tralee Bay. It lies between 1.5km to 2.5km south and southeast of Illaunnabarnagh and Mucklaghmore Islands, which are small rocky outcrops.

Disposal at sea operations were permitted to commence once the MMO had ensured that no marine mammals were within the disposal site and a 500m exclusion zone was maintained.

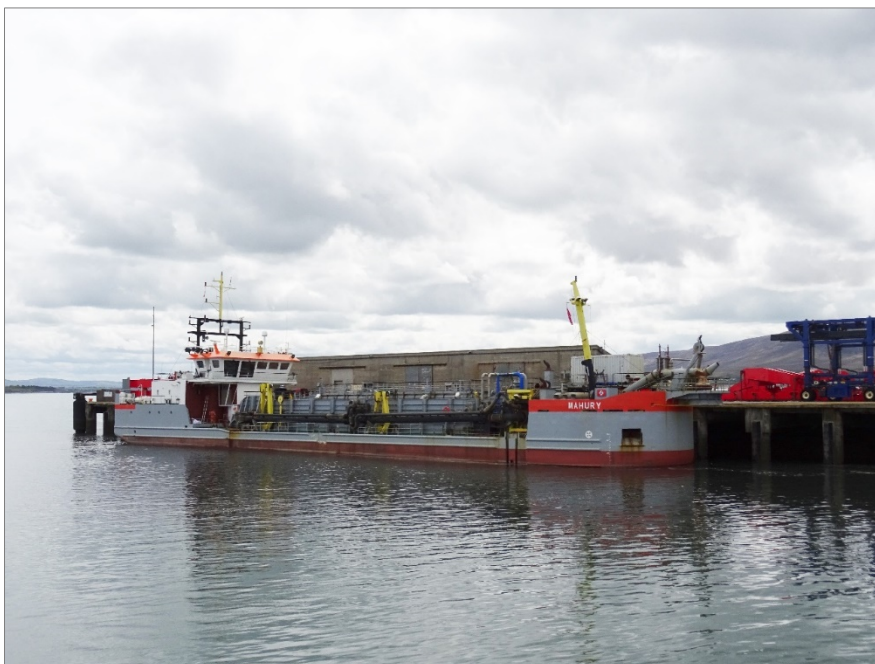
Dredging operations were carried out by the *Mahury*, a trailing suction hopper dredger (TSHD). The hopper has a capacity of 700-1,000m³ depending on the material.

Plate 13 TSHD 'Mahury' alongside at Fenit Marina 2021.

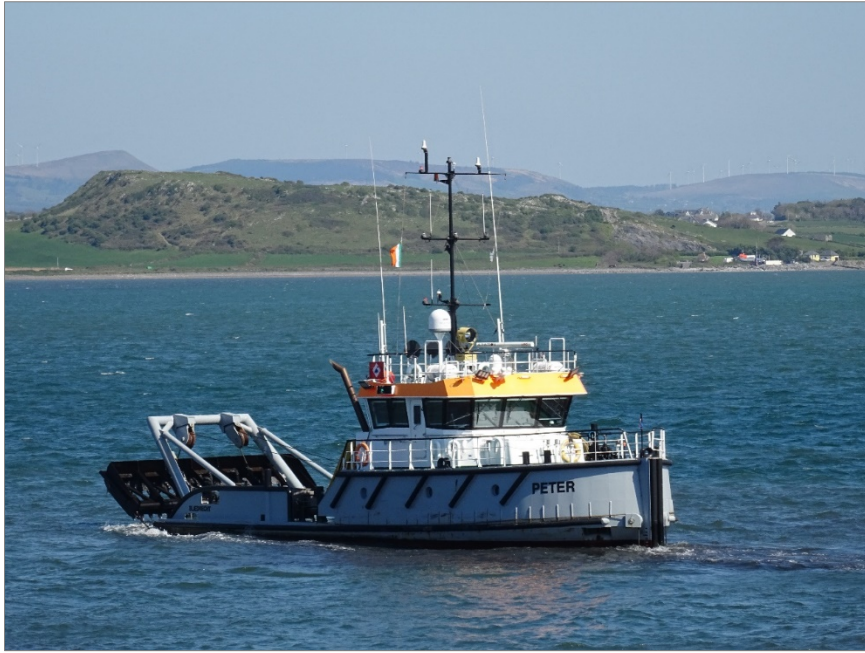
Ploughing operations were undertaken by the *Peter* with plough attachment. The *Peter* was also utilized for bathymetric surveys.

Plate 14 The Peter ploughing in Fenit 2021.

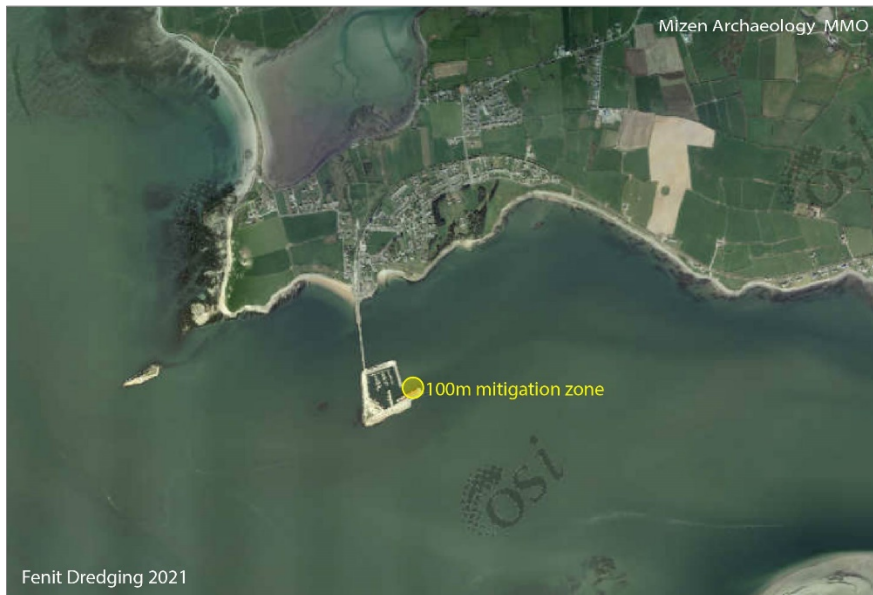
Figure 8 Aerial view of Fenit Harbour and Marina and the 100m exclusion zone.

Dredging and ploughing operations were permitted to commence once the MMO had completed a pre-start watch of 30 minutes and deemed the 100m exclusion zone to be free of marine mammals. Any marine mammals within 100m of the dredging vessel resulted in a delay until the mammal moved outside the 100m mitigation zone or 30 minutes had passed and the mammal was not seen again within the mitigation zone.

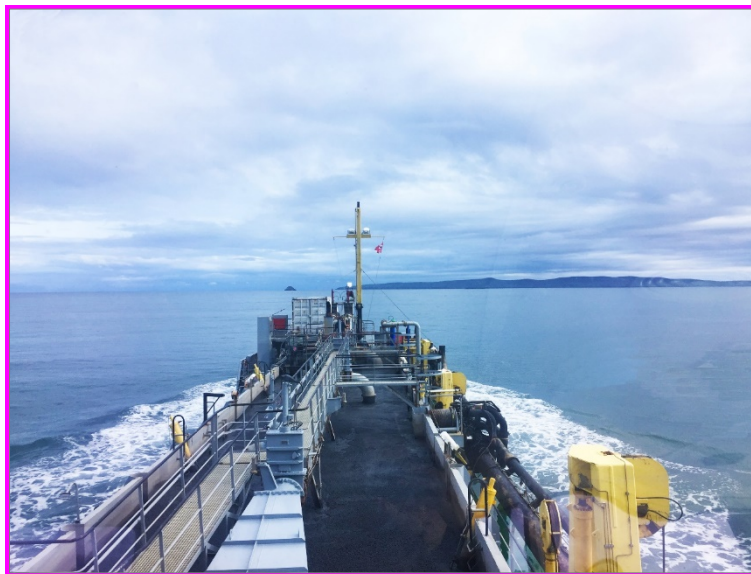
The *Mahury* is a trailing suction hopper dredger. The bridge is 10m above sea level and allows clear, unobstructed 360° viewing of the surrounding area. The deck outside the bridge was also utilized and offered the same viewing advantages. The bow is 8m above sea level. This offered unobstructed views during disposal at sea but could only be accessed during calm weather.

Plate 15 View from bridge looking forward of TSHD 'Mahury' en route to disposal site in Tralee Bay.

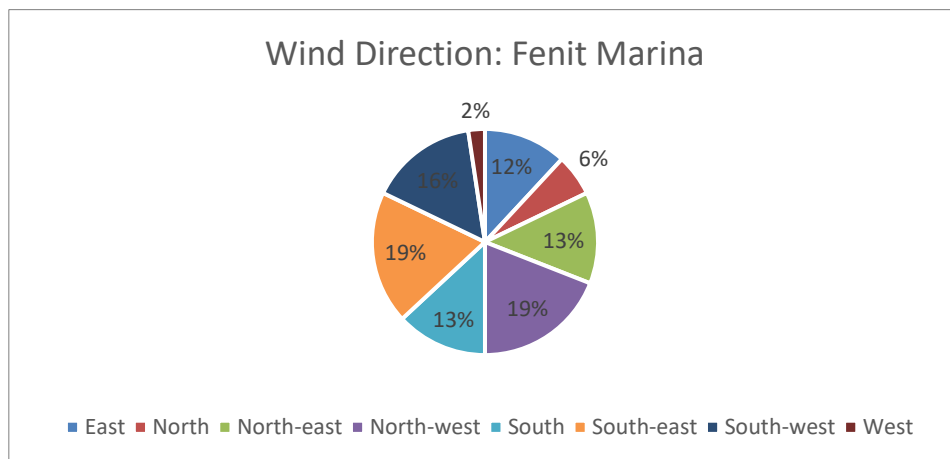
Monitoring conditions 22 April to 16 May 2021 were generally good but poor weather did occur.

Table 5 Breakdown of wind direction data recorded during monitoring effort in Fenit Marina..

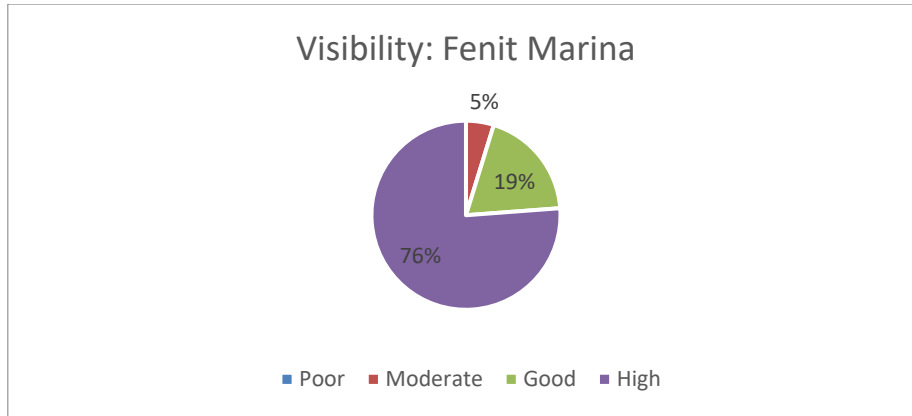
Visibility was generally good during the project with the mitigation zone always clear for observation. High visibility (>10 km) accounted for 80% of all operations. Poor visibility was logged 0 times during dredging and ploughing operations. The rest of dredging and ploughing operations were logged with moderate visibility (1-5km) and good visibility (5-10km) at 5% and 15% respectively.

Table 6 Breakdown of visibility data recorded during monitoring effort in Fenit Marina.

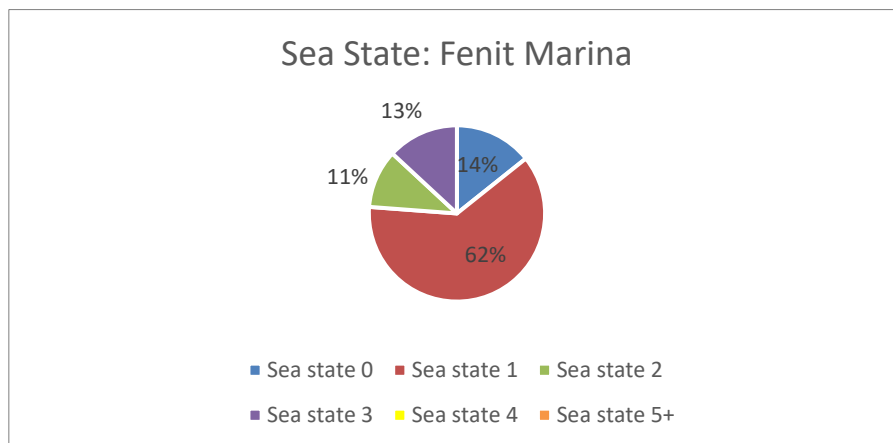
Sea state was good for the majority of observations during the project. The majority of observations (76%) were carried out in a sea state of ≤ 1 , while remainder were carried out in sea states 2 and 3. The highest sea state recorded was sea state 3 and this accounted for 11 observations.

Table 7 Breakdown of sea state data recorded during monitoring effort in Fenit Marina.

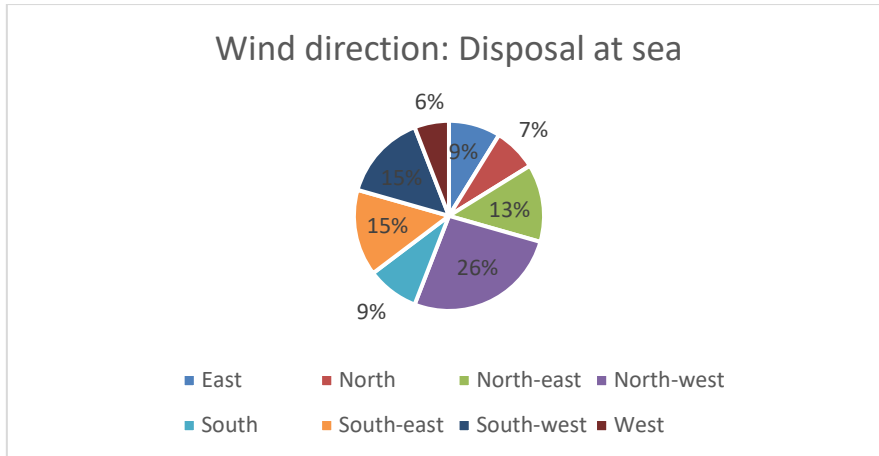
Sightings conditions during the project were generally good but poor weather did occur, with fewer disposal at sea operations due to high swell and high winds on 03 May 2021.

Table 8 Breakdown of wind direction data recorded during monitoring effort during disposal at sea operations.

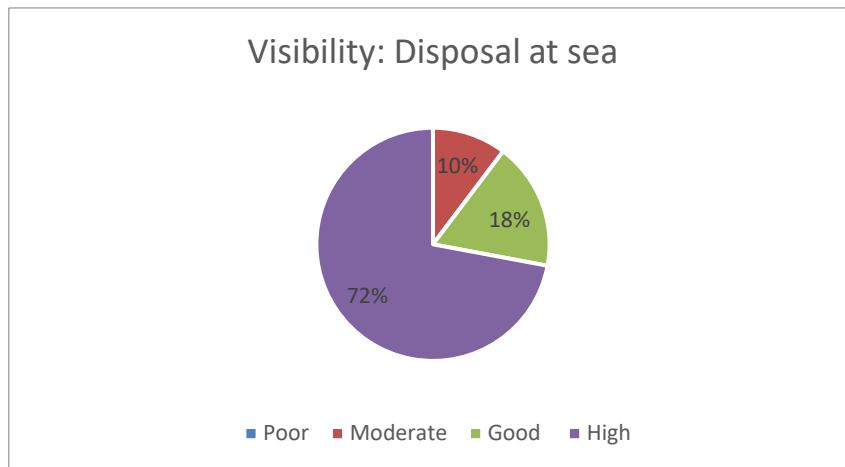
Visibility was good during the project with the mitigation zone always clear for observation. High visibility (>10km) accounted for 72% of disposal at sea operations. The rest of all disposal at sea operations were logged with moderate (1-5km) and good (5-10) visibility at 10% and 18% respectively. Poor visibility was logged 0 times during disposal at sea operations.

Table 9 Breakdown of visibility data recorded during monitoring effort in Fenit Marina.

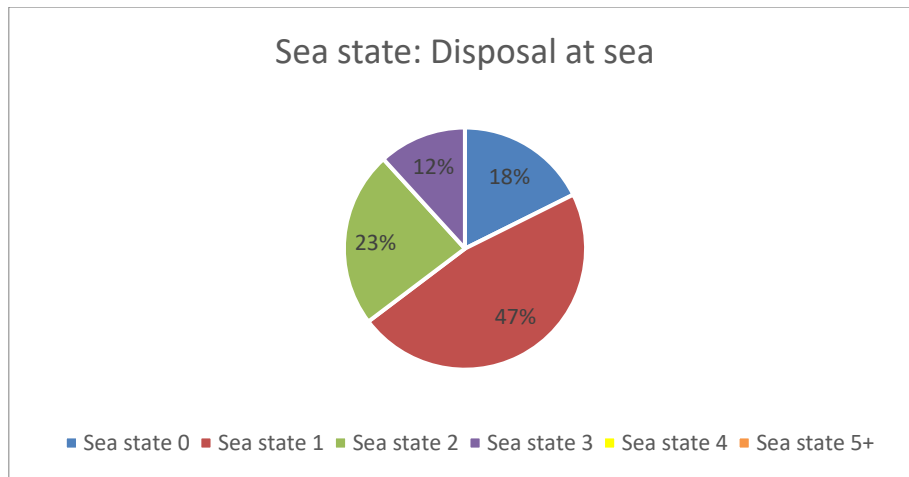
Sea state was good for the majority of observations during the project. The majority of observations (46%) were carried out in a sea state of ≤ 1 , while remainder were carried out in sea states 2 and 3. The highest sea state recorded was sea state 3 and this accounted for 8 observations.

Table 10 Breakdown of sea state data recorded during monitoring effort in Fenit Marina.
