**Biological Assessment of the Water Quality of
the Rivers Funshion and Gradoge in the Vicinity of
Discharges from the Dairygold Plant at
Mitchelstown**

September 2023

*Prepared by:
Pascal Sweeney B.Sc., M.Sc.
Sweeney Consultancy,
Rahan,
Mallow
Co. Cork.
Tel. 022/26780*

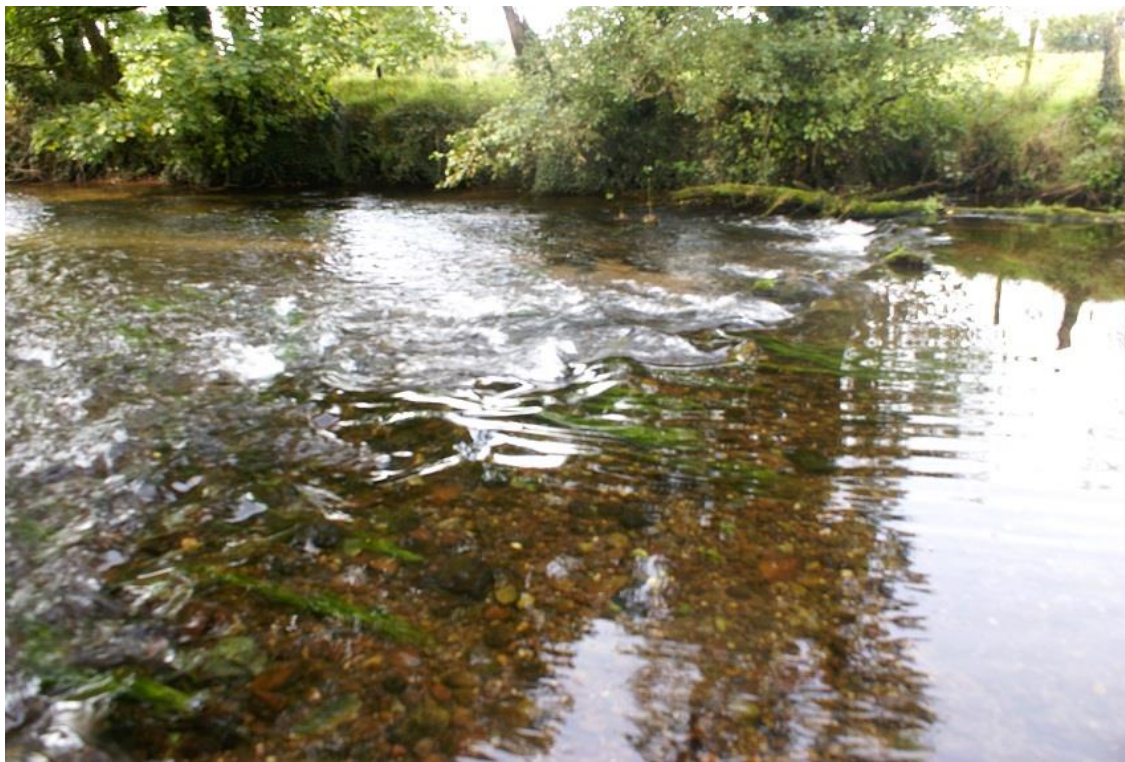
Photo 1: Funshion Site 1

Funshion Site 1. 30m downstream Ballyarthur Bridge. This is the next bridge downstream of EPA Station 0100 (approximately 650m downstream). Results from this site give information on the water quality of the River Funshion upstream of the confluence of the Gradoge River and the discharge point of the combined Dairygold treated effluent and the Mitchelstown WWTP effluent.

Funshion Site 1. The fauna of this site is dominated by Group C (Relatively Pollution Tolerant) species. Group A (Very Pollution Sensitive) is represented by a few specimens of the flat mayfly nymph, *Ecdyonurus sp.*. Three Group B (Relatively Pollution Sensitive) species are present in low numbers. No Group D (Very Pollution Tolerant) were found and tubificid worms from Group E (Most Pollution Tolerant) were present in low numbers. With a few specimens from Group A and few from Groups B and E and no Groups D representation in a fauna dominated by Group C, this invertebrate community indicates a Q-value of **Q3-4**.

Site	Funshion Site 1
Watercourse	River Funshion
EPA River Code	18/F/05
EPA Site Code	None
	Downstream of Site 0100
GPS Reading	R8065 1430
Location	30m downstream Ballyarthur Br.
Photograph No.	1
Wet Width (m)	10
Sampling depth (m)	0.15
Flow	Riffle: 70%
	Glide: 30%
Substrate	Cobble: 50%
	Coarse Gravel: 30%
	Fine Gravel: 10%
	Sand: 10%
Instream Vegetation	<i>Vaucheria sp.</i> : 3%
	<i>Fontinalis antipyretica</i> : 5%
	<i>Platyhypnidium riparioides</i> : 1%
	<i>Hygrohypnum sp.</i> : 2%
	<i>Ranunculus sp.</i> : 10%
	<i>Apium nodiflorum</i> : 3%
Shade	Moderate

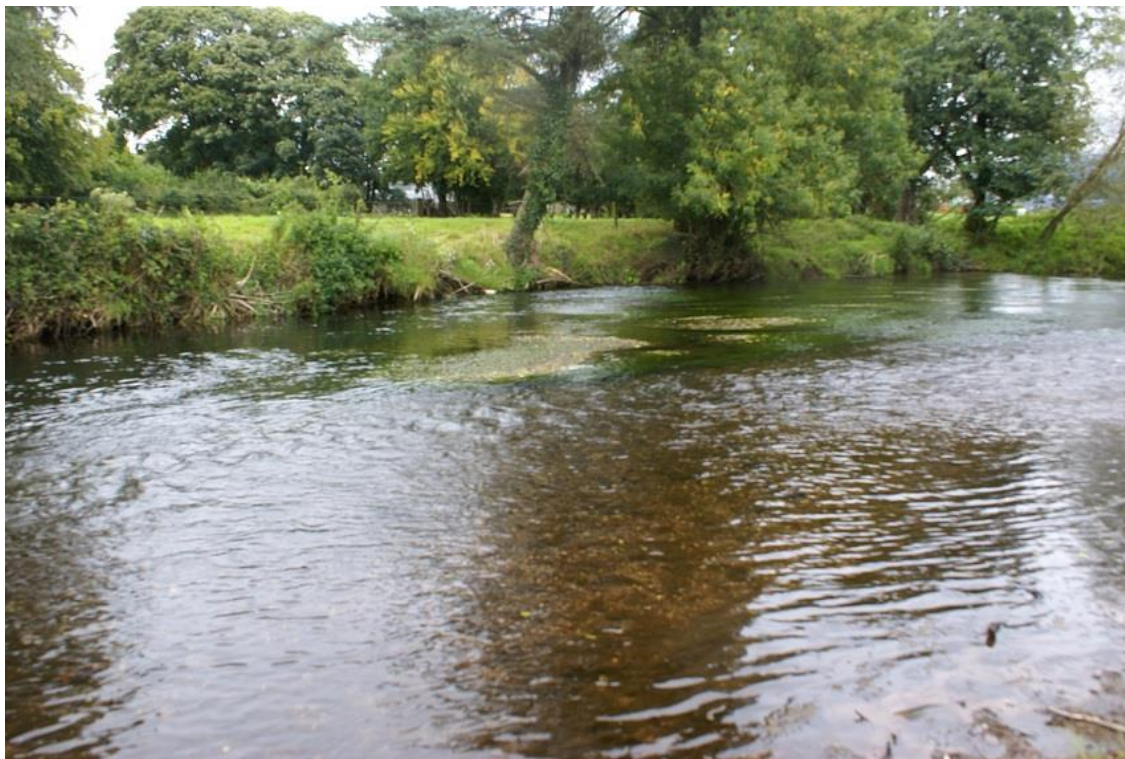
Photo 2: Funshion Site 2

Funshion Site 2. Approximately 250m downstream of the treated effluent outfall. The site is approximately 250m upstream of EPA Station 0200. Results establish the water quality status of the R. Funshion downstream of all discharges from Dairygold, as well as from the Mitchelstown WWTP and other urban runoff from Mitchelstown. To avoid a localised impact, sampling was undertaken just upstream of cattle access to the river.

Funshion Site 2. Similar to Funshion Site 1, the fauna of this site is dominated by Group C species and Group A is represented by a few specimens of the flat mayfly nymph, *Ecdyonurus sp.* Only one Group B species is present in low numbers. Single specimens of three Group D species were found and Group E was absent. With a few specimens from Group A and few from Groups B and E and no Groups E representation in a fauna dominated by Group C, this invertebrate community indicates a Q-value of **Q3-4**.

Site	Funshion Site 2
Watercourse	River Funshion
EPA River Code	18/F/05
EPA Site Code	None
	Upstream of Site 0200
GPS Reading	R7941 1363
Location	330m d/s of treated effluent discharge
Photograph No.	2
Wet Width (m)	12
Sampling depth (cm)	0.25
Flow	Riffle: 100%
Substrate	Cobble: 20%
	Coarse Gravel: 25%
	Fine Gravel: 25%
	Sand: 20%
	Silt: 10%
Instream Vegetation	<i>Cladophora sp.</i> : 1%
	<i>Fontinalis antipyretica</i> : 2%
	<i>Hygrohypnum sp.</i> : 1%
	<i>Ranunculus sp.</i> : 30%
	<i>Oenanthe crocata</i> : 3%
	<i>Glyceria fluitans</i> : 1%
	<i>Apium nodiflorum</i> : 1%
Shade	Light

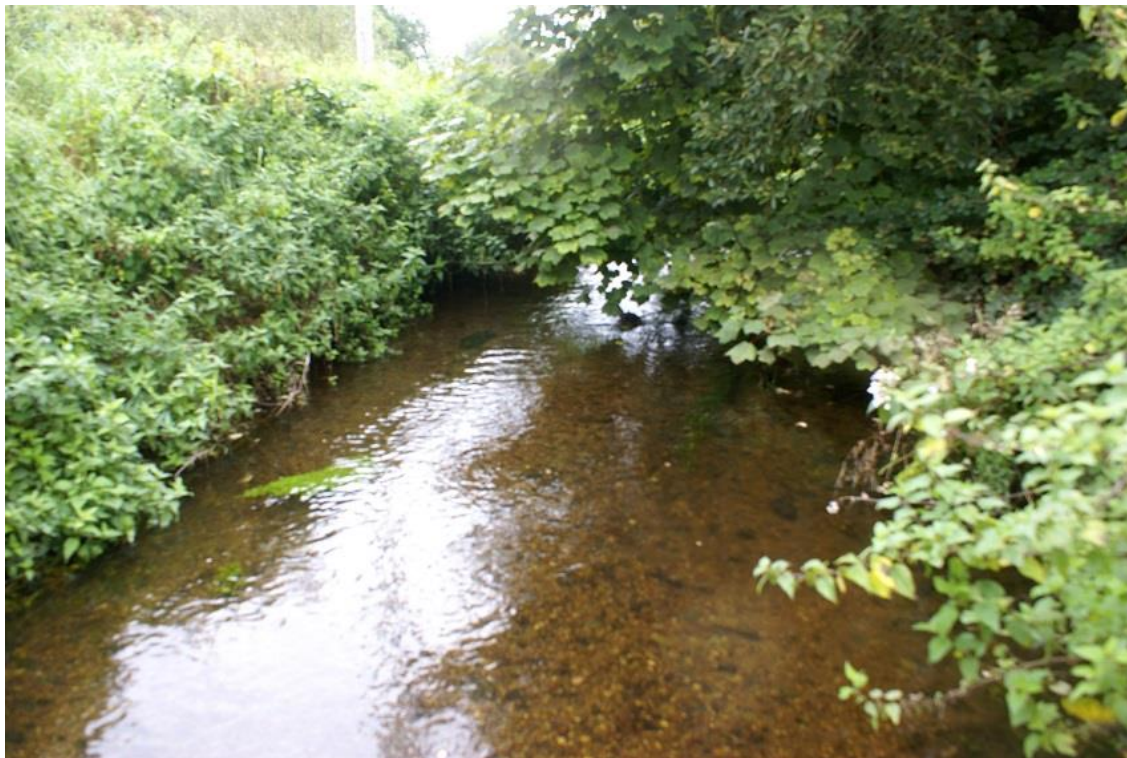
Photo 3: Gradoge Site 1

Gradoge Site 1. Approximately 40m upstream of the surface water discharge at the Clonmel road. Results from this site give information on the water quality of the Gradoge River upstream of surface runoff from the Dairygold plant.

Gradoge Site 1. The fauna of this site is dominated the Group C species. Group A is represented by low numbers of the flat mayfly *Ecdyonurus sp.* Two species from Group B are present in low numbers. Groups D and Group E are each represented by a few specimens of a single species. With low numbers of Group A taxa, some Group B, no Groups D or E representation in a fauna dominated by Group C, this invertebrate community indicates a Q-value of **Q3-4**.

Site	Gradoge Site 1
Watercourse	Gradoge River
EPA River Code	18/G/13
EPA Site Code	None
	Downstream of Site 0100
GPS Reading	R8178 1308
Location	u/s of Clonmel Rd. Surface water discharge
Photograph No.	3
Wet Width (m)	3
Sampling depth (cm)	0.25
Flow	Riffle: 80%
	Glide 20%
Substrate	Cobble: 10%
	Coarse Gravel: 250%
	Fine Gravel: 25%
	Sand: 40%
Instream Vegetation	<i>Phalaris arundinacea</i> 2%
	<i>Fontinalis antipyretica</i> : 5%
	<i>Callitriche sp.</i> 10%
	<i>Ranunculus sp.</i> 10%
	<i>Apium nodiflorum</i> : 5%
Shade	Moderate

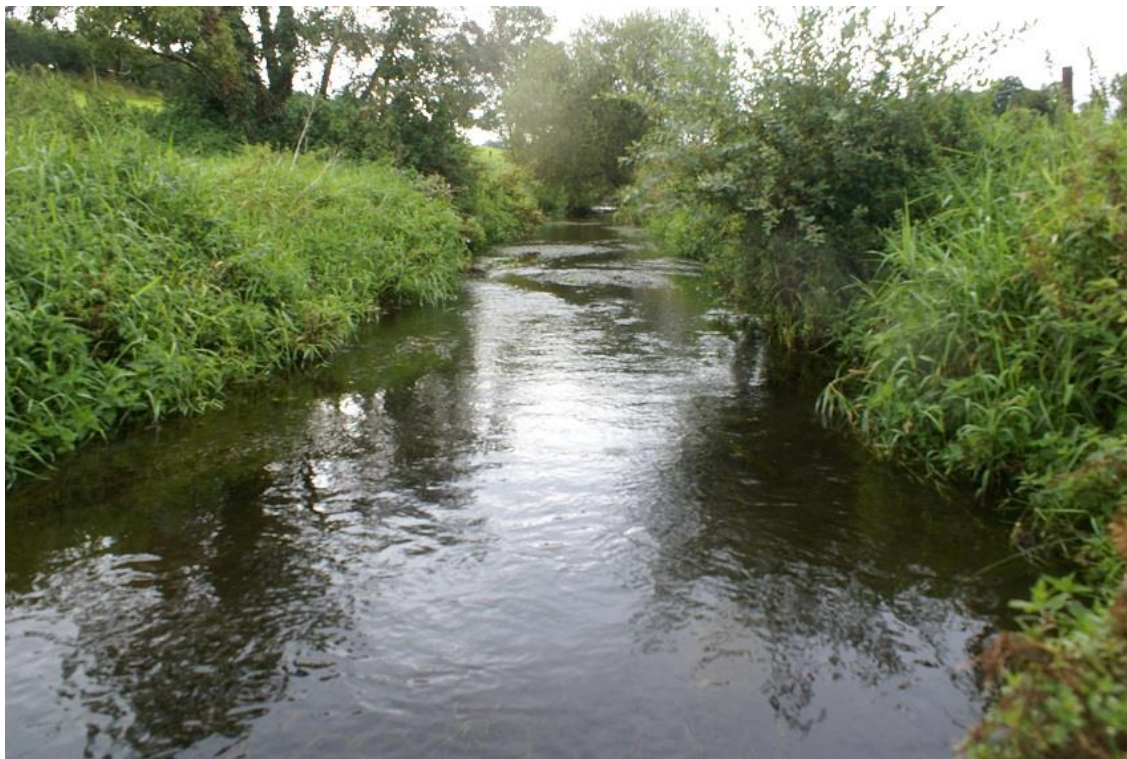
Photo 4: Gradoge Site 2

Gradoge Site 2. Approximately 50m upstream of the confluence with the River Funshion (EPA Station 18/G/13/0200). Results from this site give information on the water quality of the Gradoge River downstream of the Dairygold surface water discharge, as well as urban surface water runoff from Mitchelstown and the Mitchelstown WWTP storm outfall.

Gradoge Site 2. *Gammarus duebeni* from Group C dominates the fauna here. Group A is absent. Groups B, D and E are absent. This faunal composition with Group C dominant and Groups A, B, D and E absent indicates a Q-value of **Q3**.

The biological water quality of the Gradoge declines from moderate to poor ecological quality in the c. 2km between the two sites assessed. However, this cannot conclusively be attributed solely to inputs from Dairygold, as there are other potential sources of impact, such as runoff from the urban area of Mitchelstown also entering the river and the possibility of inputs from the Mitchelstown WWTP storm overflow during the heavy rainfall of July 2023, which was 2.4 times greater than the long-term average for the month (see Met Eireann rainfall data, Appendix 4). Despite the poorer quality of the lower end of the Gradoge, the site on the Funshion downstream of the combined Dairygold and Mitchelstown WWTP outfall and the Gradoge confluence does not show any decline in ecological quality from the upstream site on the Funshion, which indicates that the treated effluent discharge is not having a significant additive effect on the biota of the Funshion at the downstream site.

Site	Gradoge Site 2
Watercourse	Gradoge River
EPA River Code	18/G/13
EPA Site Code	0200
GPS Reading	R7980 1368
Location	50m u/s confluence with R. Funshion
Photograph No.	4
Wet Width (m)	5
Sampling depth (m)	0.3
Flow	Fast Glide: 100%
Substrate	Cobble: 20%
	Coarse Gravel: 25%
	Fine Gravel: 10%
	Sand: 40%
	Silt: 5%
Instream Vegetation	<i>Cladophora sp.</i> : 1%
	<i>Fontinalis antipyretica</i> : 1%
	<i>Callitriche sp.</i> 1%
	<i>Ranunculus sp.</i> 5%
	<i>Potamogeton crispus</i> : 20%
	<i>Apium nodiflorum</i> 1%
Shade	Light
