Heavy Fuel Oil Spill Response

Tarbert Generating Station
Soil Sampling

SSE Generation Ireland Limited

Project number: 60673806
60673806_ACM_EN_RP_003

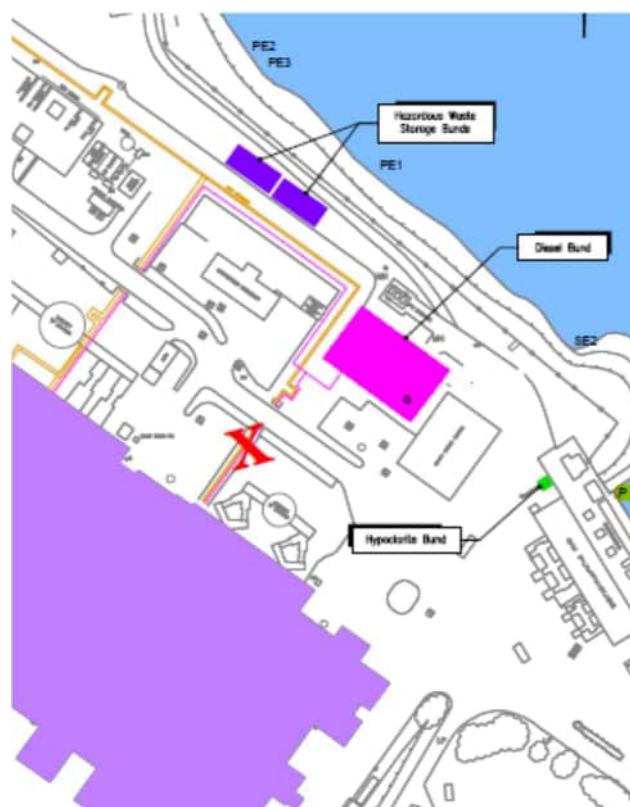
Figure A. HFO Spill Location

The HFO loss is reported to have occurred on 12 April 2022. SSE reported to AECOM that approximately 250 L of HFO was lost from an above ground pipeline close to the A Station chimney, immediately north of the generating station building, marked by the **X** in the figure below.

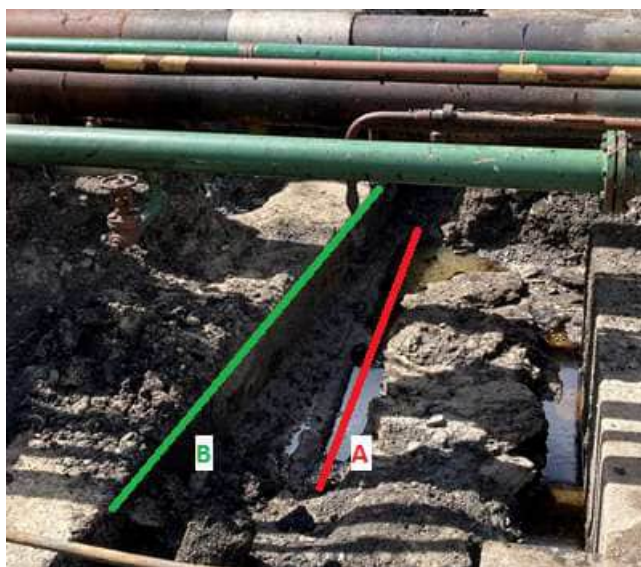
Figure B. Services Beneath the HFO Spill – Middle Trench

During the excavation works, two underground services were identified running approximately east-west, perpendicular to the above ground pipework (running north-south). One was a known surface water drain and the second is an unknown metal service.

These services are shown in Figure B below, with the green line representing the surface water drain encased in concrete and the red line representing the unknown metal pipe exposed to the north of the surface water drain, see also Appendix B Photo 7. These services appear to have been cut into the bedrock during installation, hence the increased depth to bedrock around these services compared to that to the north and south of the excavation.

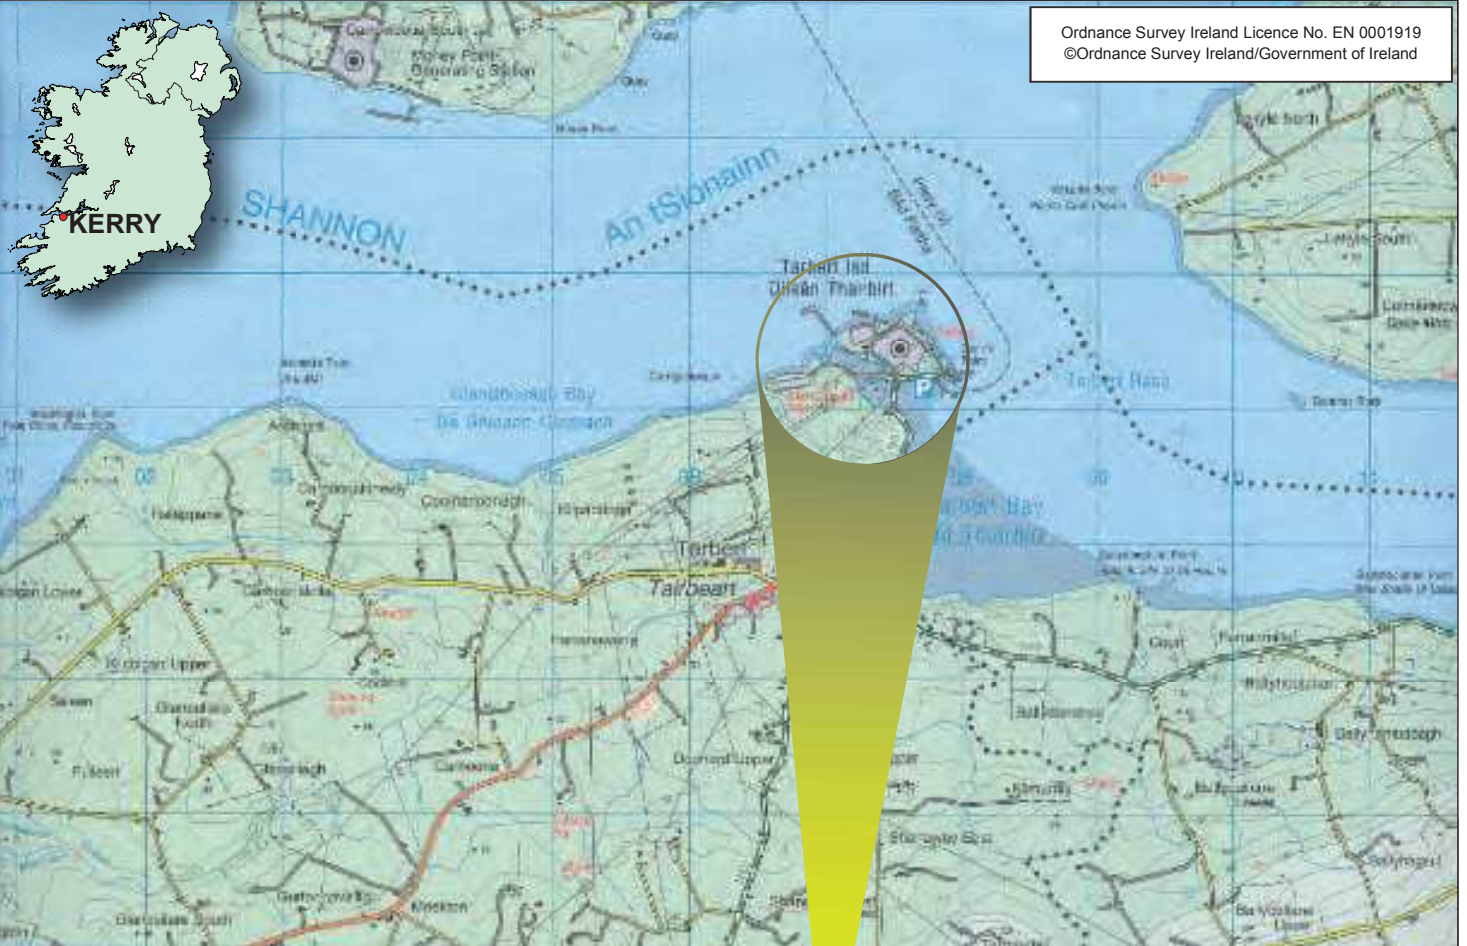
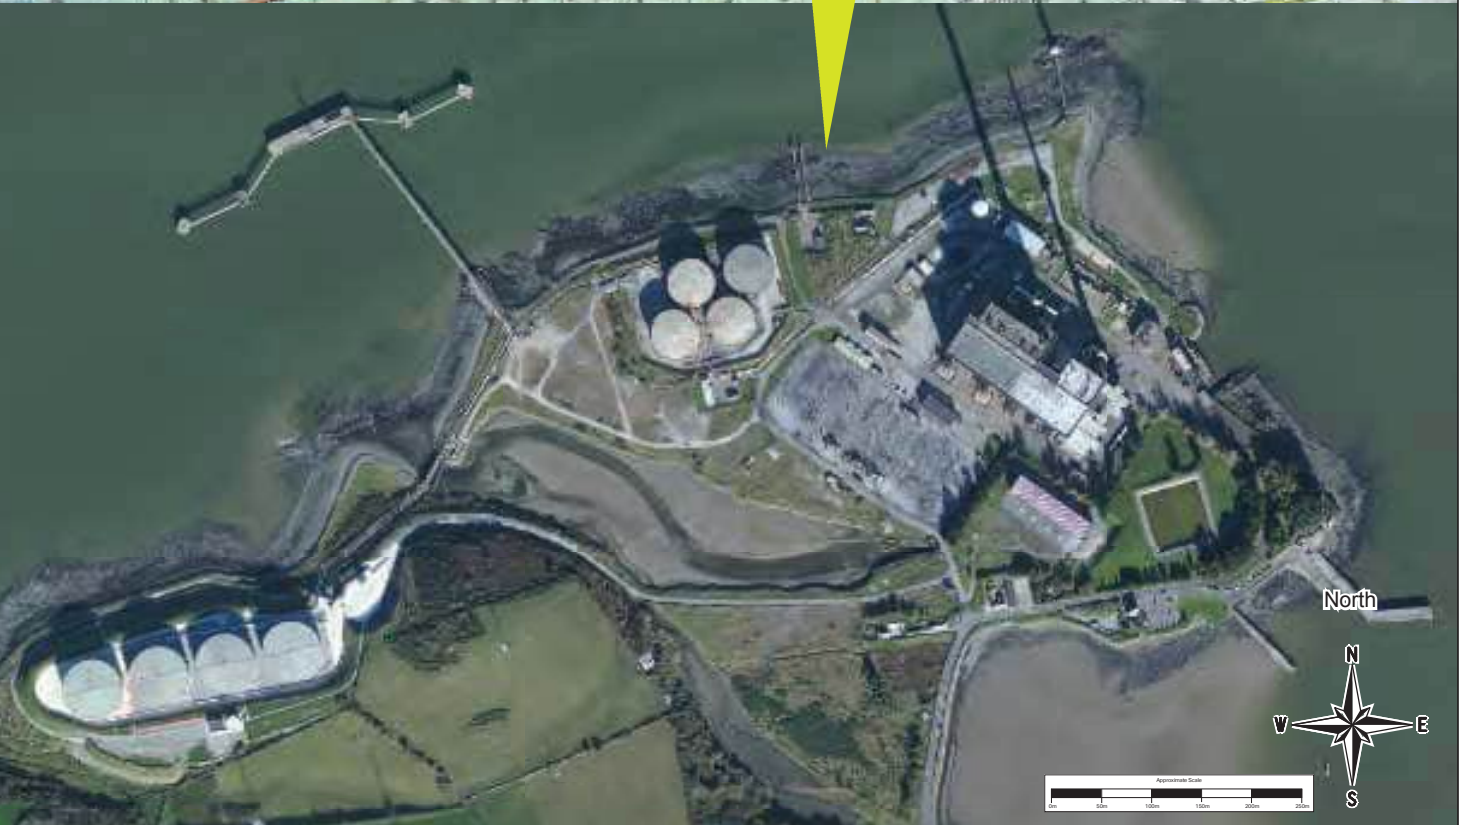
Appendix A Figures

Acid Bund	Hypochlorite Bund
Ammonia Bund	Sulphuric Acid Bund
Boiler Wash Effluent	Waste Oil Bund
Caustic Bund	Lube Oil Store
Chemical compound Bund	HFO Pump House
Chem Store Bund	Heavy Fuel Oil Line
Diesel Bund	Diesel Line
Generating Station	
Hazardous Waste Storage Bunds	
HFO Farm Bund	
Hydrazine Bund

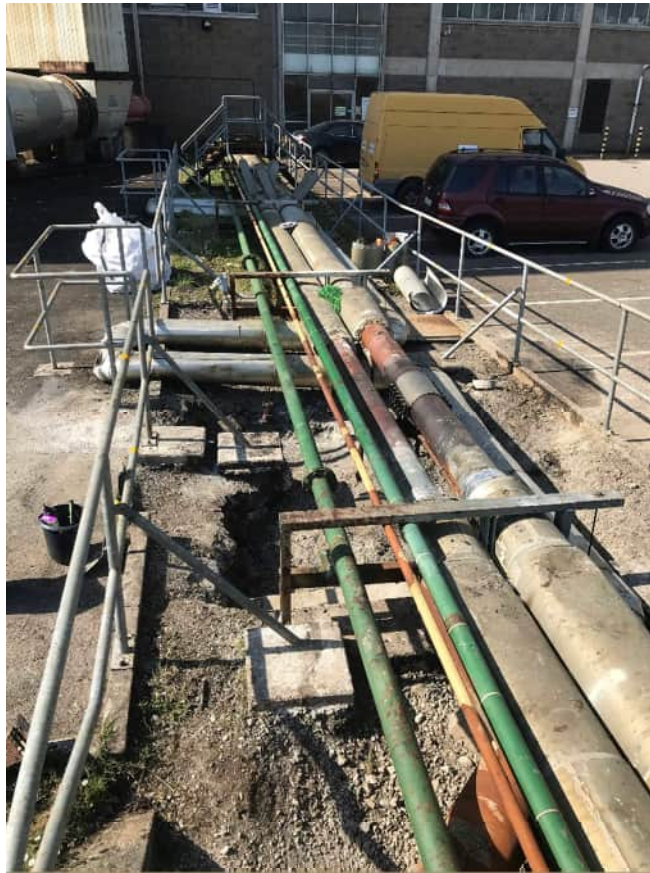
Location of HFO leak from above ground ring main to north of generation building and adjacent to car park.

On identifying the site of the leak, SSE immediately commenced repairing the clamp and cleaning-up the HFO lost to ground beneath the pipe rack. The EPA were notified within 24 hours of the leak being identified.

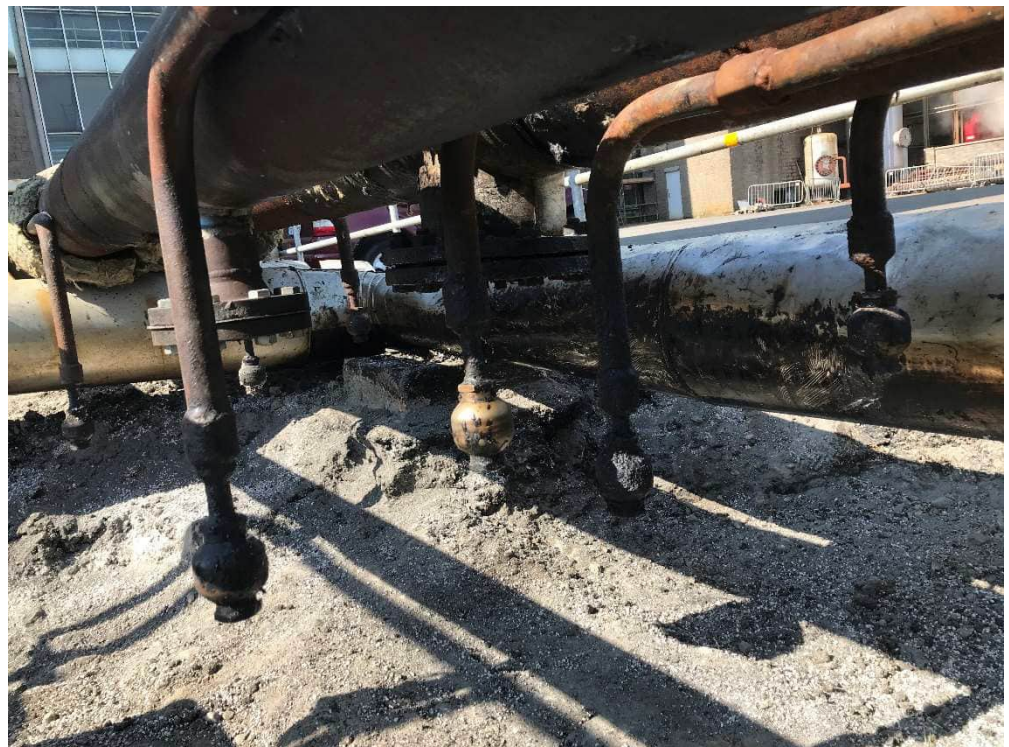
Beneath repaired HFO ring main.

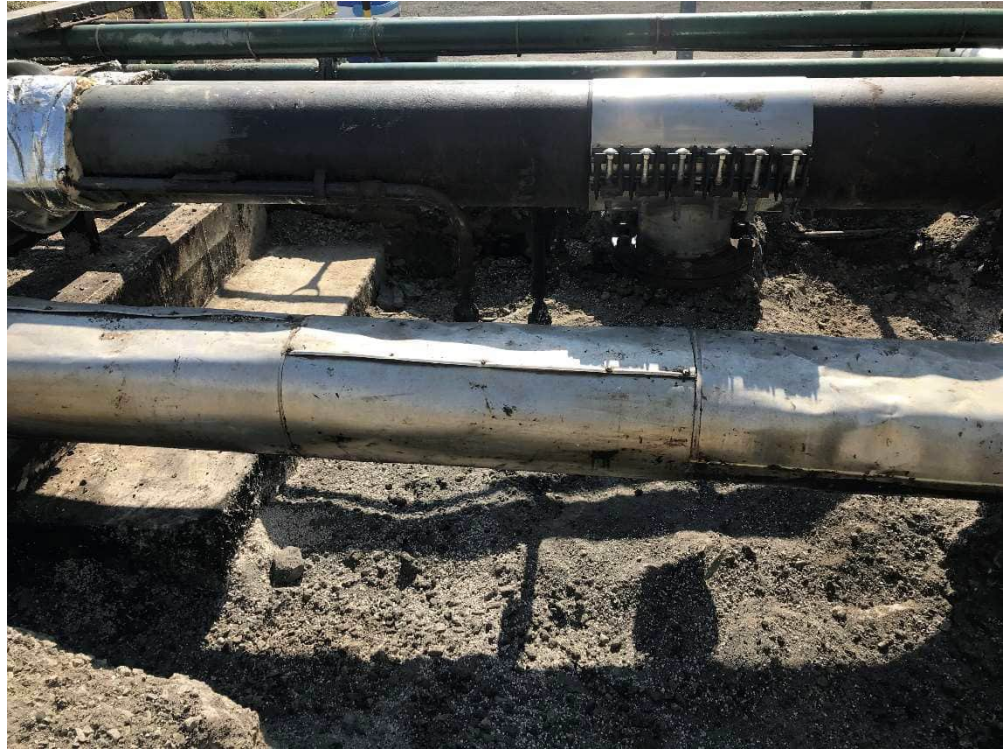
Concrete foundation on left hand side beneath support structure for above ground pipework.

The above ground pipelines are at <1 m above ground level and are supported by metal frames founded on concrete footings, however the concrete did not appear to extend beneath the full length of the pipeline but to only be present intermittently, to provide foundations for support structures for the above ground pipelines.

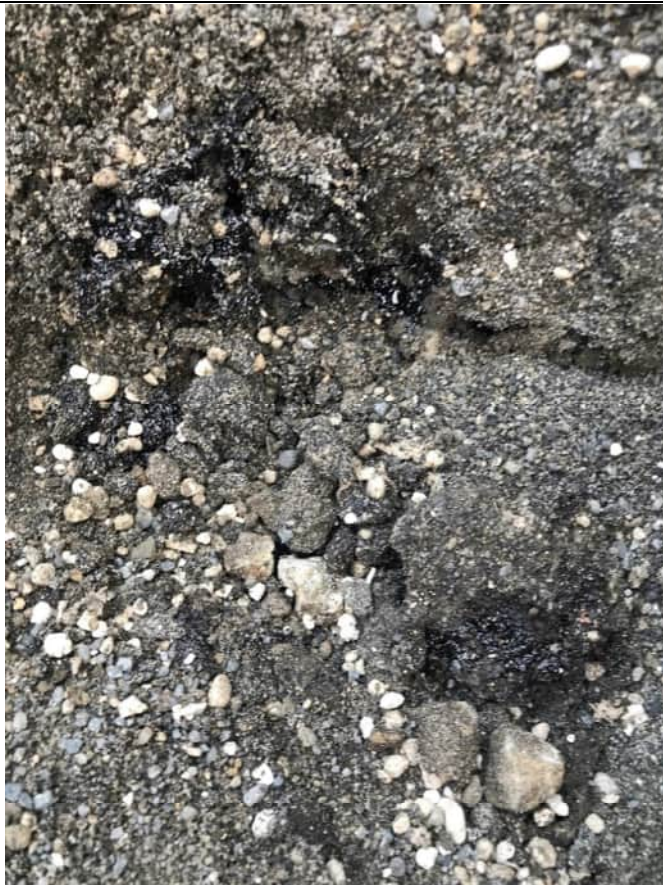
Heavy fuel oil contamination of fill material beneath the leak.

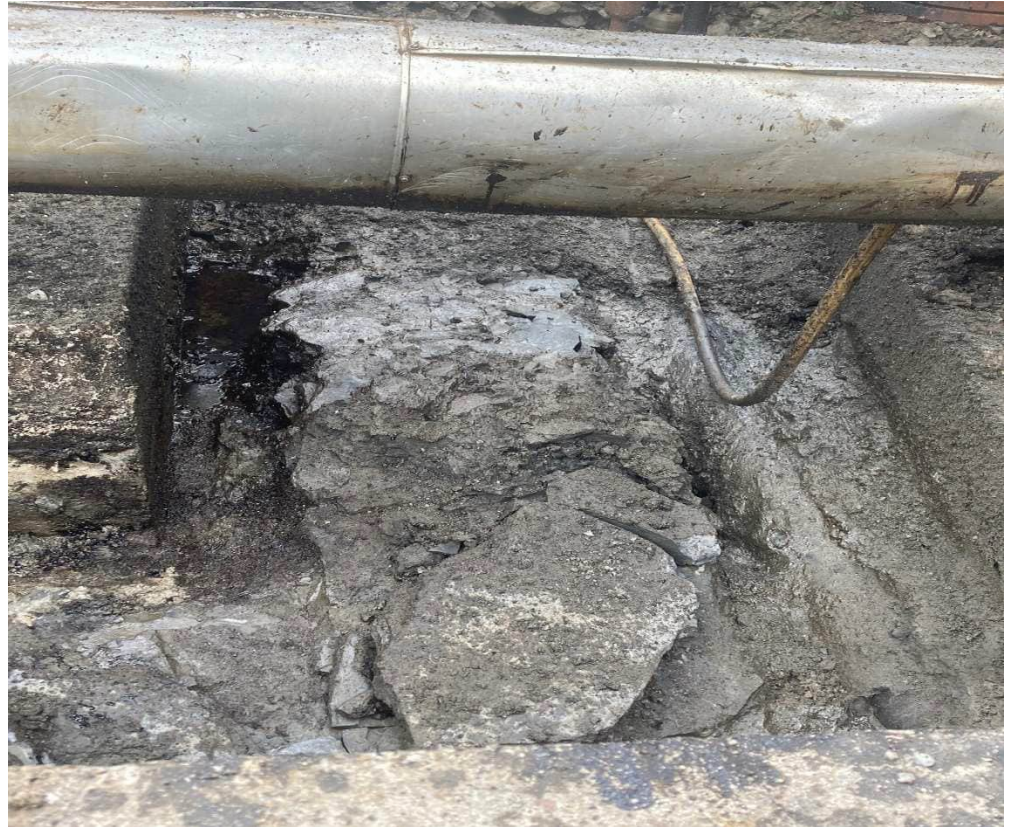
Exposed siltstone (bedrock) after removal of overlying made ground in middle trench. Impact of oily product visible at top of bedrock.

All visually contaminated soils were removed from this area, to the extent practicable, by vacuum excavation which clarified that the vertical extent of excavation was limited by the shallow depth to bedrock in the area. Bedrock was encountered at between 0.25 m bgl and 1.1 m bgl, see Appendix B Photos 5, 7 and 8. It could be seen that foundations associated with above ground infrastructure, as well as trenches for underground services, had been dug into the top of bedrock and backfilled with compact granular fill or concrete foundations, see Appendix B Photos 7 and 8.

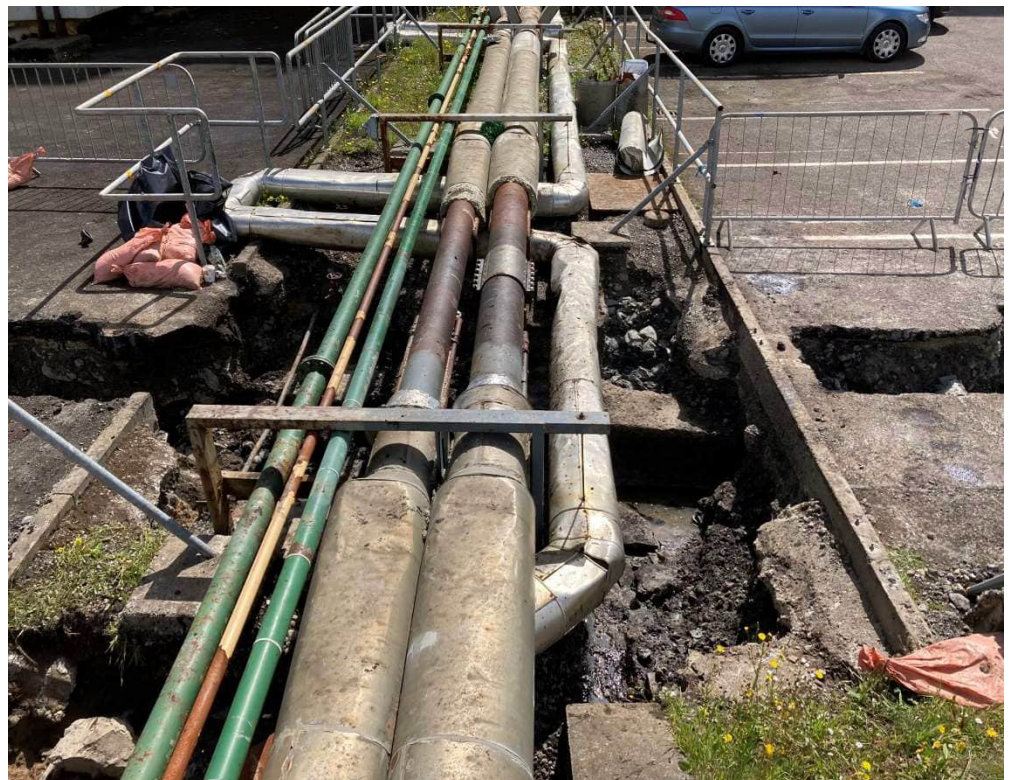
Excavation extension after completion of sitework. Above ground pipeline running in north-south alignment. Eastern trench showed to the left-hand side. Western trench showed to the right of the photo.

Following source removal from the middle trench, vacuum excavation then focussed on areas to the east and west, referred to as the eastern and western trenches. These trenches followed the line of a surface water drain in the base of the excavation, to trace the extent of contamination along this granular preferential pathway, see Appendix B Photos 7 and 9. HFO was visible along the line of the eastern trench but less evidence of contamination was noted from the western trench.

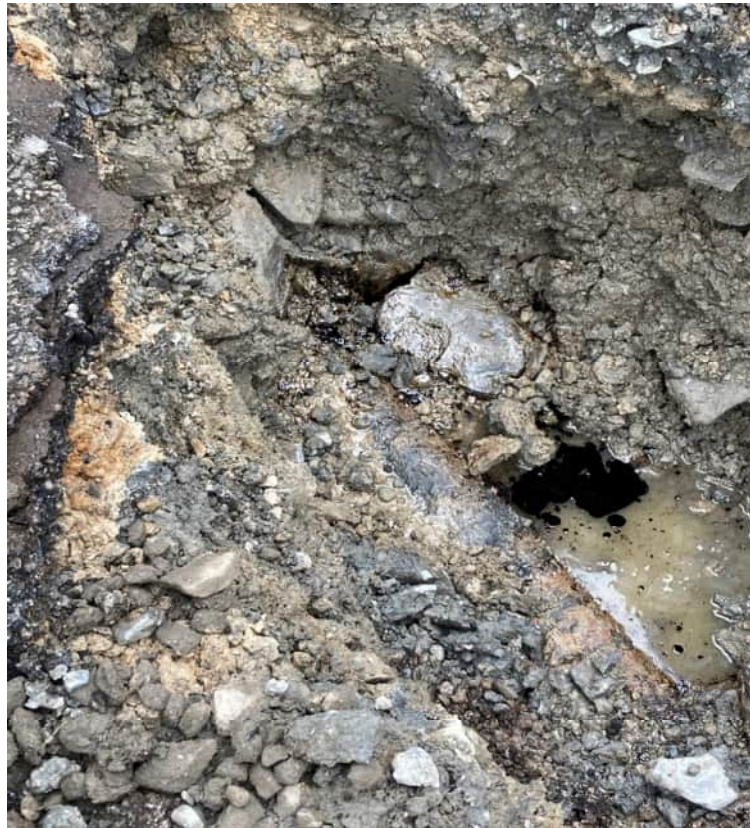
Heavy fuel oil contamination and water standing on bottom of eastern trench.

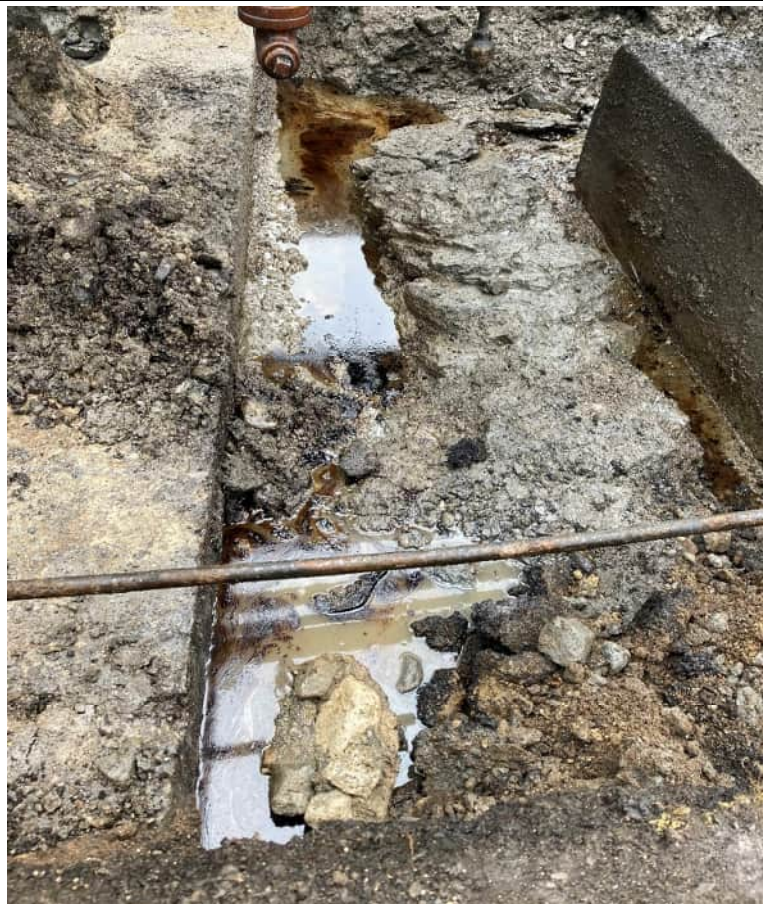
Heavy fuel oil contamination and water forming pools around concrete foundations on top of siltstone (bedrock)

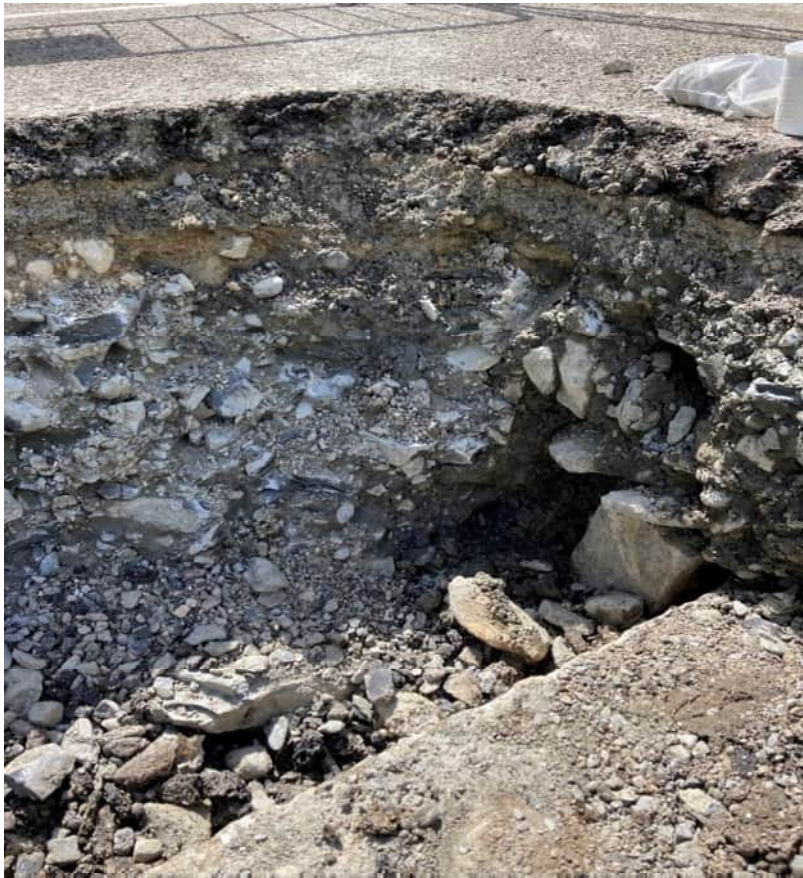
Made ground encountered on top of bedrock in western trench. No evidence of visual/olfactory contamination was noted at the western end of trench.

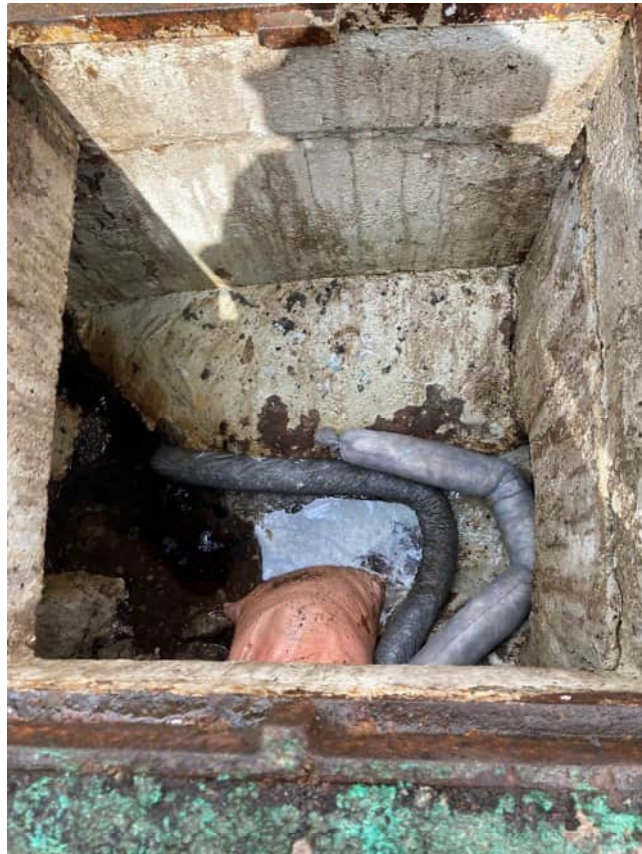
It is understood that, following the HFO loss, a minor sheen was noted in manhole S575 (see Appendix B Photo 10). Some defects in the drain line were noted close to the area of the HFO loss and this section of the drain has been relined.

Minor sheen was noted in manhole S575 down gradient of the spill.

Following the relining works, no sheen has been observed in manhole S575, and it is noted that even following the heavy rainfall of 24 to 26 June 2022¹, no sheen was reported at manhole S575 by SSE.

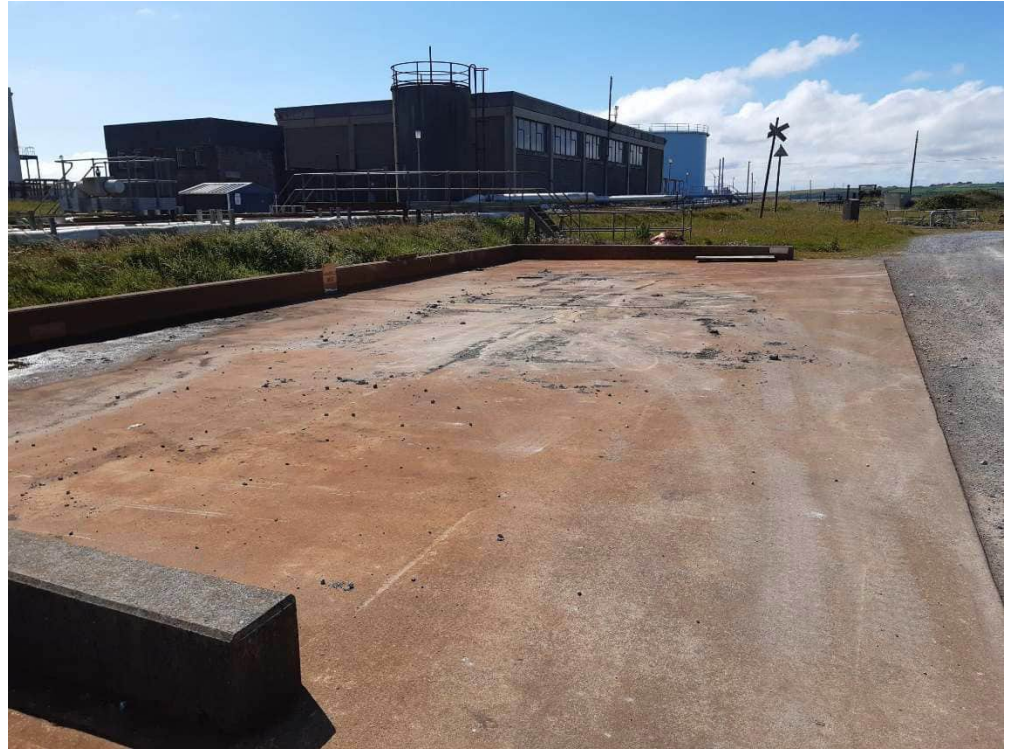
Hazardous waste bund where excavated soil had been stored prior to removal off-site.

Soil removed by vacuum excavation was left on-site overnight and stored on the hazardous waste bund (Appendix B Photo 11). This waste was collected on 10 June 2022 by the site's licensed waste contractor and taken to a licensed facility for treatment. A total of 33.82 tonnes of soils were removed from site. This included soil removed by vacuum excavation on 08 and 09 June 2022 (20.76 tonnes) and that which had been removed by hand-digging in April 2022 (13.06 tonnes).
