The Lisheen Mine - Closure, Restoration & Aftercare Management Plan

As Built Document

Golder Associates Ireland Limited

November 2020

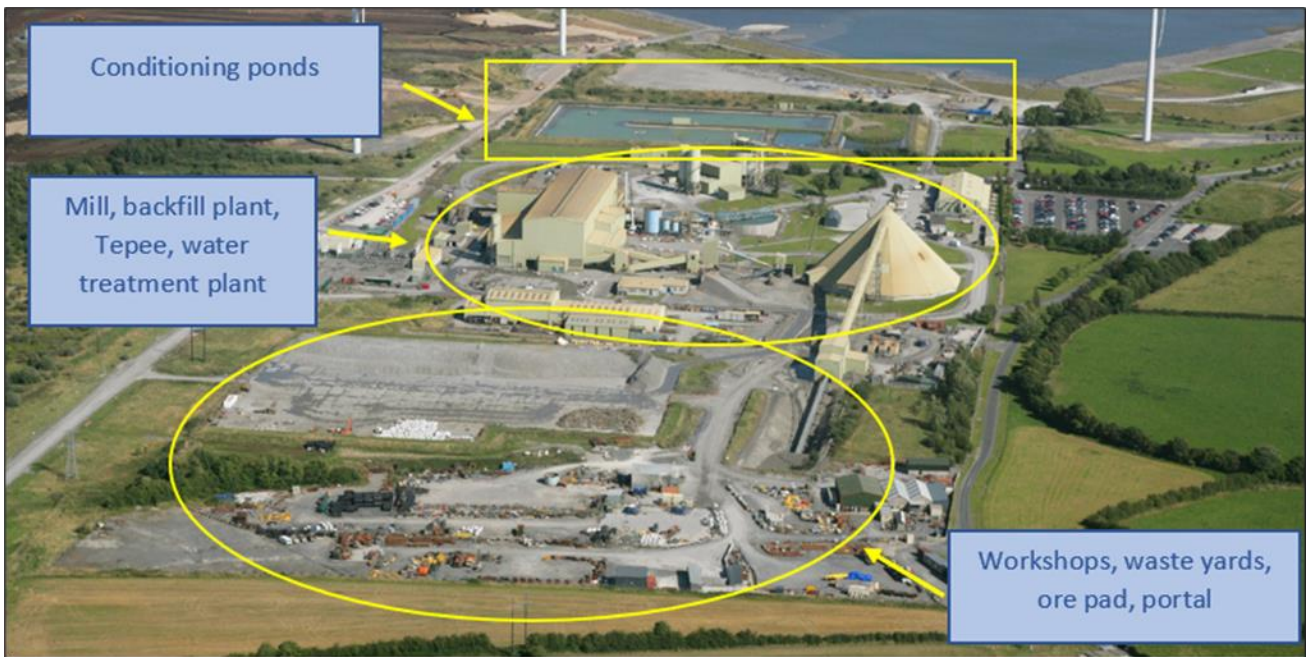
Figure 3-1: Mine Site pre demolition

Figure 3-1 and Figure 3-2 compare conditions at the Mine Site pre demolition, with conditions post demolition and rehabilitation.

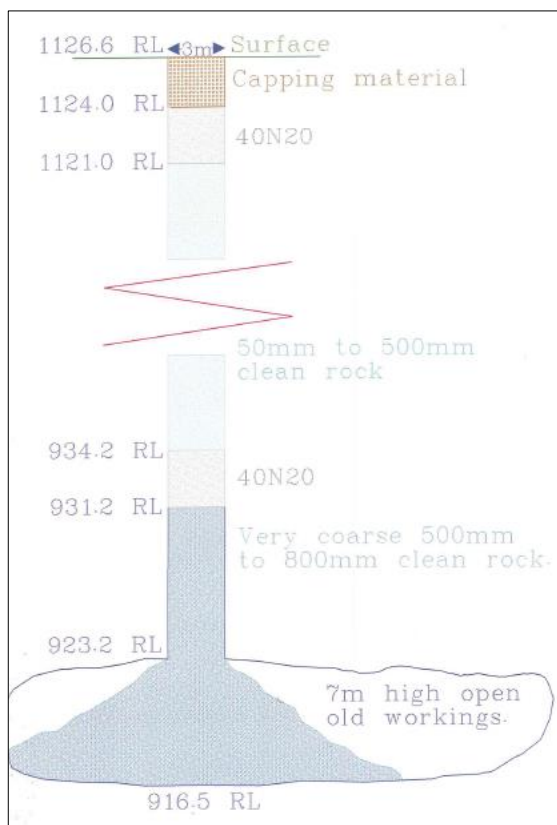
Figure 3-3: Vent Raise 2 – typical of all the shaft fill designs

Each shaft has a base rock plug and a base concrete plug above the Mine excavation. The full columns of the shafts were filled with rock followed by a concrete plug on top which was then covered with a lintel on surface (Figure 3-3). Each ventilation shaft location was rehabilitated in harmony with the surrounding environment.

The finalised construction of this work package ensures that the Mine cannot be accessed by any of the shafts and it also ensures that the surface of all shafts are stable with no chance of settlement expressing itself on surface.

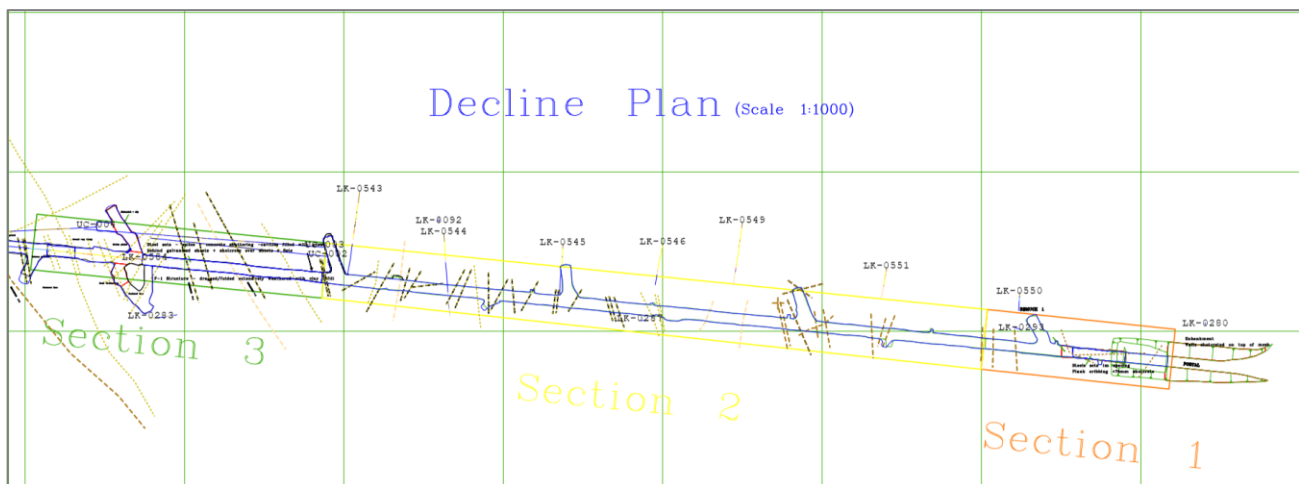
Figure 3-8: Design for the Decline Fill

A berm was constructed at a vertical distance of ca. 20 m below surface – which gave a linear distance of ca. 188 m in the Decline that had to be filled. The vertical distance of ca. 20 m was derived by an experienced geotechnical engineer who previously worked at Lisheen for 15 years. The design for the Decline fill is presented in Figure 3-8.

The Decline fill design was split into three sections. Section 1 extends ca. 188 m from the surface. Due to a risk of caving on surface if failure were to occur the section was backfilled. A pressure bulkhead was installed below Remuck 1 with a grout plug up gradient of it with the remainder of the area up to the Portal packed with washed rock which was sealed with fibre reinforced shotcrete.

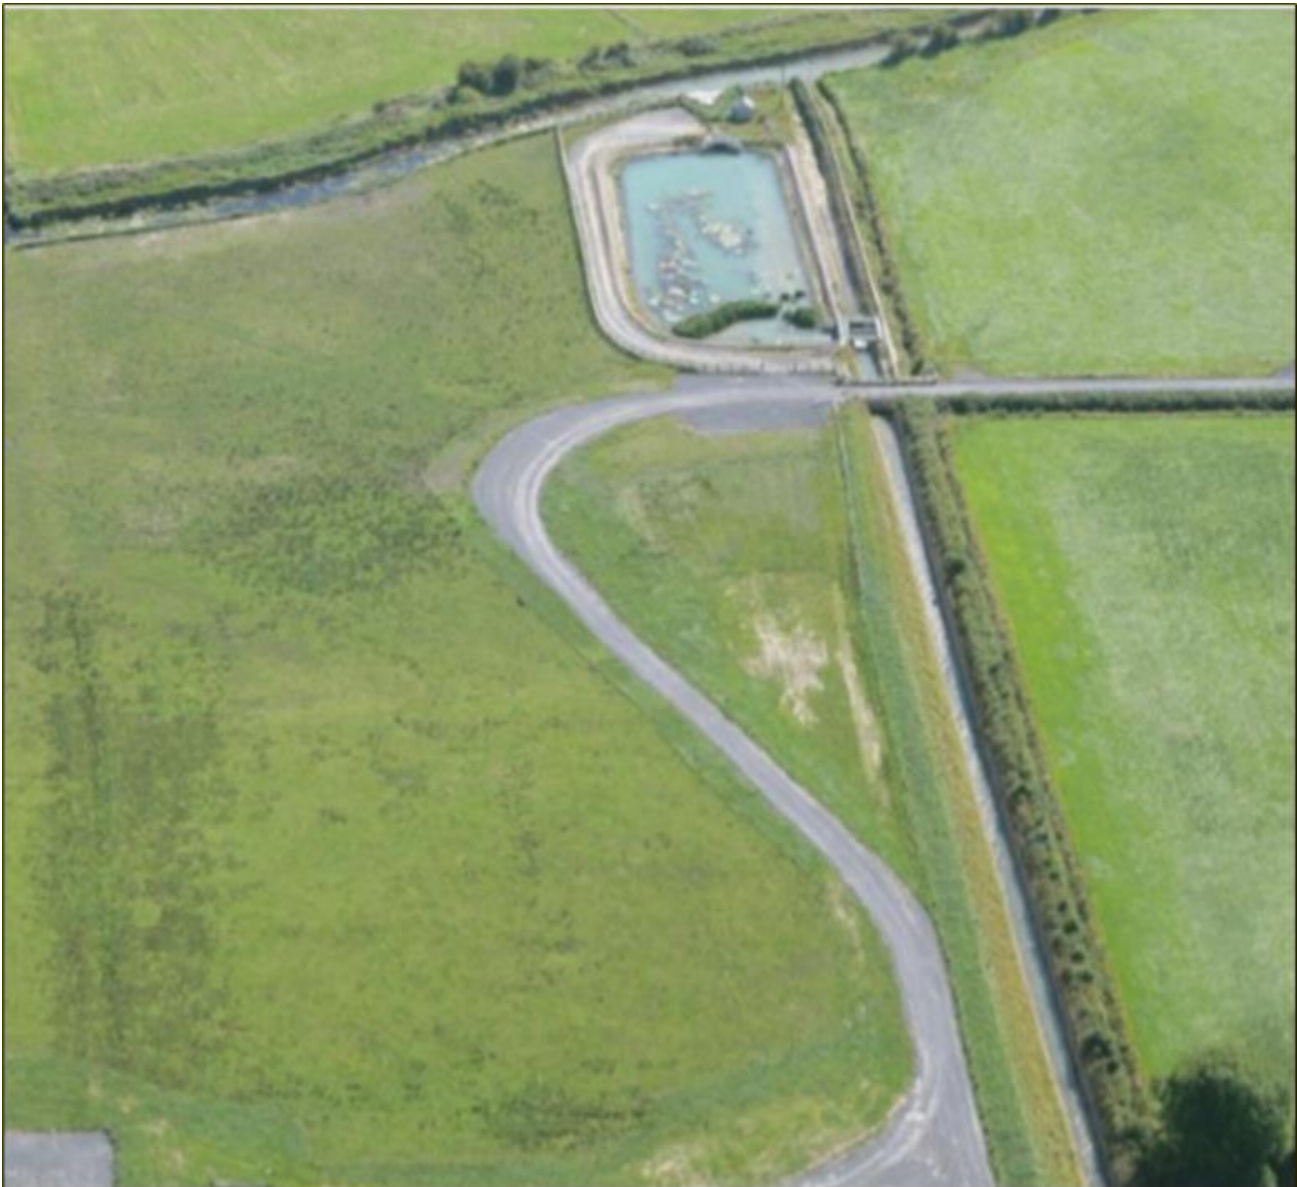
Figure 3-12: Drish Channel and Pond pre demolition

All water and sludge were removed from the Drish Pond and the entire Drish Pond and Channel area was rehabilitated. The works involved breaking out the concrete chambers and sumps and hauling the demolition rubble to the TMF. All residues and silt from the pond area were also hauled and placed within the TMF.

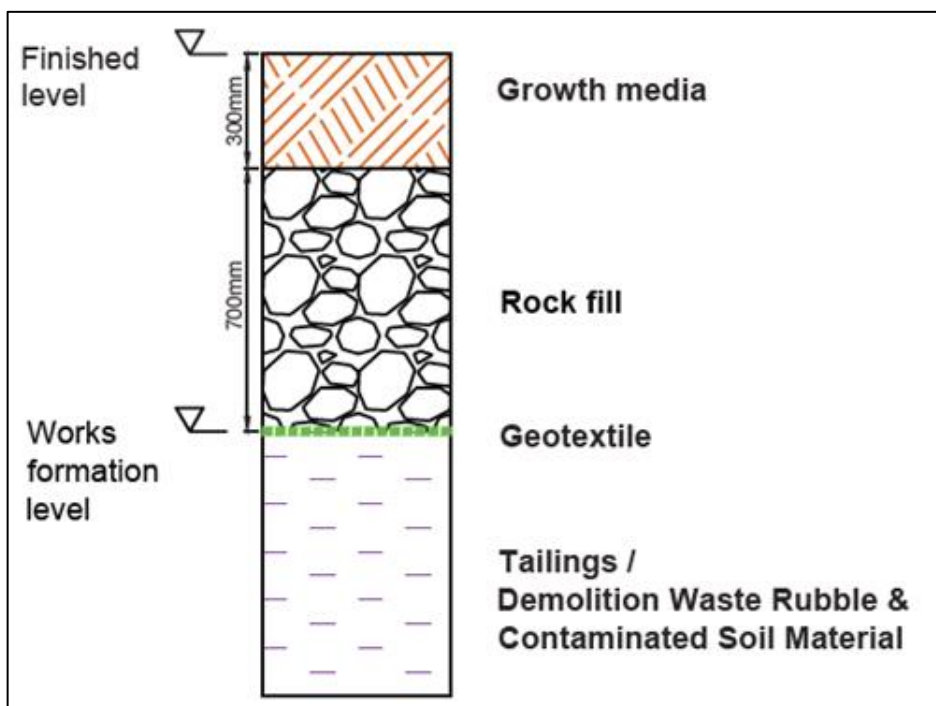
Figure 4-1: Cap Cross Section Detail

This was accomplished with the installation a composite cap made up of a layer of geotextile placed above the tailings, an approximately 700 mm depth of limestone rock fill cap and an approximately 300 mm depth of soil material layer to sustain vegetation. This approximately 1 m depth cap ensures that the tailings are comprehensively covered and decoupled from the grassland vegetation on the surface (Figure 4-1).

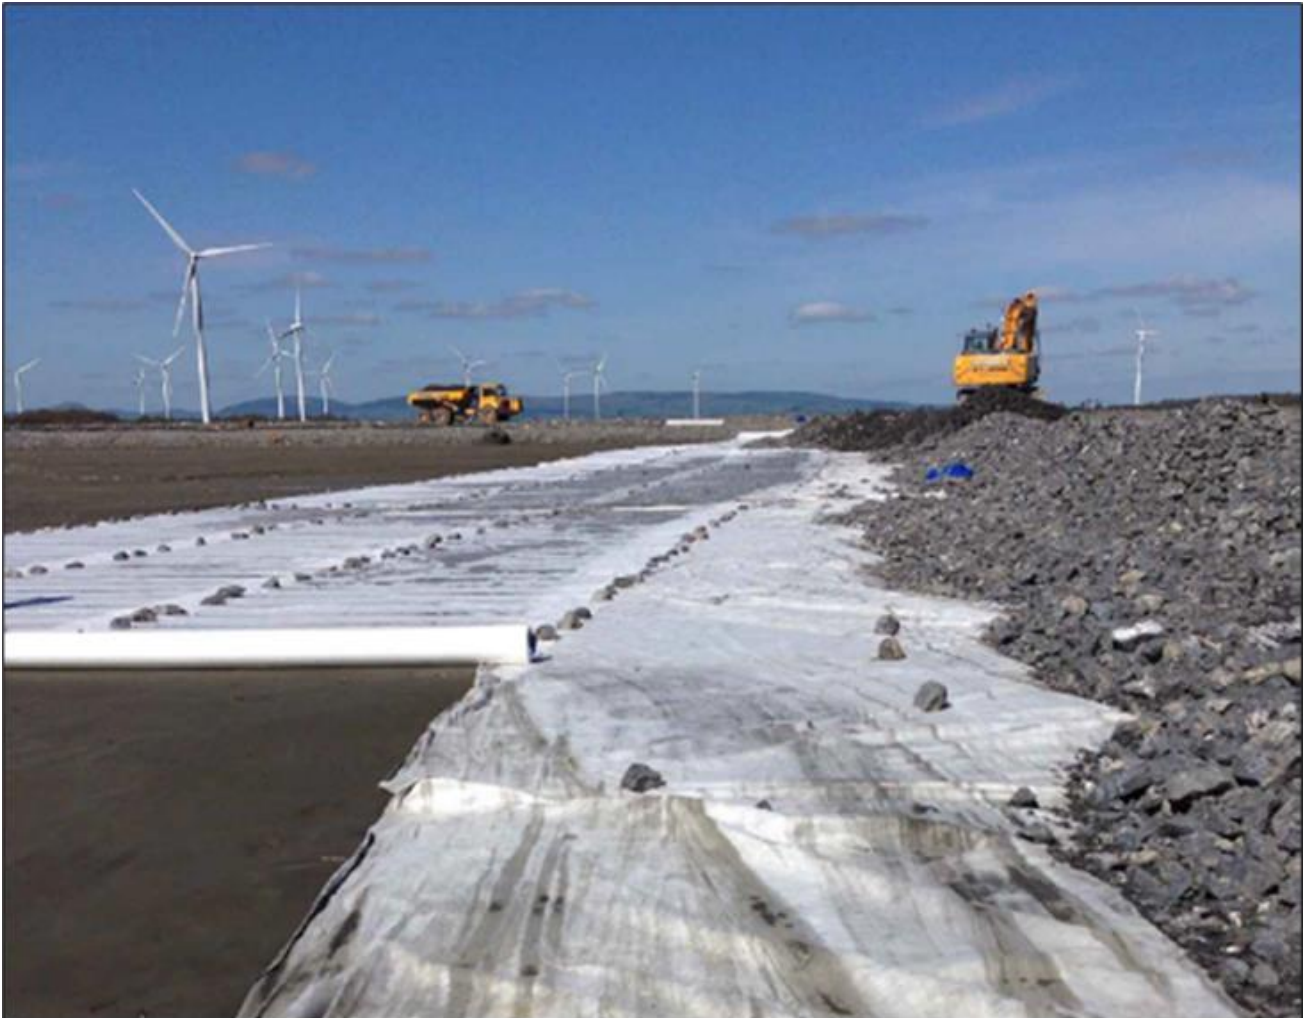
Figure 4-6: Placement of geotextile above the beached tailings

Once the tailings beaches had been desiccated sufficiently, they were inspected by the CQA team, prior to the placement of the separation geotextile material, to ensure that there were no excessive voids beneath. When required, the Capping Contractor was directed to fill voids with rock fill, which were graded to the level of the surrounding tailings. The separation geotextile was then extended across the exposed tailings beach, with panels overlapped with a minimum lap length of 750 mm (Figure 4-6).

Samples of geotextile were taken every ca. 15,000 m² of capping footprint and sent for conformance testing, results of which are included in the CQA Validation Reports. Inspections of all geotextile laid and lapped ensured that they have been placed in compliance with specifications. The minimum required overlap of 750 mm was increased at the discretion of the CQA team and Capping Contractor and was dependant on the condition of the tailings and the performance of the tailings during construction; the typical lap length was 1,000 mm. Any holes or tears found in the geotextile were repaired as they occurred using a patch made from the same geotextile lapped with a minimum of 750 mm overlap in all directions from the defect.

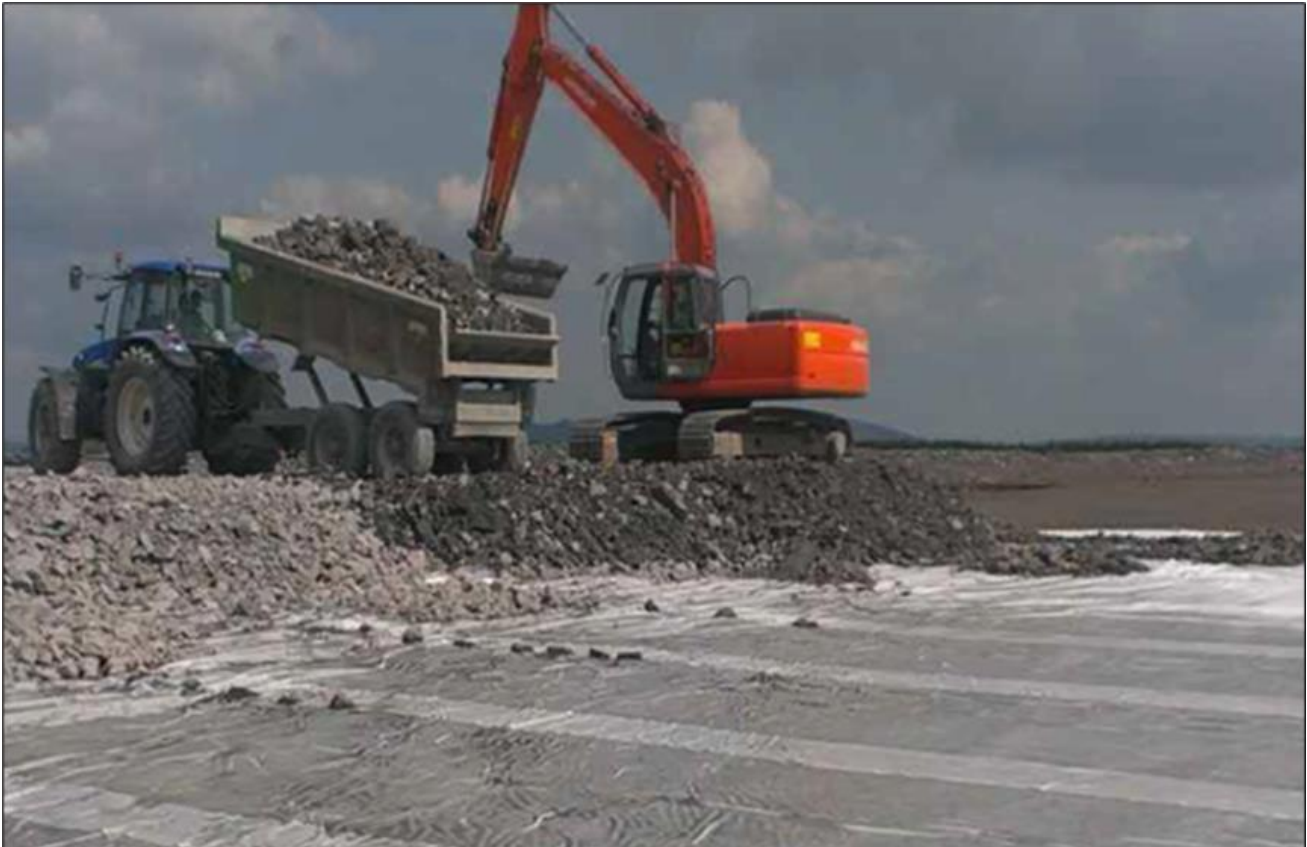
Figure 4-7: Placement of the rock cap above the geotextile layer

A rock fill depth of approximately 1 m was typically placed above the separation geotextile and this rock fill was subsequently graded to the design elevation as the capping works progressed (Figure 4-7). The minimum total depth of rock fill cap was at least 700 mm (0.7 m). Regular surveying of the material placed confirmed that the minimum depth of material was achieved and, in most locations, exceeded by 200 mm (based on settlement survey data).
