Galmoy Mines Ltd

Galmoy Mines TMF Independent Audit 2023

Project no. 41000013

Date: March 2024

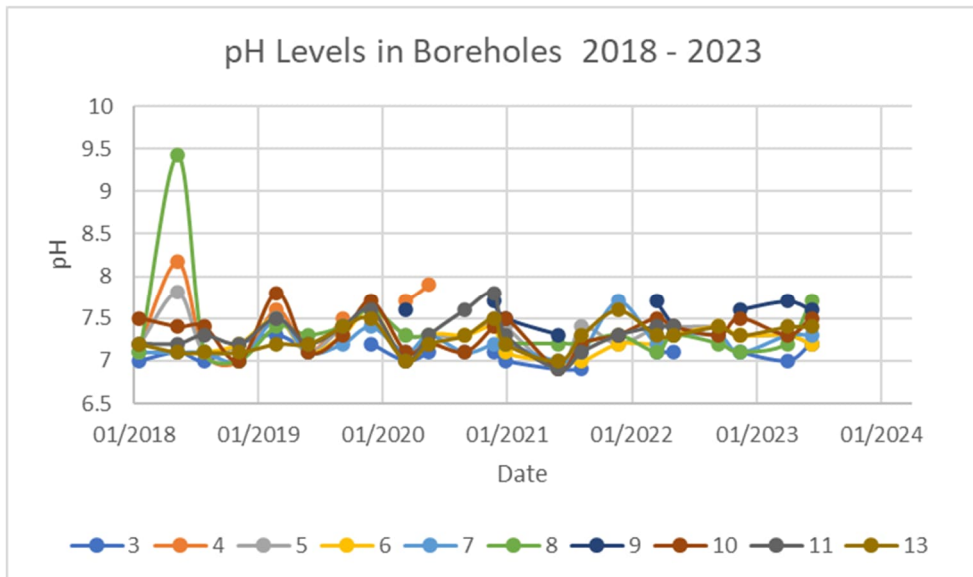
Figure 2-3 – pH Levels in Boreholes 2018 - 2023

- The pre-rebound pH values are similar in range for those recorded for post-rebound and generally range from 6.9 to 8.1 pH. Anomalies present in the data only extend slightly outside this range (BH7 9.42 pH May 2018). Data from 2018 – 2023 is consistent with previous years.
- The range of conductivity values has increased from 2018 to a range of 347 μ S to 1,227 μ S. The higher values are being recorded at BH8, similar to 2018 and this can be correlated to increasing sulphate values.

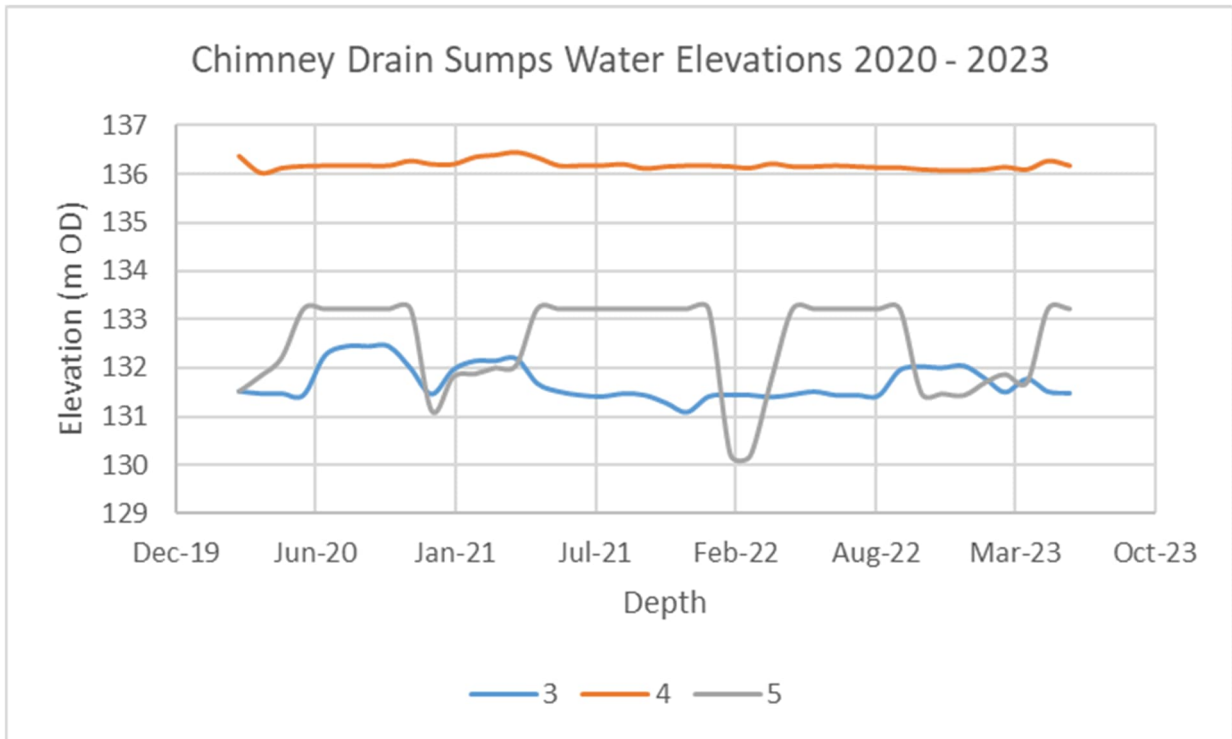
Figure 2-10 - Chimney Sumps Water Levels 2020

The following was observed from the analysis of the monitoring data:
