Side Slope Stability Assessment 2023

Arthurstown Landfill (W004-04)

Project Number: GCU0303001

6 October 2023

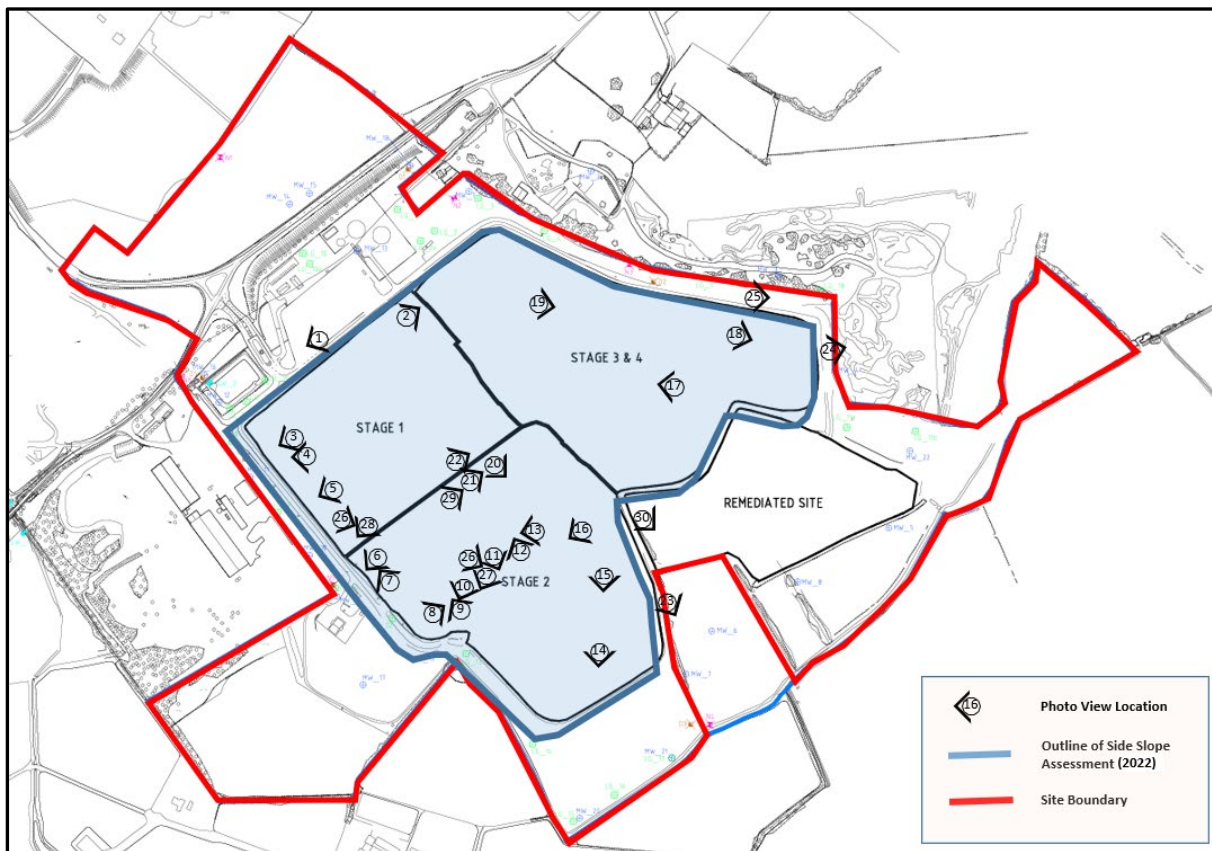
Figure 2: Photo View Locations.

Figure 2 below depicts Photo View locations 1 to 30, which are presented in Appendix A. The facility was closed with no activity observed during the Site visit.

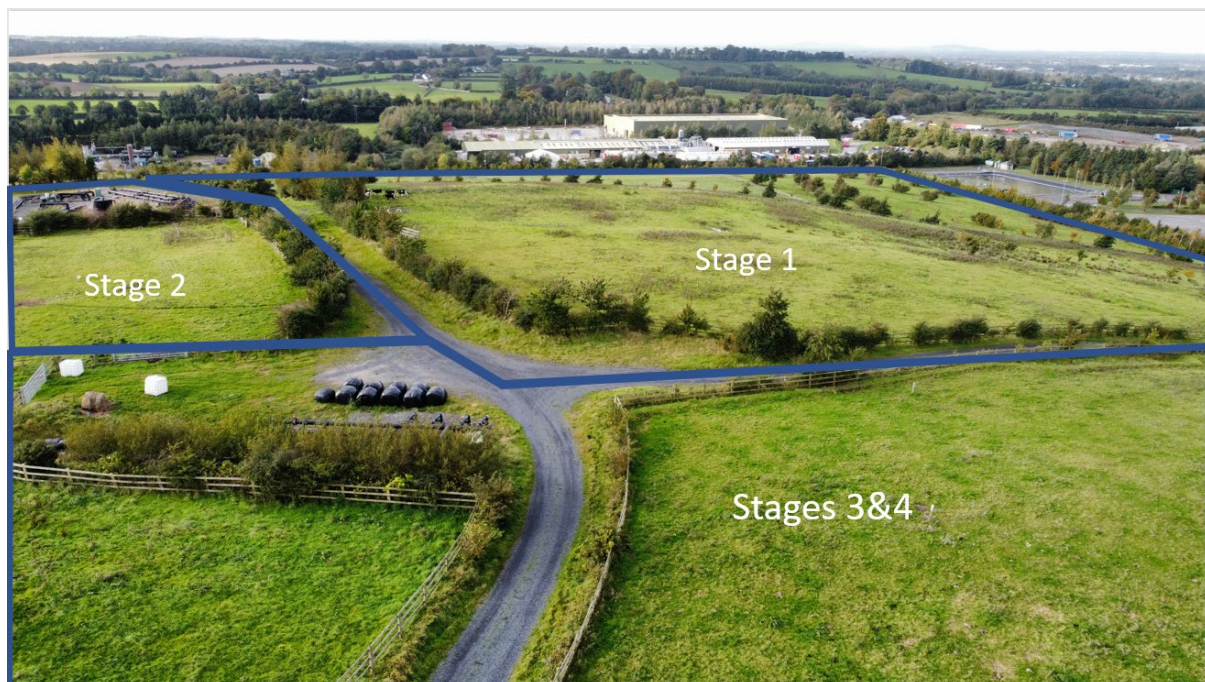
Figure 3: Aerial view from East to West – towards Stage 1 of the Site

- **Stage 1** – signs of long-term settlement were noted but no damage could be observed on the surface or any above ground structures, such as fences, drains, ditches and landscaping (trees and hedges).

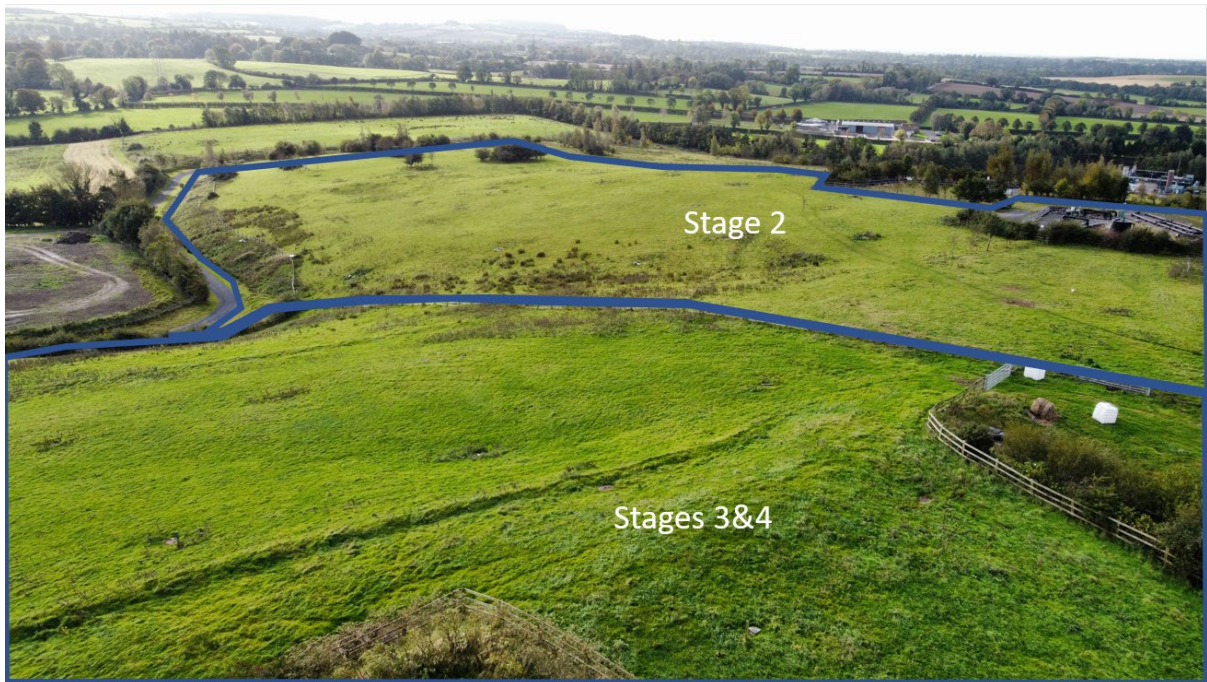
Figure 4: Aerial view from NE to SW – towards Stage 2 of the Site

- **Stage 2** – visible signs of settlement could be observed within Stage 2, i.e. at infrastructure that form a part the landfill gas collection infrastructure, such as manholes and concrete slabs (refer to Photo Views 13, 26 and 27 for an example). It is considered likely that the observed settlement occurred in the years immediately after the cessation of landfilling activities at the Site. The degree of settlement was observed to be similar when compared to the previous visual assessments. It is recommended that these locations will be inspected to assess if any damage to the underground installations have occurred and remediated if required.
