LISHEEN TMF ANNUAL REVIEW 2024

PROJECT NO. 4100013

DATE: MARCH 2025

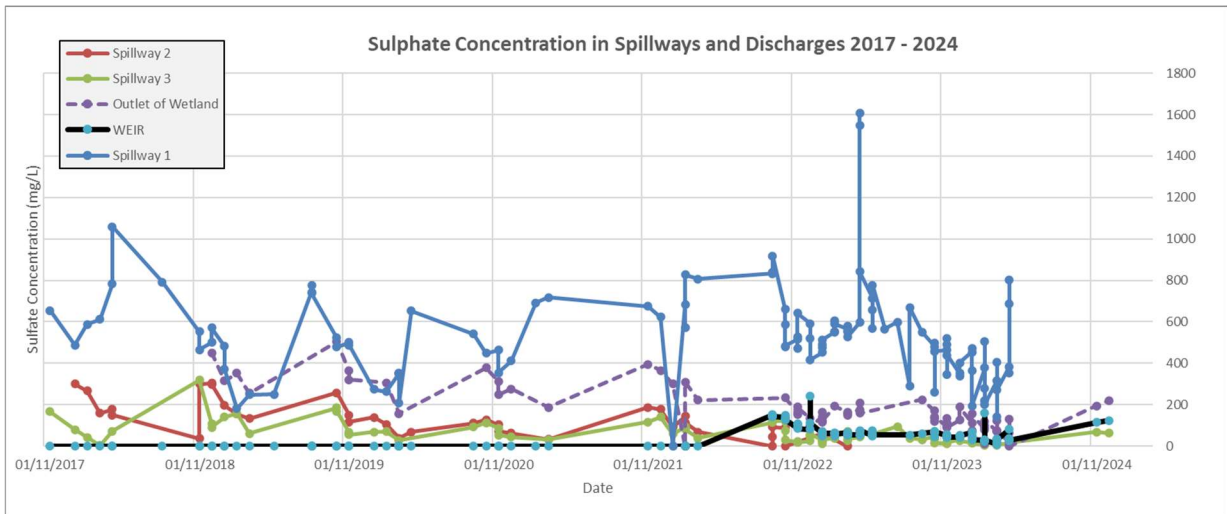
Figure 5-1 - Spillways & Discharges Sulphate Concentration (Licence Limit only relates to SW1)

Discharge at Spillway 1 (SW1) generally occurs between October and April. Figure 5-1 presents a summary of readings from 2017 to 2024, with sulphate concentration plotted on the y-axis in mg/L. A stop-start discharge pattern can be observed for Spillways and Discharges between 2017 and 2024, except for Spillway 1 during 2019, when pumping was continuous as part of seepage remediation works between CH2300 and CH2500.

Based on additional data from October 2024, this exceedance is attributed to the 'first flush' effect commonly observed at the beginning of discharge cycles.

- Spillway 1 continues to exhibit the highest sulphate, nickel, and zinc concentrations, indicating ongoing seepage influences.
- Spillway 3 continues to produce good quality water demonstrating the cap is working effectively. The water chemistry at the weir is comparable to the pre weir Spillway 2 water with the overall long term trend being downward, suggesting improved drainage control.
- The effectiveness of the weir in lowering water levels and reducing seepage will be assessed in a report towards the end of 2026.
