Response to Further Information Request (FIR)

12/09/2017

Tara Tailings Management Facility Dam Break Study

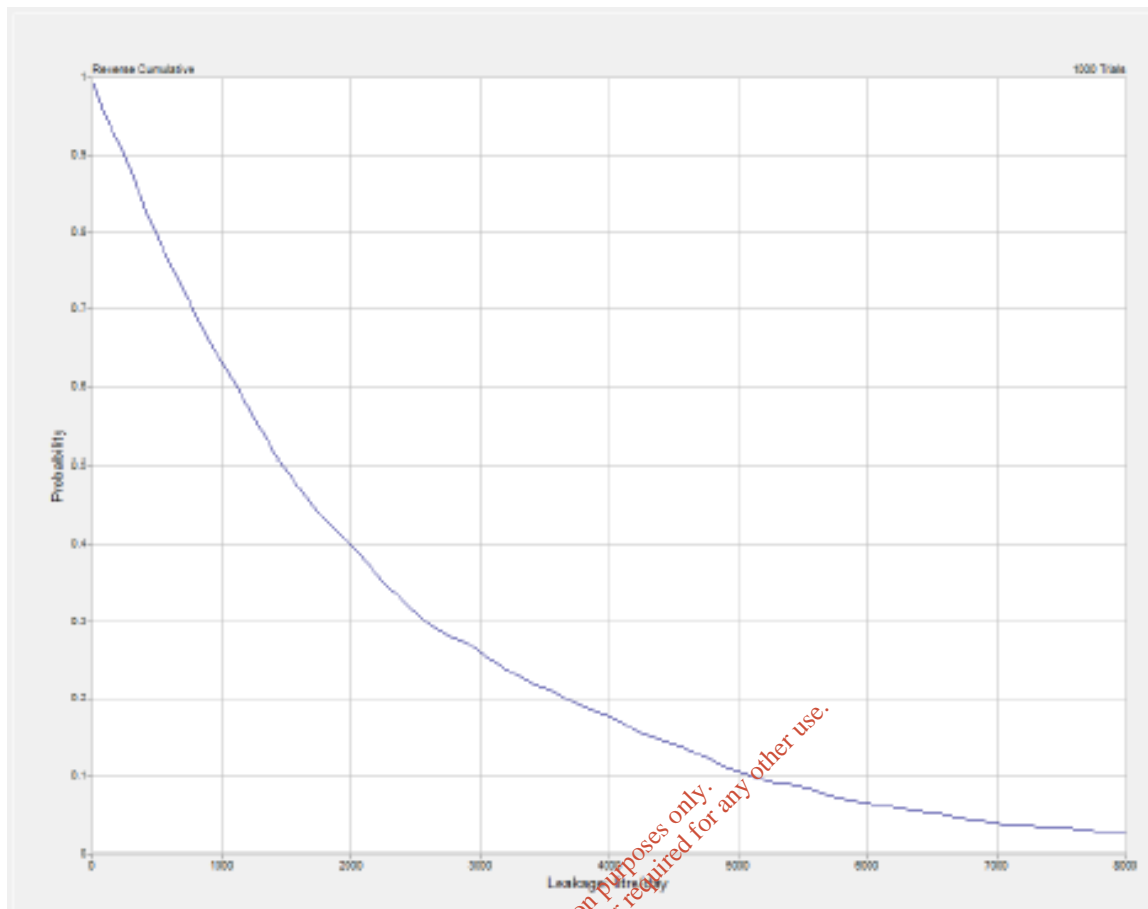
The volume of seepage flowing laterally through the dam wall via the GCL and some nominal defects in the lining system for a constant head of 20m (Phase 2) would be an average of about 1.5 m³/day with a 10% probability of the seepage being less than 0.25 m³/day and a 10% probability being greater than 5 m³/day. The range represented in the figure below, is based on a number of variables including infiltration rate based on the range of vertical permeability values of the tailings, the range of defects in the lining per hectare, the effective permeability of the composite lining and head acting on the lining.

Figure 1: Probability of Seepage from Composite Lining System

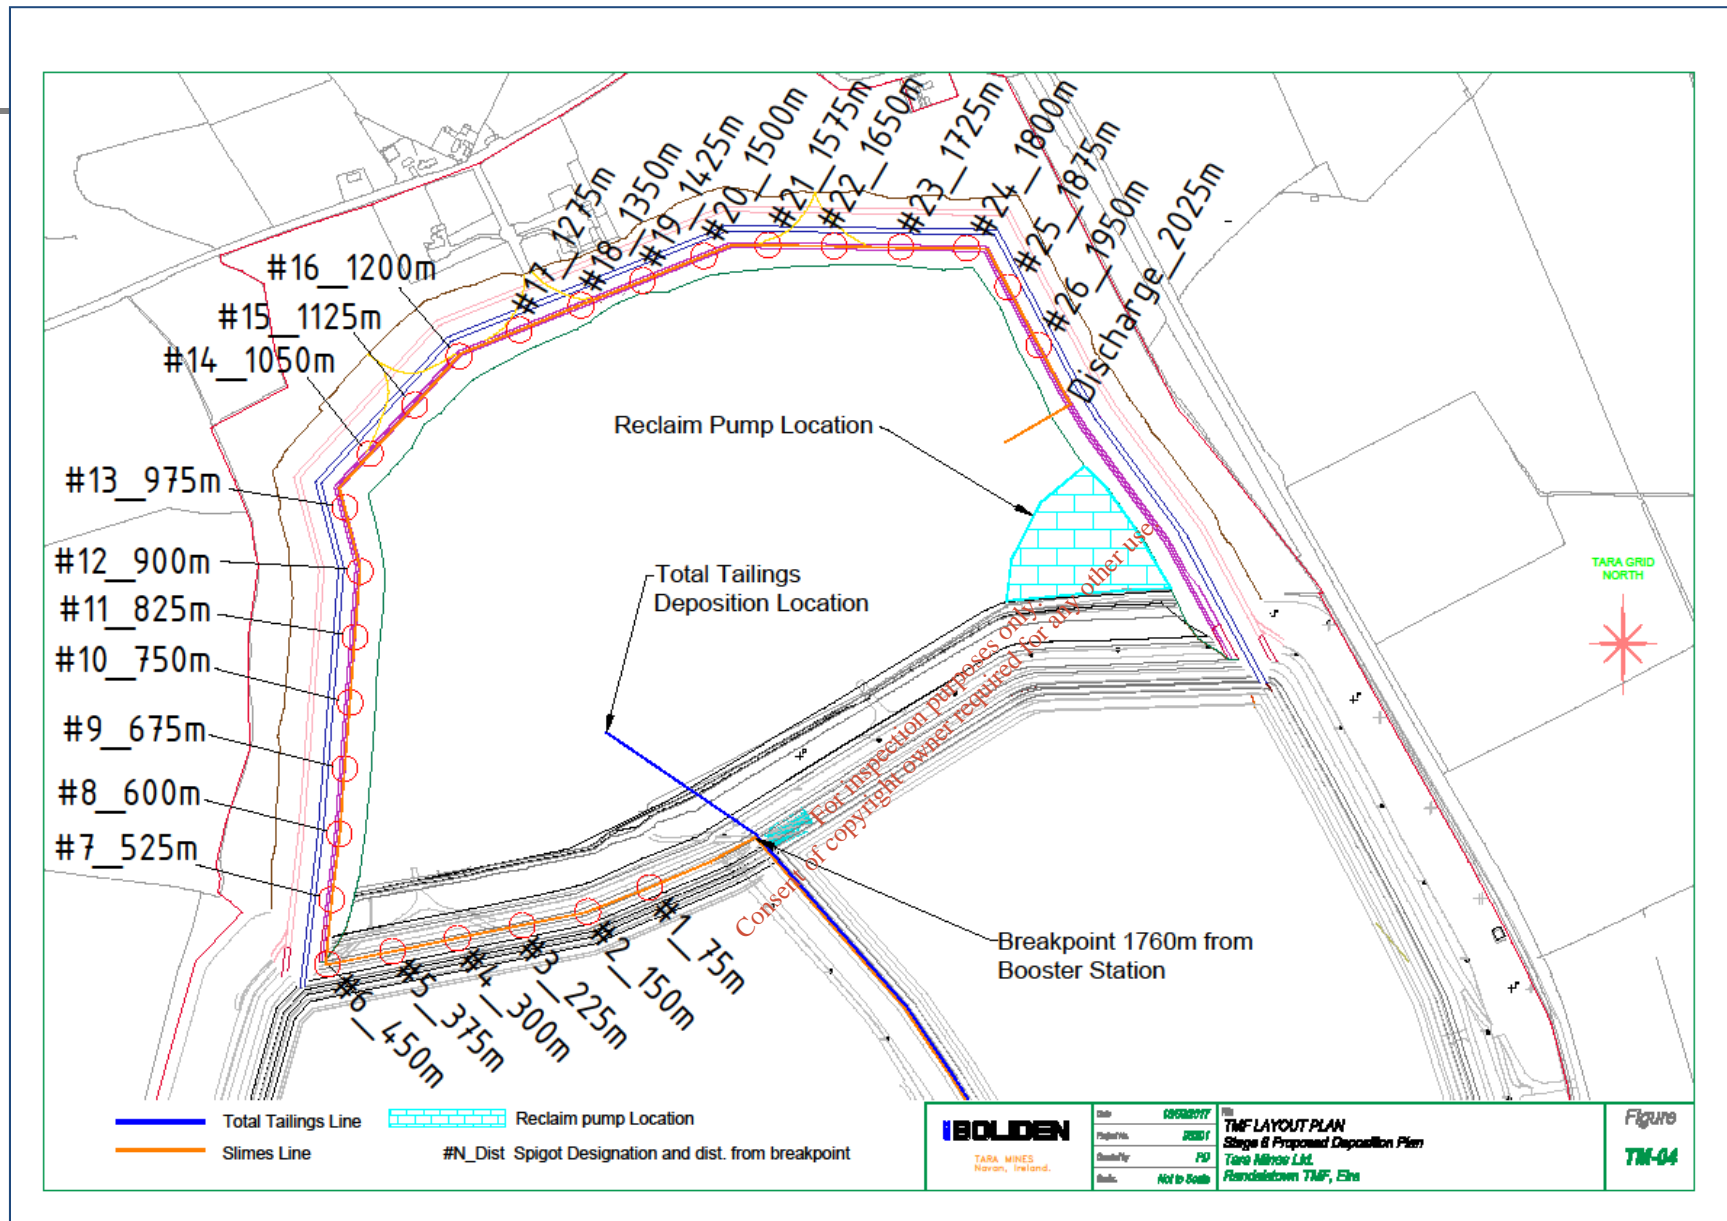
The tailings deposition systems for the Stage 6 crest are detailed in Figure 2, including spigot locations and long section (figure 3). The main header pipeline carrying the tailings is 800 mm OD, 559 mm ID, PE100 and SDR17. The spigot spacings will be at 75m. The tailings discharge pipe line at the spigots is 200 mm OD, 176 mm ID, PE 100 and SDR17. A typical spigot point is presented in Figure 4 below

Figure 2 Stage 6 Tailings Deposition Plan

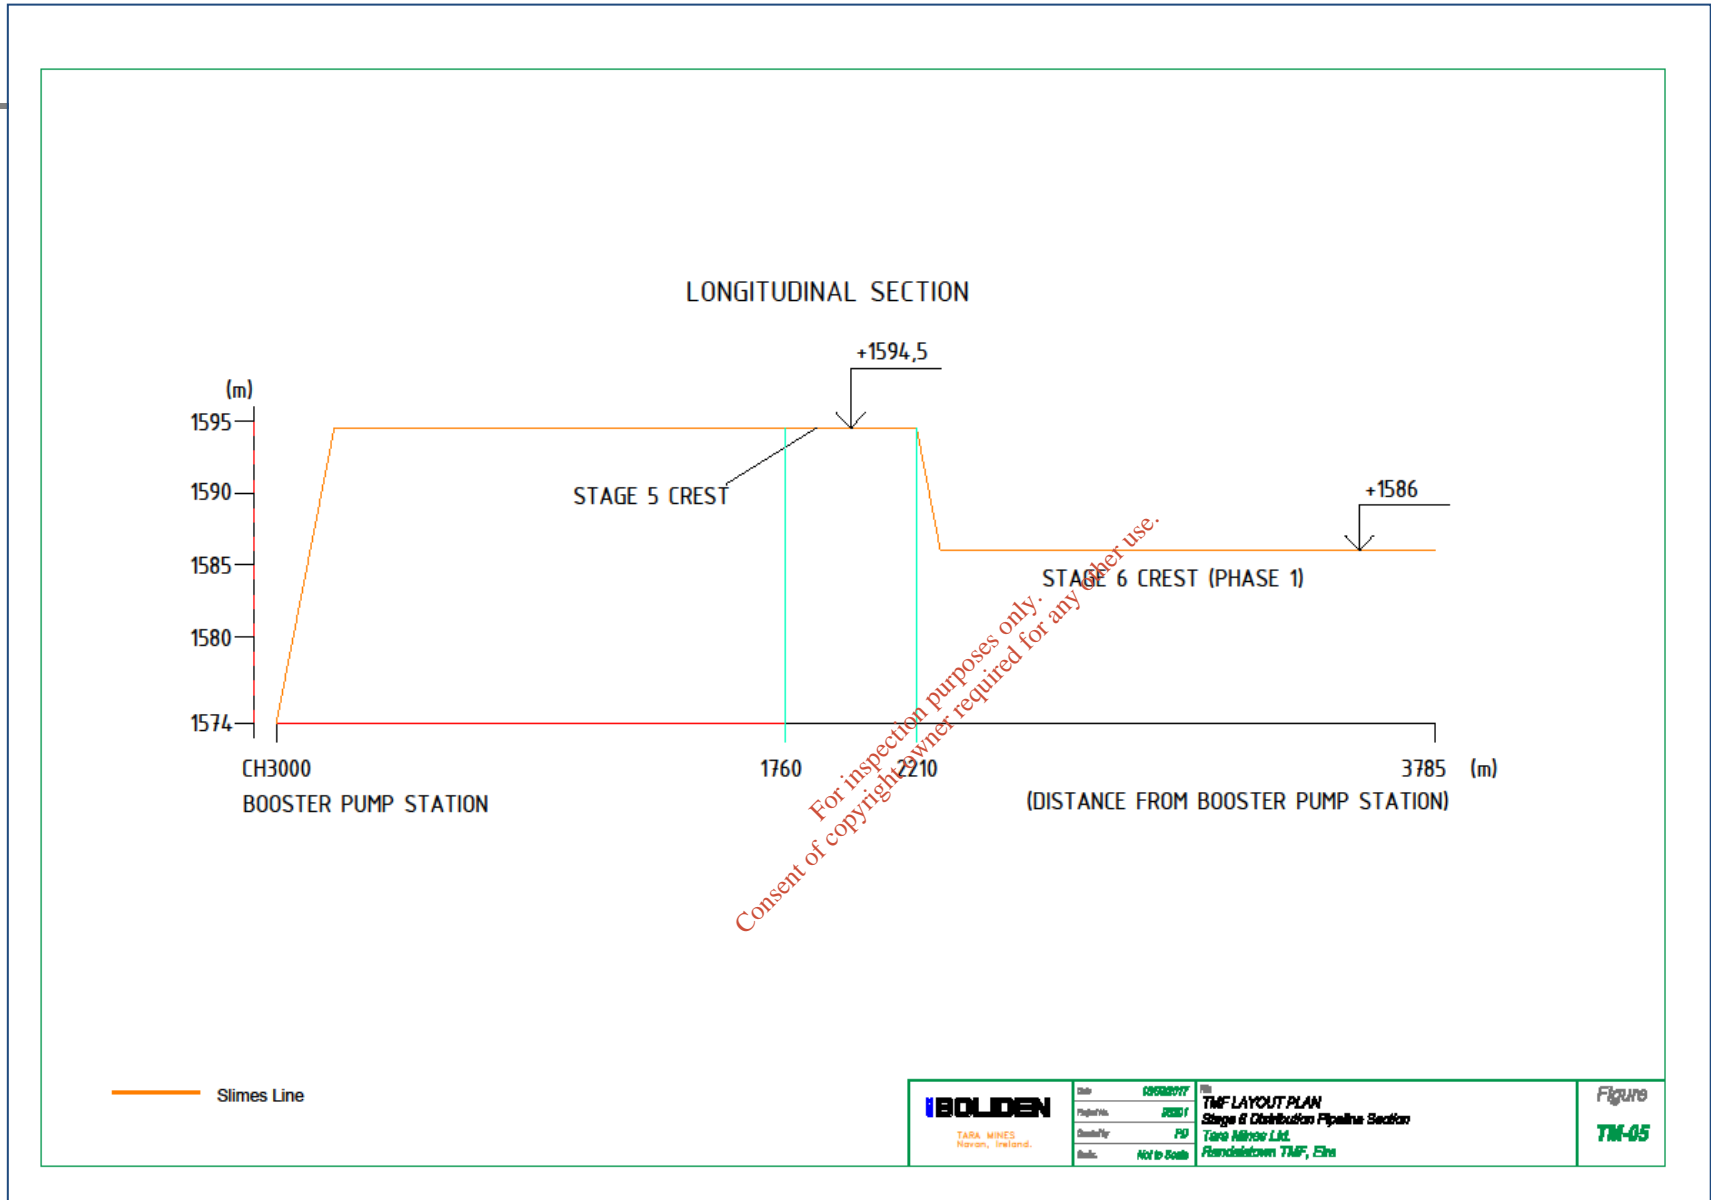
Figure 3 Stage 6 Layout Longitudinal Section

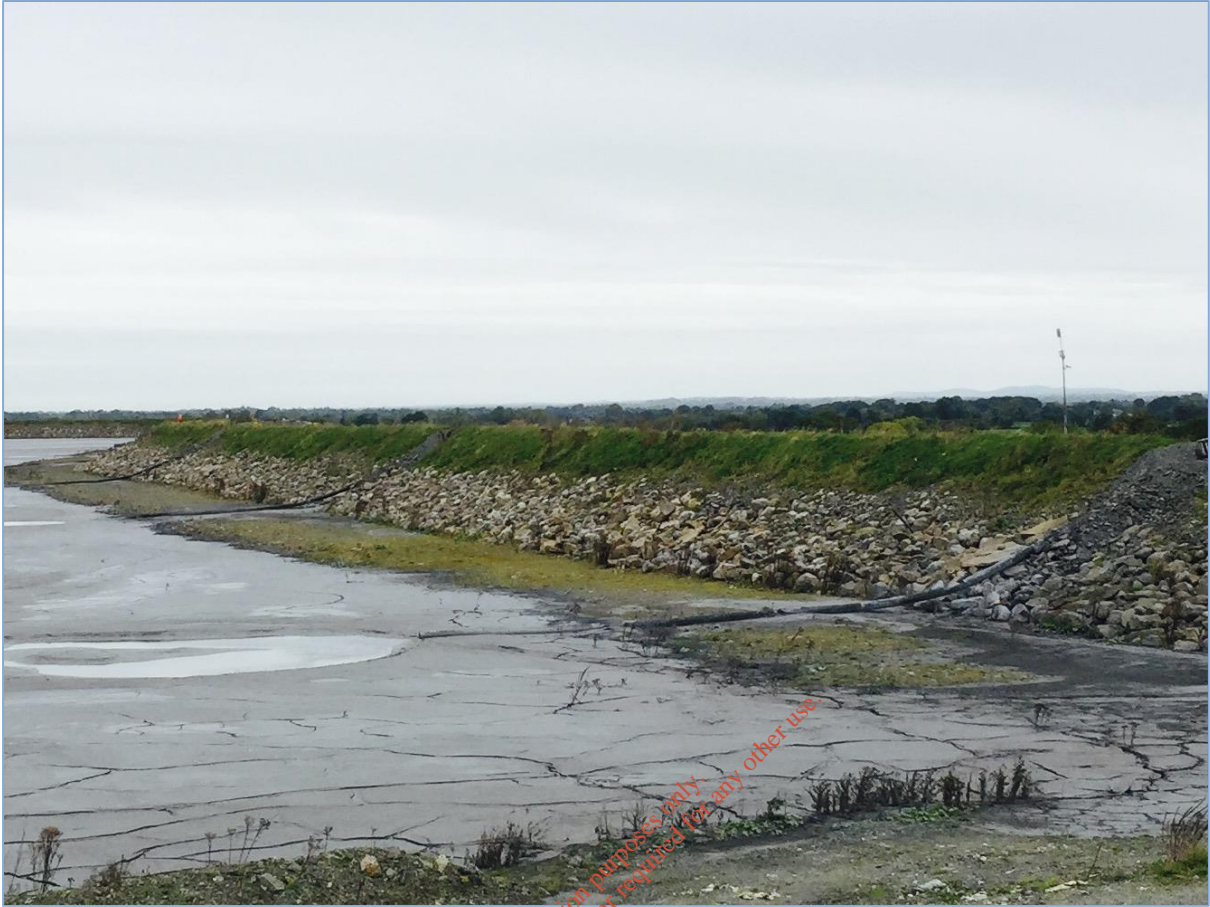
Figure 4 Typical Spigot Point

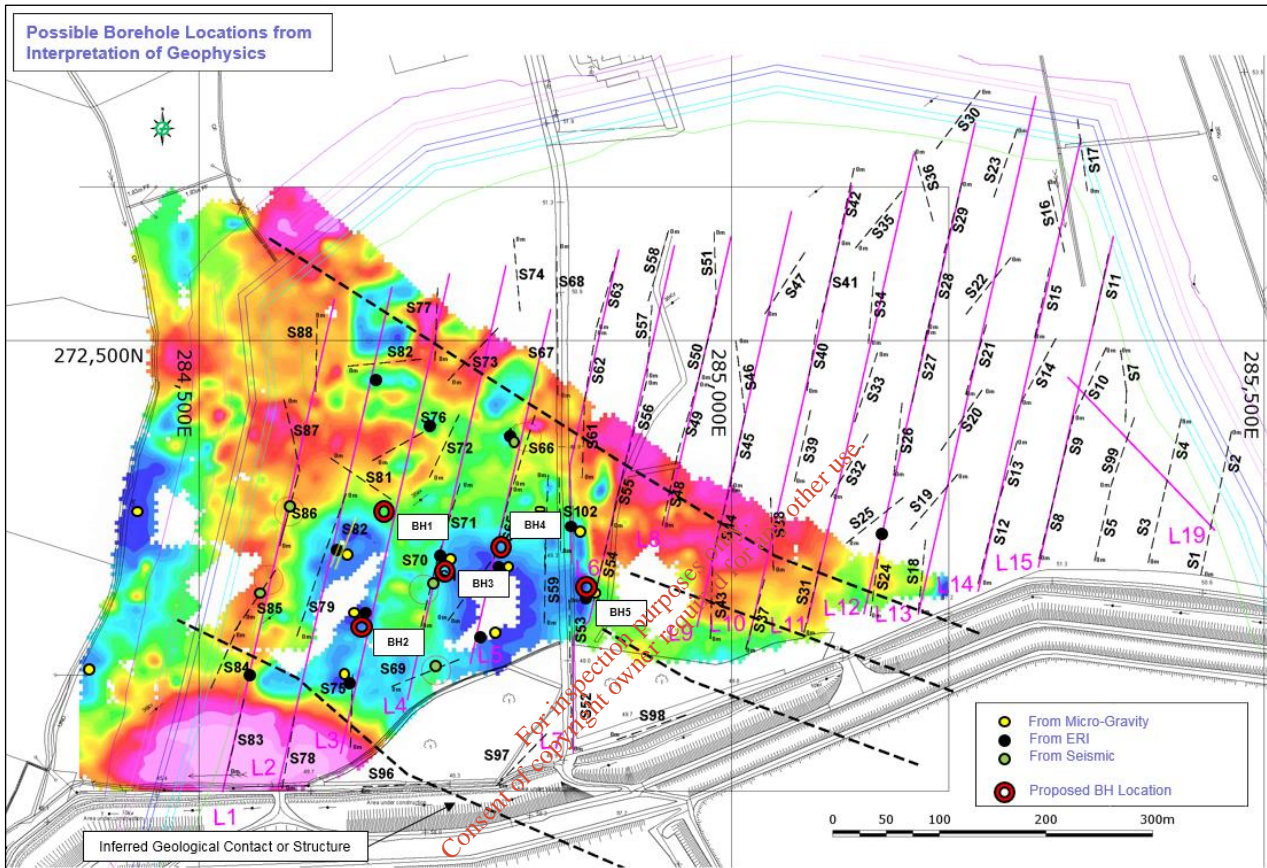
Results from the **Micro-Gravity** survey identified a number of gravity lows (Figure 3), indicating the possible presence of areas with 'low density sub-crop material'. These gravity low areas may be due to palaeokarstic

features within the underlying Pale Beds limestones. Modelling of the Micro-Gravity and comparison with the ERI pseudosections and Seismic Refraction profiles indicates that heavily weathered, fractured (and palaeokarstic) bedrock conditions may exist in the underlying Pale Bed limestones from near surface to depths of typically 40 to 50 m bgl. Five locations for boreholes, centred on the anomalies, were selected to test for the presence of palaeokarst features.

Figure 3: Residual Bouguer Gravity Map with Borehole Locations (red circles)

None of the anomalies interpreted are located beneath the dam wall footprint, all five are located in the south-west section of the base of the proposed Stage 6 TMF.

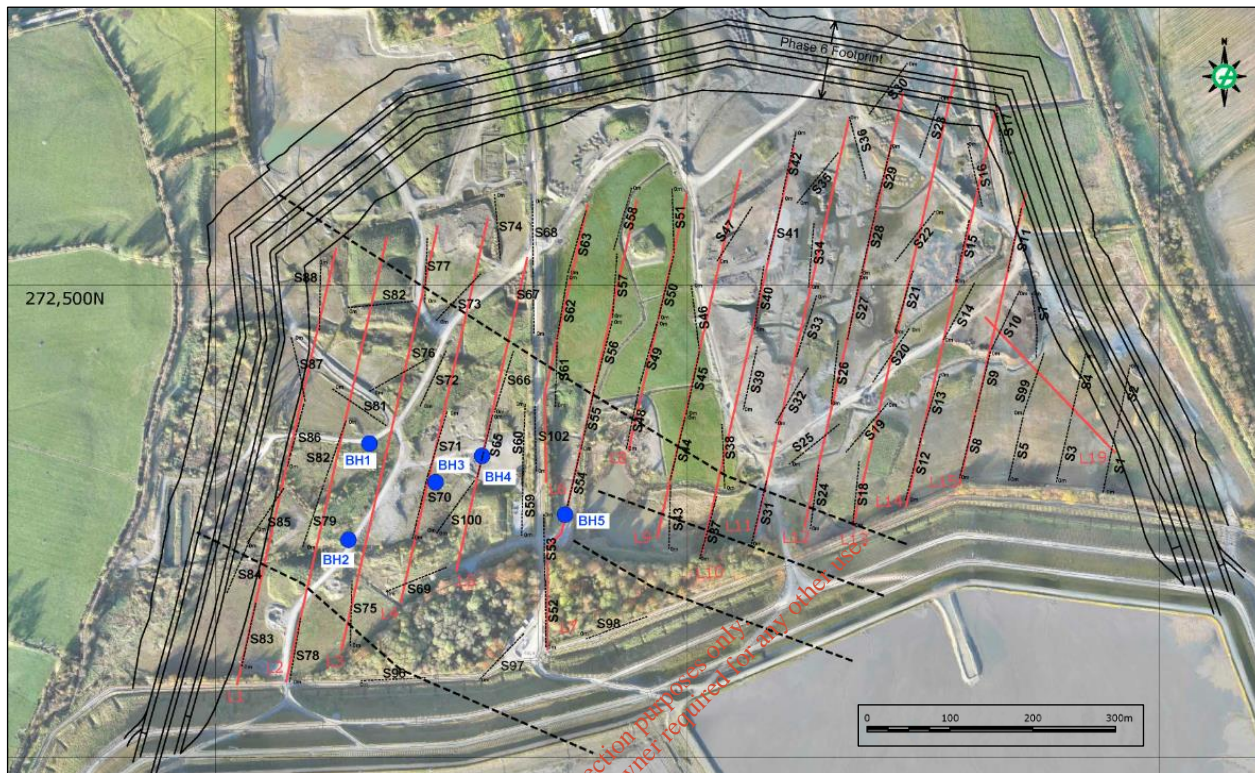
Figure 4 below presents the locations of the investigative boreholes plotted over a recent aerial photograph of the proposed Stage 6 extension to the TMF.

Figure 4: Location of Boreholes (plotted over recent aerial photograph of the Stage 6 TMF footprint)

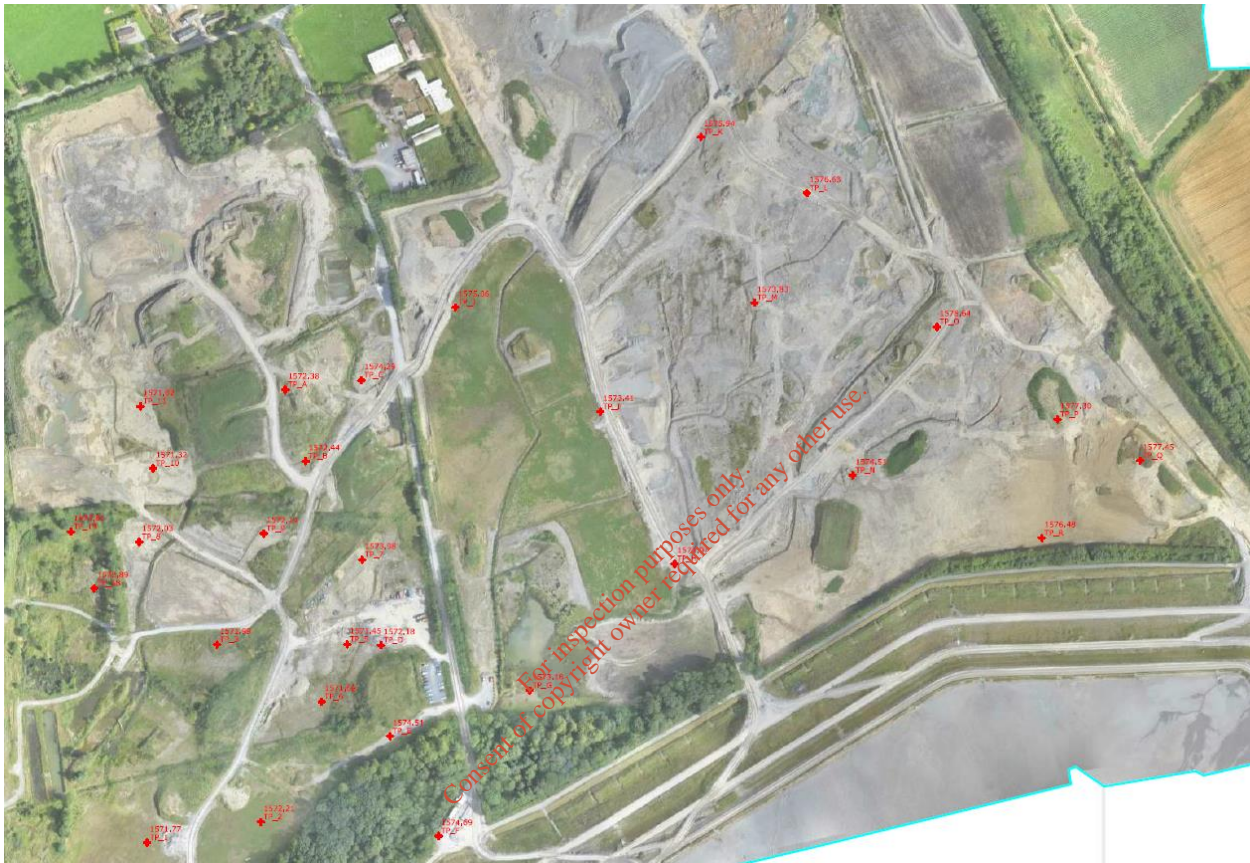
Twenty nine trial pits were excavated through the overburden material to near refusal either in bedrock or where hard digging due to the presence of numerous cobbles and boulders were observed within the basin area of Stage 6 in the northern and seven fields borrow areas. The location of the trial pits is given in Figure 3 and the logs presented in Appendix B and indicated that within the Stage 6 basin area of the western cell, the depth of overburden was generally between depths below ground level of 3.6 m and 5.0 m. In terms of elevation, the overburden extended to depths below 1570 m AMD and 1566.8 m AMD. In the eastern cell, overburden was found to depths of between 0.4 m and 3.5 m below ground level although in some areas the overburden has been removed completely to expose bedrock.

Figure 3: Location of Trial Pits in the Northern and Seven Fields borrow area

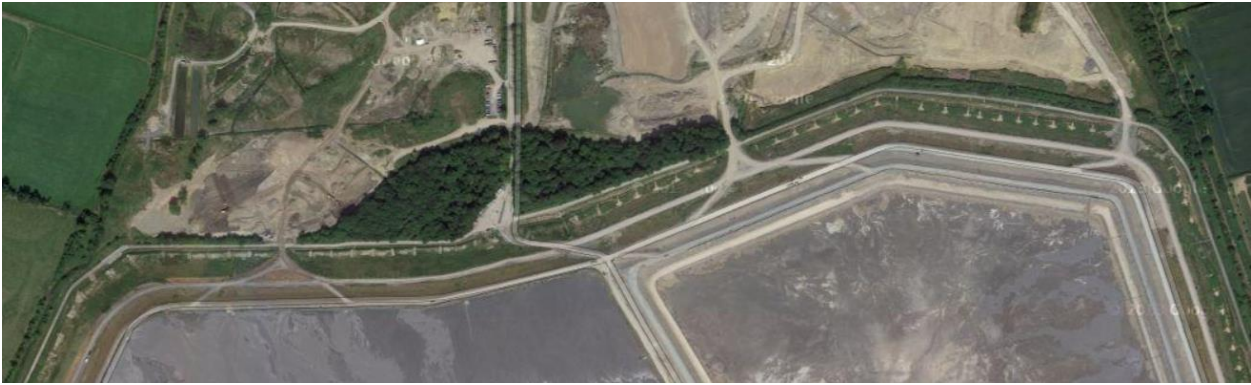
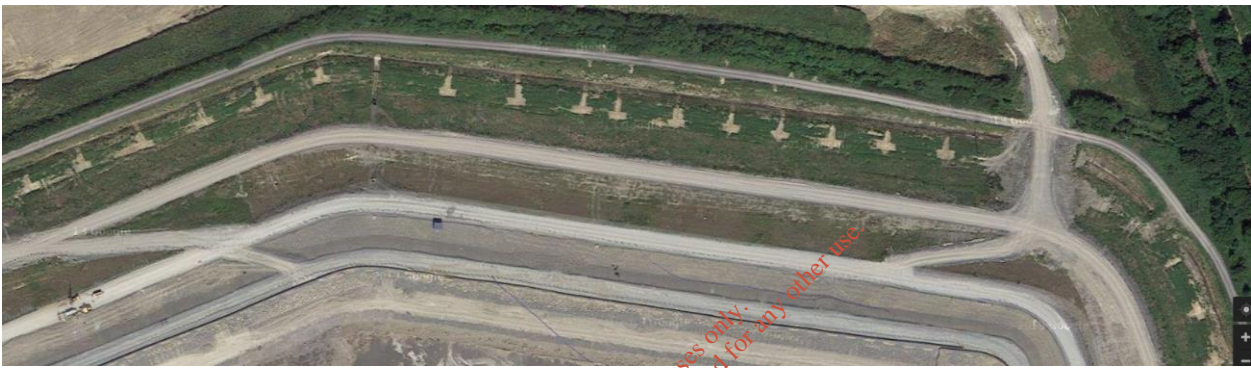
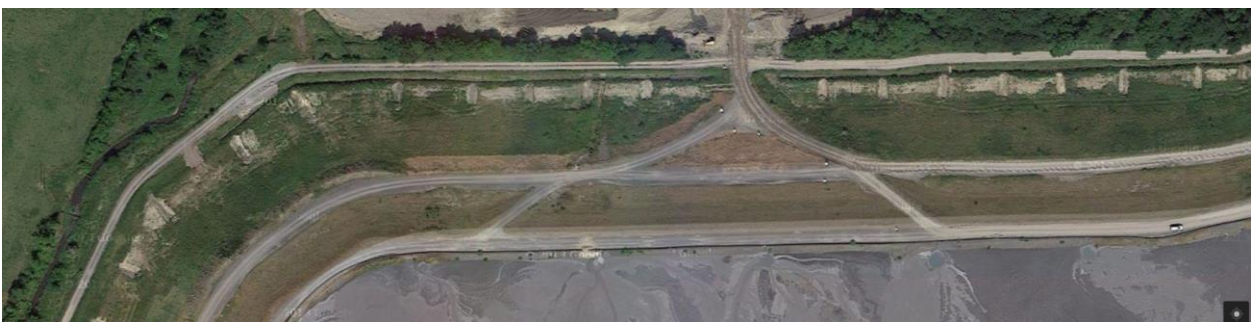
Photos showing locations of finger channels on the downstream side of the existing northern wall to be backfilled

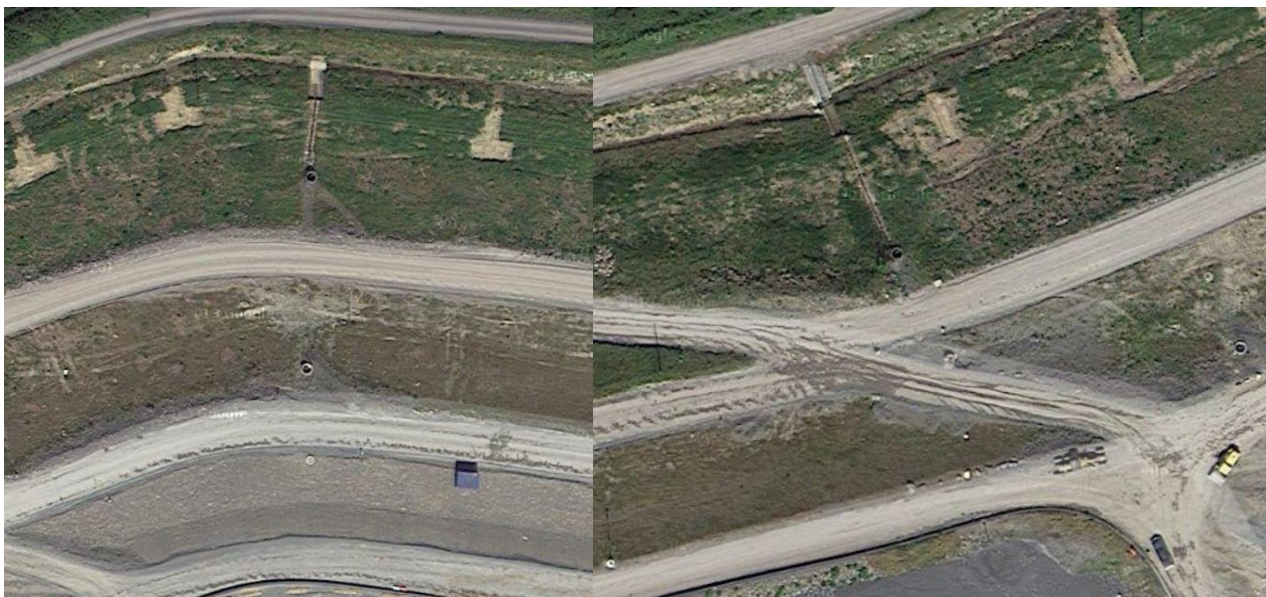
Photos showing locations of chutes and manholes on the downstream side of the existing northern wall to be backfilled
