**AQUATIC ASSESSMENT
OF
THE MAGHERARNEY RIVER**

**GROVE TURKEYS LTD
SMITHBOROUGH
CO. MONAGHAN**

LICENCE NO. P0832-01

DATE:	03 rd August 2021	PREPARED BY:	Tom Madden, BSc. Martin O'Looney, BSc.
REPORT NUMBER:	RQA_21_21145	REVIEWED BY:	Mike Fraher, BSc.

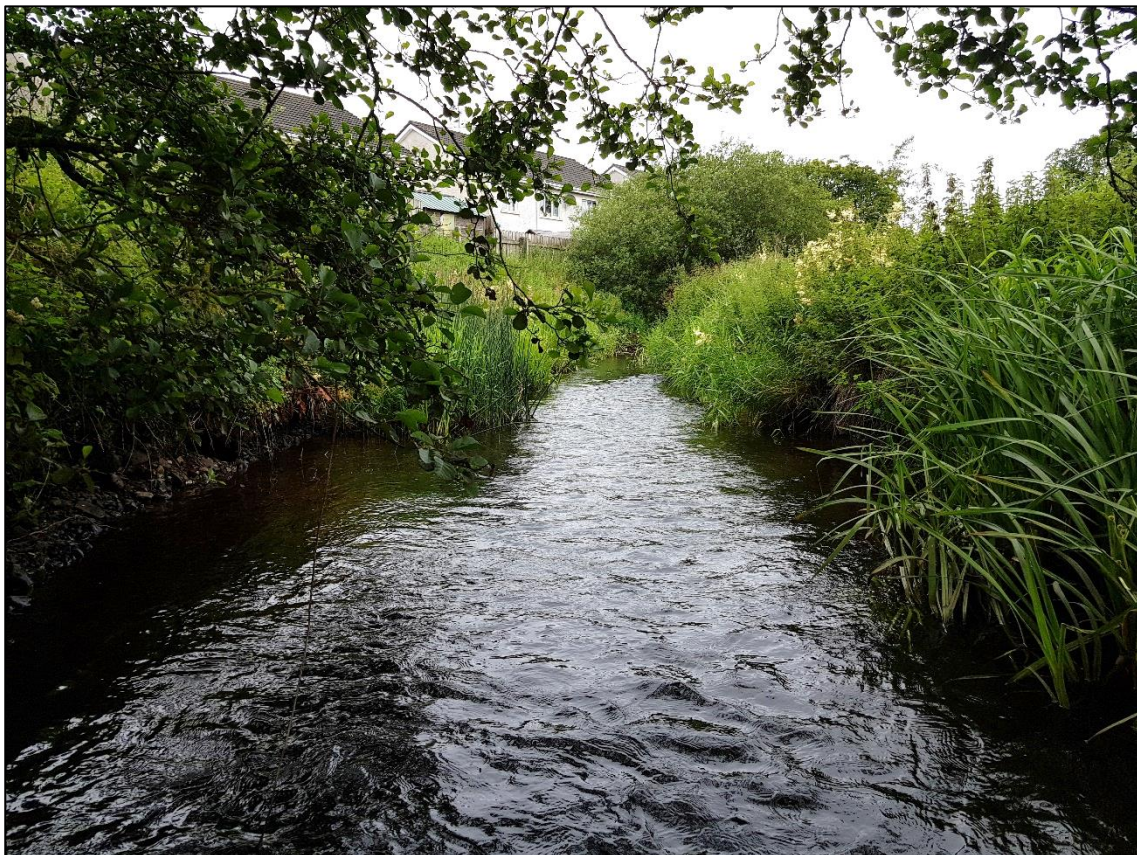
Figure 3.1: Monitoring Point 1

Monitoring Point 1 is located approximately 35m upstream of the discharge point. It is west of the Meadows Housing Estate. The EPA monitoring location “*Br E of Smithborough*” (Station code RS36M010150) is located approximately 2.2 km upstream of this monitoring point. In 2020, this monitoring position has been moved closer to the discharge point as safe access was available to a riffle area.

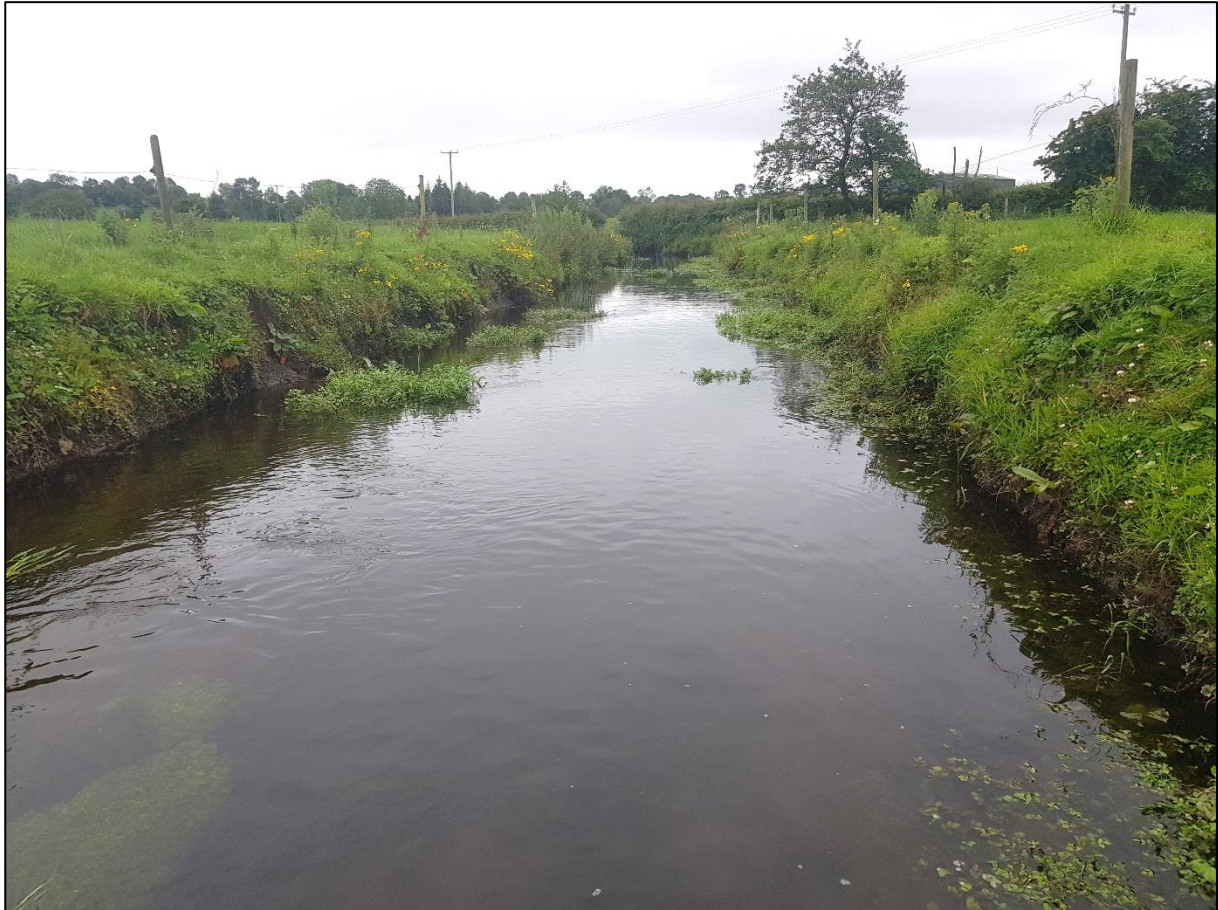
Figure 3.2: Monitoring Point 2

Monitoring Point 2 is located 100m downstream of the discharge point. It is East of the Meadows Housing Estate. The EPA monitoring location “*Magherarney Br*” (Station code RS36M010200) is located approximately 950m downstream of this monitoring point.

Following the dredging of this section of river several years ago, the substrate of the river continues to change significantly, year on year. Since 2019, a large earth island in the centre of the channel has decomposed and earth deposits are now present on the edges of the channel. The river bed was also muddier in 2020, losing areas of fine gravel/sand beds which were present in 2019.
