**Killeen Bog**

**Cutaway Bog Decommissioning and  
Rehabilitation Plan  
2025**

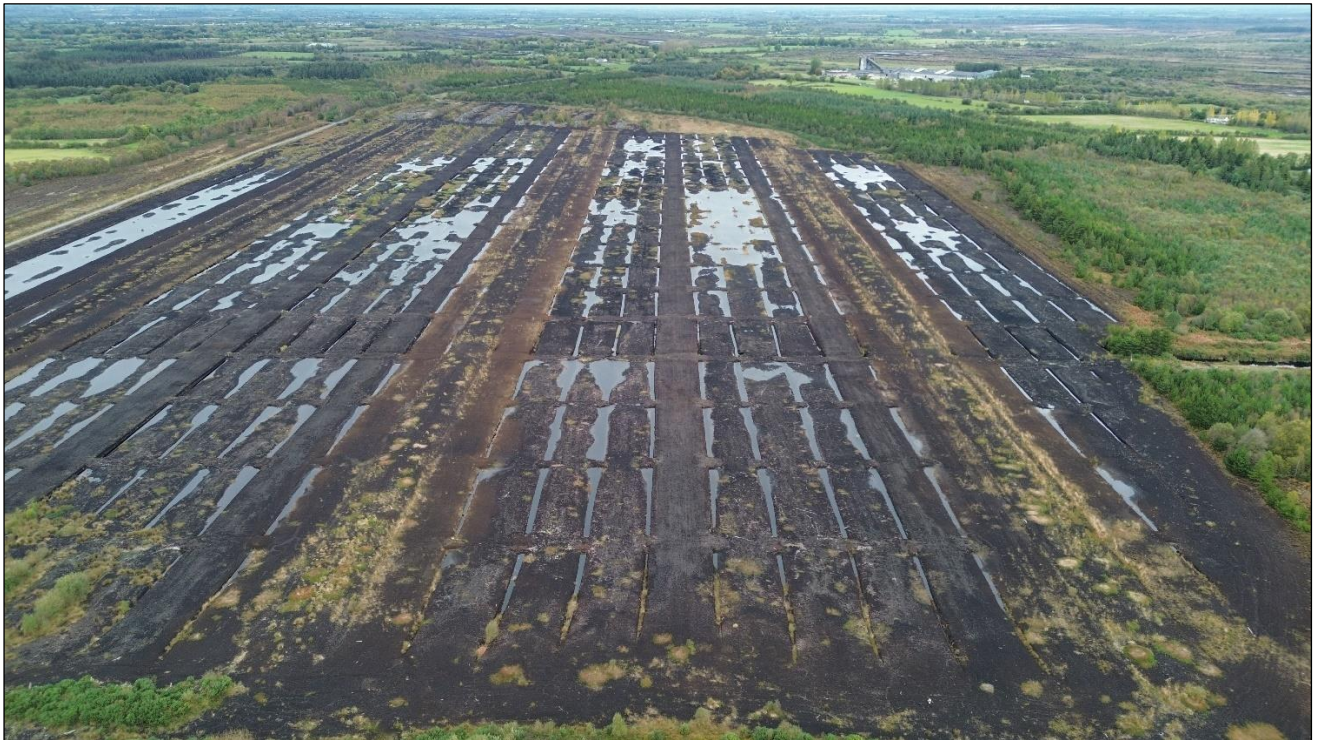
Plate 3-1 Previous standard drain blocking measures at Killeen Bog (Killeen subsection, view looking north), where pioneer vegetation has begun to slowly develop.

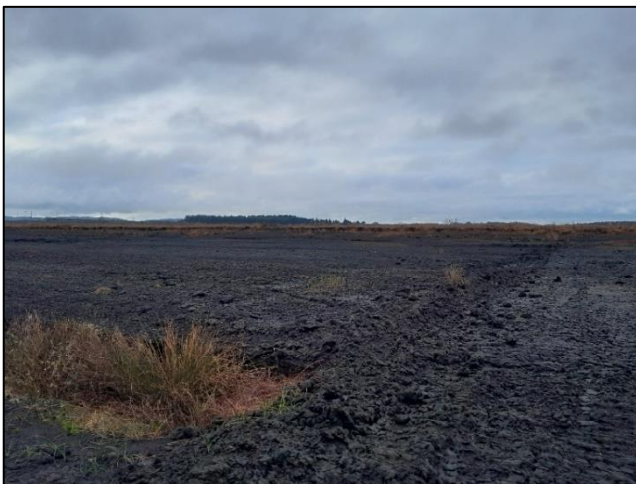
Plate 3-2 Cutover dominated by bare peat and with sparse pioneer vegetation of *Junus effusus* and *Eriophorum angustifolium* along the drains in the centre of Killeen Bog.

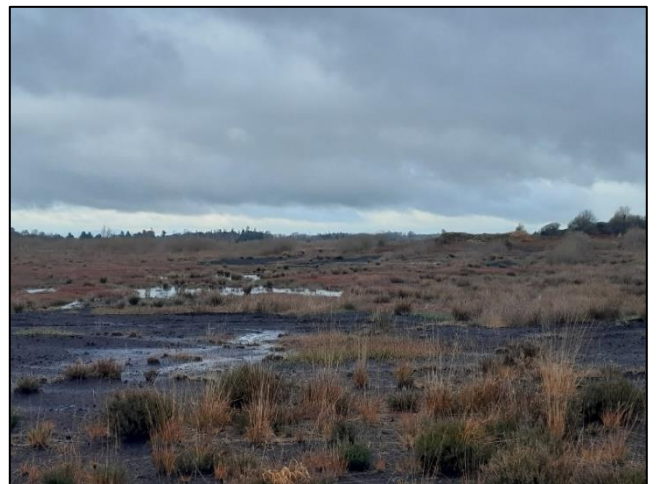
Plate 3-3 Cutover bog with pioneer vegetation including *Molinia caerulea* (gMol) and *Calluna vulgaris* (dHeath), *Junus effusus* (pJeff) and *Eriophorum angustifolium* (pEang).

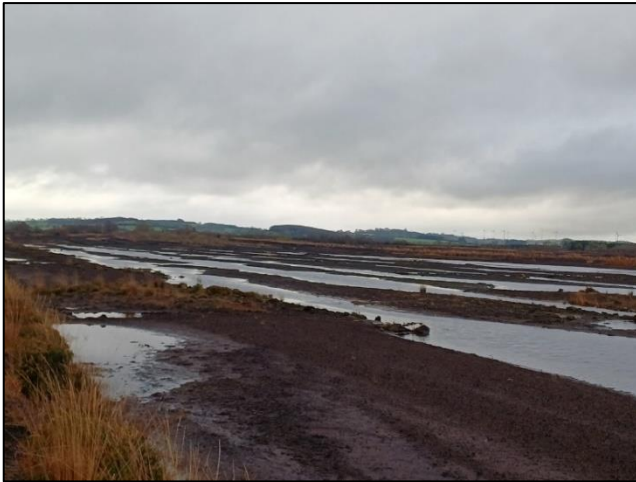
Plate 3-4 Open water (OW) in the south of Killeen Bog with pioneer *Juncus effusus* (pJeff) and *Eriophorum angustifolium* (pEang) around the edges of the ponding areas and bare peat in the foreground.

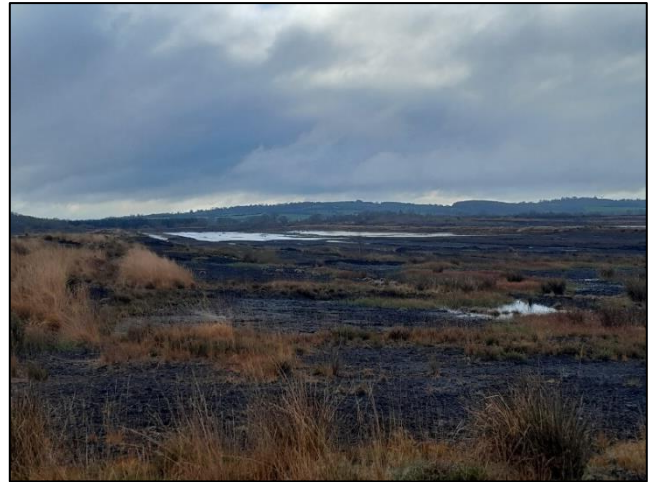
Plate 3-5 Cutover bog with pioneer vegetation dominated by *Juncus effusus* (pJeff), *Molinia caerulea* (gMol) and *Eriophorum angustifolium* (pEang) in the centre of Killeen Bog.

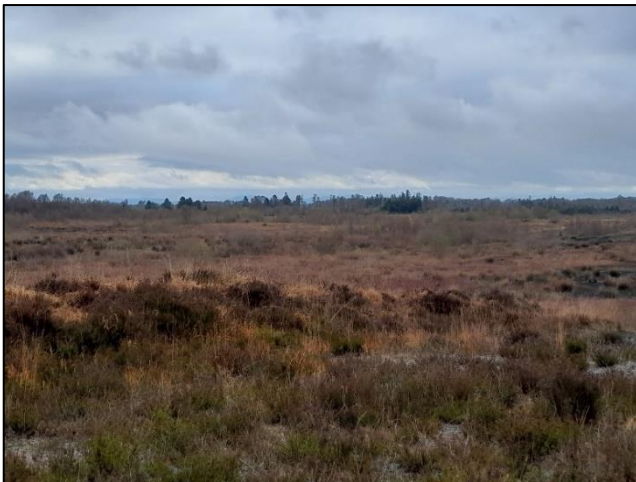
Plate 3-6 Recolonising gravel ridge in the foreground dominated by *Calluna vulgaris* and *Molinia caerulea* located in the north of Killeen Bog.

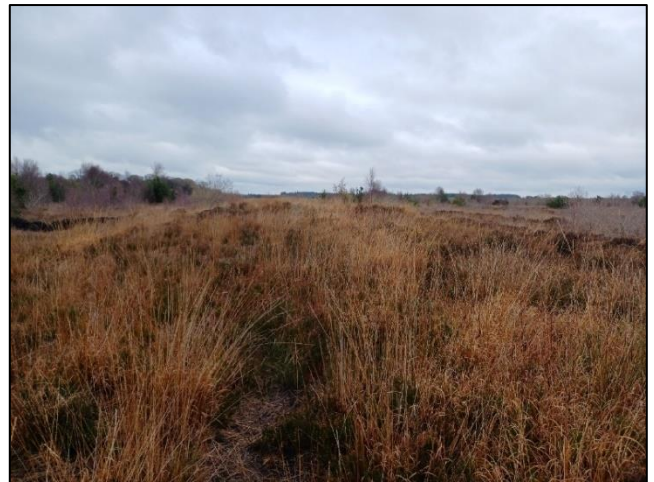
Plate 3-7 Cutover dominated by *Calluna vulgaris* (dHeath) and *Molinia caerulea* (gMol) in the foreground with scrub/birch woodland (BirWD) along the bog margins, located in the north of the site.

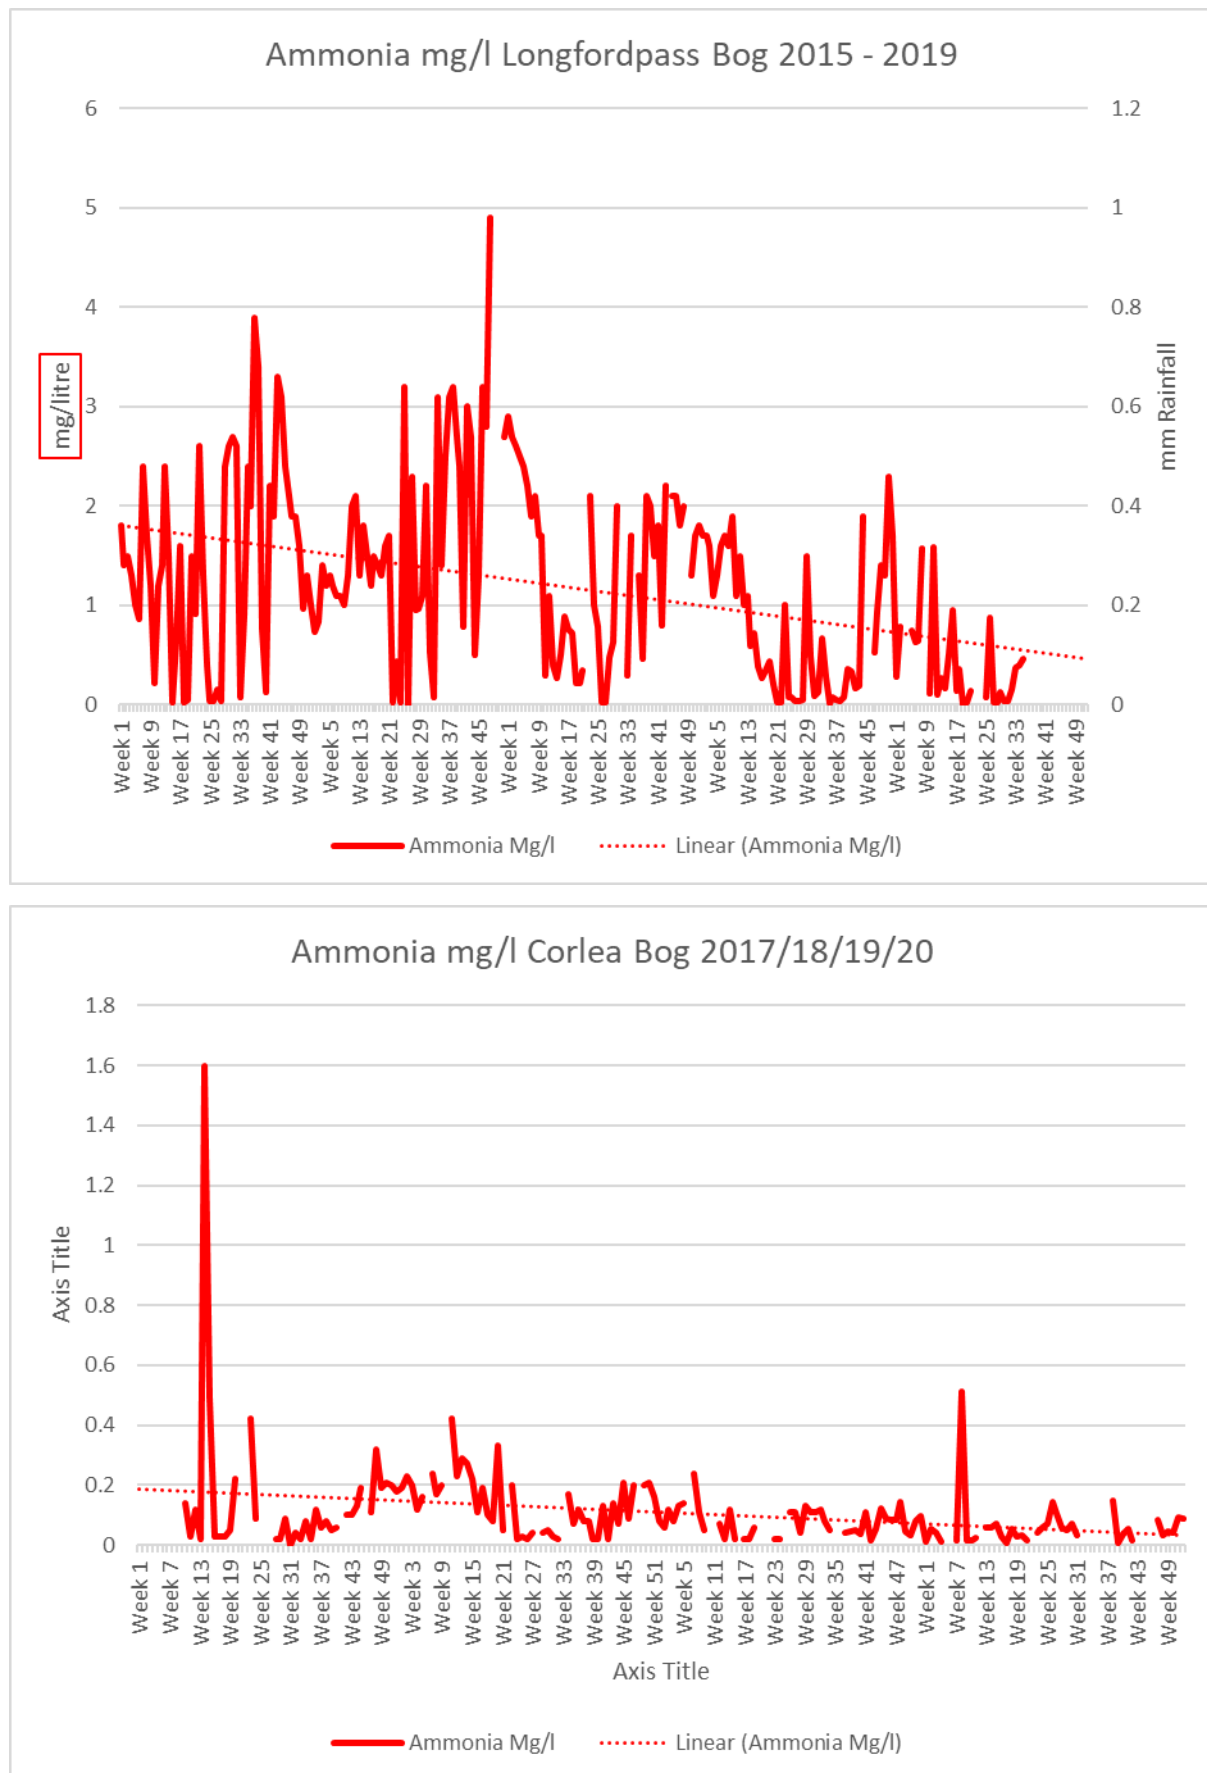
**Figure 7.1.** Ammonia levels over the period 2015-2019 at Longfordpass and the period 2017-2020 at Corlea.

Similarly monitoring of surface water ammonia emissions from a Corlea bog in Mountdillon over the past 4 years, post cessation of peat extraction with ongoing rehabilitation, indicate downward trends.

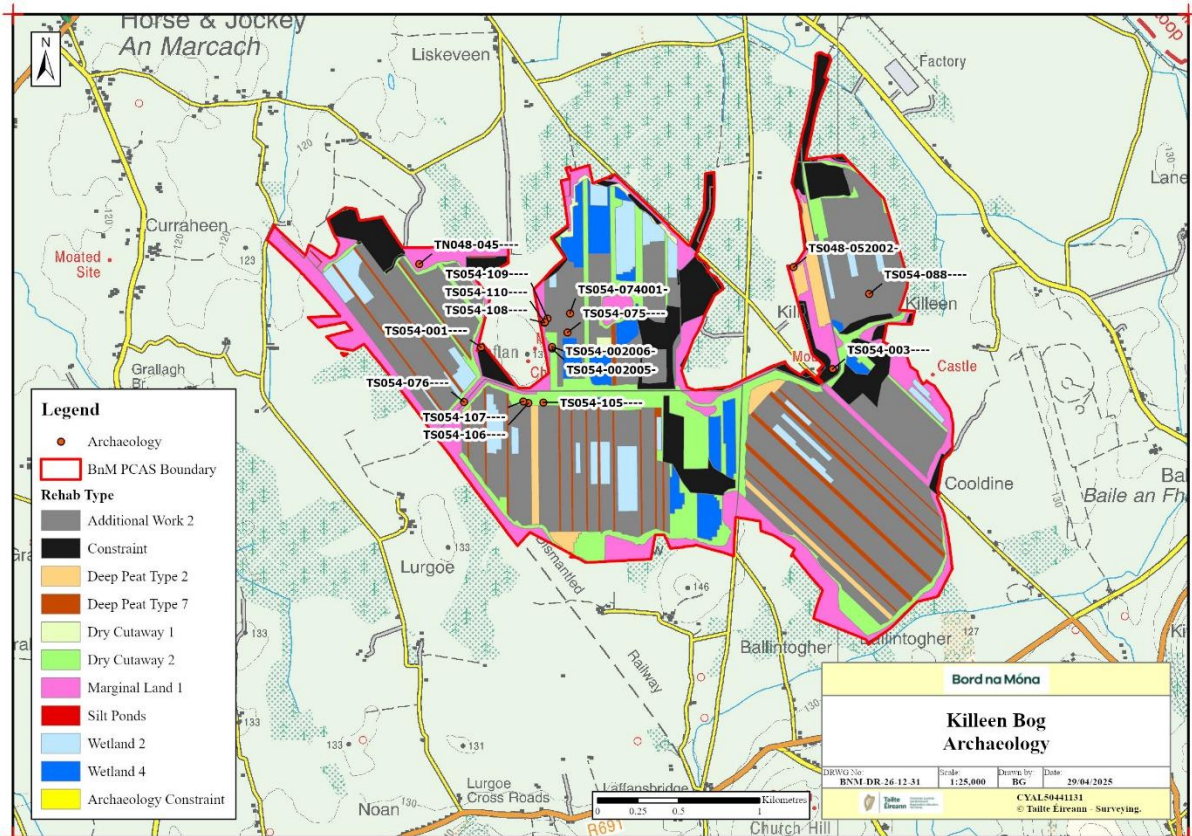
Fig. 1. Killeens Bog, Co. Tipperary, indicating the locations of the sightings mentioned in Table 2.

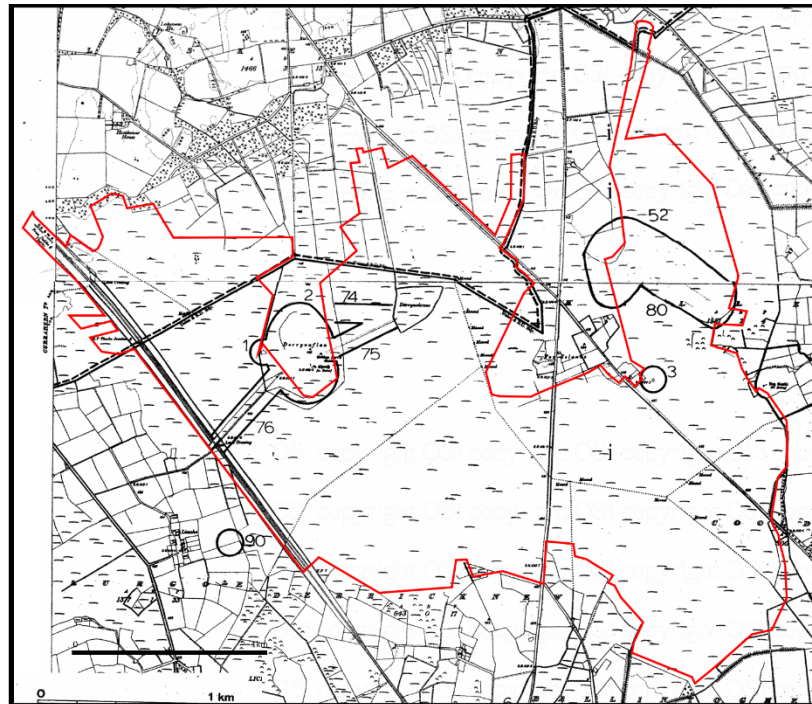
Fig. 2. Killeens Bog, Co. Tipperary, detail of the Record of Monuments and Places. The proposed rehabilitation area is outlined with the red line. There are Recorded Monuments in the rehabilitation area.

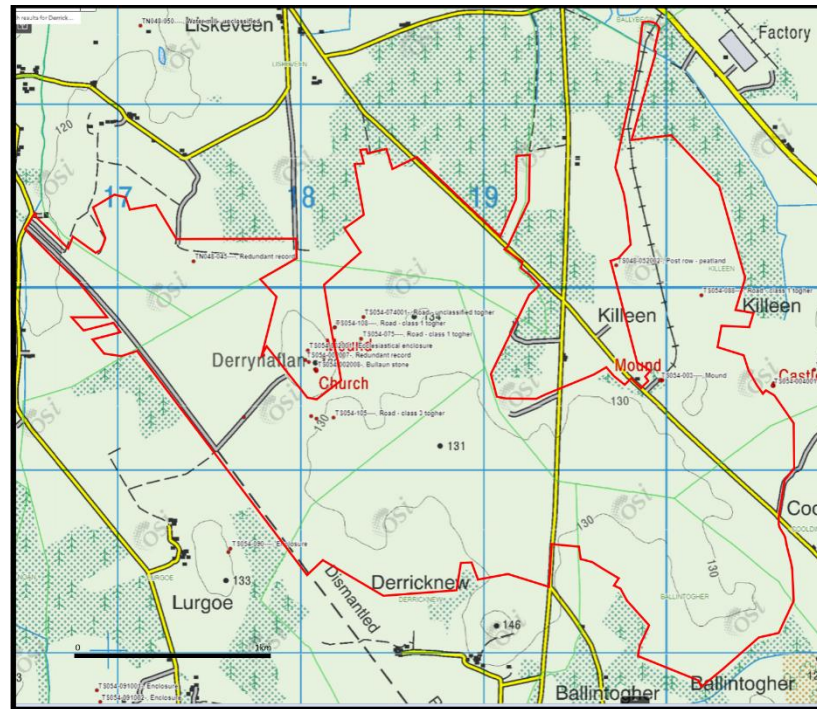
Fig. 3. Killeens Bog, Co. Tipperary, detail of the Sites and Monuments Record. The proposed rehabilitation area is outlined with the red line.

The Sites and Monuments Record (SMR) which is maintained by the Department of Housing, Local Government and Heritage was examined as part of the assessment on the 24th of April 2025. The SMR consists of records included in the RMP and sites and monuments notified to the Dept. since the publication of the RMP. This review established that there are 17 entries in the SMR in the proposed rehabilitation area (see Tables 2 and Fig. 3).
